AGARDograph No. 221

## Advanced Techniques in Crash Impact Protection and Emergency Egress from Air Transport Aircraft

R.G.Snyder

Published June 1976

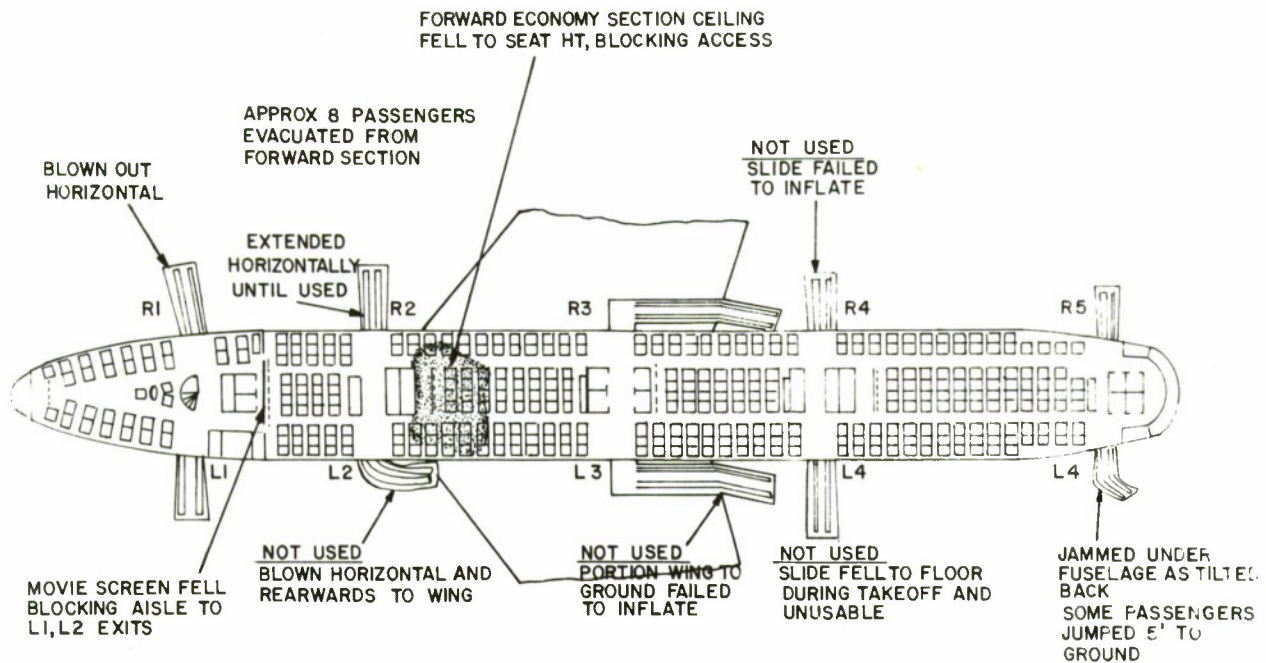
jammed under the fuselage as the aircraft tilted to the tail-down position. The exit floor was then about 1.5 m (5 ft) above the ground and some passengers utilized the exit by jumping to the ground. The forward exit slides became almost vertical as the aircraft settled back on its tail. At least four persons were observed using slide L-1 and others used R-1 after the aircraft tilted. Eight passengers were hospitalized with serious back injuries after they used the No. 1 slides. Nineteen other persons received minor cuts, abrasions, contusions and sprains during the evacuation. There was no record of the total elapsed time required to complete the evacuation. Fortunately there was no smoke or fire to affect evacuation.

Fig. 13. Diagram of emergency egress hazards contributing to injuries in this Boeing 747 accident.

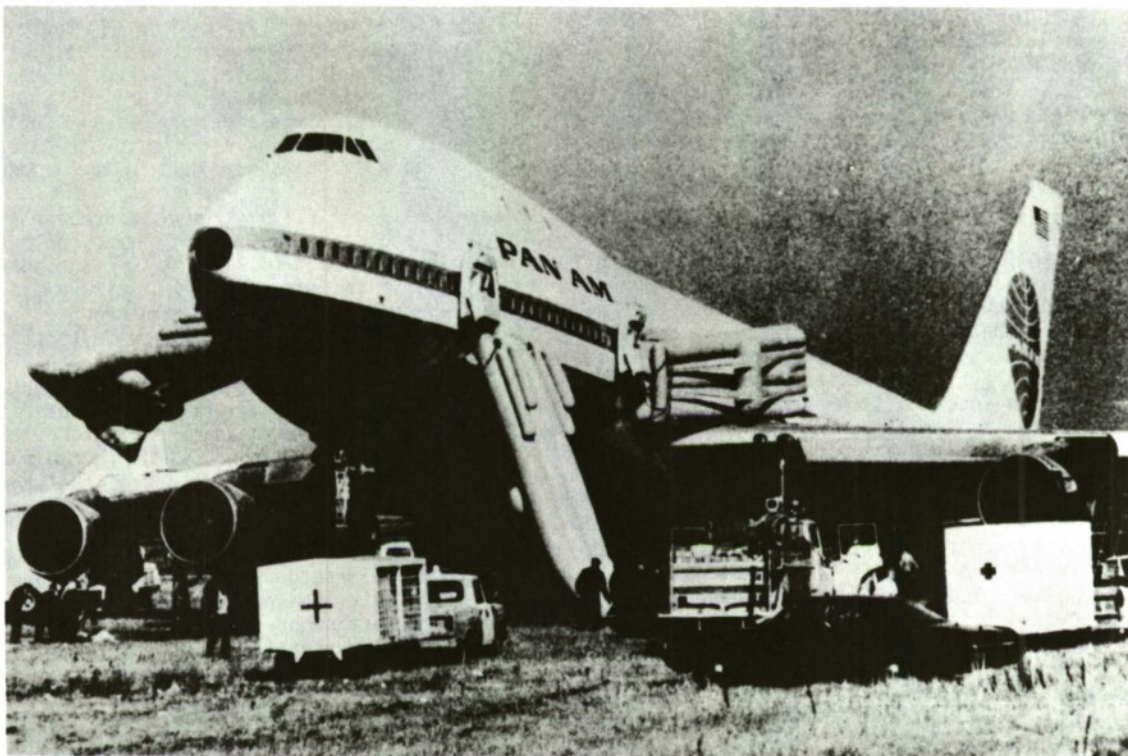
Fig. 14. Pan American Boeing 747 accident at San Francisco 30 July, 1971, resulting in nose-high attitude. 27 injuries were suffered in the subsequent evacuation. Note wind effect on left (L-2) slide, blown aft almost parallel to the wing, and right side (R-1) escape slides. The vertical deployment of left L-1 escape slide resulted in an almost vertical drop of approximately 27 feet (or a 3-story drop). (Photo courtesy NTSB. See ref. 191.)

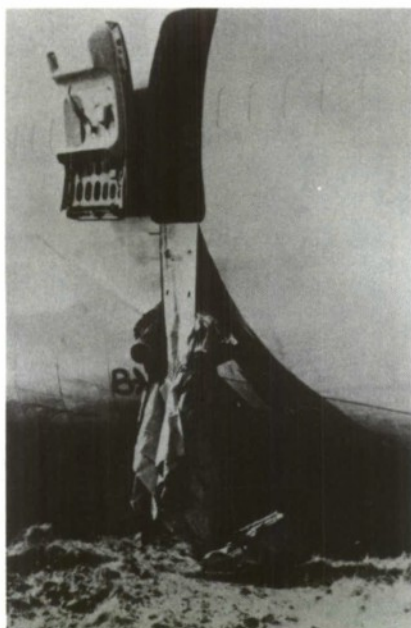
Fig. 15. Evacuation slide failure in Pan American Boeing 747 accident.

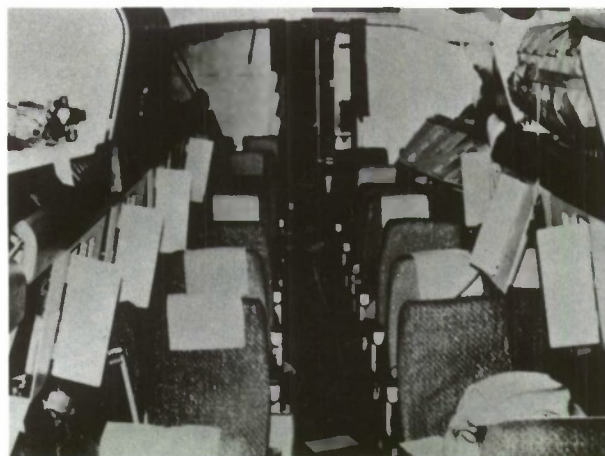
Fig. 16. Obstacles to passenger egress in Icelandic Airlines McDonnell Douglas DC-8-61 "hard landing" included failure of hat racks, injuring passengers, and failure of overhead compartments, spilling life rafts and an emergency escape slide pack into the aisle.

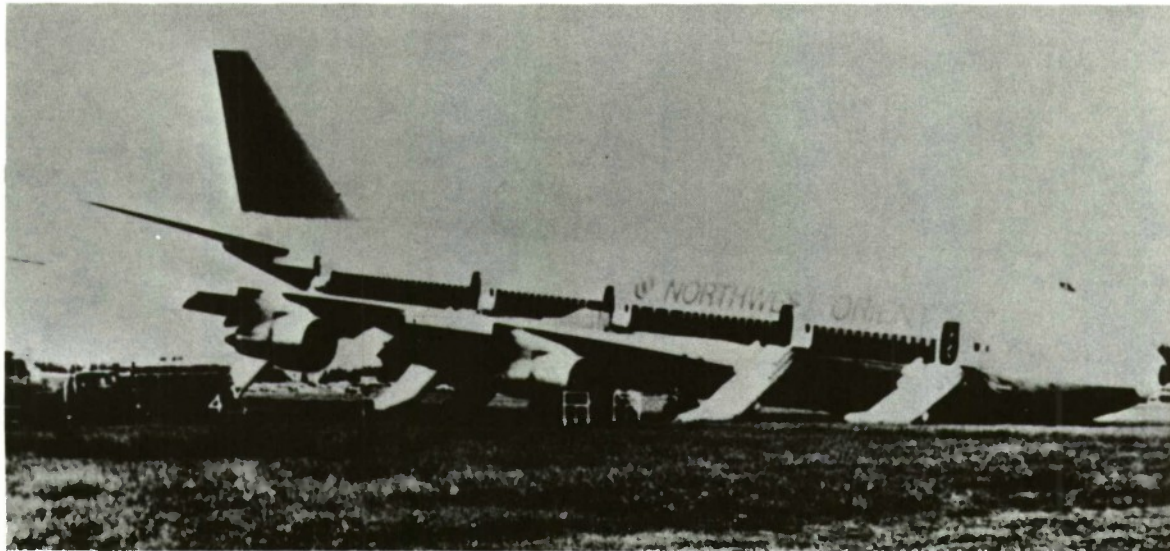
Fig. 17. Tail-high attitude in this Miami Boeing 747 accident rendered the rear emergency evacuation slide unusable (Photo courtesy Wide World Photos).

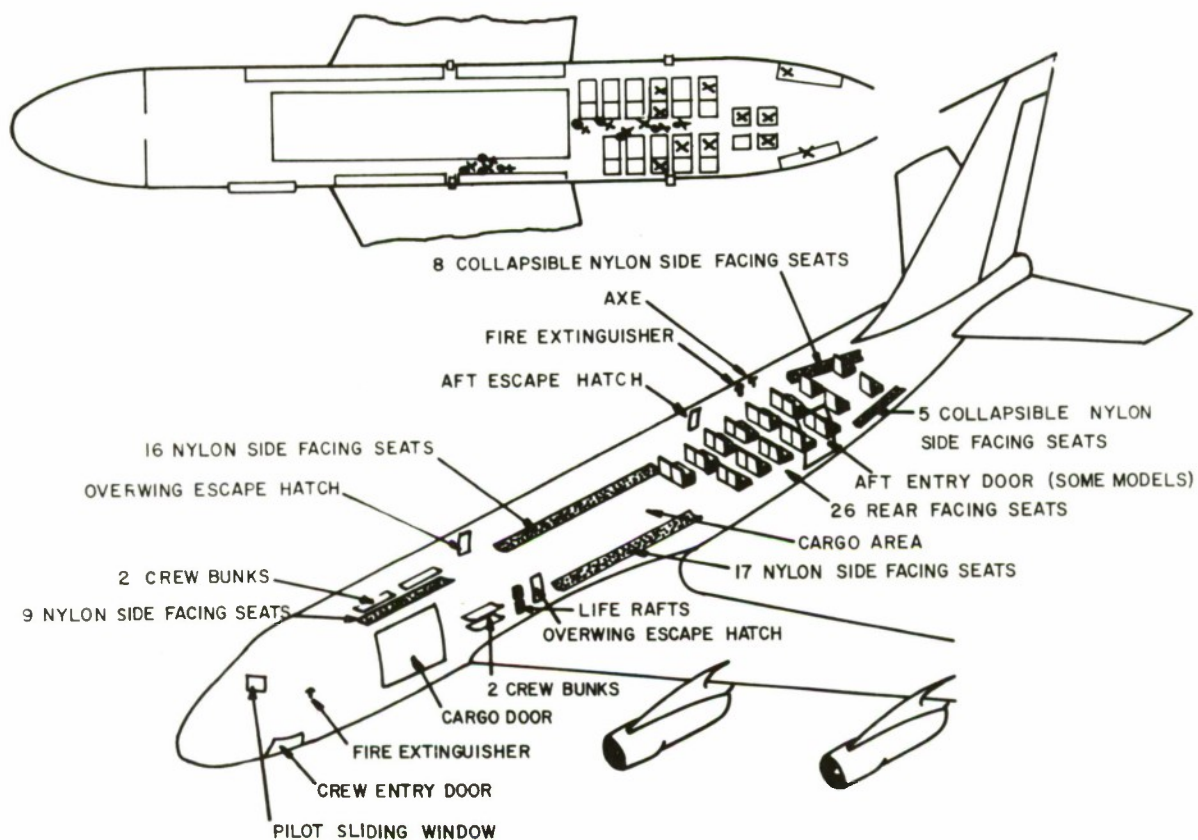
The pilot, copilot, and boom operator received vertebral compression fractures in the impact due to either not having the shoulder harness on or not locking it prior to landing impact. The navigator noted all the equipment in the compartment above his station came down on his head on impact. Egress problems were noted on the flight deck, with both the pilot and copilot getting stuck in their respective window exits, blocking exit for other crew, and not having time to locate or use the escape rope. Evacuation was completed in 45 seconds. The location of exits and fatalities is shown in Fig. 19. Note the pile-up of four fatalities which occurred aft of the left overwing exit due to aisle blockage from small cargo, and the apparent inability of those passengers in the aft compartment to egress through the right or left aft escape windows, even though one individual was identified as sitting in the aisle seat adjoining the left aft window. In this configuration, 26 individuals used rear-facing seats, but six passengers sitting over the boom pod area would have had great difficulty in assuming the recommended ditching and crash landing position as found in T01C-135KA-1 [pp. 3-52 (436)], even if they had been pre-warned of the crash. Survivors reported that they had a great problem in attempting to evacuate through the available emergency exits from any seated position.

Fig. 19. Location of emergency egress exits and fatalities in Boeing KC-135 crash (Case #1).

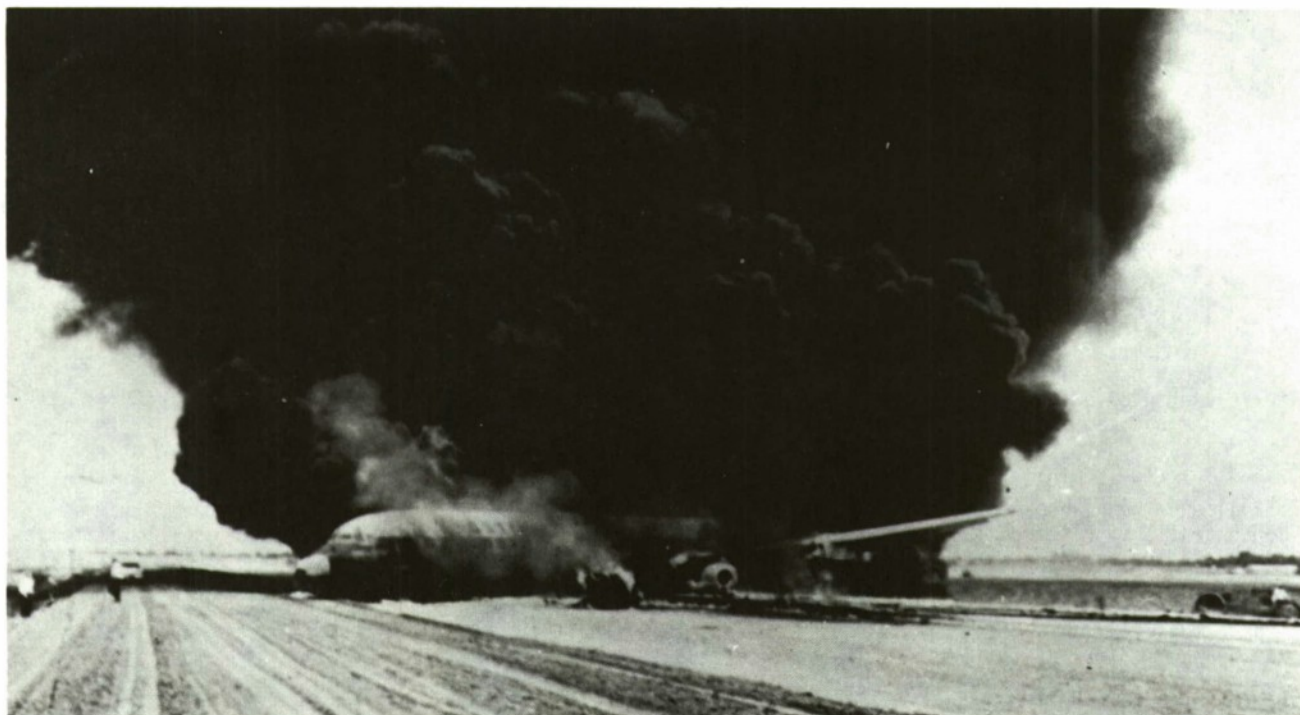
Fig. 22. Fire and heavy smoke resulted in 45 fatalities of 62 passengers in this Trans World Airlines Boeing 707-331 accident at Fiumicino Airport, Rome, 23 November, 1964 (Photo courtesy FAA).

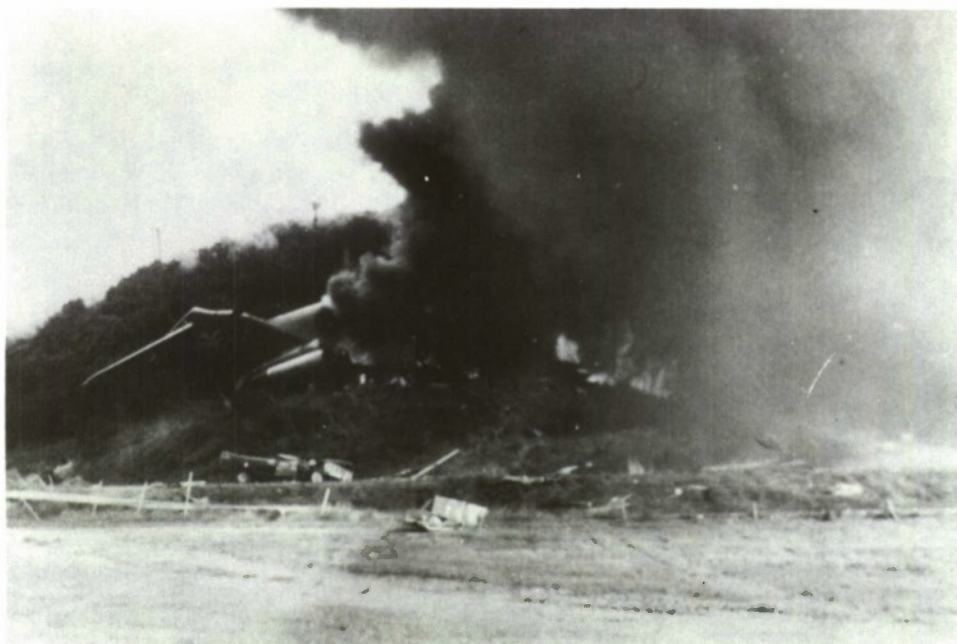
Fig. 23. Dense smoke and fire following crash of Boeing 727 at St. Thomas, Virgin Islands 28 December, 1970 (203) (Photo courtesy NTSB).

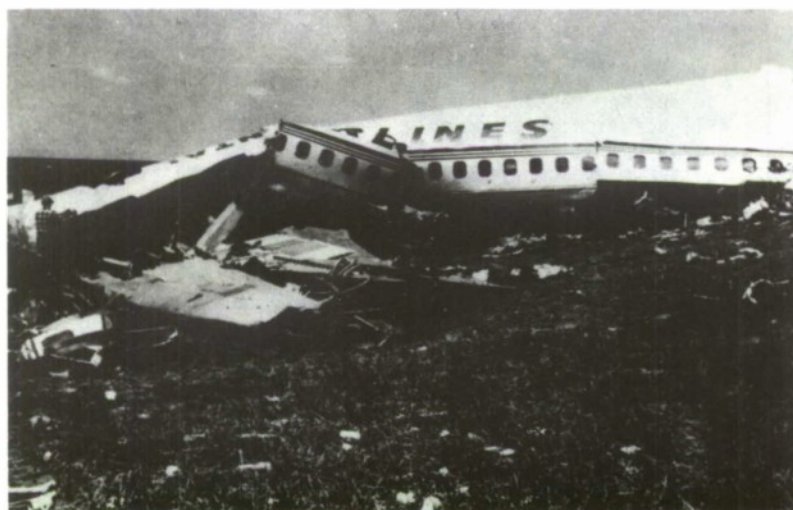
Fig. 93. Post-crash view of Douglas DC-7 aircraft crash-tested by the FAA showing typical extreme buckling of the fuselage (Photo courtesy FAA).
