| 403093S | DEPARTMENT OF THE ARMY UNITED STATES ARMY AVIATION TEST BOARD' Fort Rucker, Alabama 36360 STEBG-TD SUBJECT: Letter Propert, "Product Improvement Test, T53-L-11 Metal Spray Repaired Engine," RDT&F Project No. , USATECOM Project No. 4- | 17. |

SUBJECT: Letter Report, "Product Improvement Test, T53-L-11 Metal Spray Repaired Engine," RDT&E Project No. , USATECOM Project No. 4-5-0151-13

ENGINEERING ANALYSIS

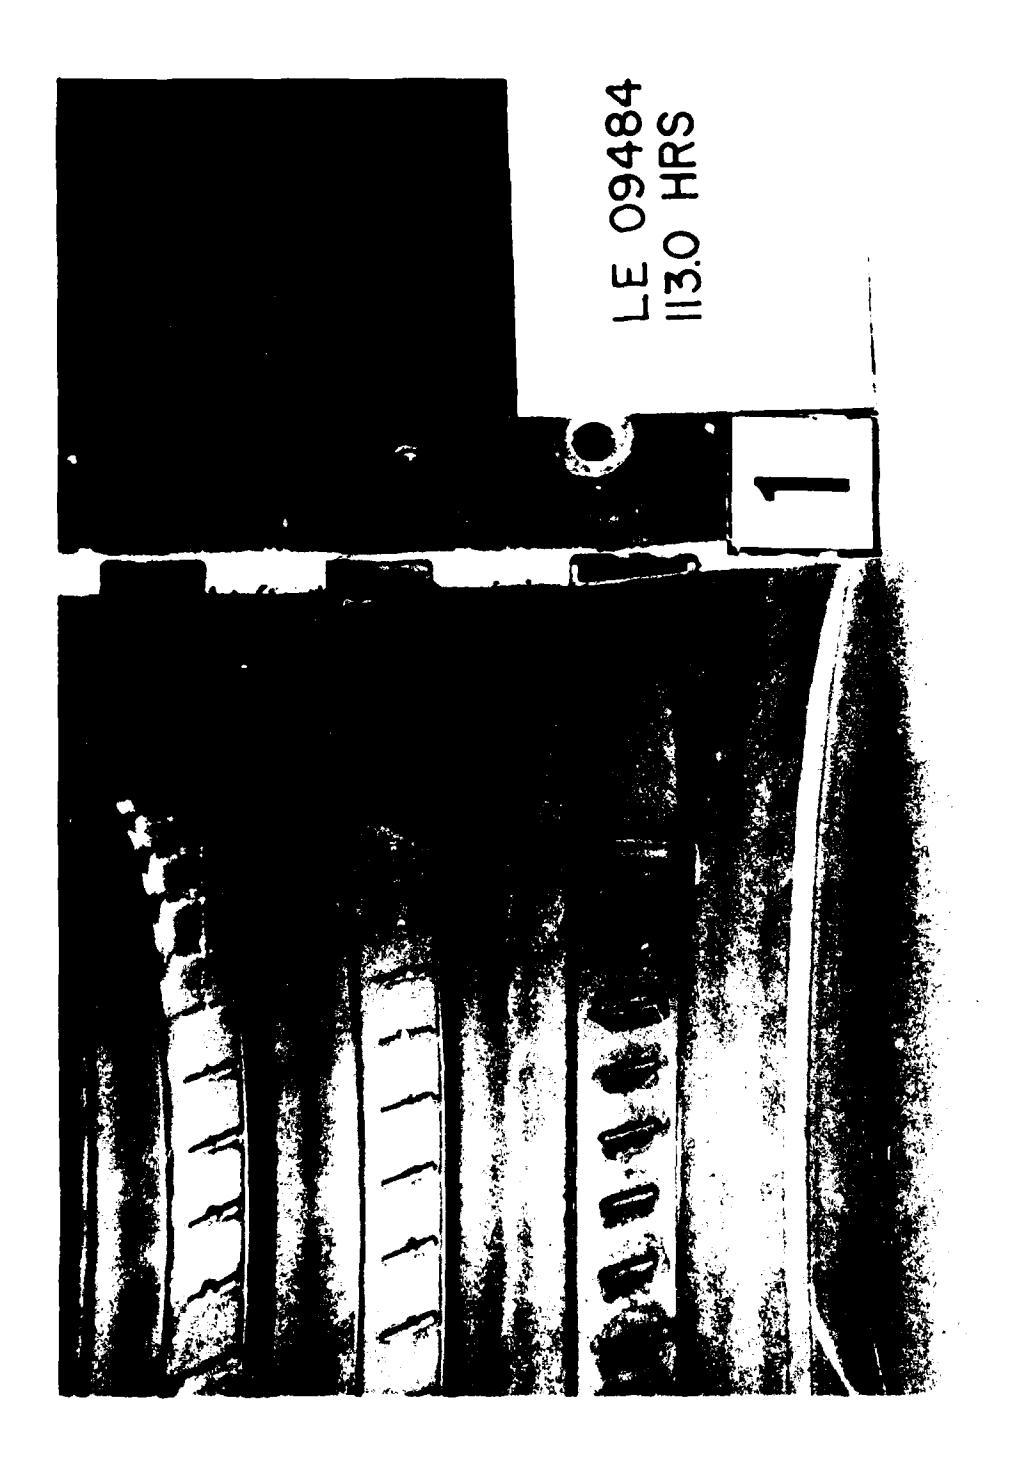
Figure 12.

upper compressor case land areas is shown in figure 11 (left side, forward section), figure 12 (right side, forward section), figure 13 (left side, rear section), and figure 14 (right side, rear section). Figure 15 is a close-up of the area shown in figure 10. The almost total disappearance of the erosion pits (shown in figure 10) along the leading edge of the third-stage land is evident in figure 15. This was because the leading edge of the metal spray land had initially extended further into the airstream than had the outer vane shrouds. The sand eroded the leading edge of the land until the land was flush with the vane outer shroud. Figure 16 shows the pitting that was beginning to develop on the leading edge of the fifth-stage land at the right rear of the upper compressor case. Figure 17 shows the trailing edge of the fifth-stage stators on the upper compressor case at the left side. The thinning of the outer trailing edges of the vanes is evident. Figure 18 shows the similar condition on the right side of the upper compressor case at the trailing edge of the fifthstage stators. The general condition of the vanes and blades is shown in figure 19.

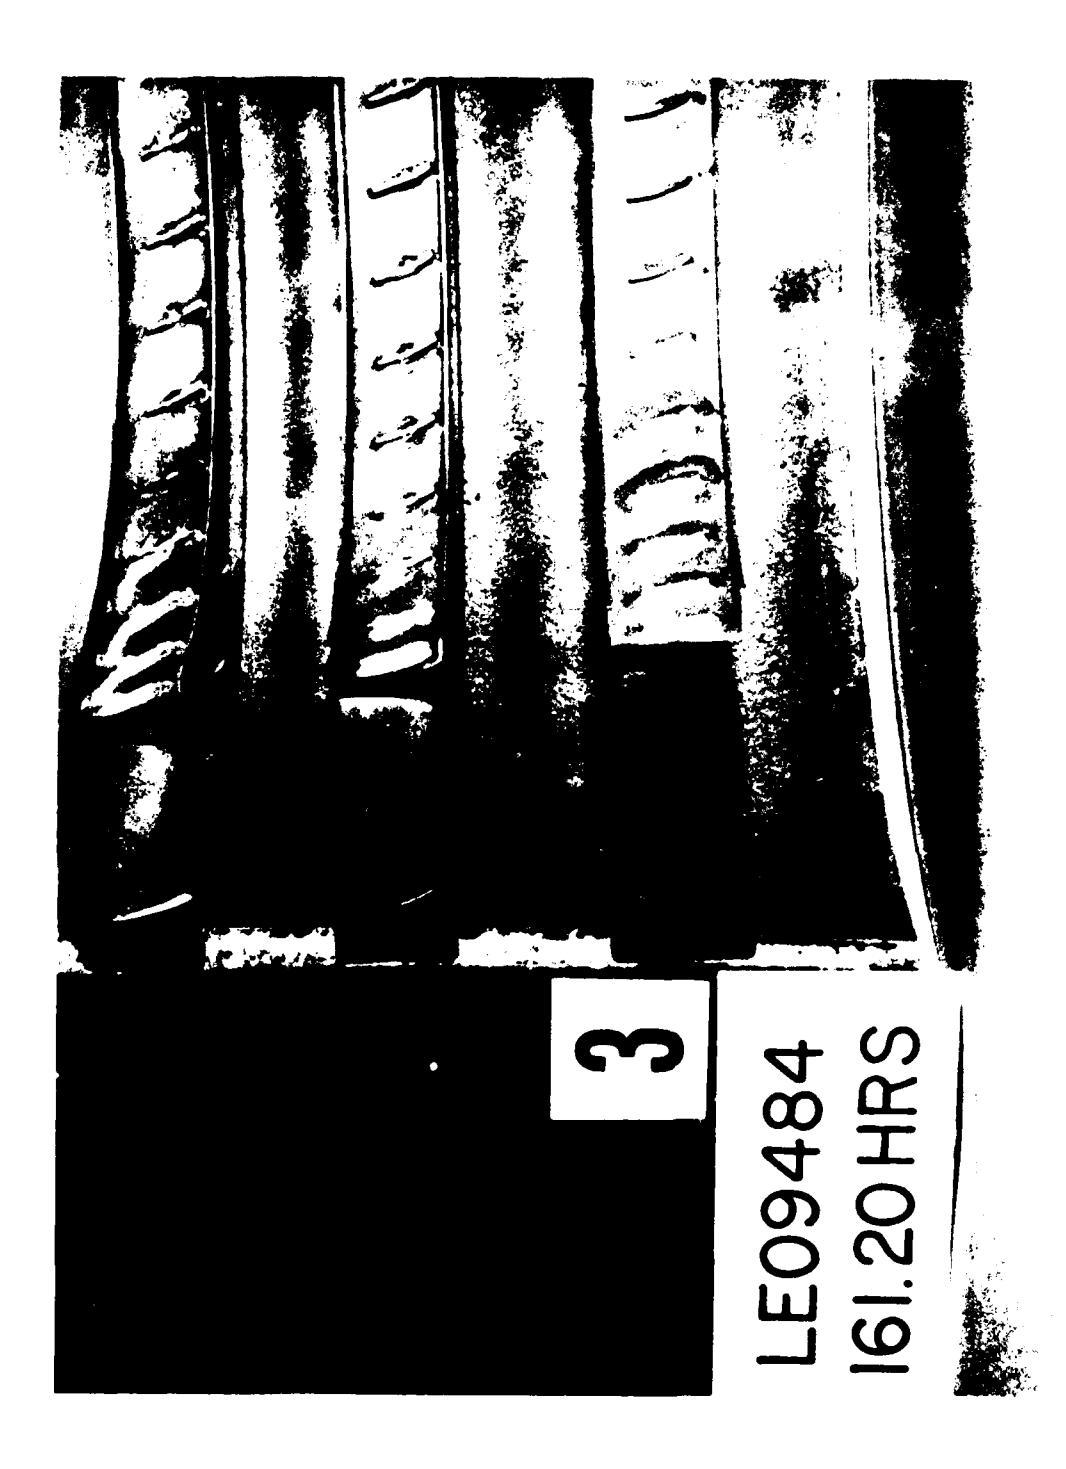
Figure 20.

3. The top compressor case was again removed and inspected at 161.2 engine hours (3.3 sand hours). The general condition of the tophalf compressor lands is shown in figure 20 (left side, forward section), figure 21 (right side, forward section), figure 22 (left side, rear section), and figure 23 (right side, rear section). Figure 24 shows a center section of the third-, fourth-, and fifth-stage lands. Figure 25 shows the same area shown in figure 16. The pitting at the leading edge of the fifth-stage land had developed further. Figure 26 shows the general condition of the blades and vanes. Also observed at this inspection and pictured in figure 26 were erosion depressions (indicated by the arrow) in the lower compressor case aft of the second-stage stator vanes. The same area after 113.0 engine hours (2.2 sand hours) is indicated by the arrow in figure 19.

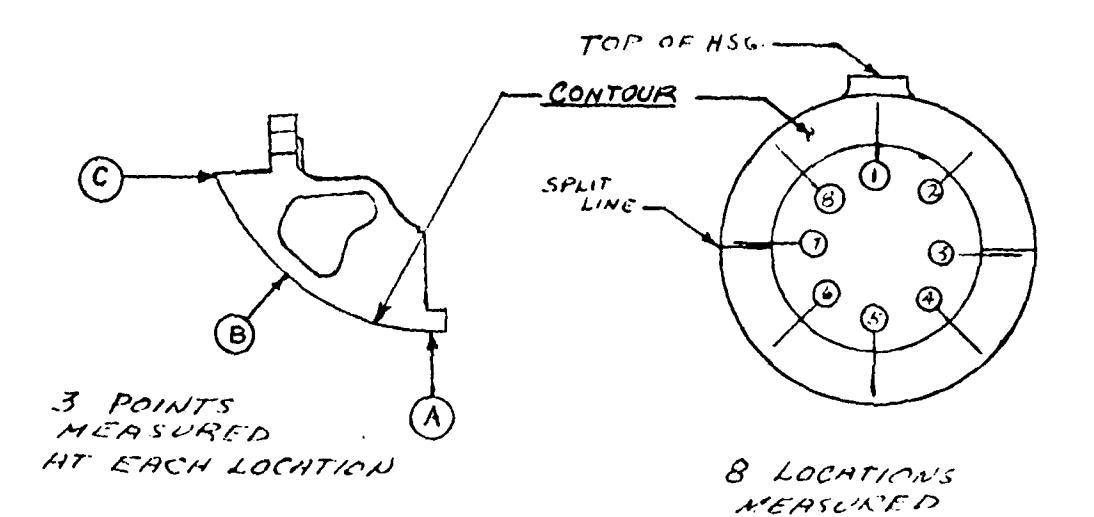
FORT RUCKER TEST ENGINE CENTRIFUGAL COMPRESSOR HOUSING

b. See Figure 3 for dimensional data. It is interesting to note that the top half realized greater erosion damage than did the bottom half of the housing. The extreme erosion damage on this housing further attests to the severity of the Ft. Rucker test. This test housing (S/N XR9192) shall be used as a basis for comparison in future tests of this nature.

The below listed data concerns the measurement of the centrifugal compressor housing contour for erosion damage. Dimensions listed show extent of erosion below drawing minimum.

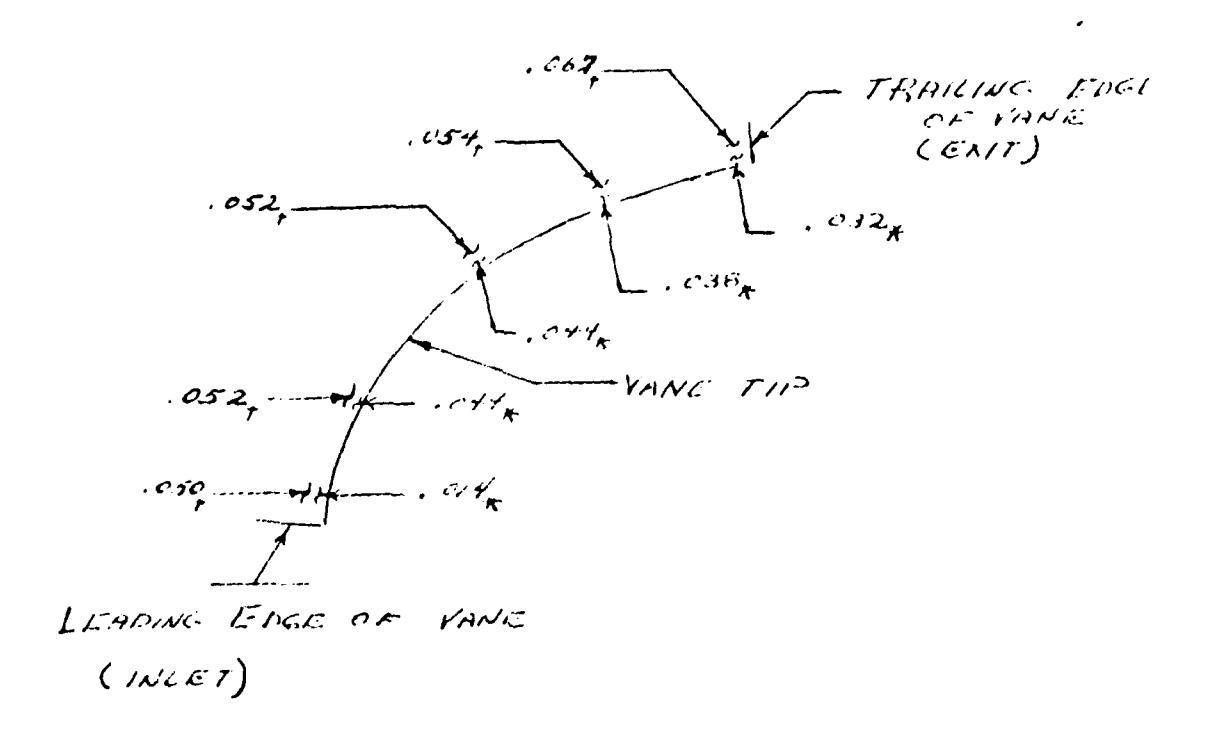
FORT RUCKER TEST ENGINE CENTRIFUGAL IMPELLER

a. See inclosures VI thru XII which show the severe erosion damage on subject stator vanes. There is no criteria available to show whether these impeller vanes were new or used parts at time of test engine overhaul in Nov 66. Dimensional inspection has been accomplished after test. Should this data be desired, contact this writer.

The below listed data concerns the vane thickness measurement as an inspection for erosion damage. One typical vane was measured five locations equally spaced along the blade length. Two measurements were taken at each location, 1/16 inch from vane tip and 3/8 inch from blade tip respectively.
