Technical Report Documentation Page 1. Report No. 3. Recipient's Catalog No. 2. Government Accession No. 5. Report Date Title and Subtitle December 1976 erforming Organization Code AIR CARRIER CABIN SAFETY. A Survey. 8. Performing Organization Report No. 7. Author's) 9. Performing Organization Name and Address 10. Work Unit No. (TRAIS) Federal Aviation Administration Office of Aviation Safety 11. Contract or Grant No. 800 Independence Avenue, S. W. Washington, D. C. 20591 13. Type of Report and Period Covered 12. Sponsoring Agency Name and Address A Survey. Kept. + ✓ July-September 1976. 14. Sponsoring Agency Code 15. Supplementary Notes 16. Abstract This is an overview report on the status and efficacy of the Federal Aviation Administration's air carrier cabin safety program. Up-to-date information on recurring cabin safety issues and problems was solicited from airplane manufacturers, air carriers, flight and cabin crews, associated organizations and others. The National Transportation Safety Board provided pertinent accident data and safety recommendations developed from aircraft accident investigation. The survey identifies significant recurring cabin safety operational problem

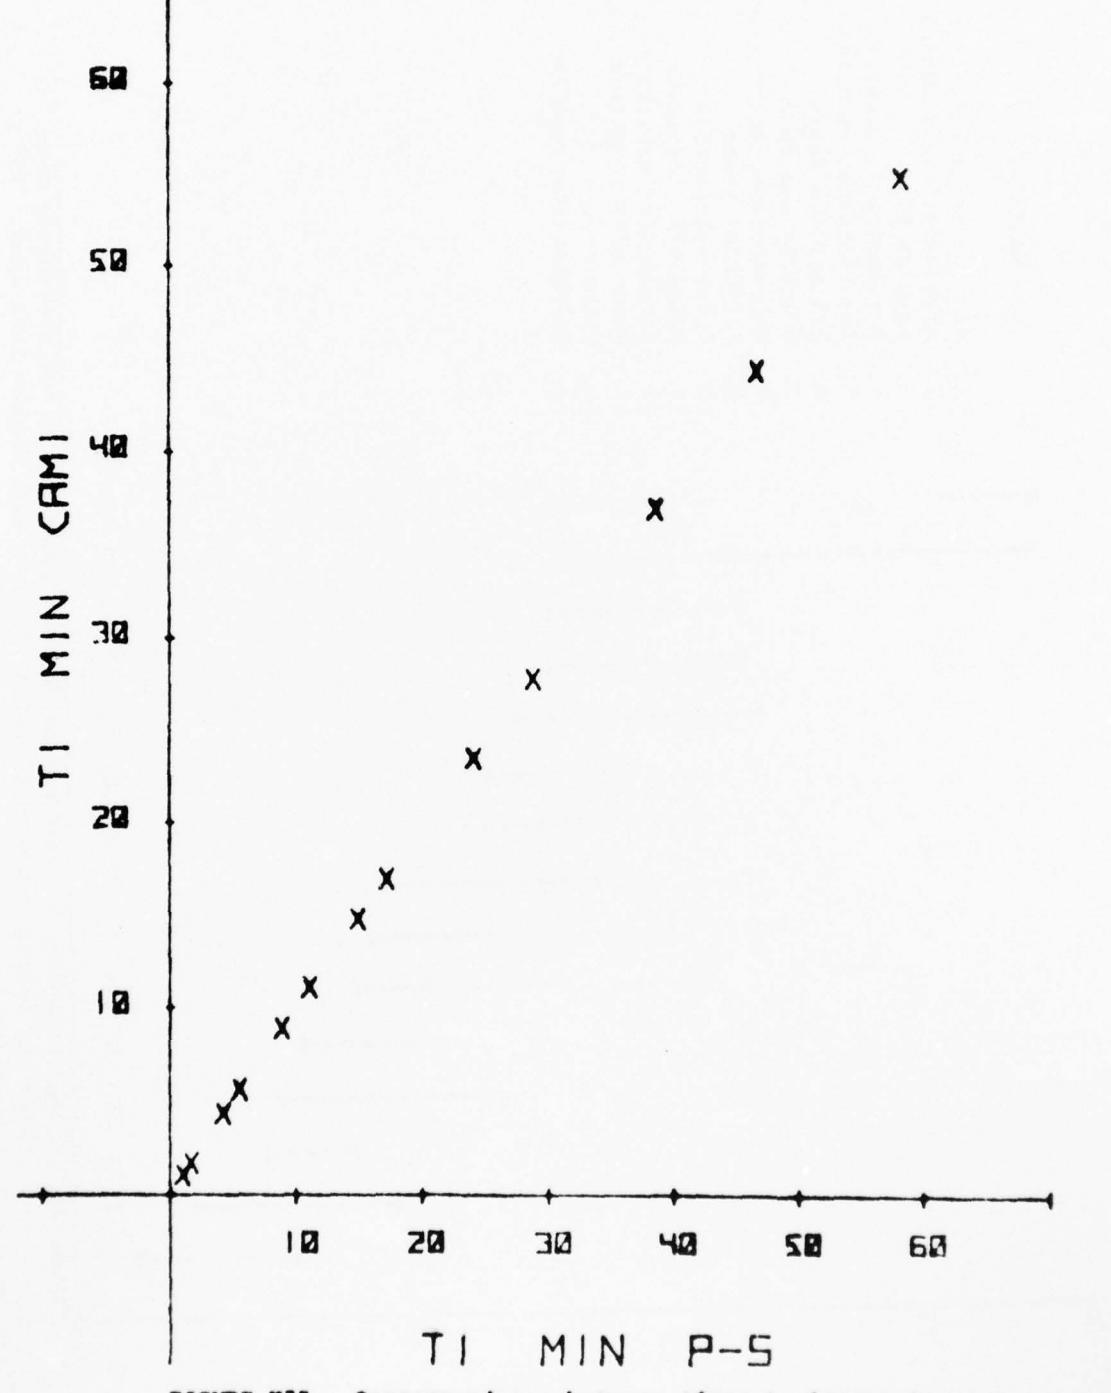
FIGURE VII. Correspondence between times-to-incapacitation for equal inhelation deeses of CO in man and rat. Based on CAMI equation derived from rat data and Feterson-Stewart equation derived from human data.
