A Laboratory Study of the Stability of Sand-Filled Nylon Bag Breakwater Structures

by Robert Ray

MISCELLANEOUS REPORT NO. 77-4

MARCH 1977

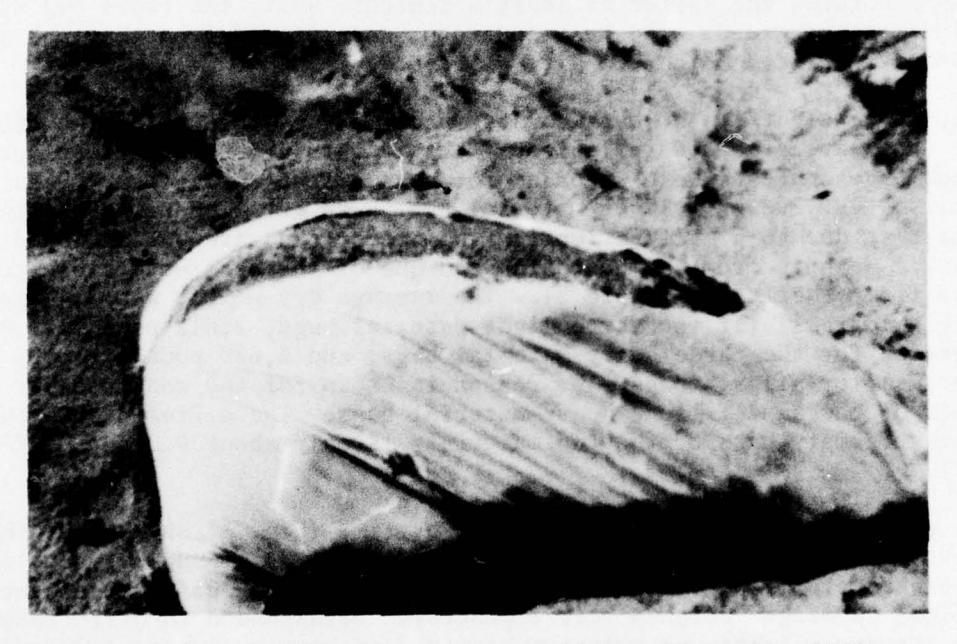
Uncoated or unprotected white nylon deteriorates under exposure to sunlight, specifically ultraviolet light. By the spring of 1967, several field installations of protective revetments had been built of bags and subjected to exposure damage. An estimate of the lifespan of nylon sandbags exposed to the weather (protected from vandalism and wave action) was needed for comparison with the performance of alternate construction materials. A single bag was filled with sand and left on a sandpile exposed to the weather from April 1967 to September 1968 (Fig. 1). Periodically, the bag was probed with the toe of a shoe to test the condition of the material. Between October 1967 and the end of the test, the bag split open along the length of the upper face, evidently due to photochemical (actinic) deterioration of the nylon filaments (Fig. 2).

Figure 2. Sandbag exposed to sunlight, September 1968.

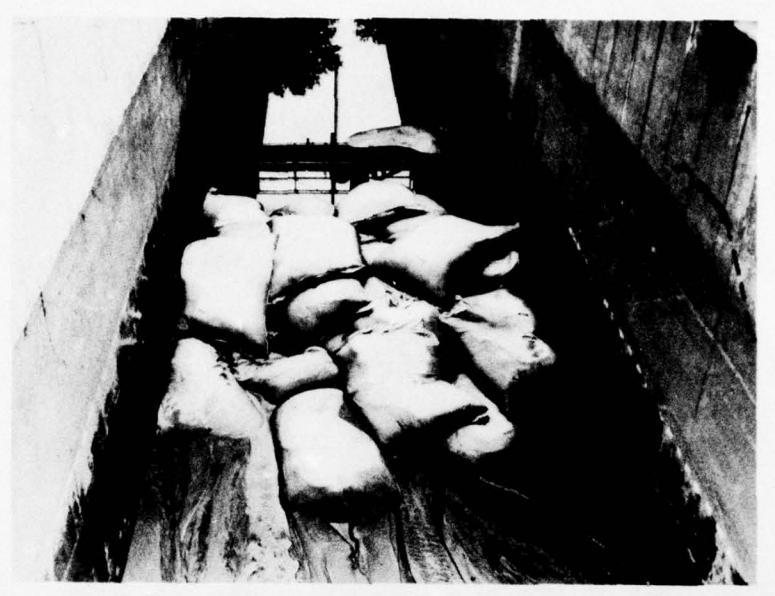
Midtest Tank Draining. Structure I was the only breakwater inb. spected during the progress of a test. Surveys during wave conditions a and b indicated that scour was occurring around the structure (Fig. 12). After 2 hours of condition b, the tank was drained for inspection. It was noted that the structure had partially trapped water on the back side and that water was leaking under and through the structure (Figs. 13, 14, and 15). Also, two bags on the bottom layer appeared to be partially emptied. The tank was refilled and wave condition b was continued for another 4 hours to determine if the scour would continue. Subsequent surveys indicated that scour had occurred at the leeward toe, and the breakwater, apparently undermined, had settled during this stage of draining and wave action. The profiles after the additional 4 hours were considered to be the adjusted initial profiles. After these difficulties, the tank was drained only between tests.

Figure 13. Front face after midtest tank draining (test I).

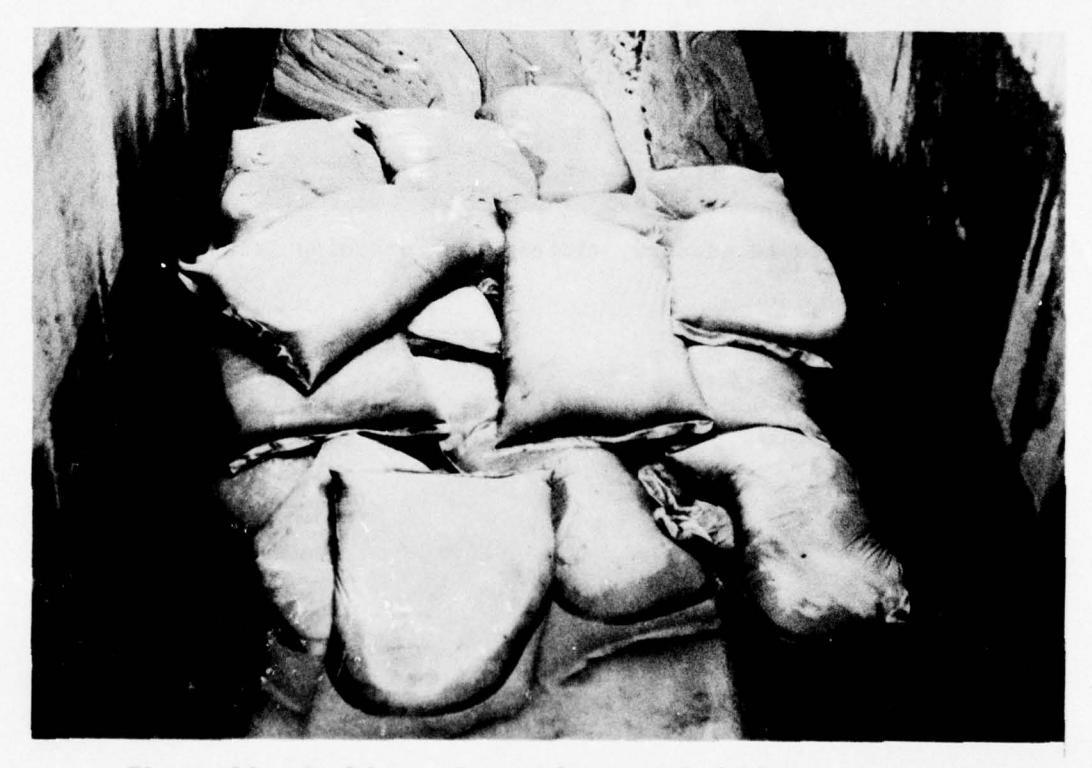
Figure 14. Backface after midtest tank draining (test I).

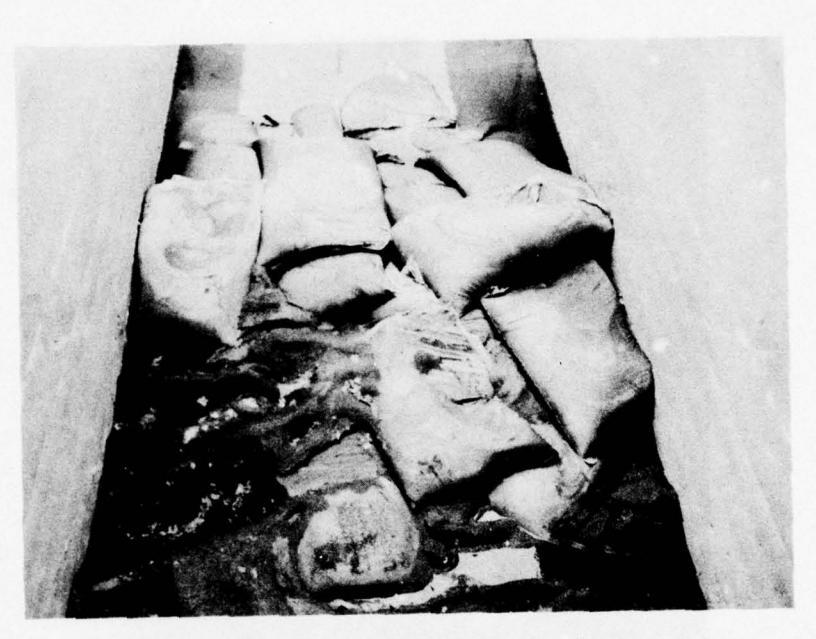
base of the structure during condition c was moved back during condition d, forming mounds at both toes of the structure (Figs. 17, 18, and 19) and flattening the front slope, but causing no change in crest elevation. Wave-induced changes in the structure were small compared to the disruption when the tank was drained.

Figure 17. Front face at end of test I.

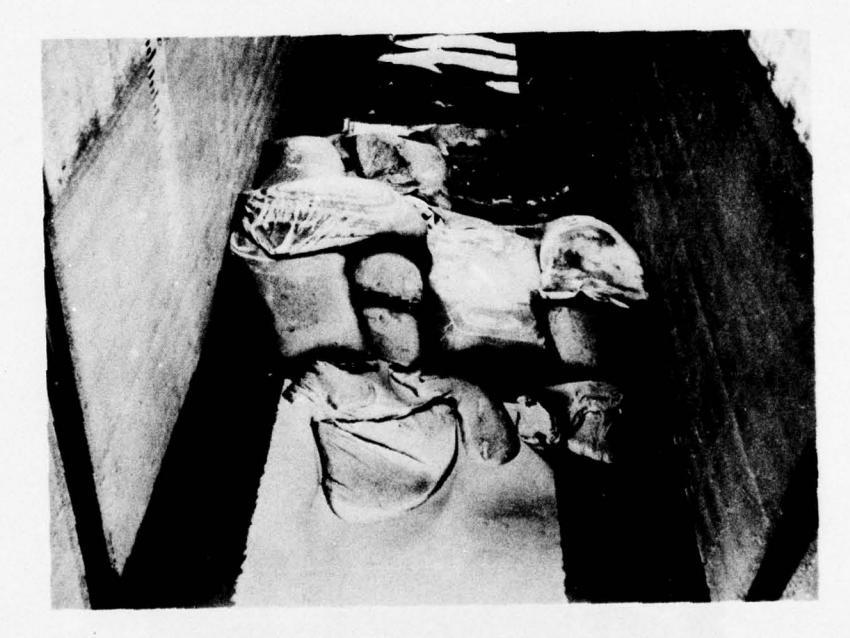
Figure 18. Backface at end of test I.

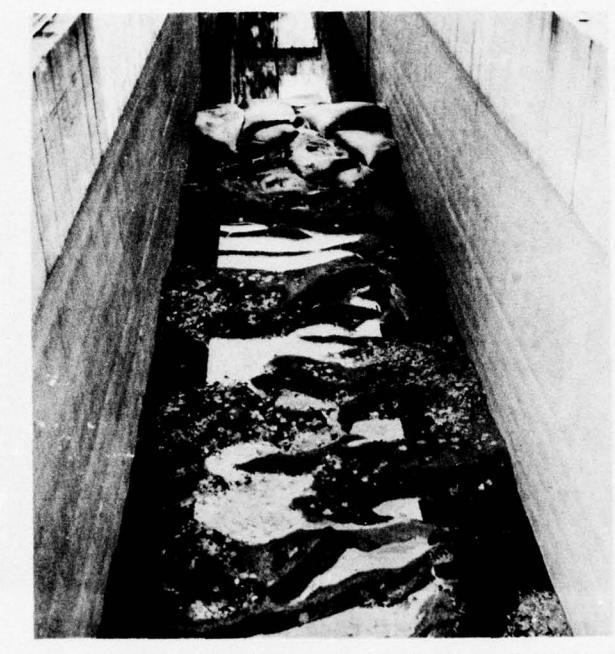
Figure 19. Sand bed to seaward at end of test I.

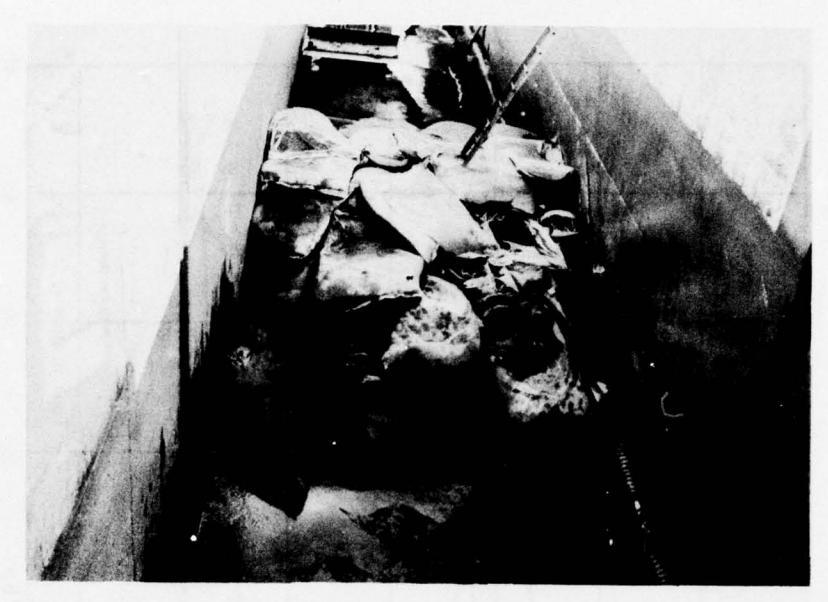
Figure 25. Backface and damaged bags at end of test II.

Both damaged and undamaged bags displayed forms of instability under wave action. Sand was "sucked out" of torn bags until the bags were nearly empty. Evidently, this loss of sand contributed to the settlement during tests I and II. Damaged bags were found in every structure, usually lying in the installed position, implying that the bags were torn during placement. Undamaged bags included even those bags that were displaced suddenly from the crests of the structures to the sand bed. Most changes in the structures were due to movement of undamaged bags. The nylon material was slippery and trapped air, which added buoyancy to the bags, formed cushioning bubbles on the tops and side, and prevented adequate interlocking despite the carefully overlapped layers.

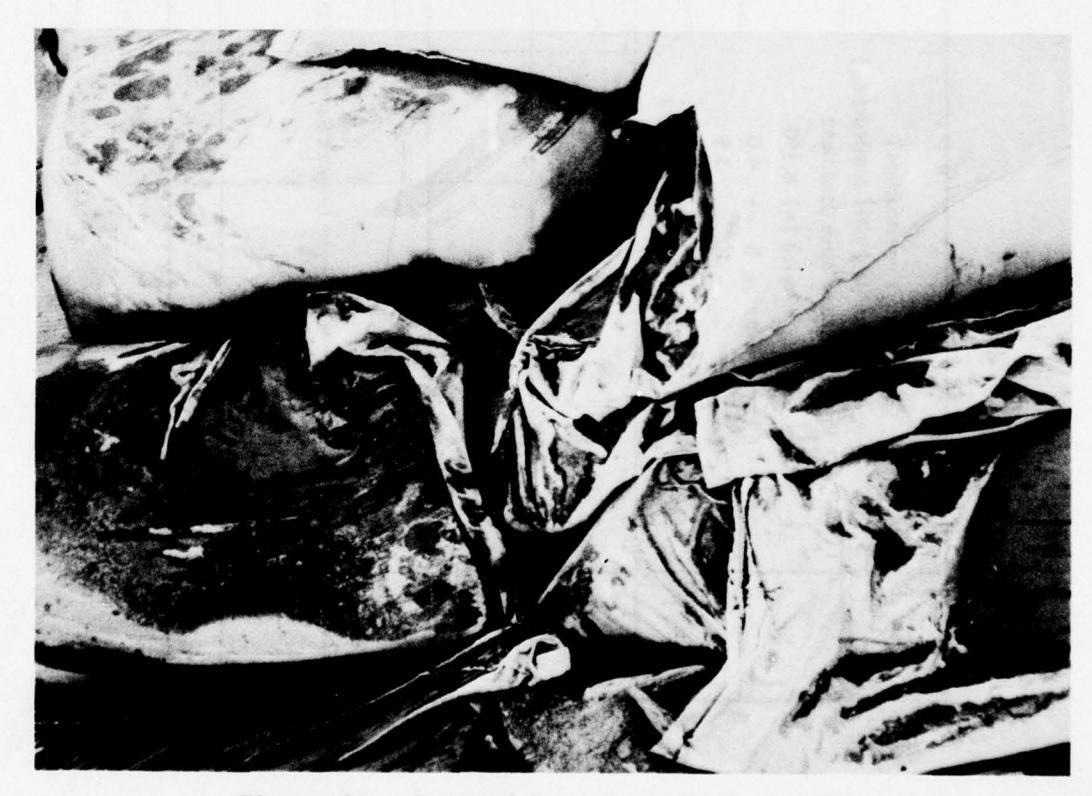
Figure 26. Damaged bags at end of test II.

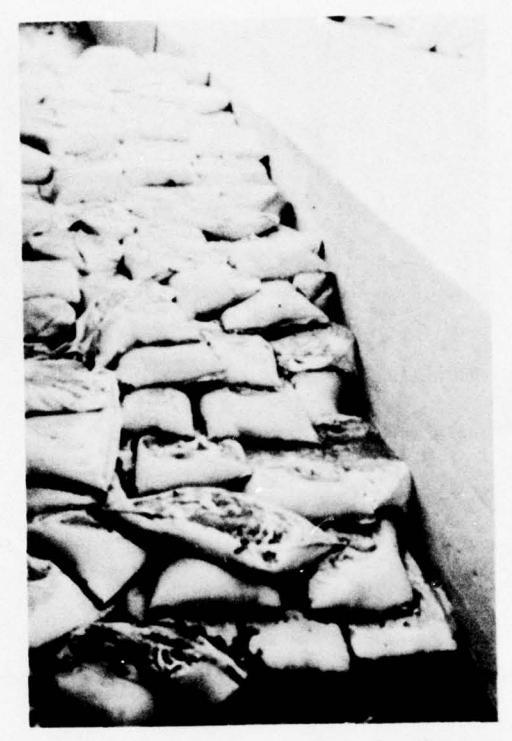
Figure 37. Front face at end of test III.

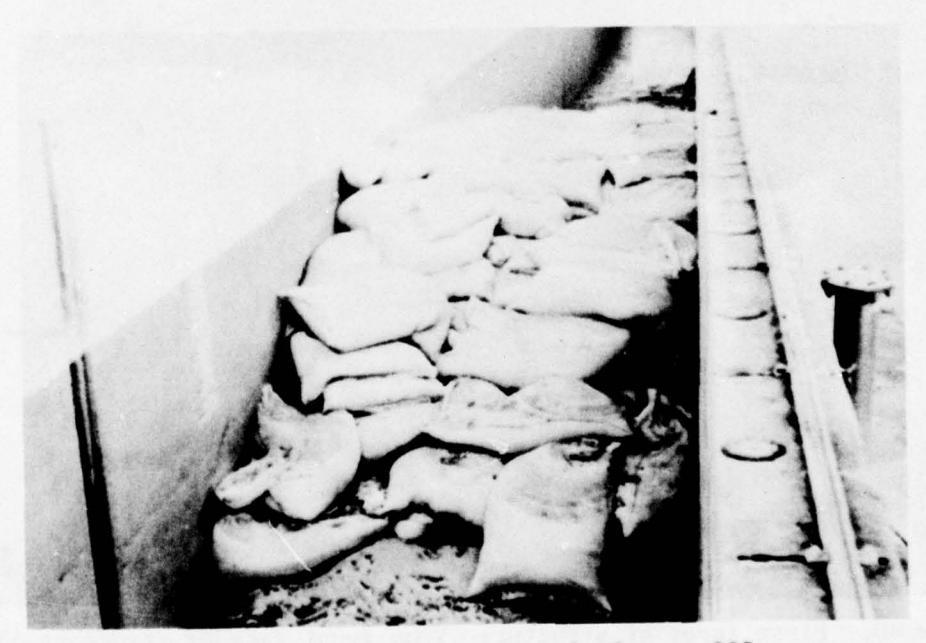
Figure 38. Backface at end of test III.

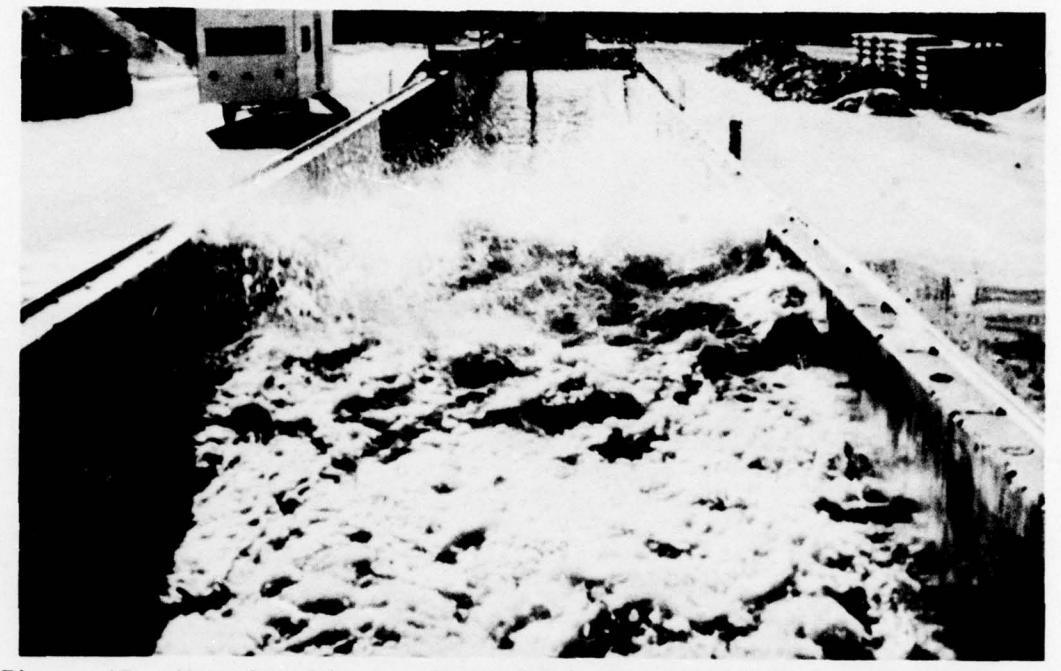
Figure 43. Wave breaking on front face after loss of seaward row of bags on breakwater crest during wave condition a (test IV).

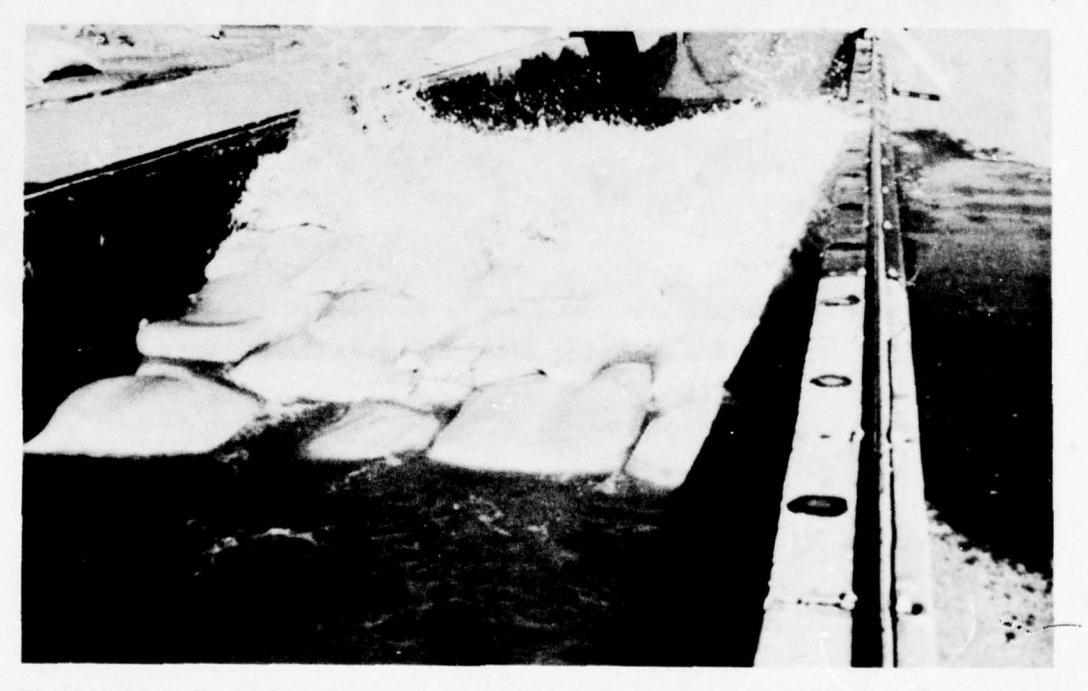
Figure 44. Breaking wave overtopping after loss of seaward row of bags on breakwater crest during wave condition a (test IV).

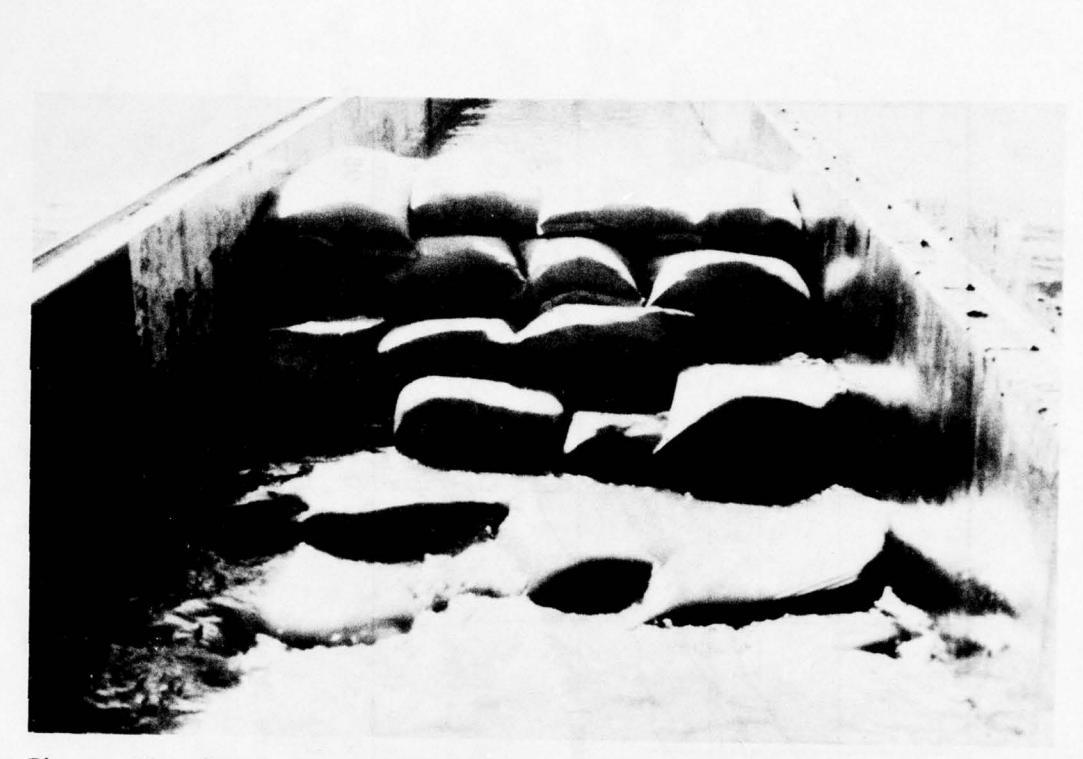
c. Structure Changes. During the first 60 waves of condition a, many bags were dislodged from the front face of structure IV, the damage starting in the third layer from the top and progressing upward to the top seaward row of bags (Fig. 45). As the wave condition was continued, the seaward row of bags in the upper part of the front face (i.e., from the crest to 3 feet below the stillwater level) slumped to the lower part of the face (Fig. 46), leaving the shoreward row on the crest almost untouched (Fig. 47). The front slope flattened dramatically and the crest lost 38 percent of its width but little of its height (Fig. 48). Wave condition b moved scattered bags on the front face downslope about 1 foot, but did not change the height or front slope significantly. During the first burst of waves of condition c, three bags from the remaining row on the crest were displaced onto the backface, decreasing the crest elevation. After the 60th wave, bags on the front face began moving with the wave action, slowly sliding down the face. After 440 waves, the whole upper half of the front face began slumping toward the toe and the bags remaining on the top of the structure began moving shoreward. All bags visible above water appeared to be moving. The slope of the upper half of the front face continued to flatten as the crest elevation continued to decrease. Wave

Figure 46. Front face after 50 waves shows seaward row of bags missing from breakwater crest during wave condition a (test IV).

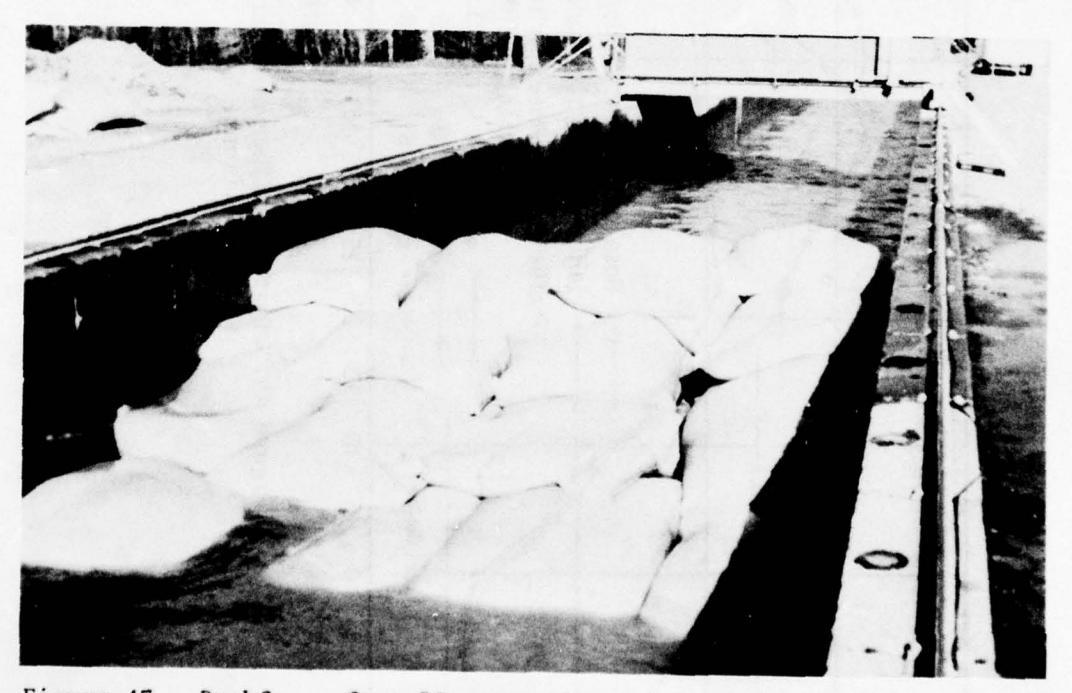
Figure 47. Backface after 50 waves shows shoreward row of bags across crest intact during wave condition a (test IV).

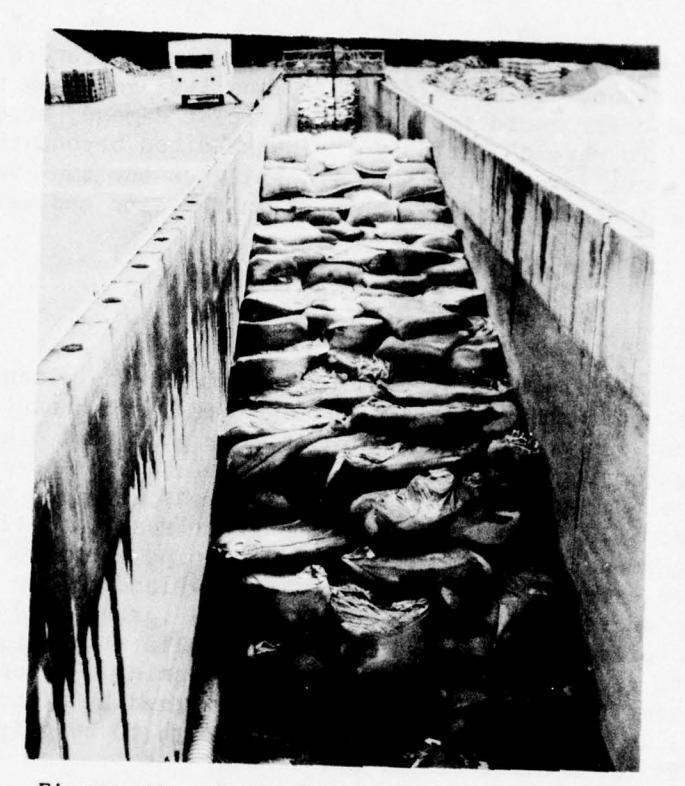
condition c was terminated when all visible movement stopped (Figs. 49 and 50). As experience during tests I, II, and III had shown that wave conditions a and c produced the most significant damage, structure IV was not subjected to wave condition d. The sand bed beyond the toes of the structure was not surveyed in test IV, but when the tank was drained at the end of the test, only slight changes in the sand bed were observed.

Figure 49. Front face at end of test IV.

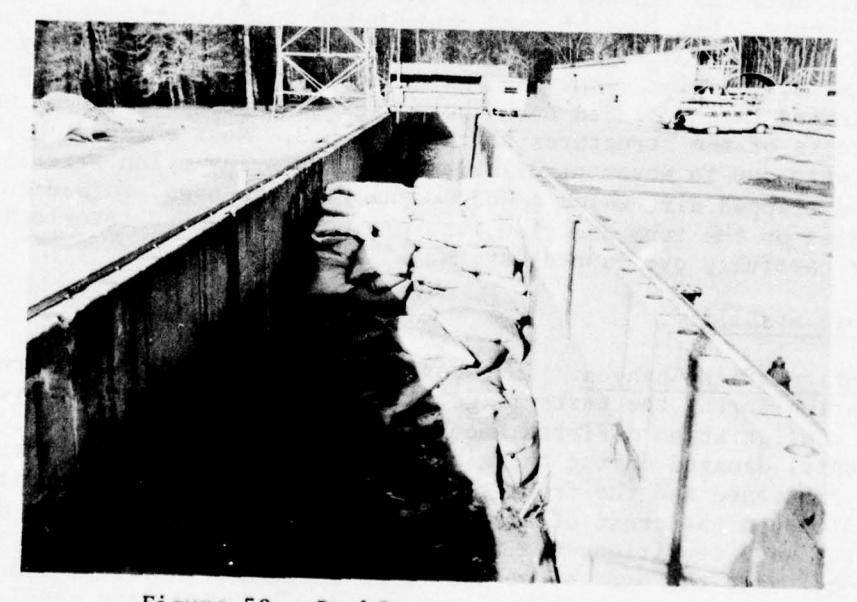
Figure 50. Backface at end of test IV.
