# PULSED PLASMA PROPULSION TECHNOLOGY

FINAL REPORT FOR PERIOD 10 MARCH 1972 - 30 MAY 1977

AUTHORS: DOMINIC J. PALUMBO  
WILLIAM J. GUMAN

FAIRCHILD INDUSTRIES, INC.  
FAIRCHILD REPUBLIC COMPANY  
FARMINGDALE, N.Y. 11735

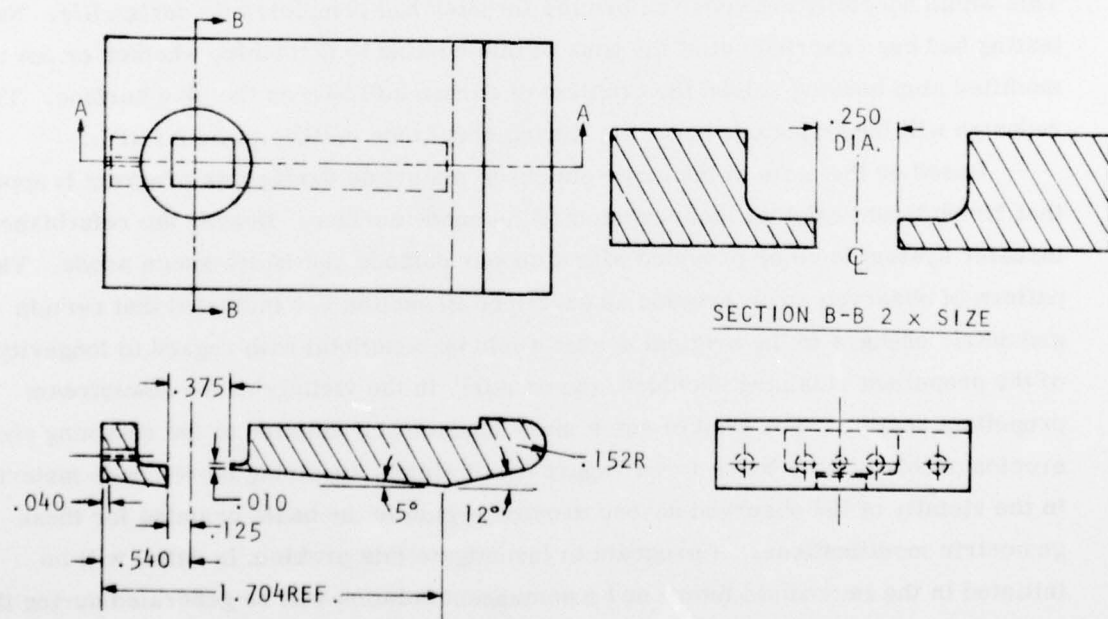
Figure 10. Modifications to Cathode Design in the Vicinity of the Ignition Hole

The first step taken in attempting to resolve the misfiring problem was a redesign of the cathode surface in the vicinity of the ignition hole. The original design called for a 0.25 inch (6.35 mm) dia. chamfered hole in the flat cathode surface as shown in Figure 10a. Carbon deposition on the downstream lip of this hole and subsequent buildup of deposits there caused the hole to become almost entirely closed off by the time the first misfiring was observed. It was reasoned at that time that the downstream lip of the hole represented a stagnation region to the accelerating plasma and that something should therefore be done to minimize the frontal area of this stagnation region and also try to deflect the flow of plasma away from the hole itself. Hence, the configuration shown in Figure 10b was arrived at. Note that the .25 inch diameter circular hole was changed to a rectangular hole 0.25 inches long by 0.375 inches (9.53 mm) wide. The surface of the cathode upstream of this hole is slanted downward at a 5° angle to deflect the plasma flow away from the hole. The cross section of the hole on the downstream side is decreased in area by beginning a constant slope of 5° to the full thickness of the electrode from an initial thickness of .01 inches (.254 mm). The modified cathode was not installed on the thruster immediately following the first misfiring occurrence because the manufacturing time would have caused the system to be down for a longer period of time than was desired. Hence, the original configuration was replaced on test after deposits were cleaned out of the hole and off the surface of the plug.

The space provided around the circumference of the plug cathode, between the plug and the ceramic housing would now prevent accumulation of carbon on the surface of the plug cathode until the surrounding cavity was completely filled with carbon. This would hopefully not occur before the thruster had completed its design life. No testing had been carried out at the time of this writing to determine whether or not the modified plug housing solved the problem of carbon build-up on the plug surface. The redesign will be evaluated, however, during endurance testing at the AFRPL.
