AD-A052 883

PRATT AND WHITNEY AIRCRAFT GROUP WEST PALM BEACH FL
INFLUENCE OF SUBSURFACE DEFECTS ON FATIGUE PROPERTIES OF TITANI--ETC(U)
JUL 77 M J BLACKBURN, C C LAW

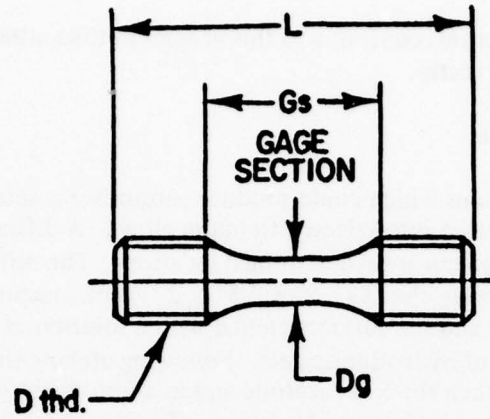
L ref.	Gs	Dg	D thd.
2.000	.960-.980	.249-.251	.500-20UNJF

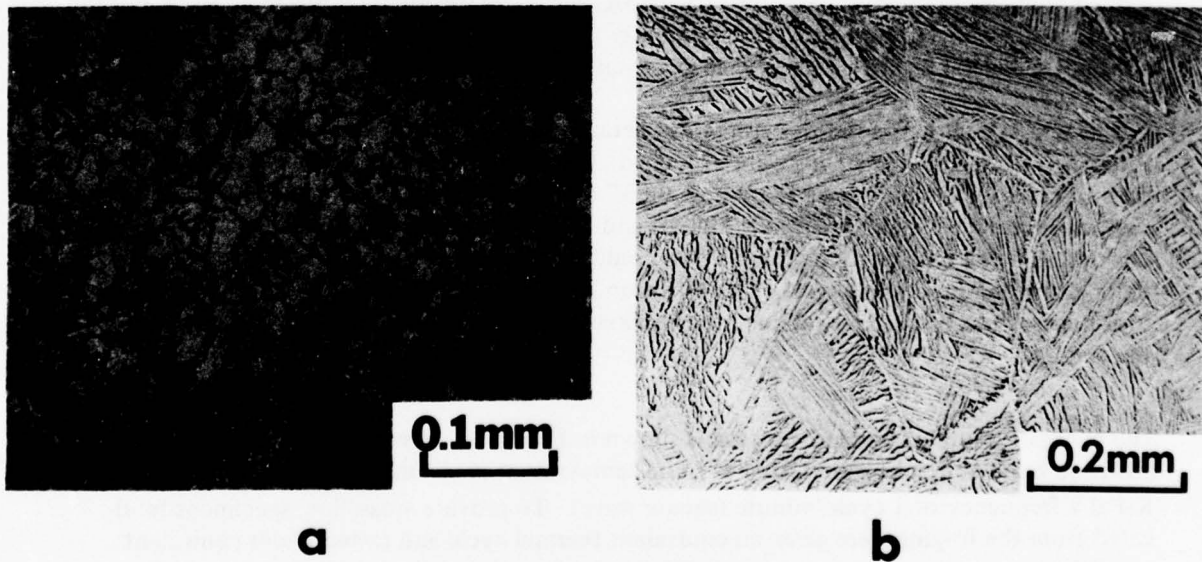
Figure 2 Microstructures of the Seeded Ti-6Al-4V Specimens
 (a) in the first and second sets
 (b) in the third set

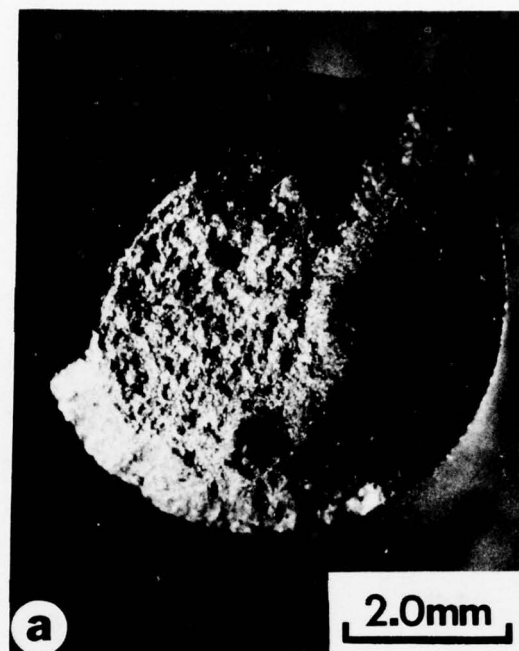
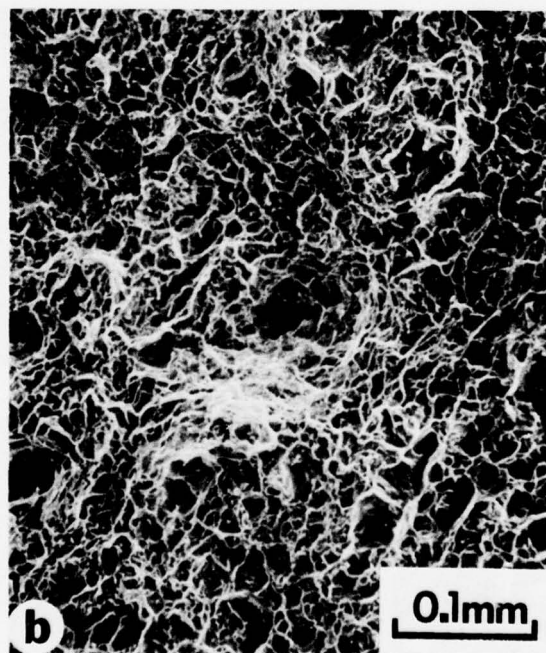
Figure 3 (a) General Appearance of the Fracture Surface of a Hydride-Seeded Specimen (No. 16). Note the circumferential shear lip. The subsurface nucleation site could not be located.

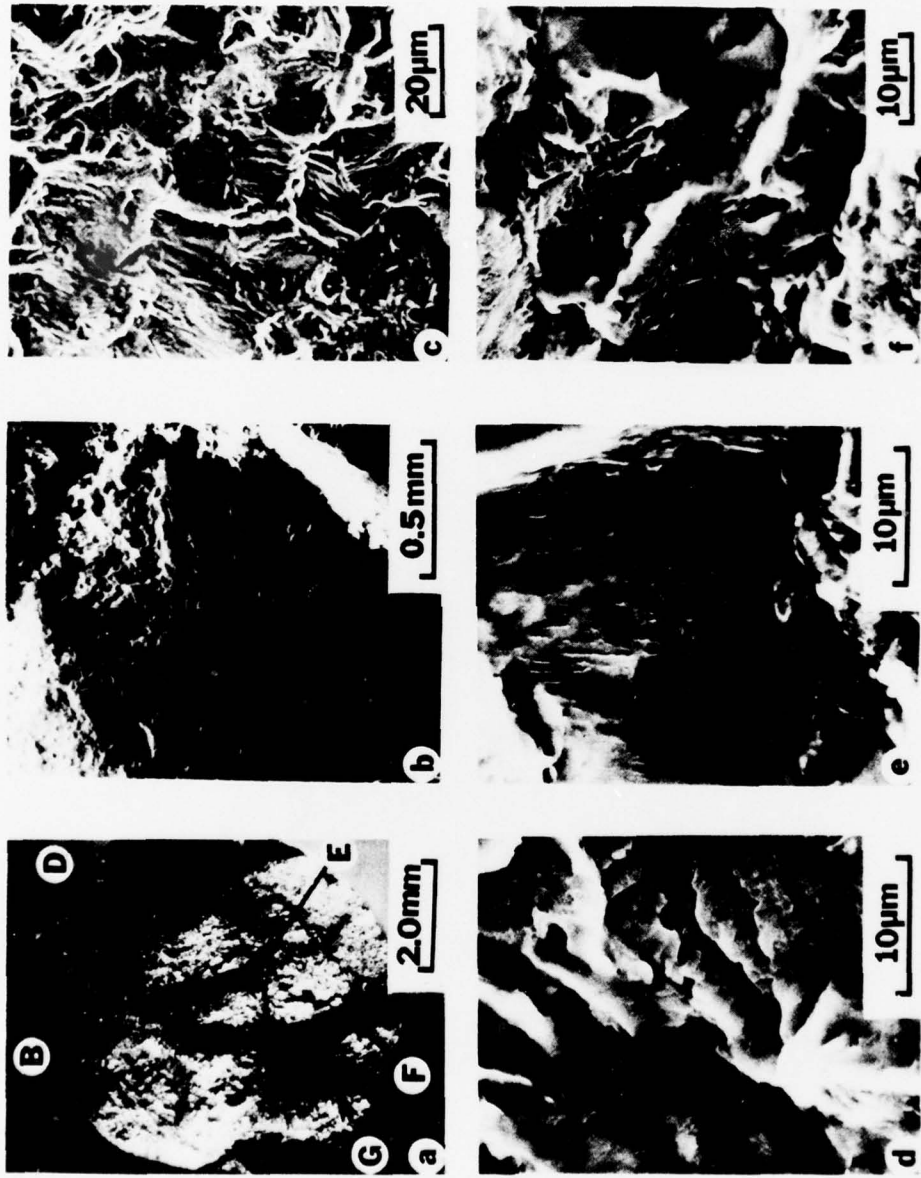
Figure 4 Scanning Electron Micrographs of the Fracture Surface of the Ti-6Al-4V Specimen No. 10 (Pore Only). The microstructure is given in Figure 2(a). (a) General appearance of the entire fracture surface. Note the circumferential shear lip and the five subsurface nucleation sites facets B, D, E, F and G. Facet B is shown in greater detail in (b), while the typical striation observed at its periphery is illustrated in (c). The striations observed at the periphery of facet D is shown in (d), (e) and (f).

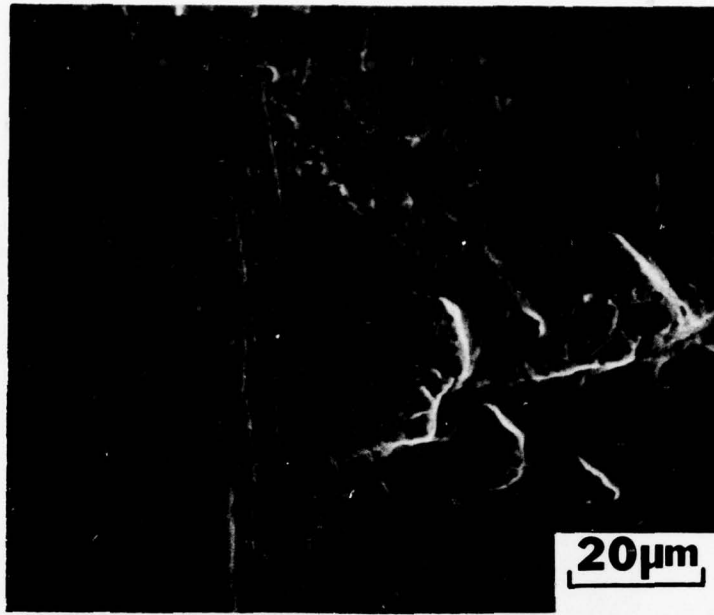
Figure 5 Scanning Electron Fractographs of Hydride-Seeded Ti-6Al-4V with Acicular Microstructure shown in Figure 2(b). (a) Subsurface fracture initiated at the seeded pore (partially exposed) indicated by an arrow. (b) Fracture initiated at the seeded pore near the surface. Striations observed on facets A and B are illustrated in Figure 6.

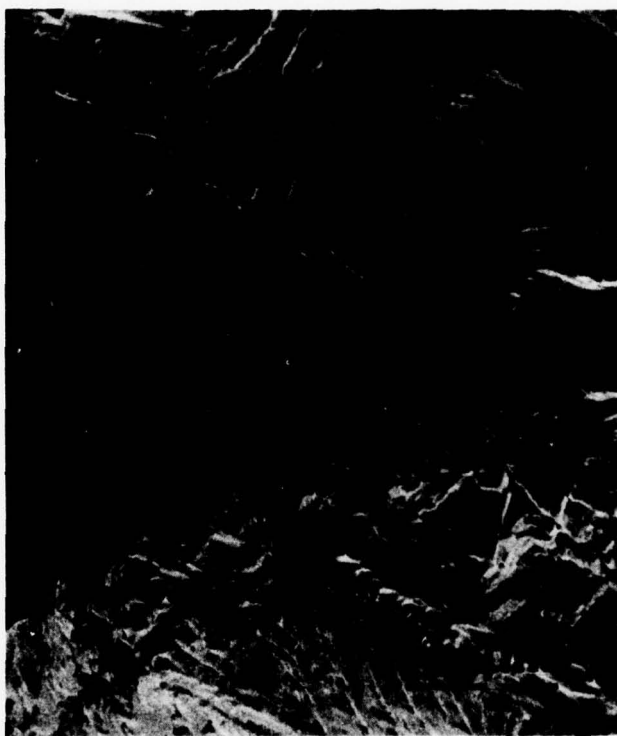
Figure 7 Appearance of the Region Adjacent to the NaCl-seeded Pore. Note the reacted layer around the tip of the pore (hardness indentation).

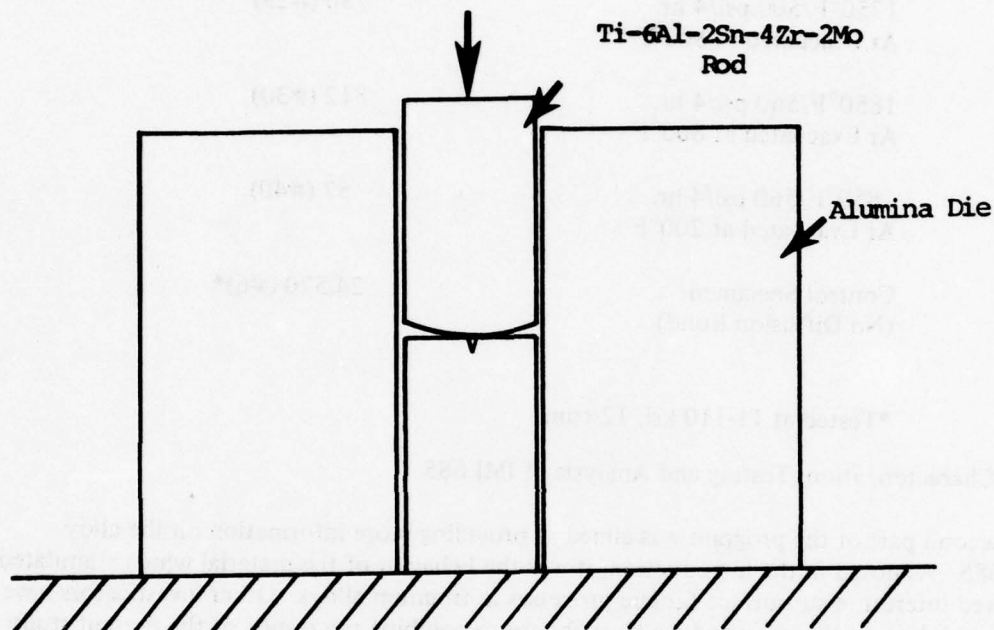
Figure 8 Experimental Setup for Trapping Argon in a Pore Between Two Rods Which Were Subsequently Diffusion Bonded Together and Machined into a LCF Specimen

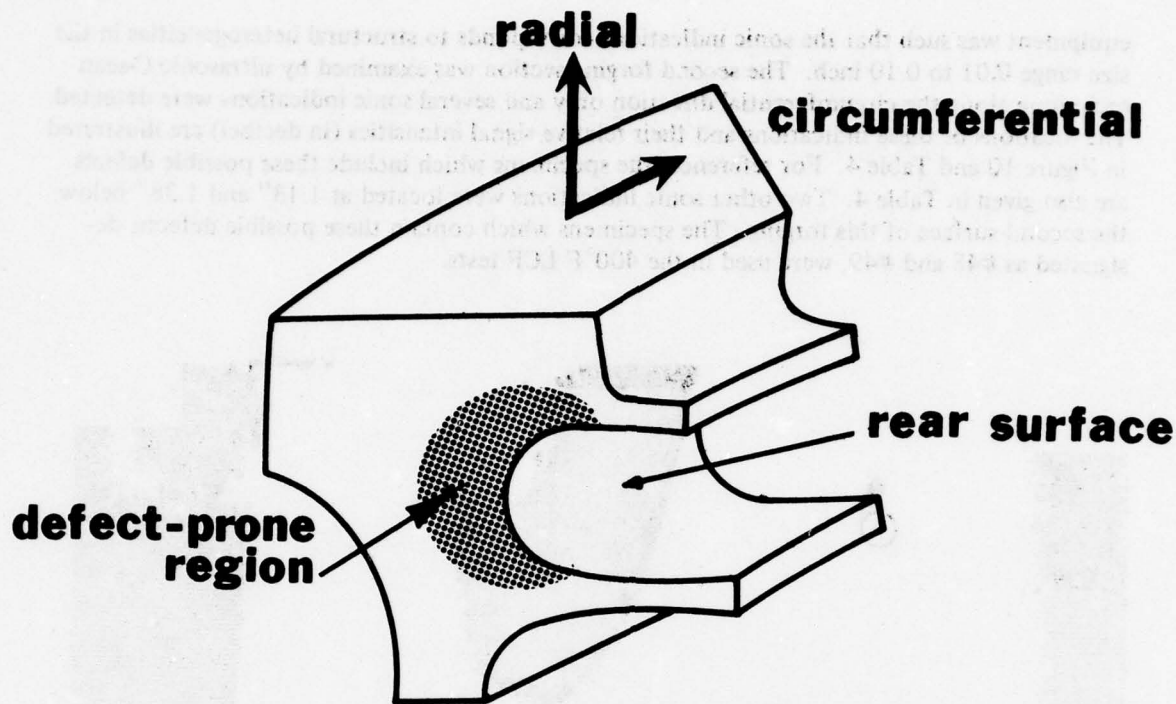
Figure 9 Schematic of the Machined IMI 685 Forging

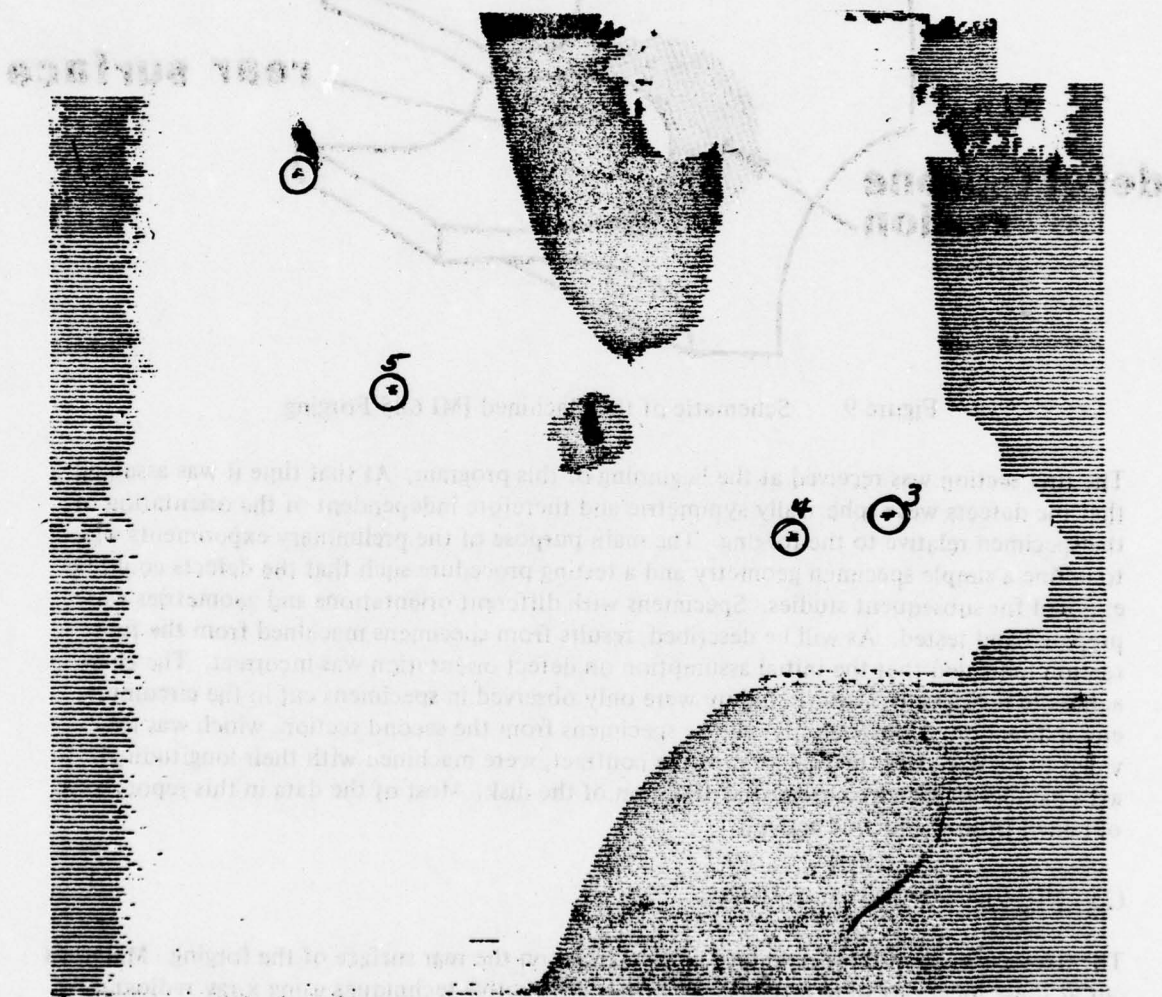
Figure 10 Ultrasonic C-Scan Recording from an IMI 685 Forging Section. The probe was oriented parallel to the circumferential direction of the forging.

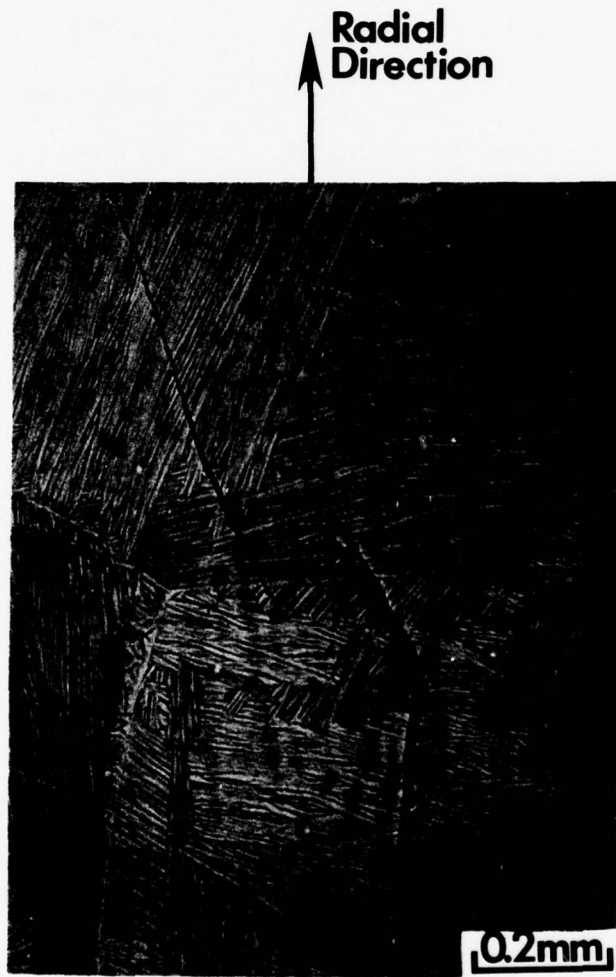
Figure 11 Microstructure and Cracks Observed at the Defect-Prone Area of the IMI 685 Forging Which had 62 Stress Cycles Before Retirement From Service

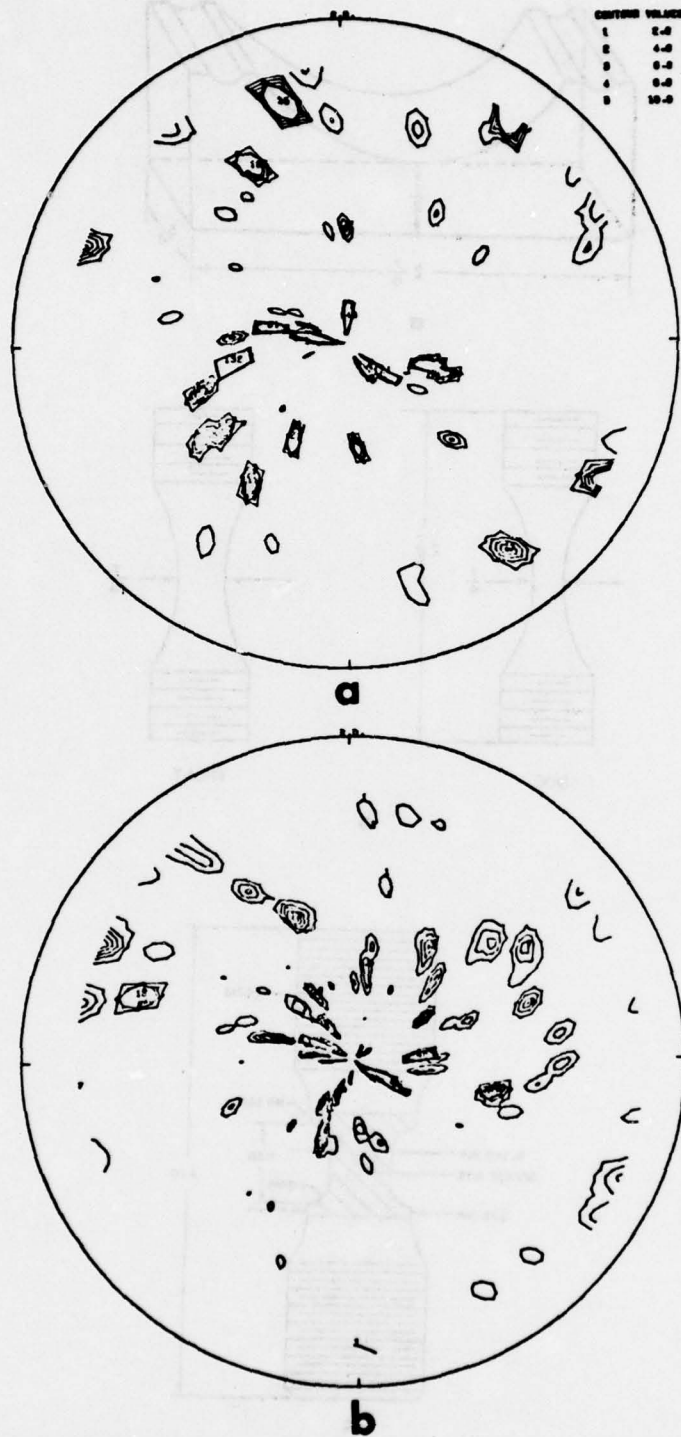
Figure 12 X-ray Pole Figures (a) (0002) Pole and (b) (10 $\bar{1}$ 0) Pole

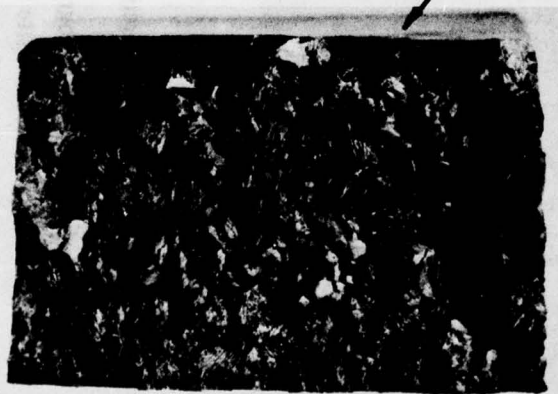
CRACK NUCLEATION SITE

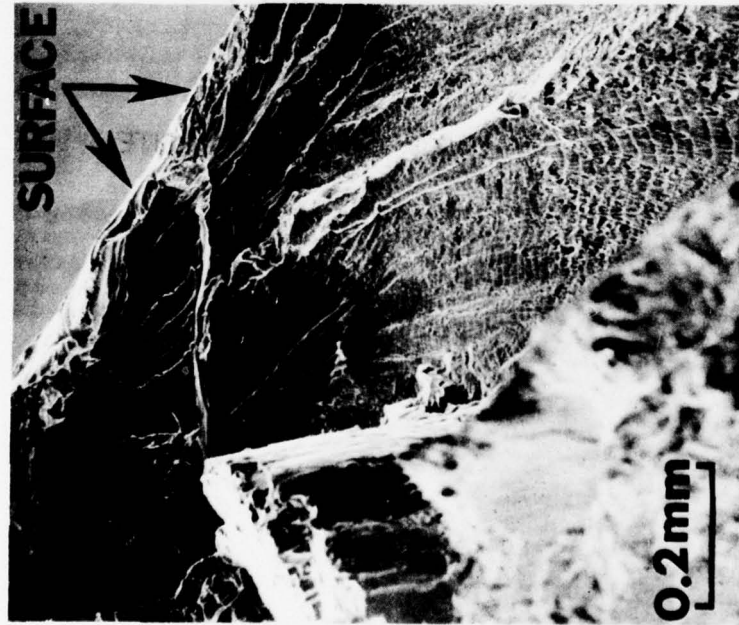
Figure 14 (a) Schematic Diagram Showing the Locations of Cracking in the IMI 685 Bend Specimen after LCF Testing and (b) Appearance of the Fracture at Location A

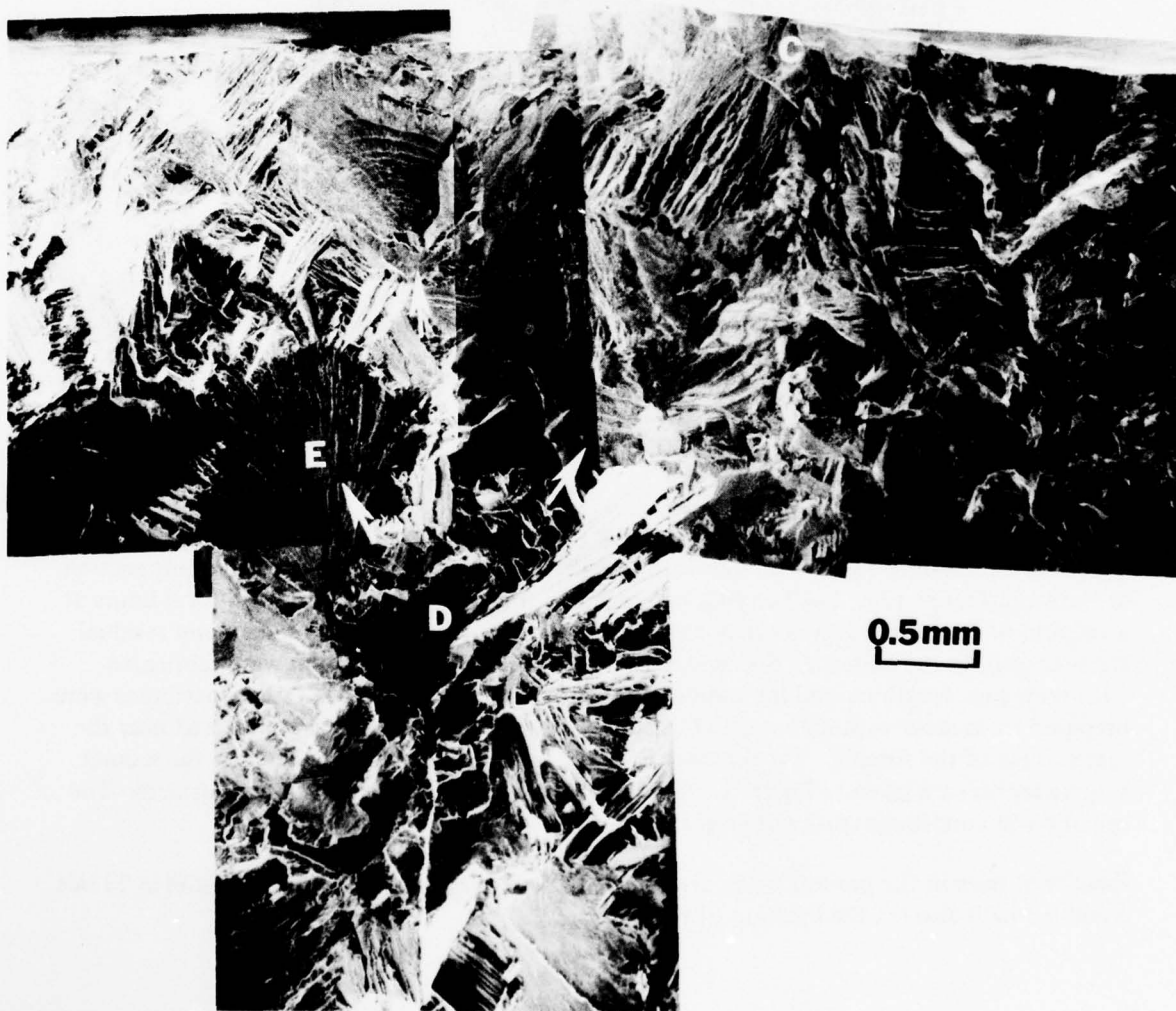
Figure 16 Scanning Electron Micrographs Illustrating the General Appearance of the Fracture Surface in the IMI 685 LCF Tension Specimen No. 2. Striations on regions C and E can be traced to an origin at region D. Arrows indicate directions of crack propagation.

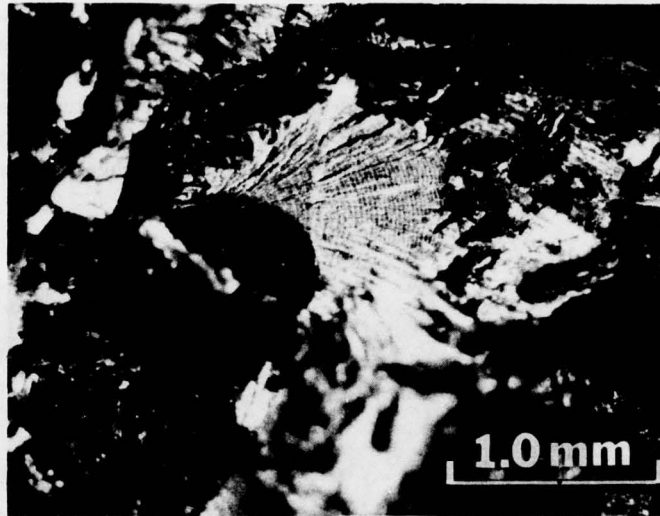
Figure 17 Fatigue Striations Observed on Facet E of the Fracture Surface Shown in Figure 16. Note the gradual decrease in striation spacing as the crack propagated across this facet from left to right.

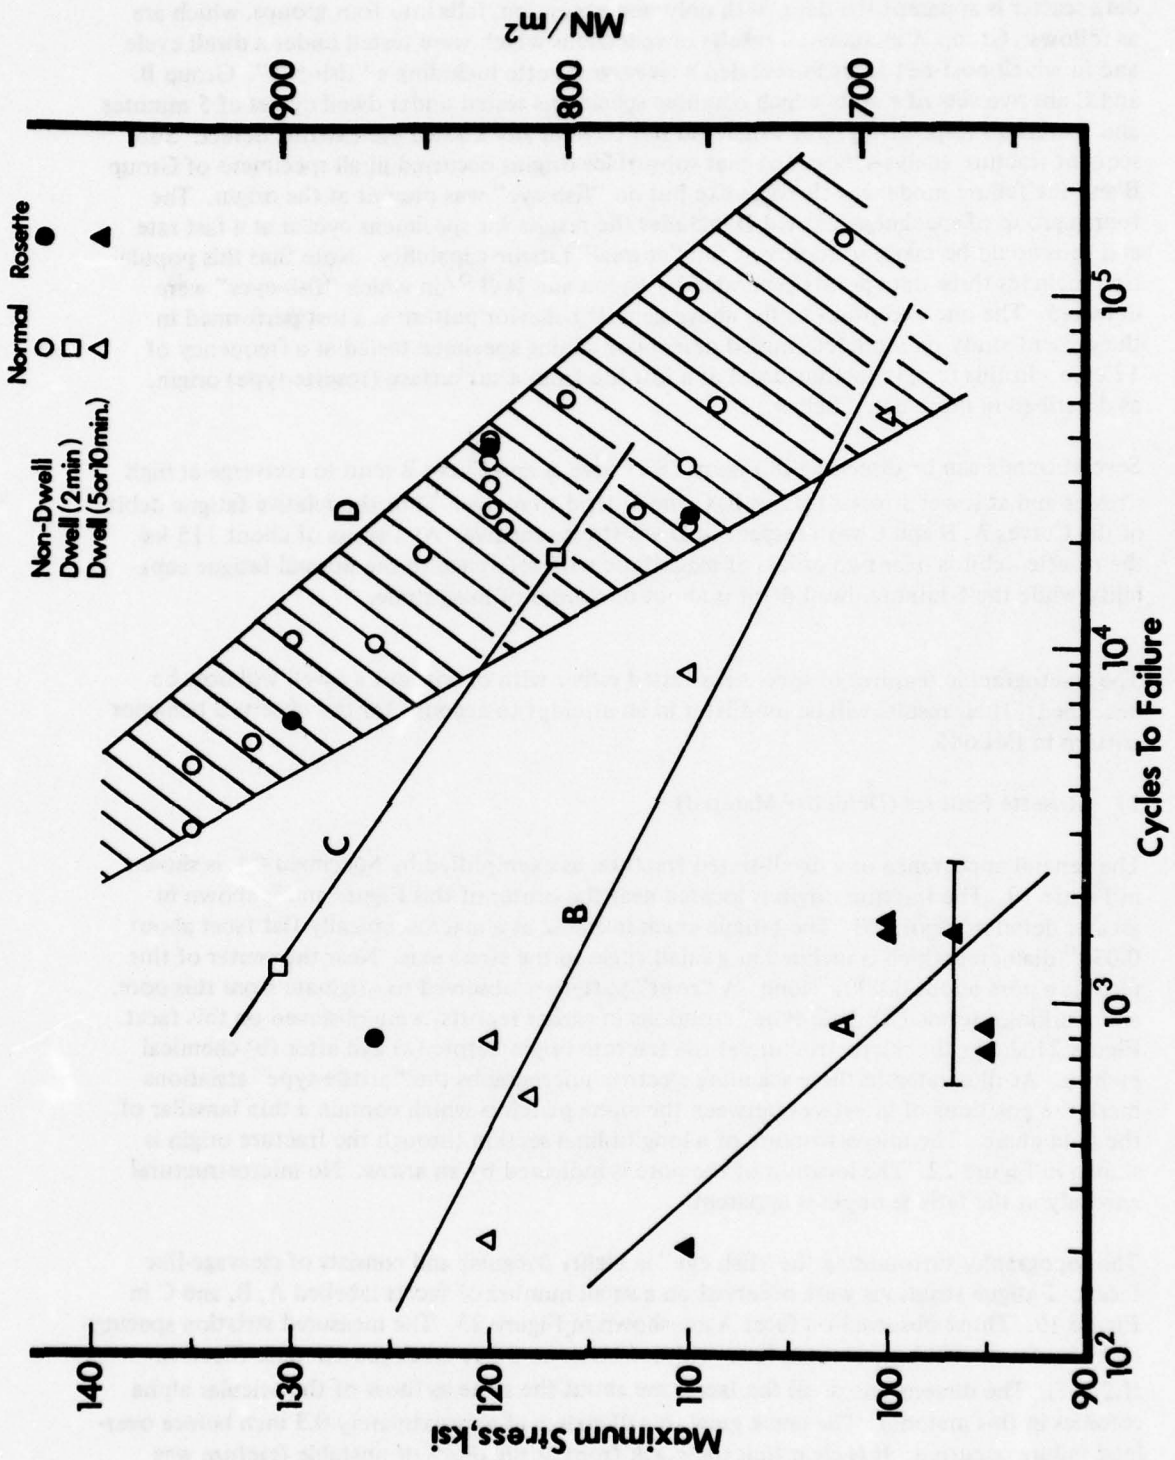
Figure 18 S-N Curves of IMI 685 at 70°F, the Sources of Data Are Indicated in Tables 5 and 6.

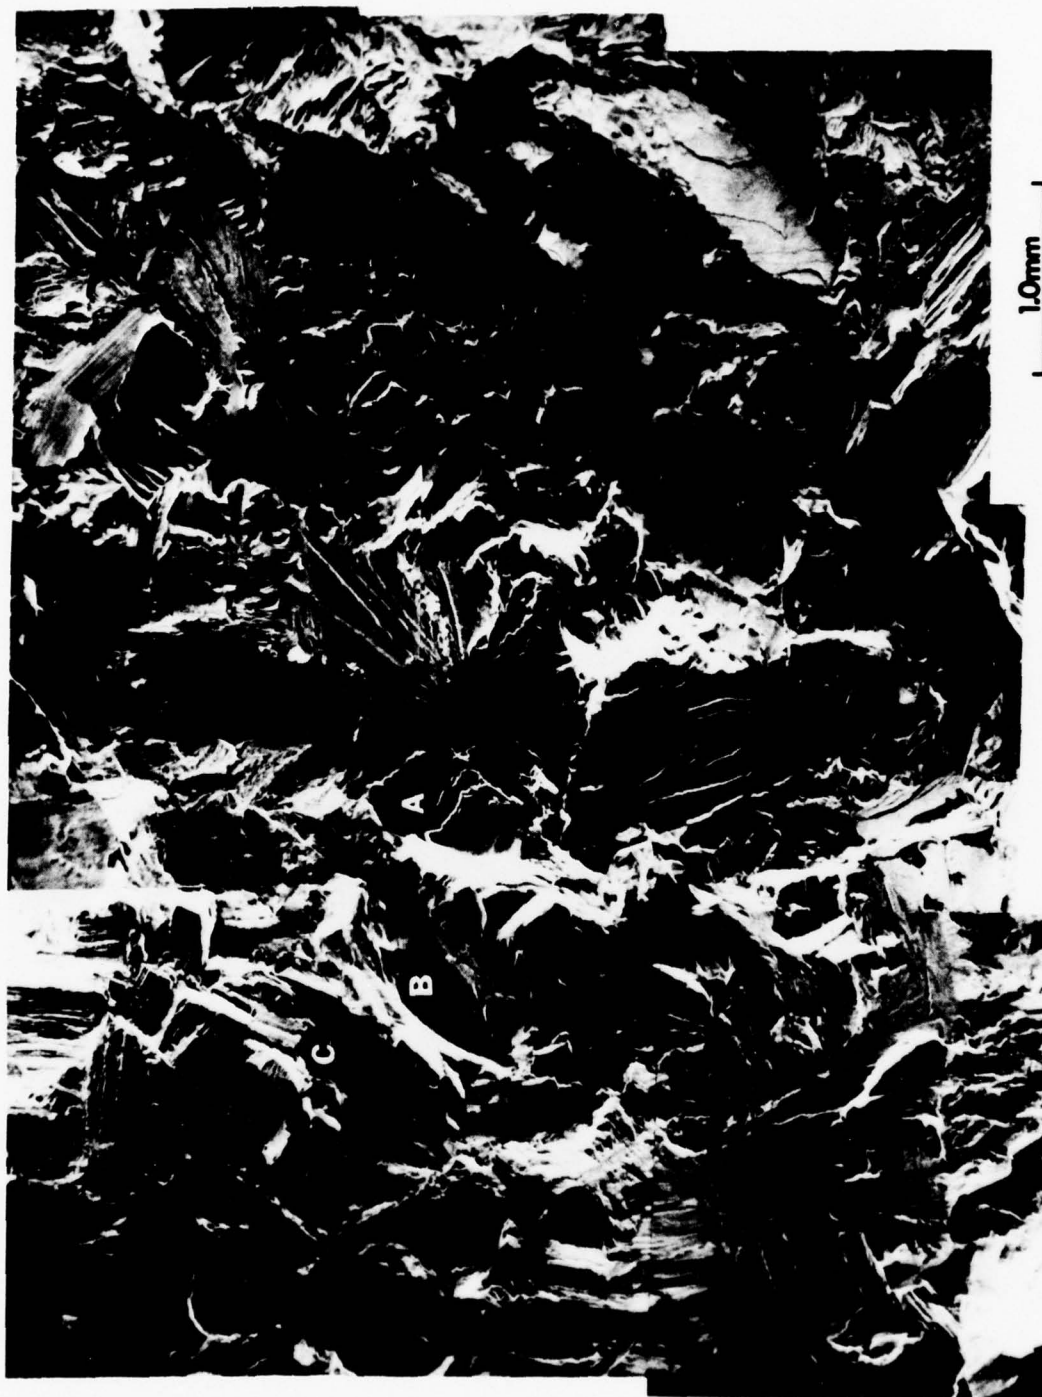
Figure 19 Scanning Electron Fractograph of the Rosette-Fracture Observed on IMI 685 Specimen No. 4. Details of the 'fish eye' fracture origin are shown in Figure 20. Striations have been observed on facets A, B and C. Those on facet A are shown in Figure 23.

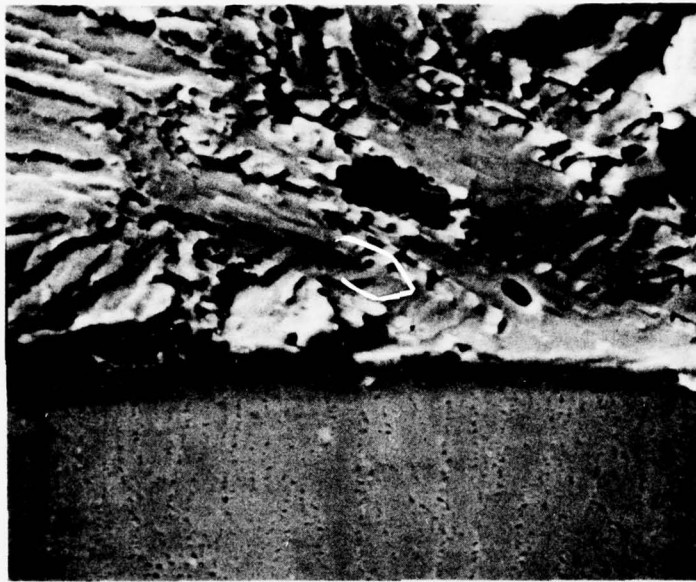
Figure 20 (a) The Topography of the 'fish eye' Crack Nucleation Site
(b) Detailed Appearance of the Central Pore and its Surrounding. Note the presence of the "brittle-type" striations on the 'fish eye'.

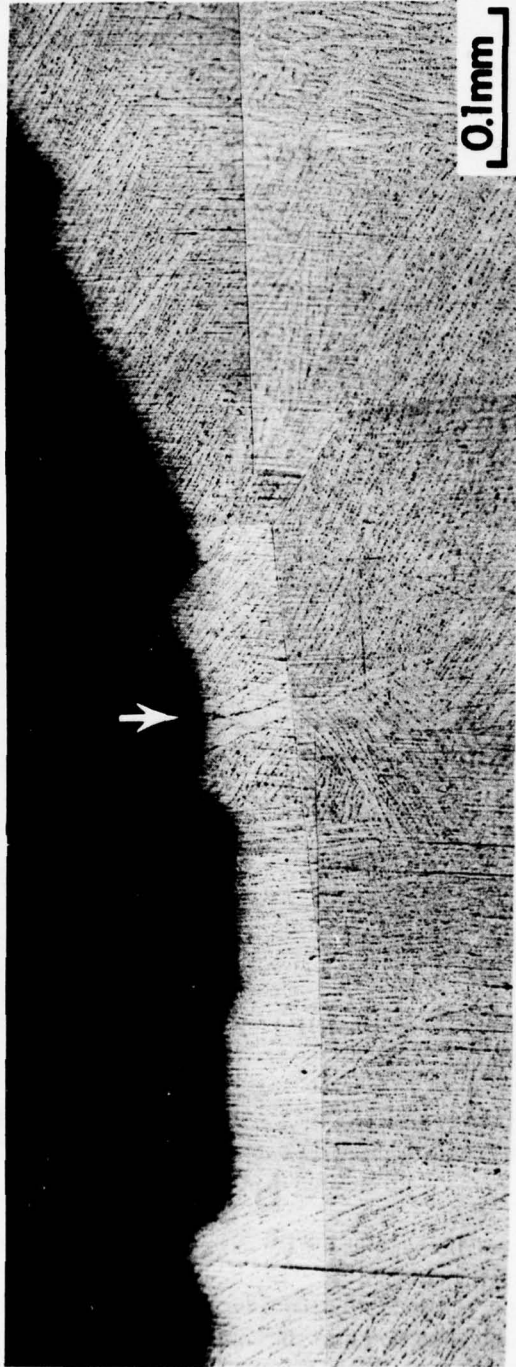
Figure 22 Microstructure at a Longitudinal Section Through the Central Pore (Location Indicated by the Arrow)

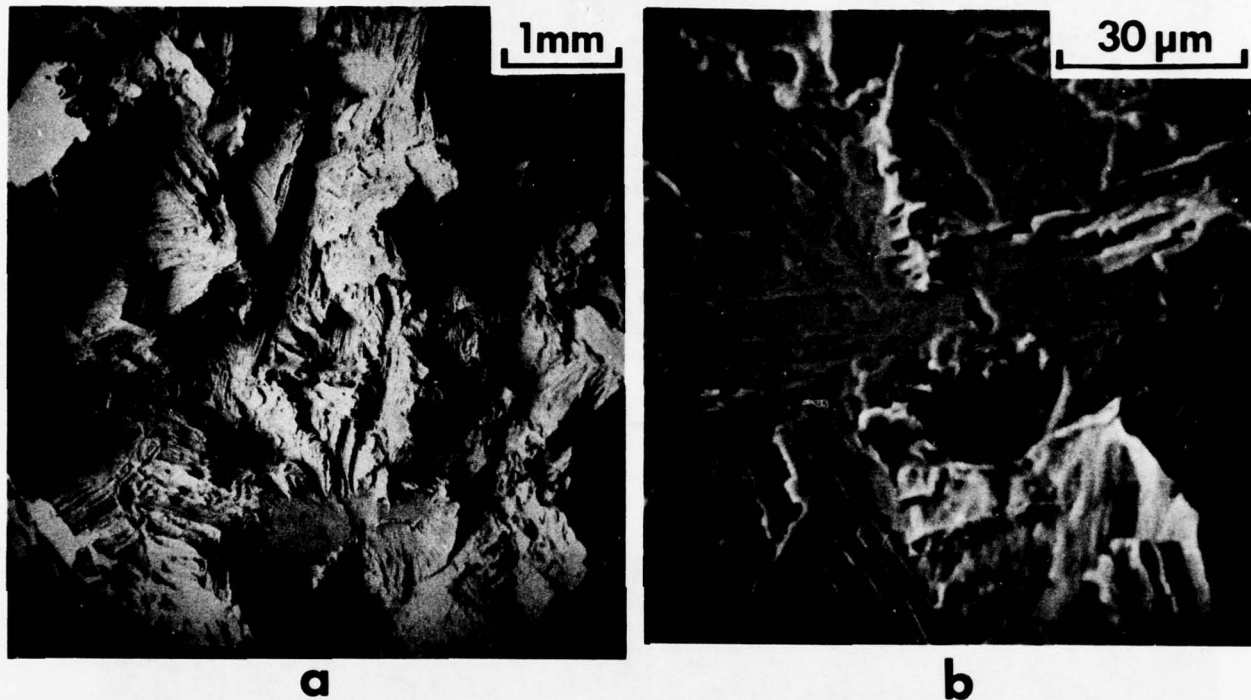
Figure 24 (a) General Appearance of the Fracture Surface of Specimen No. 25.
(b) The Fracture Origin which is Located Between the Two Fan-Shaped Facets, showing the Small pore and the Brittle-Type Striations.

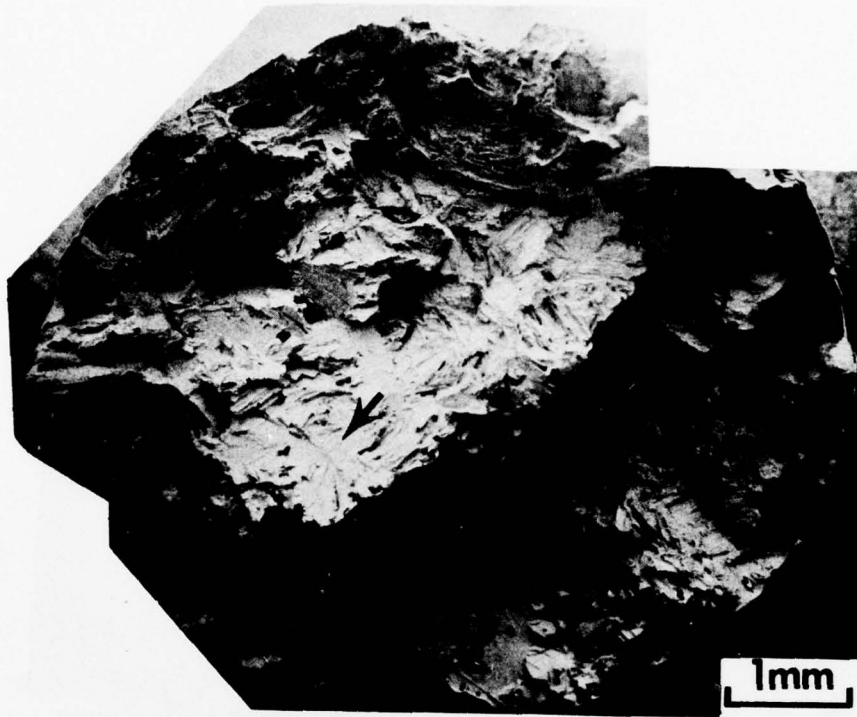
The general appearance of a normal fracture surface in a nondwell test is shown in Figure 26a for specimen #45. The location of the surface origin is indicated by an arrow. It is interesting to note the absence of a relatively large facet at the origin as those shown in previous fractures. The fatigue-propagation region around the fracture origin is relatively flat and contains cleavage-like facets on which fatigue striations were observed as shown in Figure 26b.

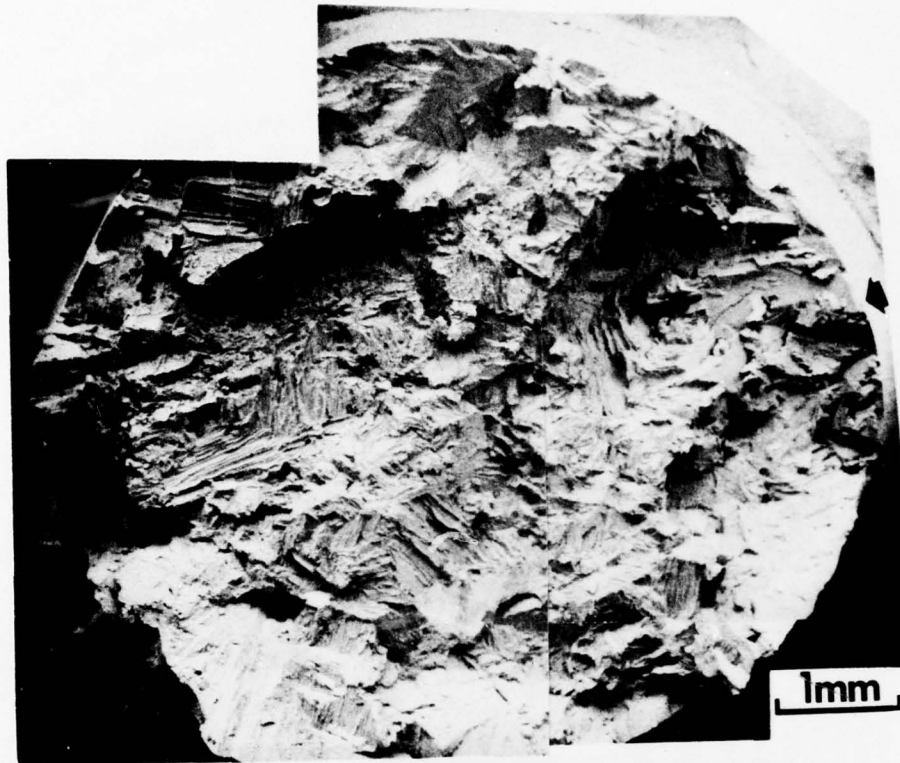
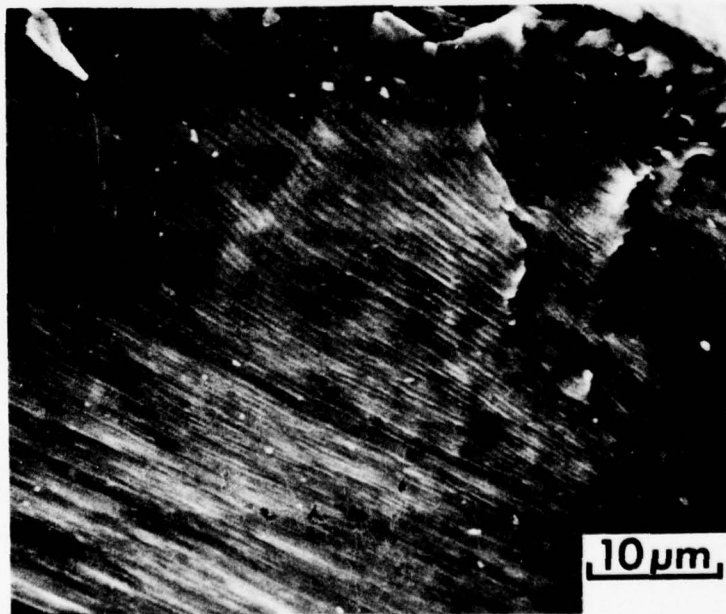
Figure 26 (a) The General Appearance of the Fracture Surface of Specimen No. 45. The surface crack origin is indicated by an arrow. Note the absence of large cleavage-like facets at the fracture origin.
(b) Fatigue Striations Observed Near the Fracture Origin.

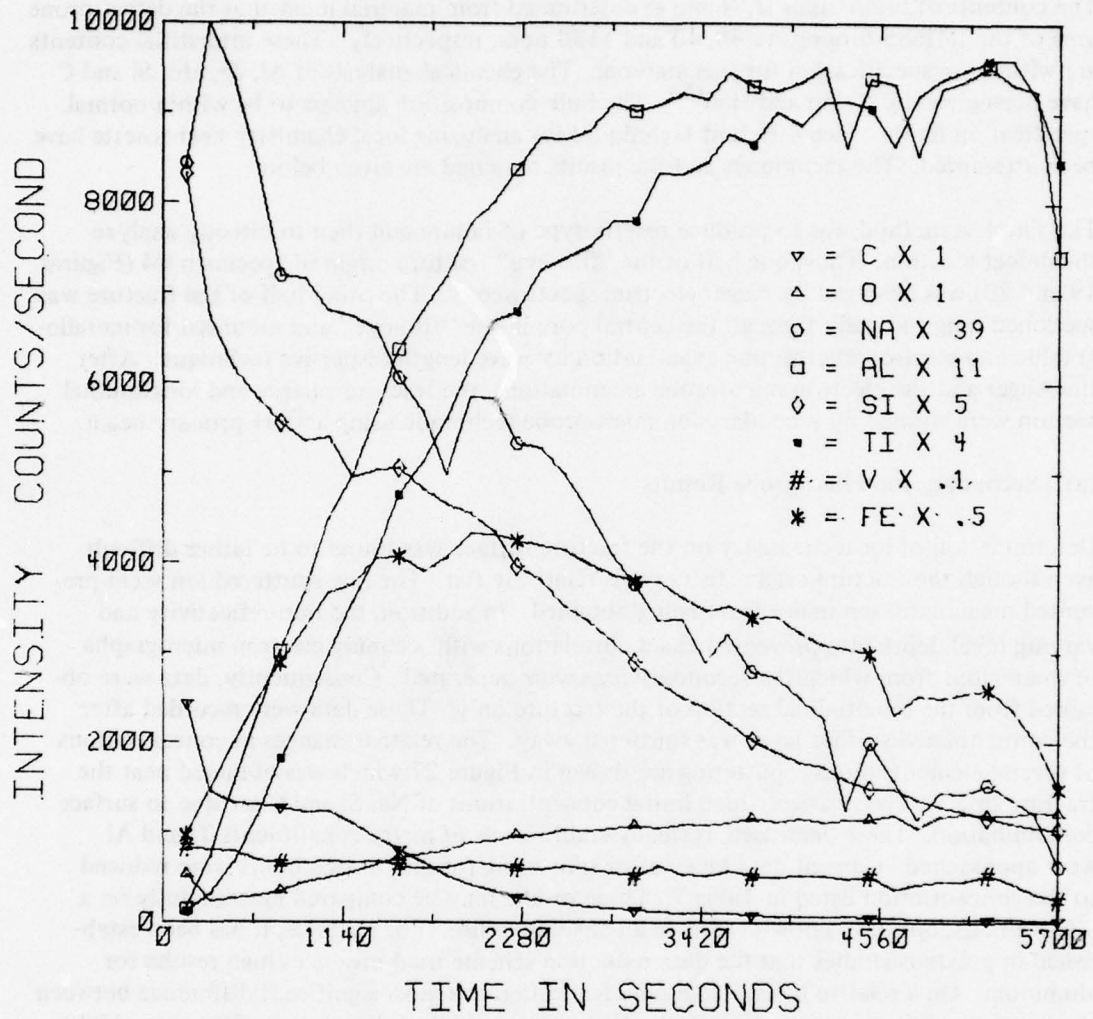
Figure 27 Change in Intensities of Several Elements as a Function of Sputtering Time. Determination of compositions at the 'fish eye' fracture origin and the bulk commenced after steady levels of major elements were observed.

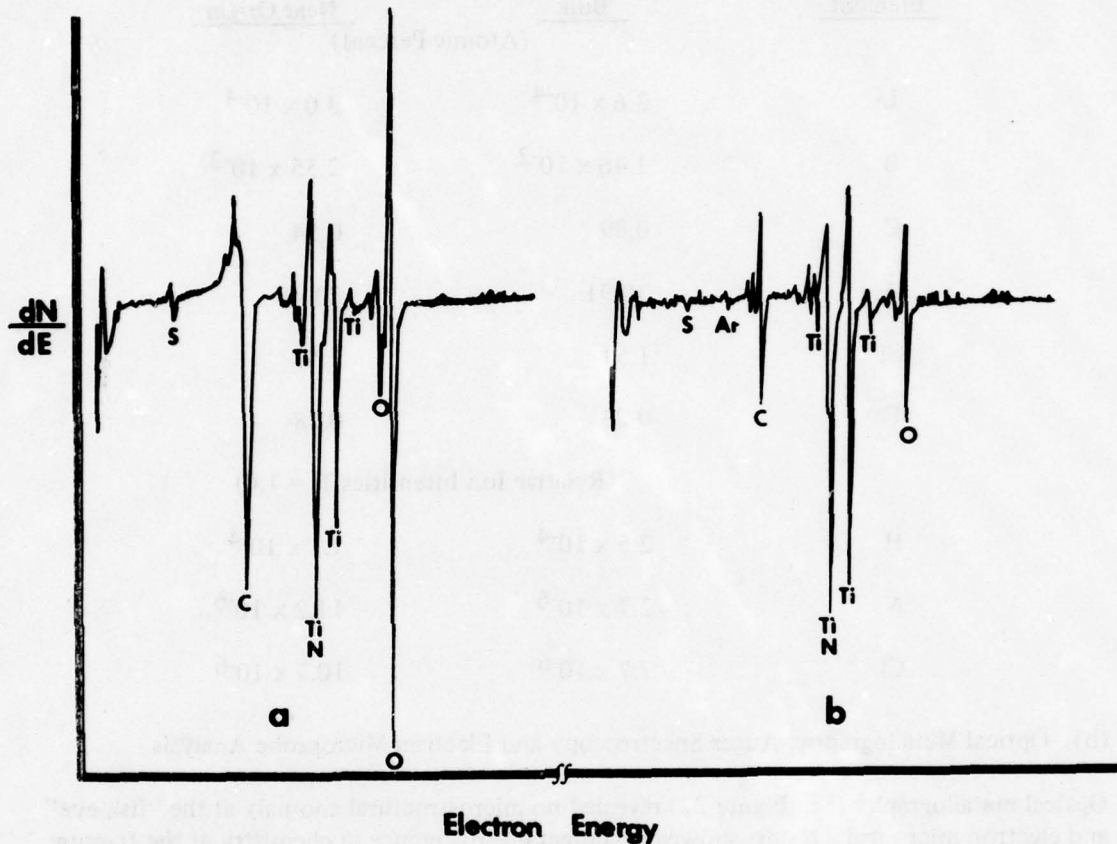
Figure 28 Auger Electron Spectrographs at the 'fish eye' Fatigue Origin
 (a) Before sputtering
 (b) After sputtering, note the decrease in C, O and S which are common surface contaminants.

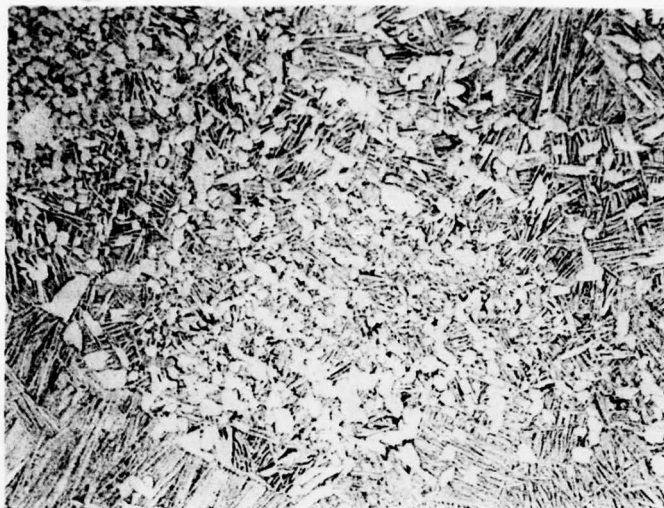
Figure 29 Microstructure Near the Expected Rosette Defect Site in an IMI 685 Specimen Which had been Isothermally compressed at 1830°F.

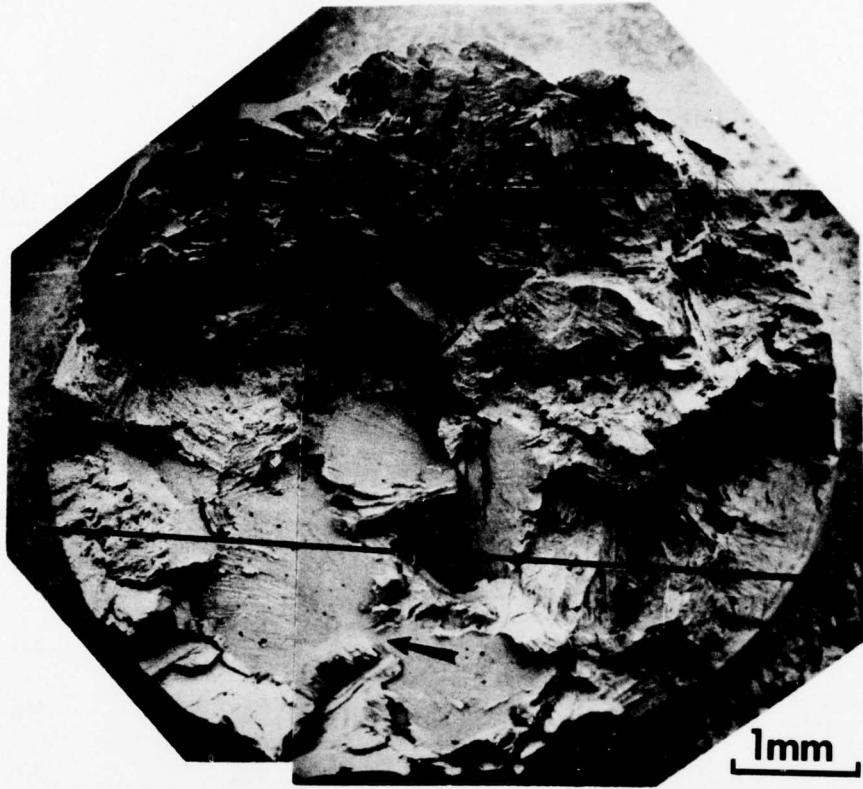
- 1) Cracking rates that occurred in IMI 685 under dwell test conditions could be very high. These rates needed to be determined and compared with data from other tests and behavior in other alloys.
- 2) The relationship between the seeded defects experiments on Ti-6Al-4V, the higher nitrogen content at a rosette origin and the rosette failure in IMI 685 required elucidation.
- 3) It was unclear if the remarkable fatigue characteristics observed in IMI 685 were unique or if they occurred in other alpha:beta titanium alloys. Cracking behavior from naturally occurring flaws and also dwell-testing effects in non-defective material were areas of interest.

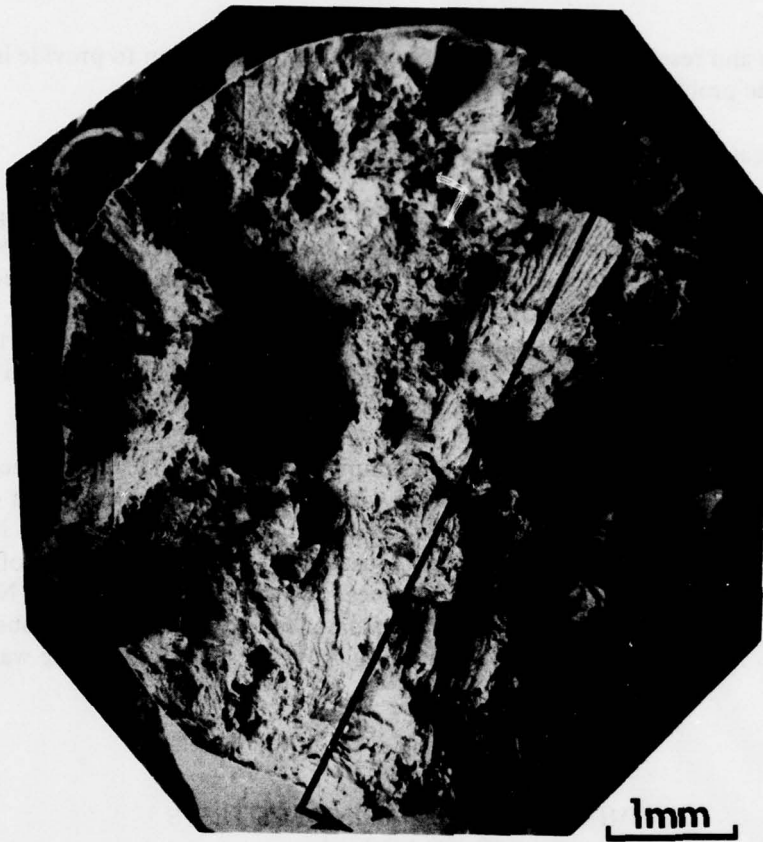
Figure 31 (a) General Appearance of the Fracture of Specimen No. 49 Tested at 400° F. The apparent fracture origin is indicated by an arrow.
(b) A Longitudinal Section Along the Line Indicated in (a), Showing the prior β grain size adjacent to the fracture surface.

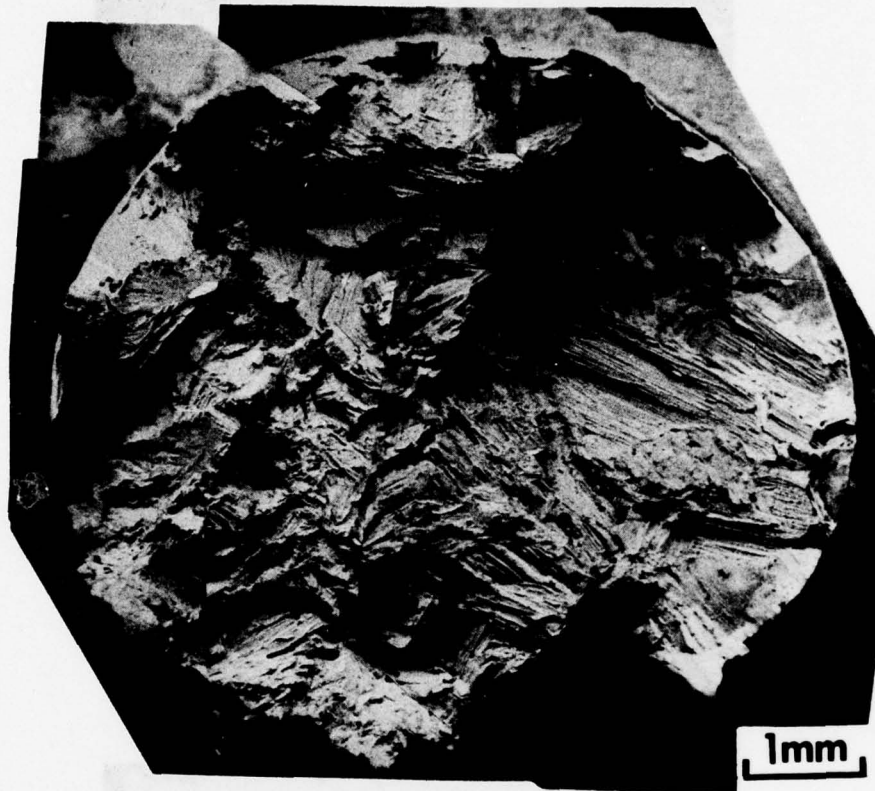
Figure 33 The General Appearance of the Fracture of Specimen No. 9. The stress had been incrementally increased four times before fracture. No crack-front marking due to the unloading is apparent on the fracture surface.
