AD-A052 883

PRATT AND WHITNEY AIRCRAFT GROUP WEST PALM BEACH FL
INFLUENCE OF SUBSURFACE DEFECTS ON FATIGUE PROPERTIES OF TITANI--ETC(U)
JUL 77 M J BLACKBURN, C C LAW

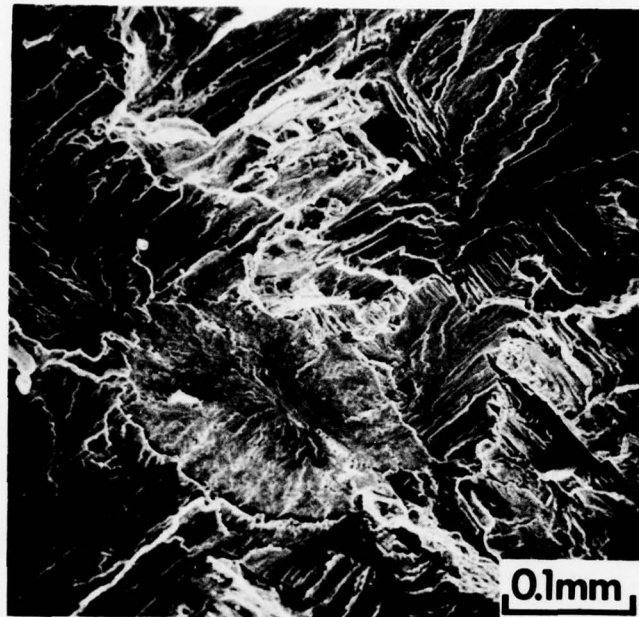
Although the crack propagation rates could not be determined from results of any of the above tests, fatigue striations observed in dwell-tested will be presented later.

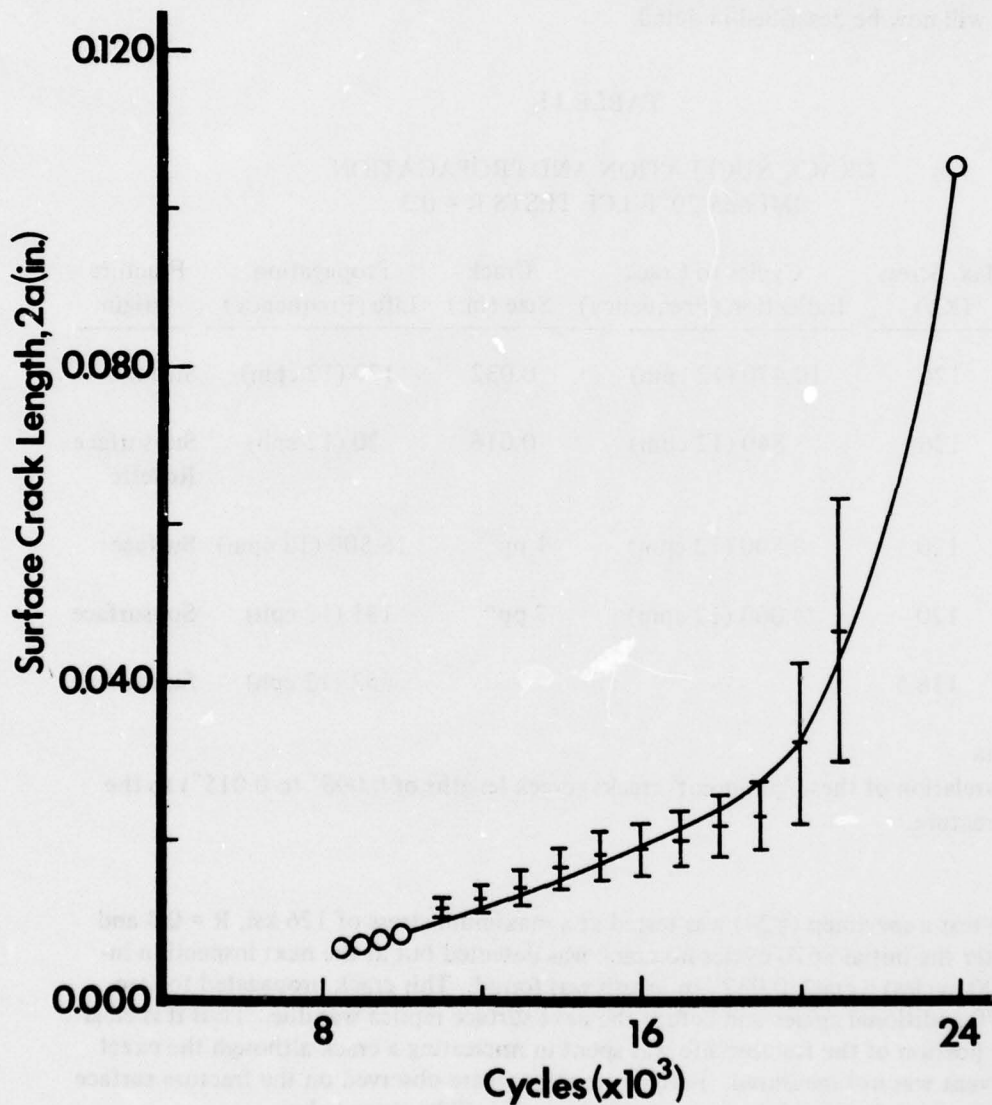
Figure 35 Surface Crack Length, $2a$ Versus Number of Cycles for Specimen No. 45

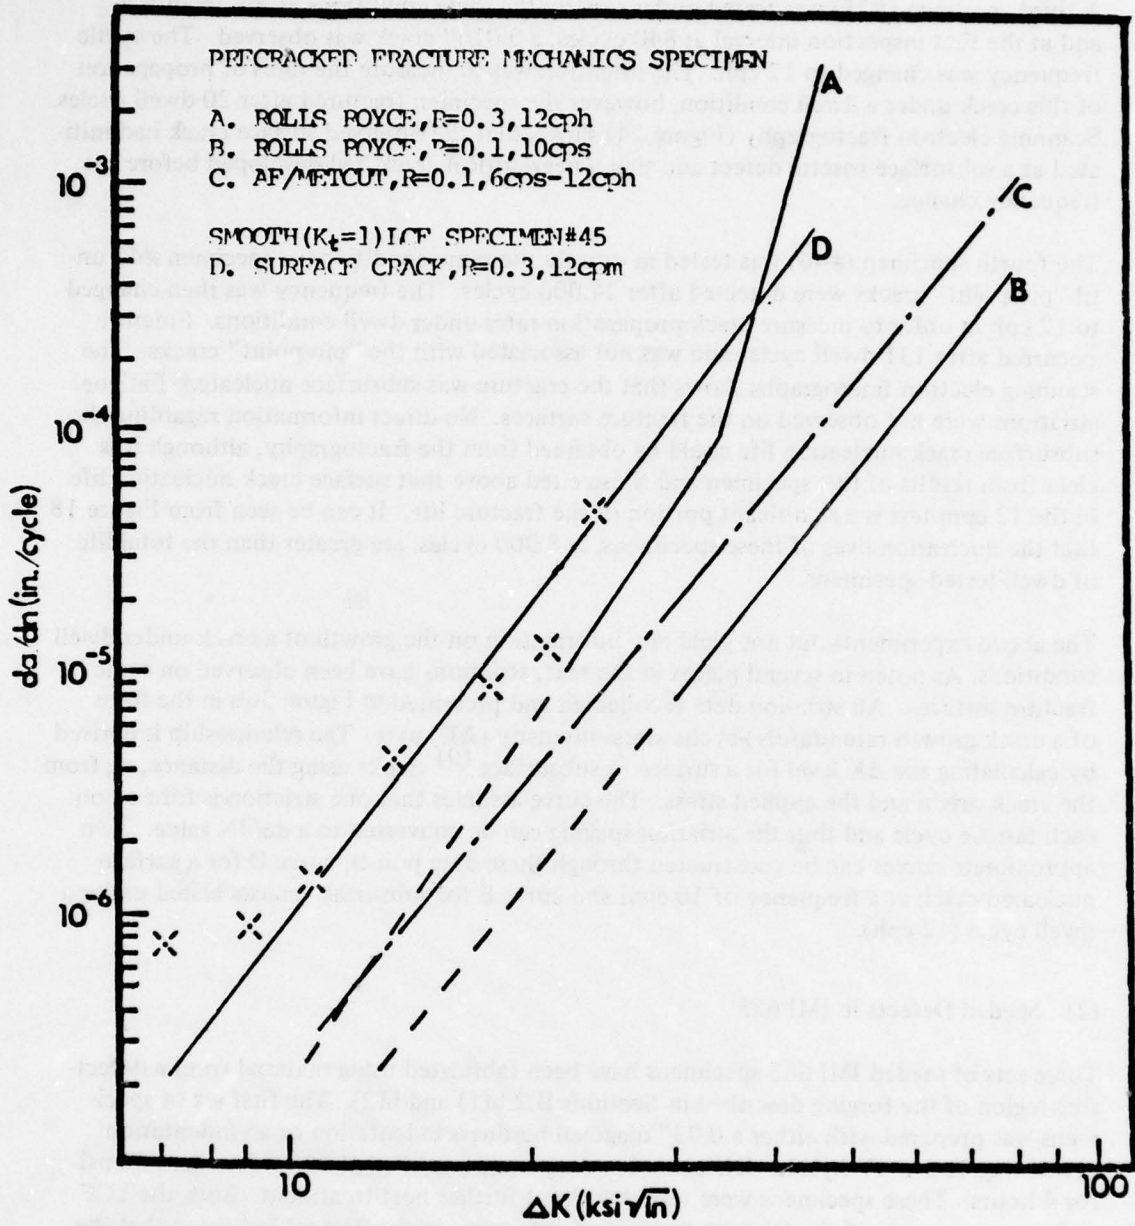
Figure 36(a) Crack Propagation Results as Determined by Measurement of a Surface Crack on a Smooth ($K_t=1$) LCF Specimen (Curve D) Compared With Those Determined From Fracture Mechanics Specimens (Curve A, B, and C).

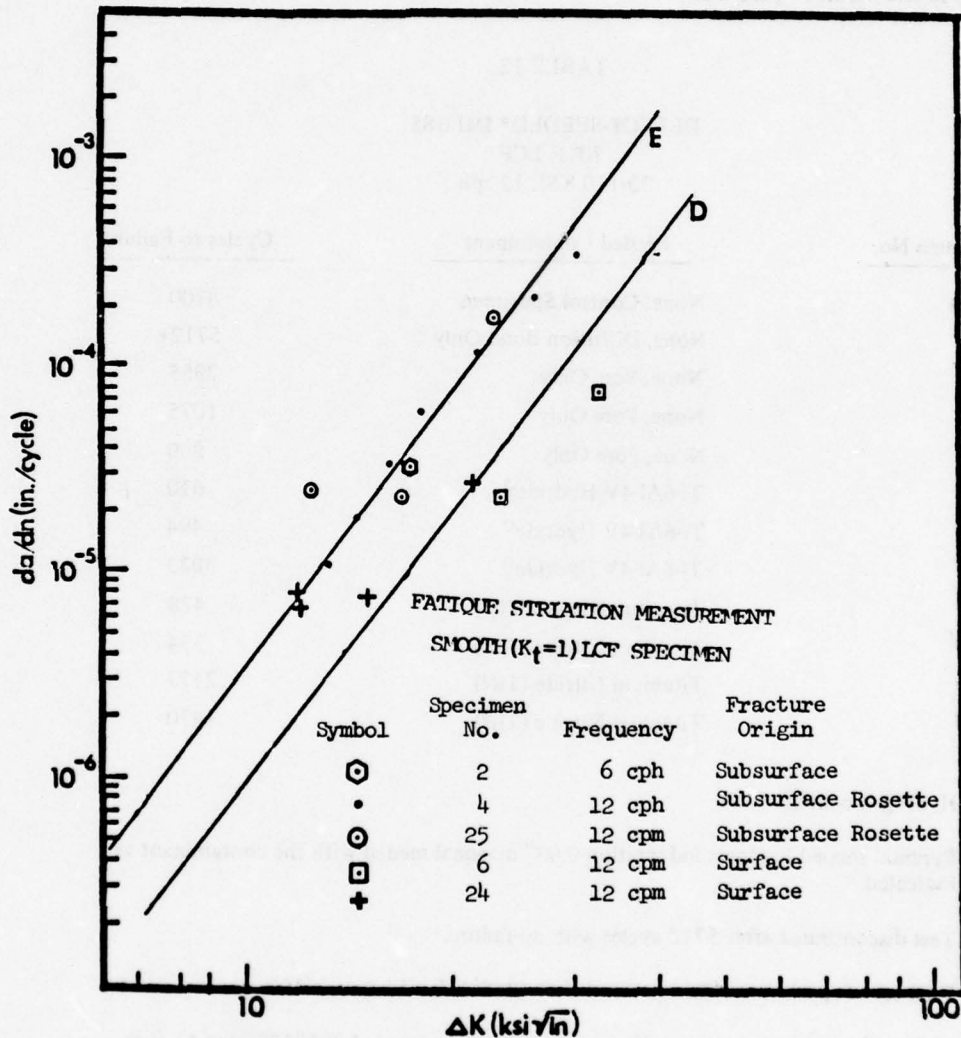
Figure 36(b) Crack Propagation Results as Determined by Fatigue Striation Measurement on Smooth ($K_t=1$) LCF Specimens.

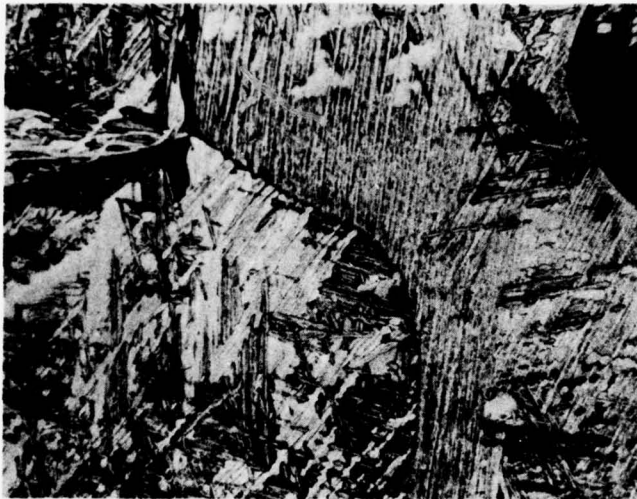
(3)' Third set of specimen reheat treated to produce microstructure shown in Figure 37b.
 Tested at 33-110 ksi, 12 cpm.

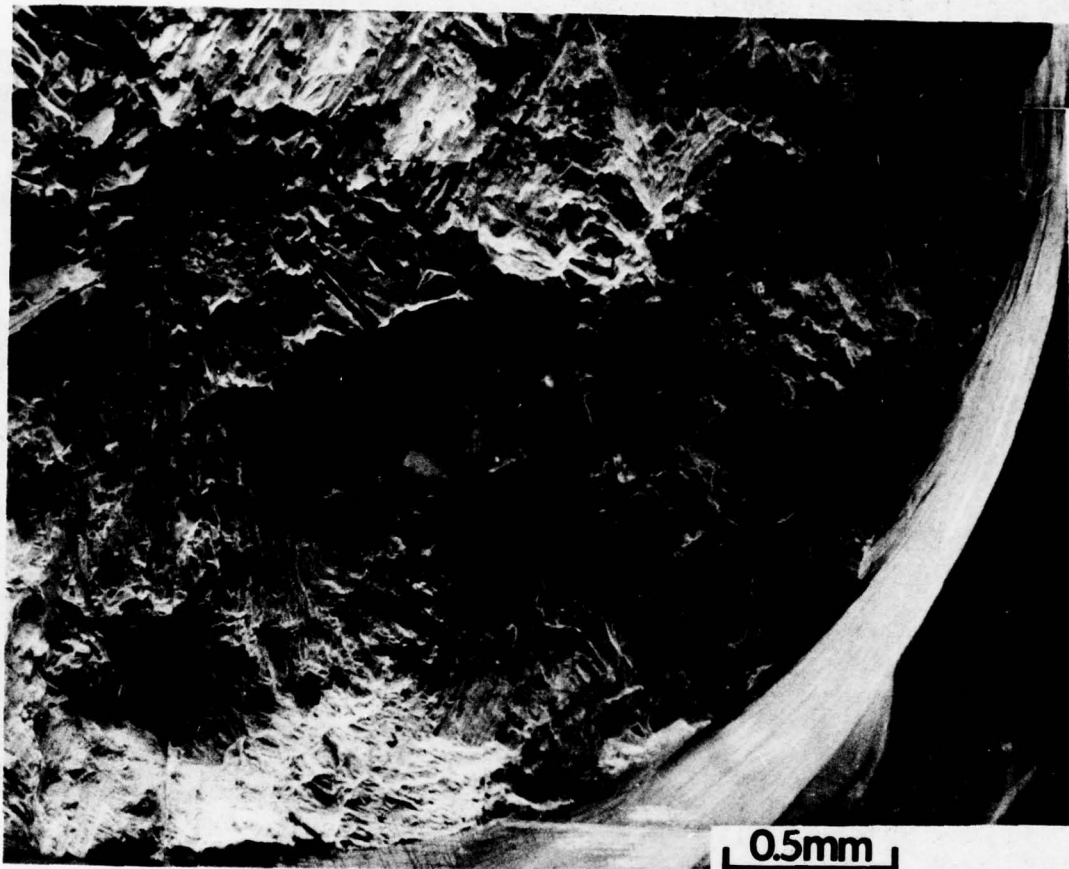
Figure 38 The Appearance of the Fracture Surface of the Nitrided-Seeded Specimen No. 41. The microstructure is given in Figure 37a. Fracture initiated at the seeded pore which can be located at the upper left corner.

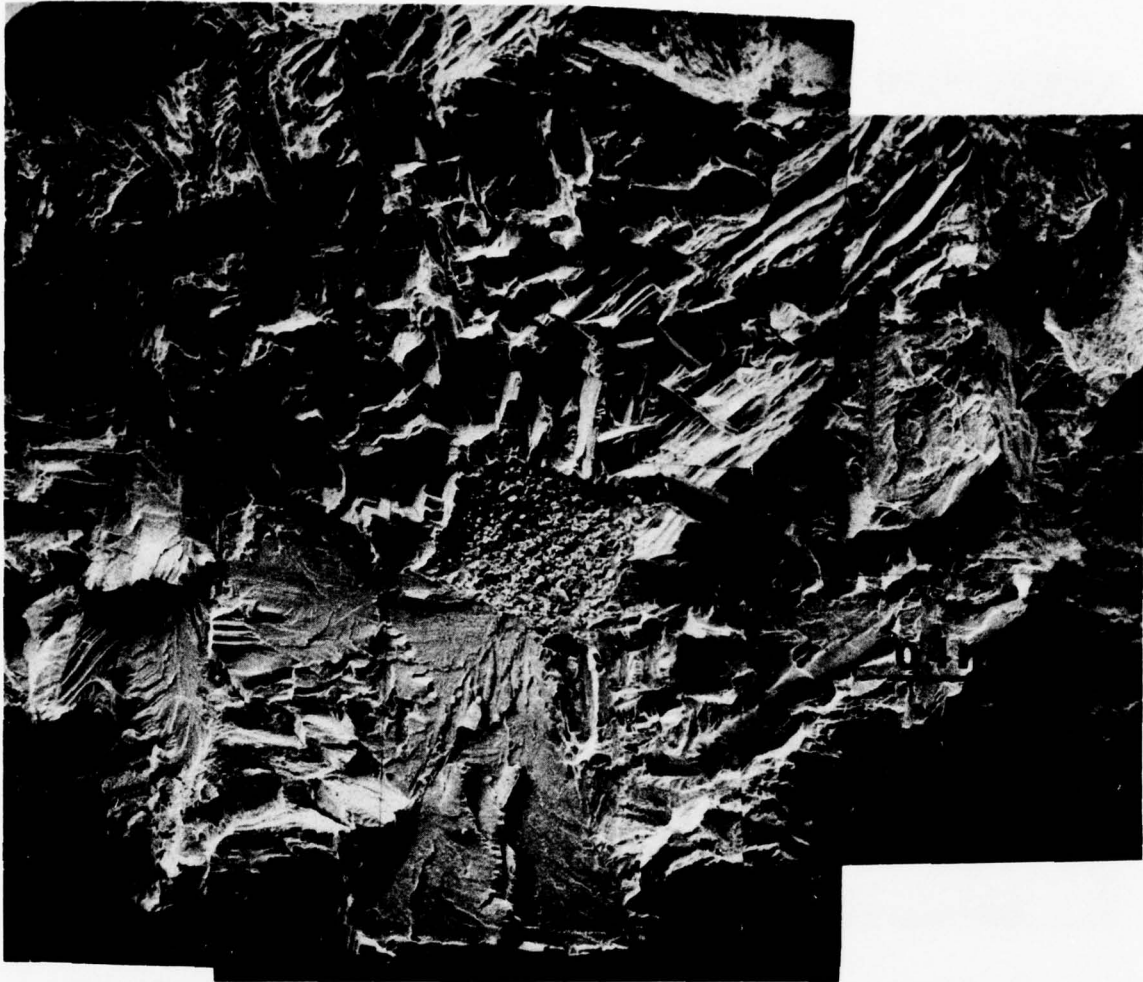
Figure 39 Fracture Appearance of the Dwell-Tested Specimen (No. 38) Which Contains A Nitride-Seeded Pore

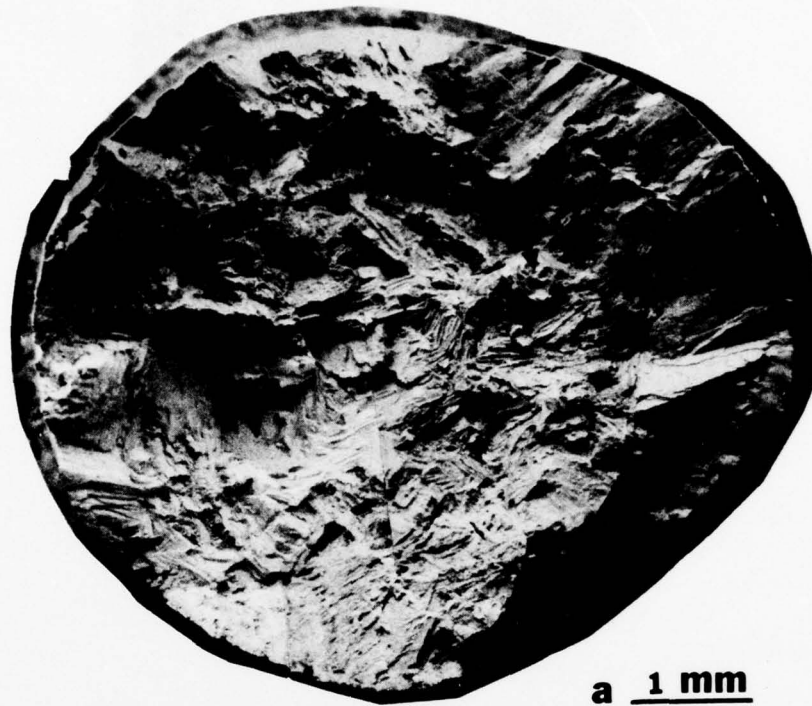
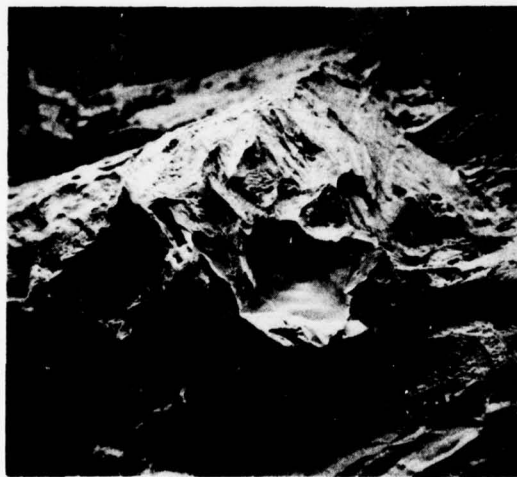
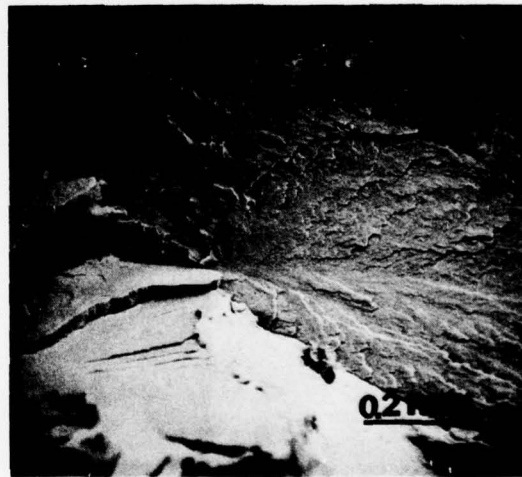
Figure 41 (a) General Fracture Appearance of the Dwell-Tested Specimen (No. 31) Which Contains a Clean Pore. The pore (indicated by the upper arrow) is partially exposed and is located at the overload failed region.
(b) The Clean Pore Shown at Higher Magnification.
(c) The Fracture Origin which is Indicated by the Lower Arrow in (a).

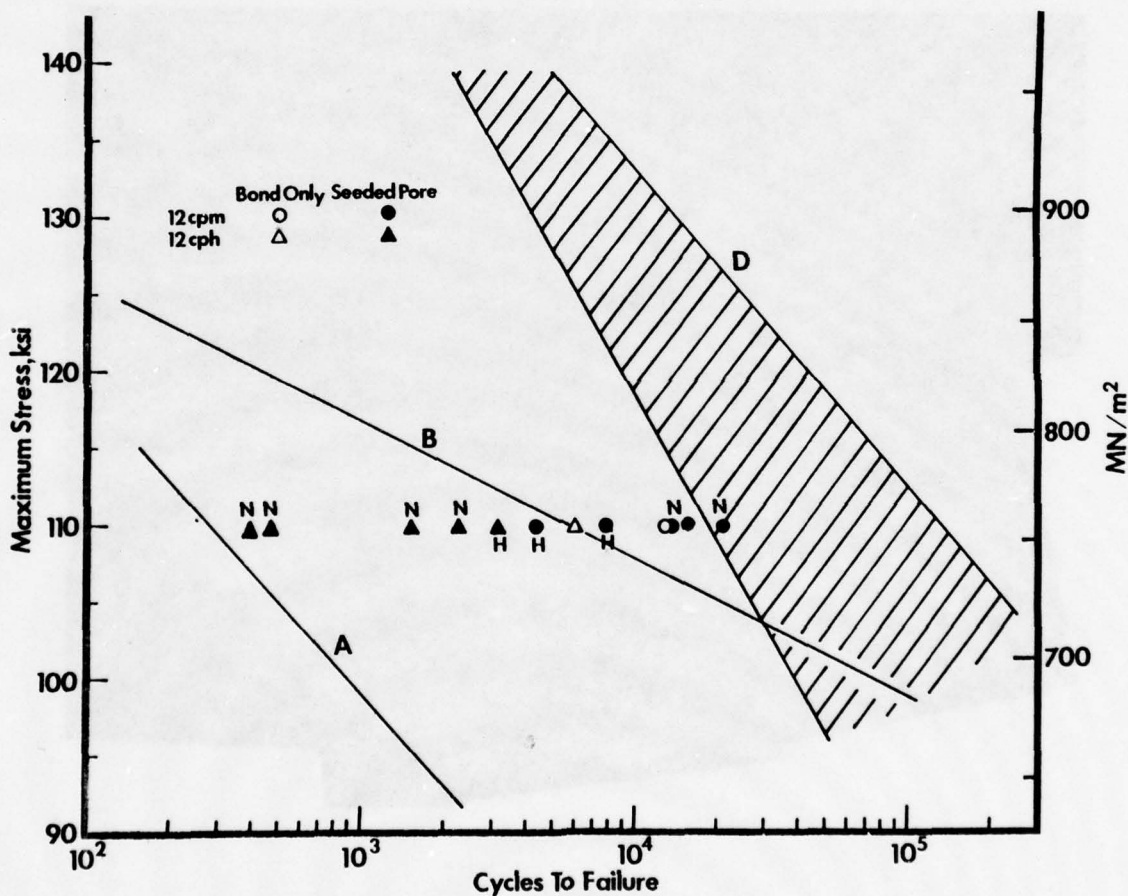
Figure 43 The LCF Lives of Seeded IMI 685 Specimens Relative to those of the Dwell-Tested (12 cph) Specimens Containing Rosette Defects (Curve A) and Defect-Free Specimens (Curve B); Those of the Defect-Free or Rosette-Containing Specimens test at 12 cpm are Given by the Scatterband D. The data points from specimens seeded with hydride are indicated by H and those from specimens seeded with nitride by N.

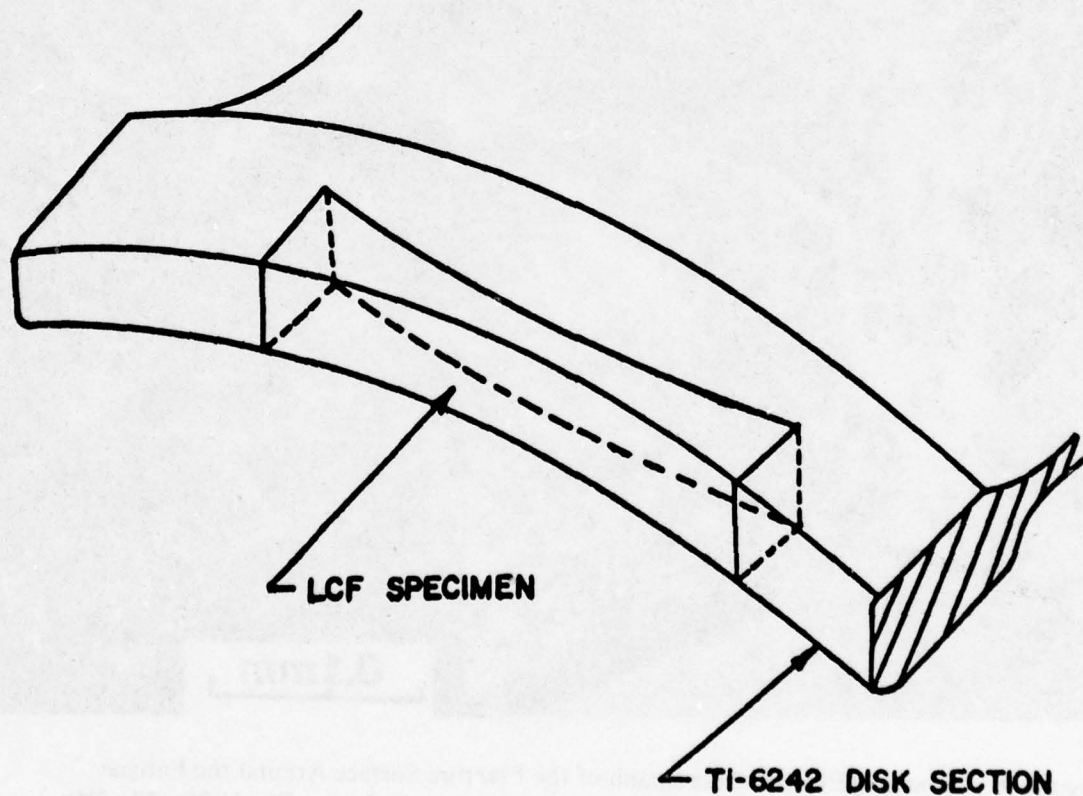
Figure 44 The Shape and Relative Orientation of the Fatigue Specimen Machined from the Ti-6Al-2Sn-4Zr-2Mo Flat Disk. A defect had been located at the gage section of the specimen by the ultrasonic C-scan technique.

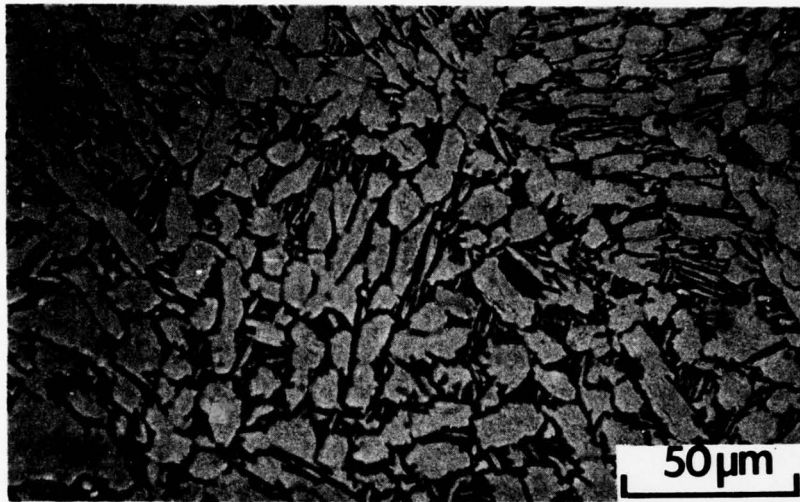
Figure 45 Microstructure of the Ti-6Al-2Sn-4Sn-2Mo Disk

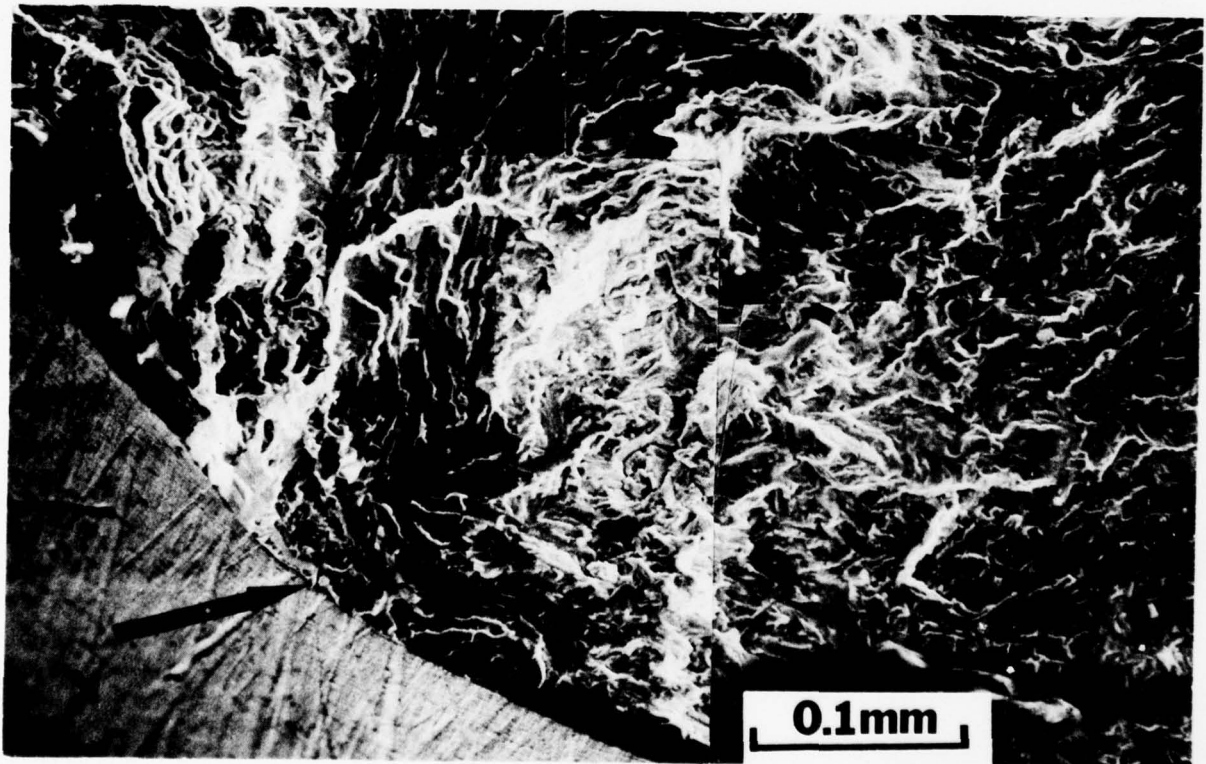
Figure 46 Scanning Electron Micrograph of the Fracture Surface Around the Fatigue Crack Origin in the Specimen Machined from a Defective Ti-6Al-2Sn-4Zr-2Mo Flat Disk (see Figure 44). The nucleation site which is shown in greater detail in Figure 47(a) is indicated by an arrow.

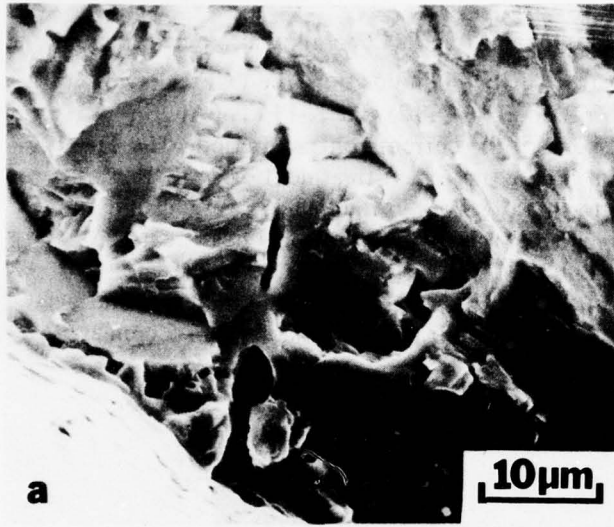
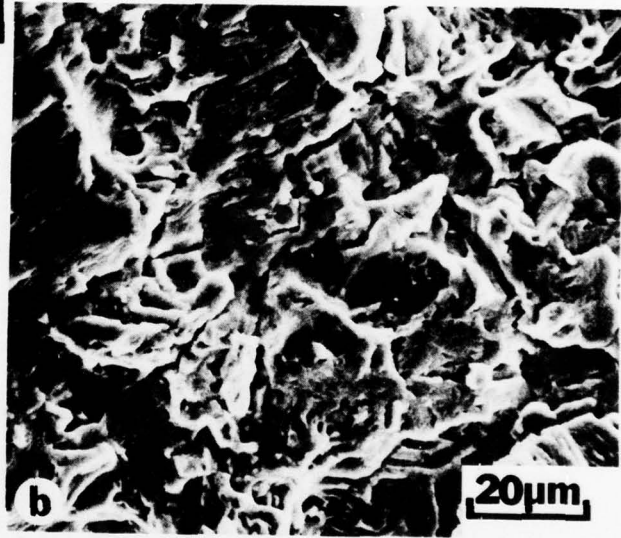
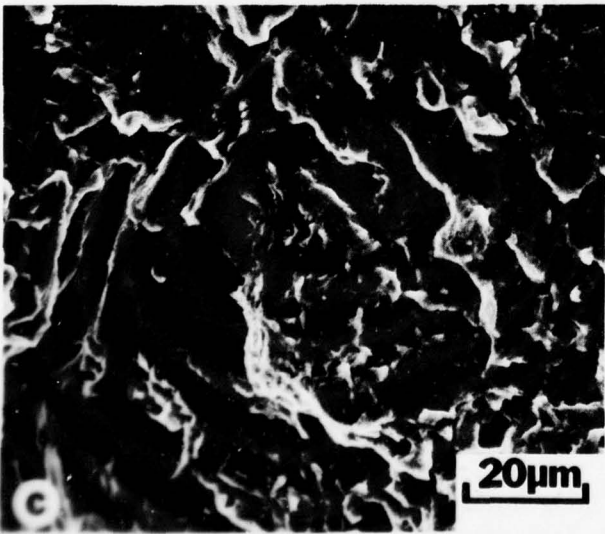
Figure 47 (a) Details of the Crack Nucleation Site Shown in Figure 46. Typical appearance of fatigue striations on fracture surfaces are shown in (b) and (c).

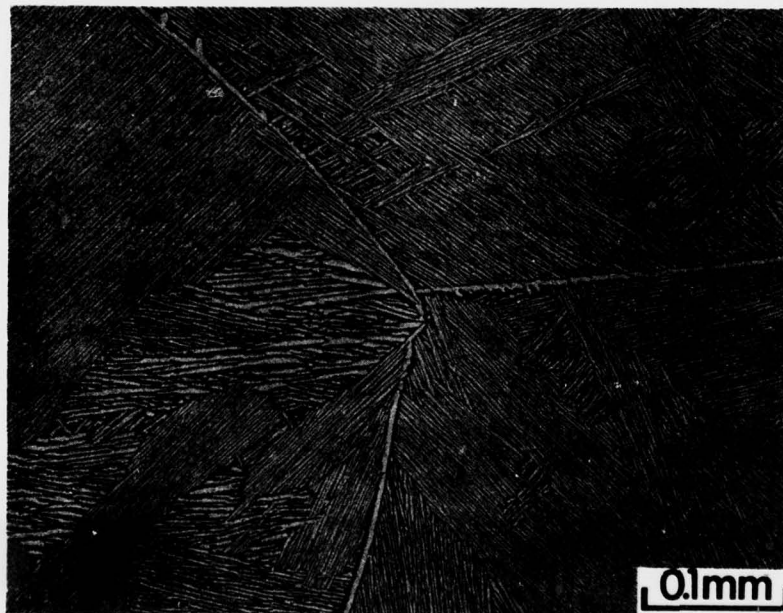
Figure 48 Microstructure of the Beta-Heat Treated Ti-6Al-2Sn-4Zr-2Mo.

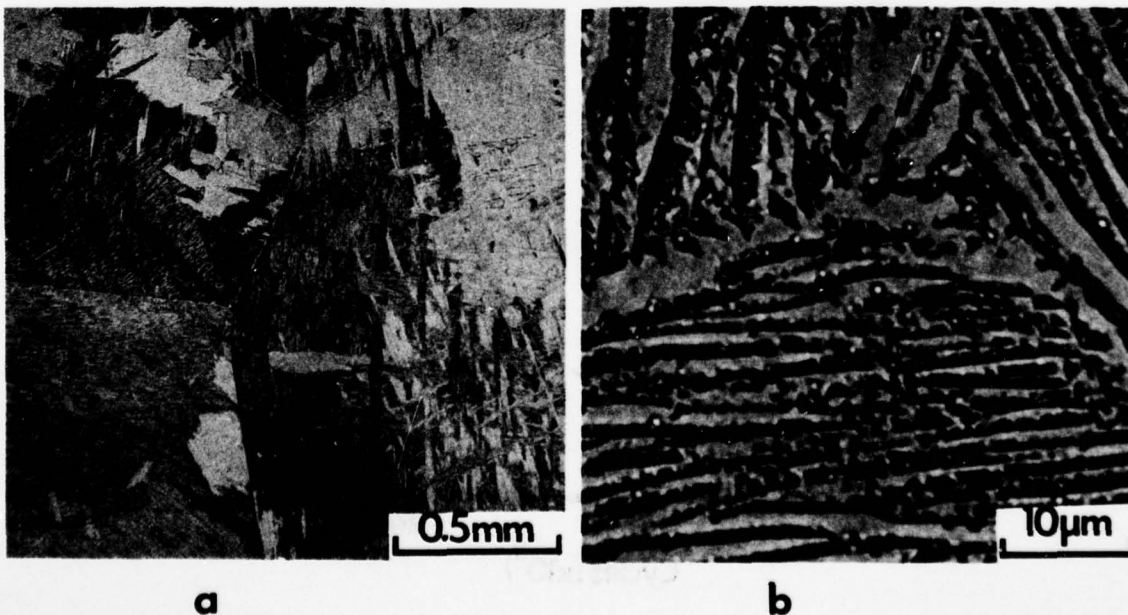
Figure 49 Microstructure of Ti-11 (a) shows the Large Prior Beta Grains and (b) Shows the Spheroidized Beta Phase

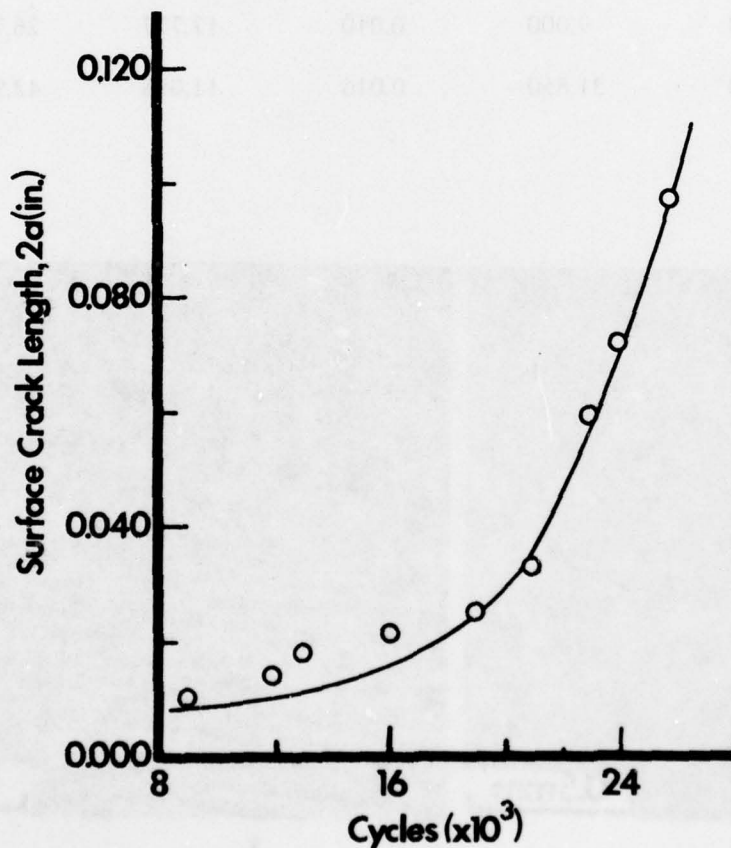
Figure 50 Surface Crack Length, $2a$ Versus Number of Cycles for Ti-6Al-2Sn-4Zr-2Mo Specimen No. 10

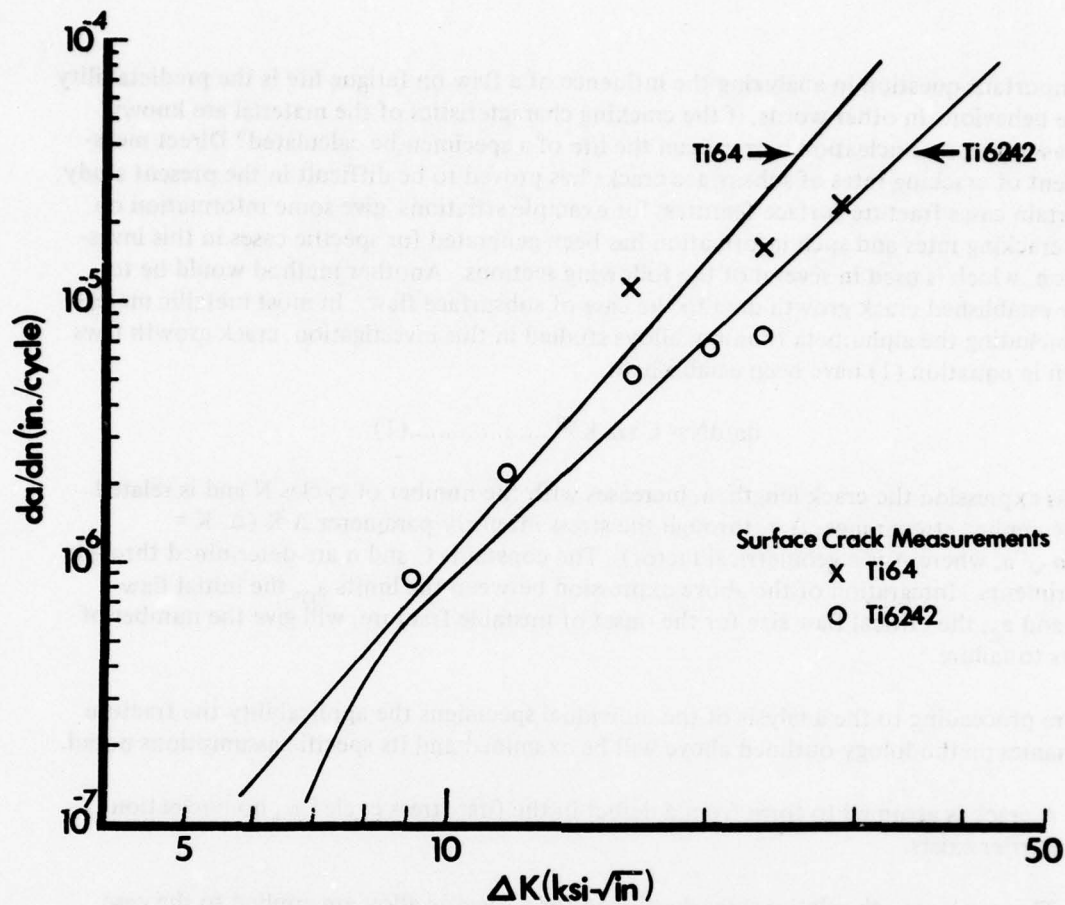
Figure 51 Results of Surface Crack Measurements on Beta-Heat Treated Ti-6Al-2Sn-4Zr-2Mo and STA Treated Ti-6Al-4V LCF Test Specimens Plotted in Terms of da/dN versus ΔK . The fatigue crack propagation rates determined from fracture mechanics specimens are indicated by solid lines.

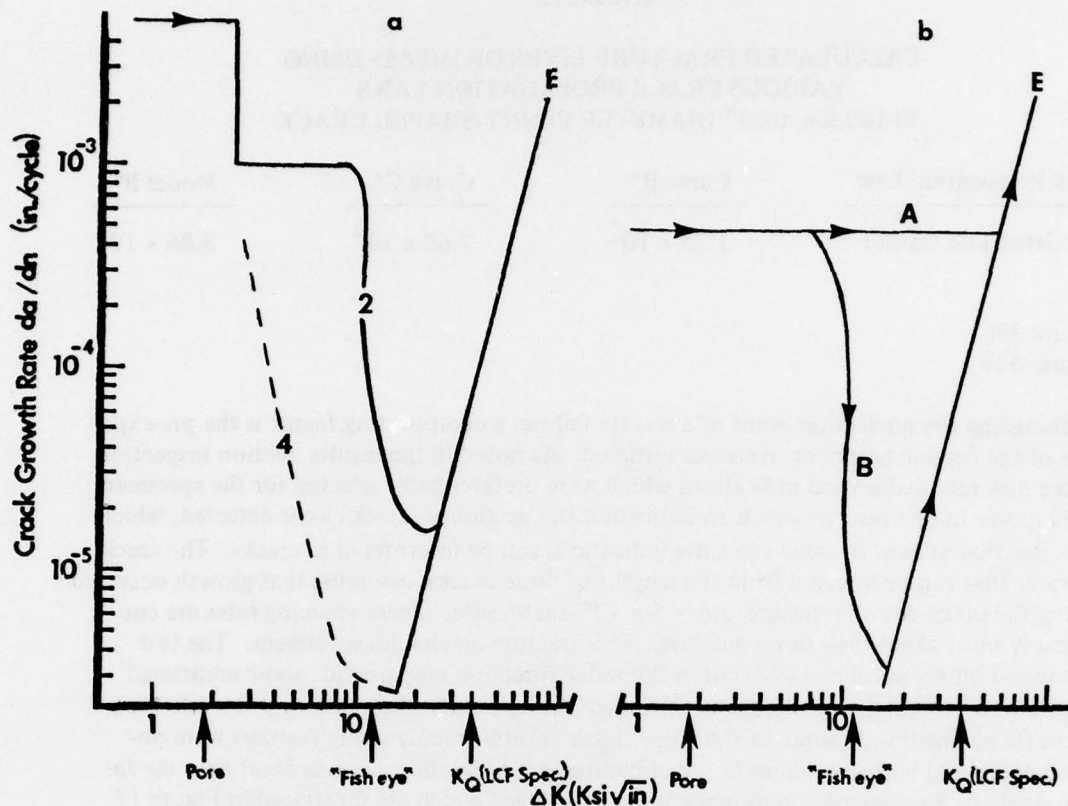
Figure 52 (a) Crack Growth Behavior Inferred From Striation Observation on IMI 685 Specimen No. 2 (Curve 2E) and Specimen No. 4 (Curve 4E)
 (b) Idealized Representations of Results Shown in (a). Curve AE represents an initially constant rate of crack propagation until a more rapid crack mode (Curve E) becomes available. Curve B represents an average of Curves 2E and 4E in (a).

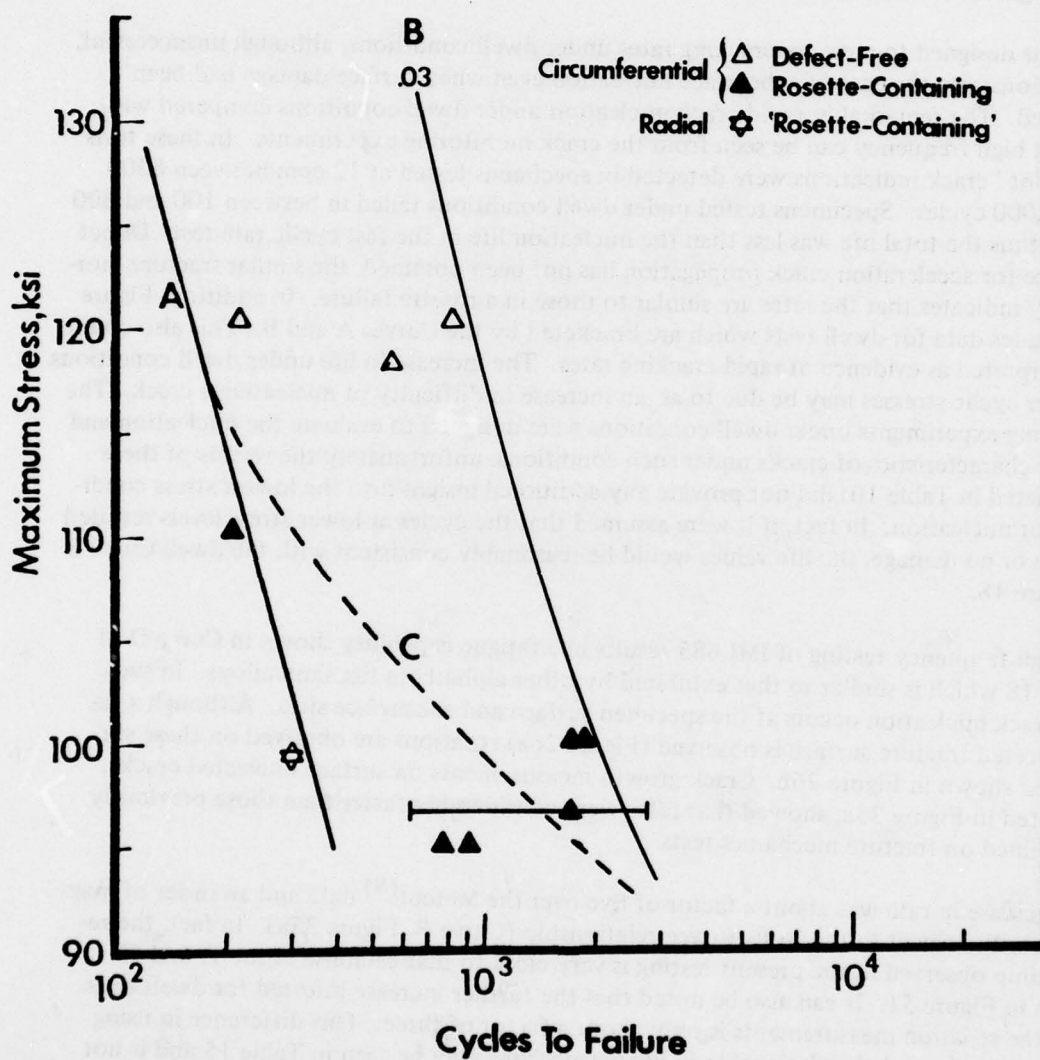
Figure 53 Calculated Fracture Lives as Function of the Maximum Stresses Assuming an Initial Penny-Shaped Flow of 0.03" Diameter. Curves A and B are obtained, respectively, from Curves AE and BE shown in Figure 52b. A combination of Curves A and B results in Curve C.

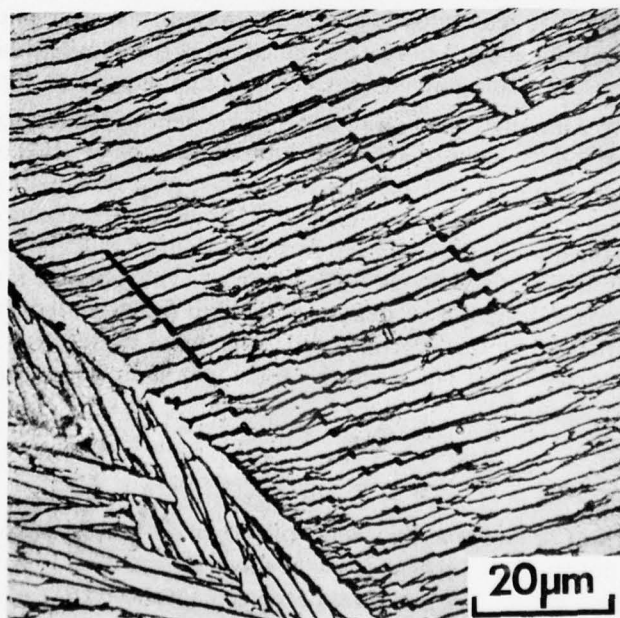
Figure 54 Formation of a Shear Crack in a Beta-Colony Structure. (Taken from the unpublished work of Roberson et al, ARL, 1972)

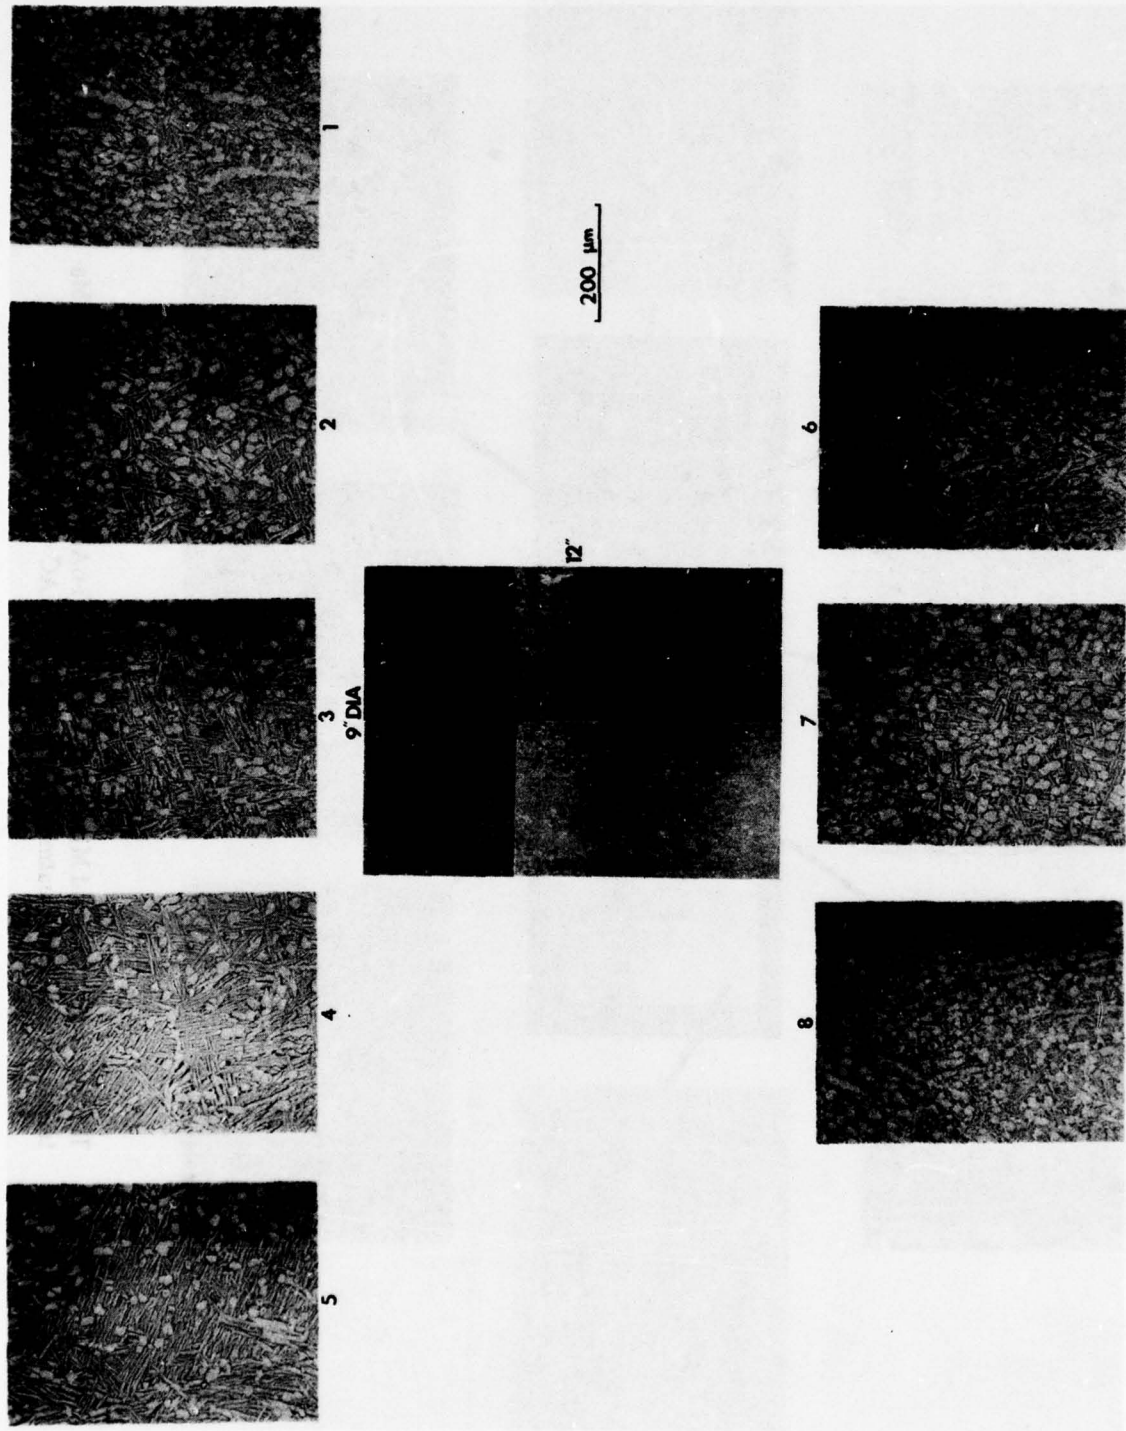
Figure 55 The Macrostructure and Microstructure of the Longitudinal Midsection of the Ti-6Al-4V Bar (TMCA Material) in the As-Received Condition

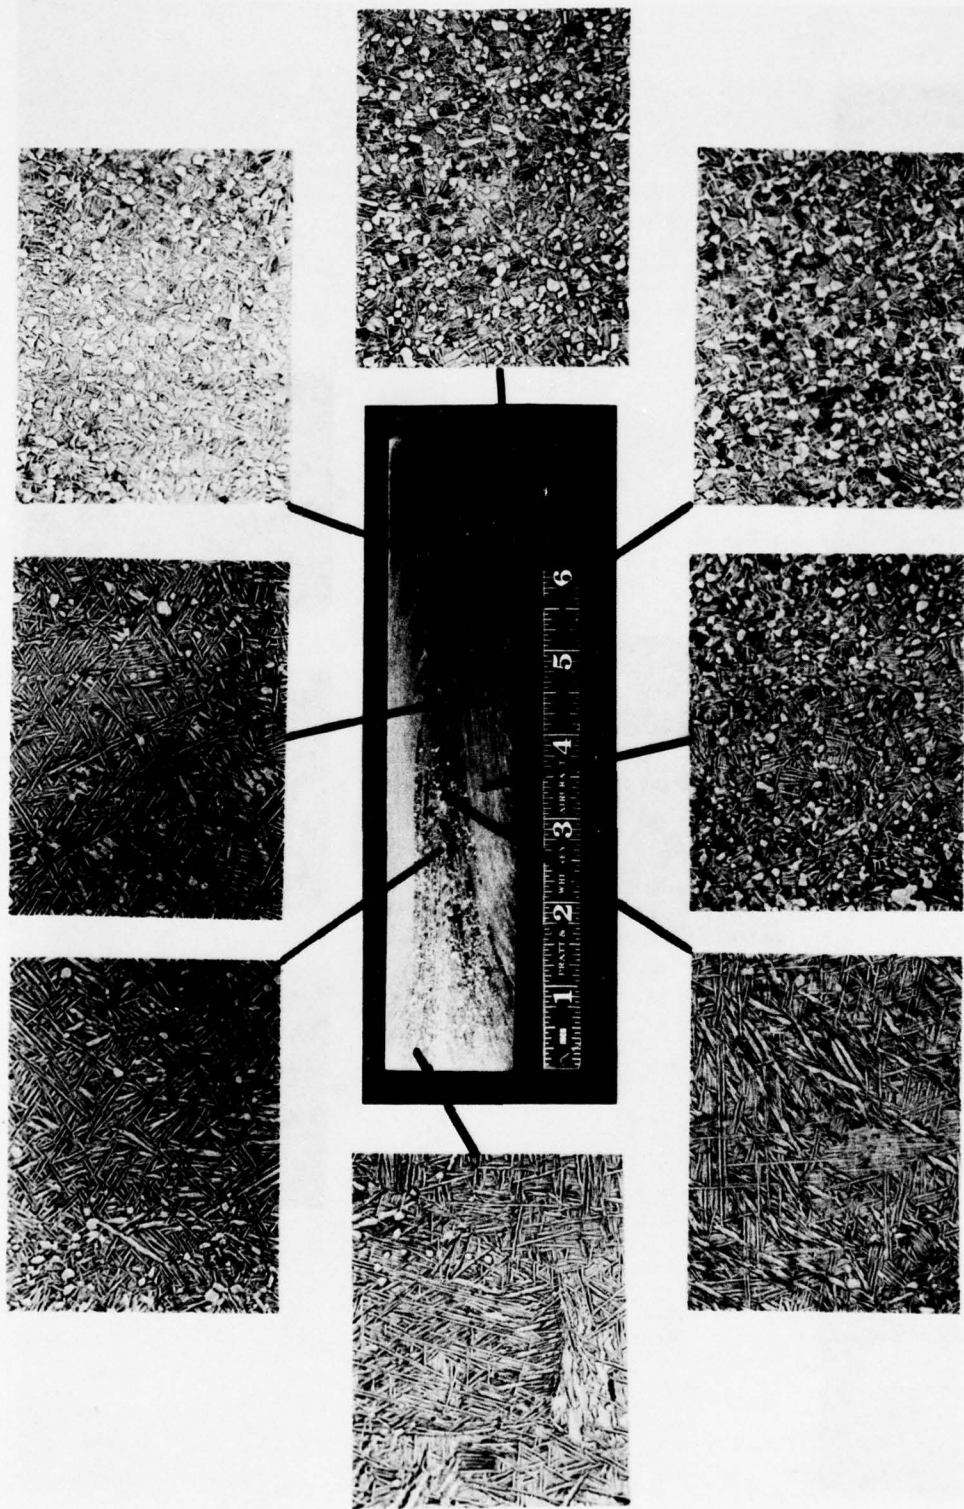
Figure 56 The Macrostructure and Microstructure of the Ti-6Al-4V Forging (P&WA Material) After a Heat Treatment of 1750F/1 hour AC + 1300F/2 hours AC.

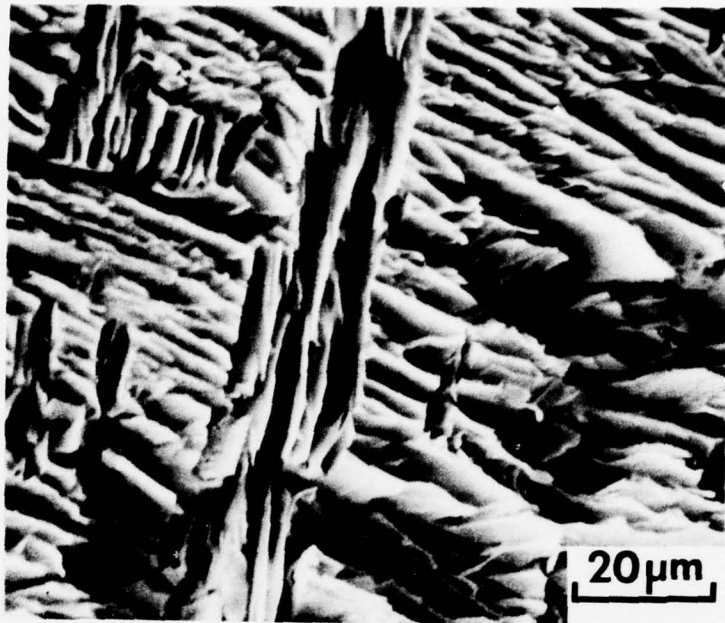
- 1) Exposure for 1 hour at temperatures of 1750°F, 1780°F, 1810°F and 1830°F.
- 2) Isothermal forging of a center sample at 1675°F to a strain of 130% followed by exposure for 1 hour at 1780°F.

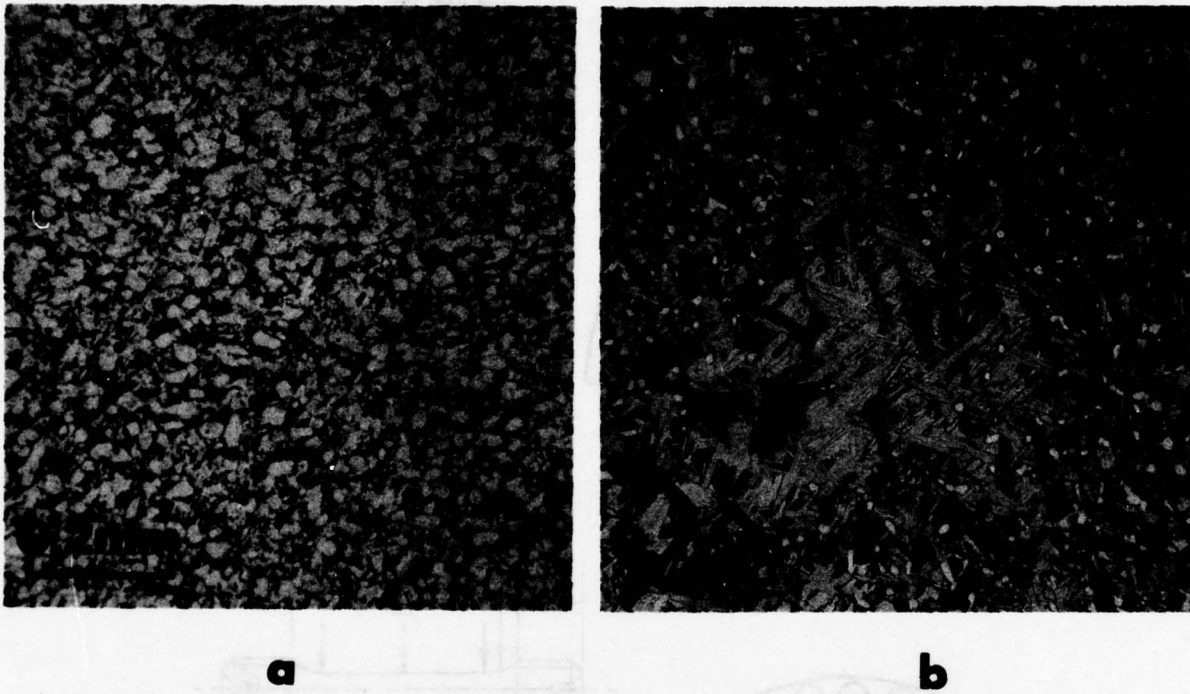
Figure 59 The Microstructure of a Center Specimen Isothermally Forged at 1675°F to a Strain of 130%. (a) before and (b) after heat treatment for one hour at 1780°F.
