AD-A052 883

PRATT AND WHITNEY AIRCRAFT GROUP WEST PALM BEACH FL
INFLUENCE OF SUBSURFACE DEFECTS ON FATIGUE PROPERTIES OF TITANI--ETC(U)
JUL 77 M J BLACKBURN, C C LAW

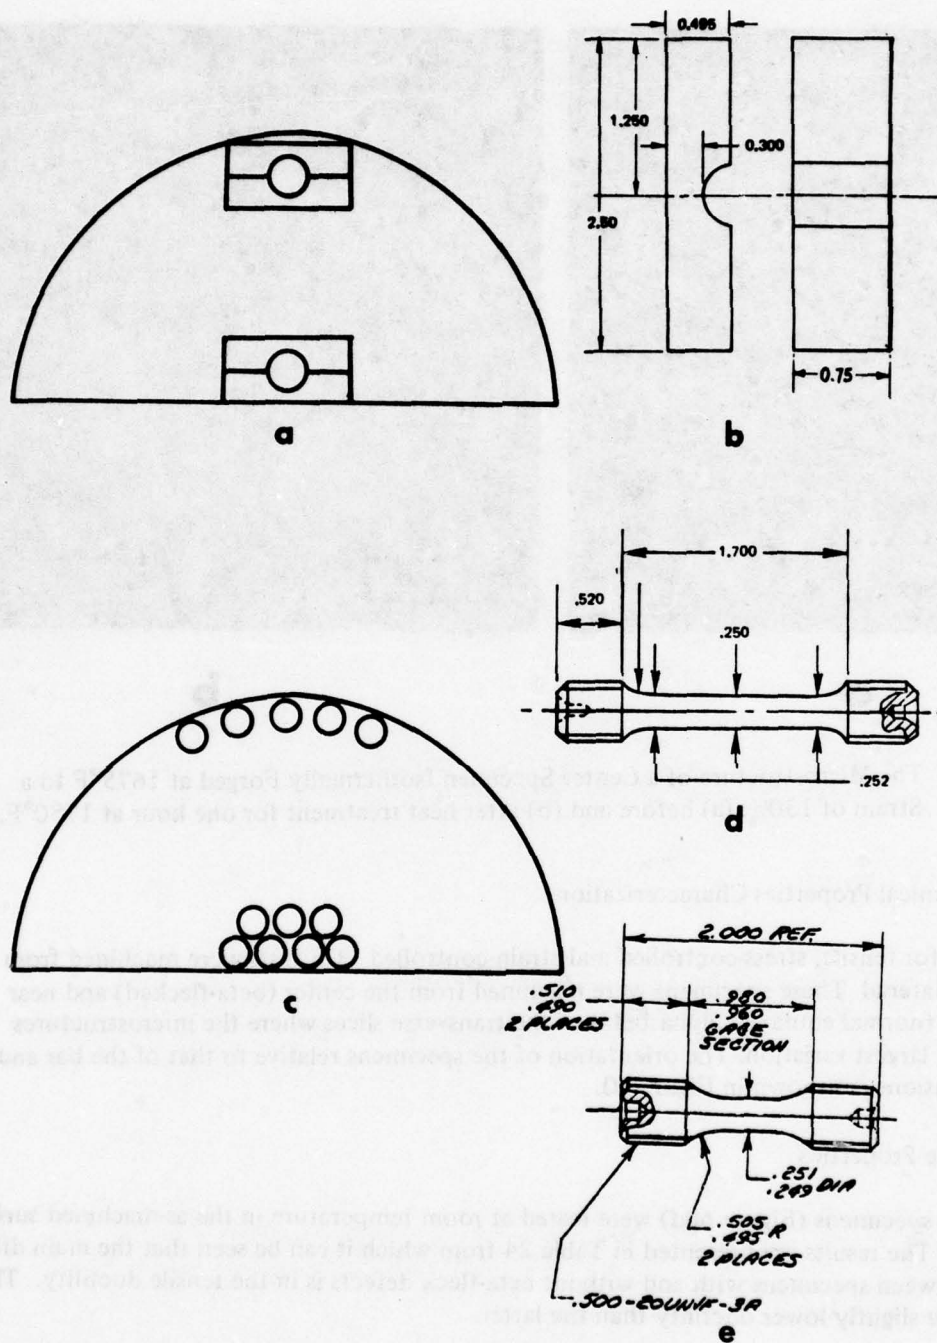
Figure 60 Orientations of the Half Bolt Hole Specimens (a) and Tensile and LCF Specimens (c) relative to the transverse slices cut from the longitudinal halves of a Ti-6Al-4V bar. The dimensions of these specimens are given in (b), (d) and (e), respectively.

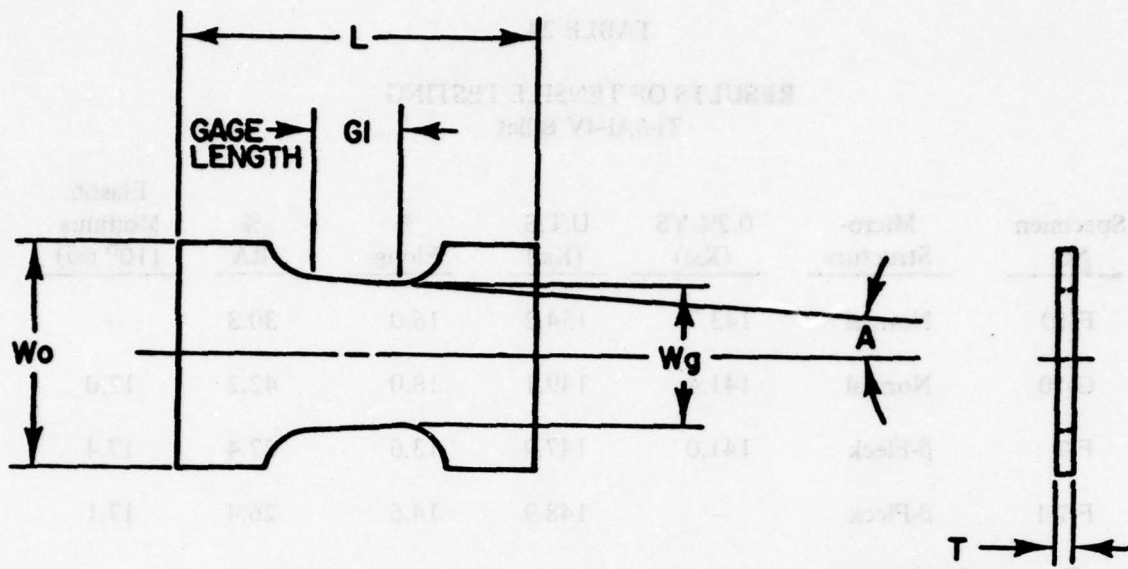
L	GI	W _o	W _g	A	T
1.625	.510-.515	.740-.750	.495-.505	2°52'	.100-.102

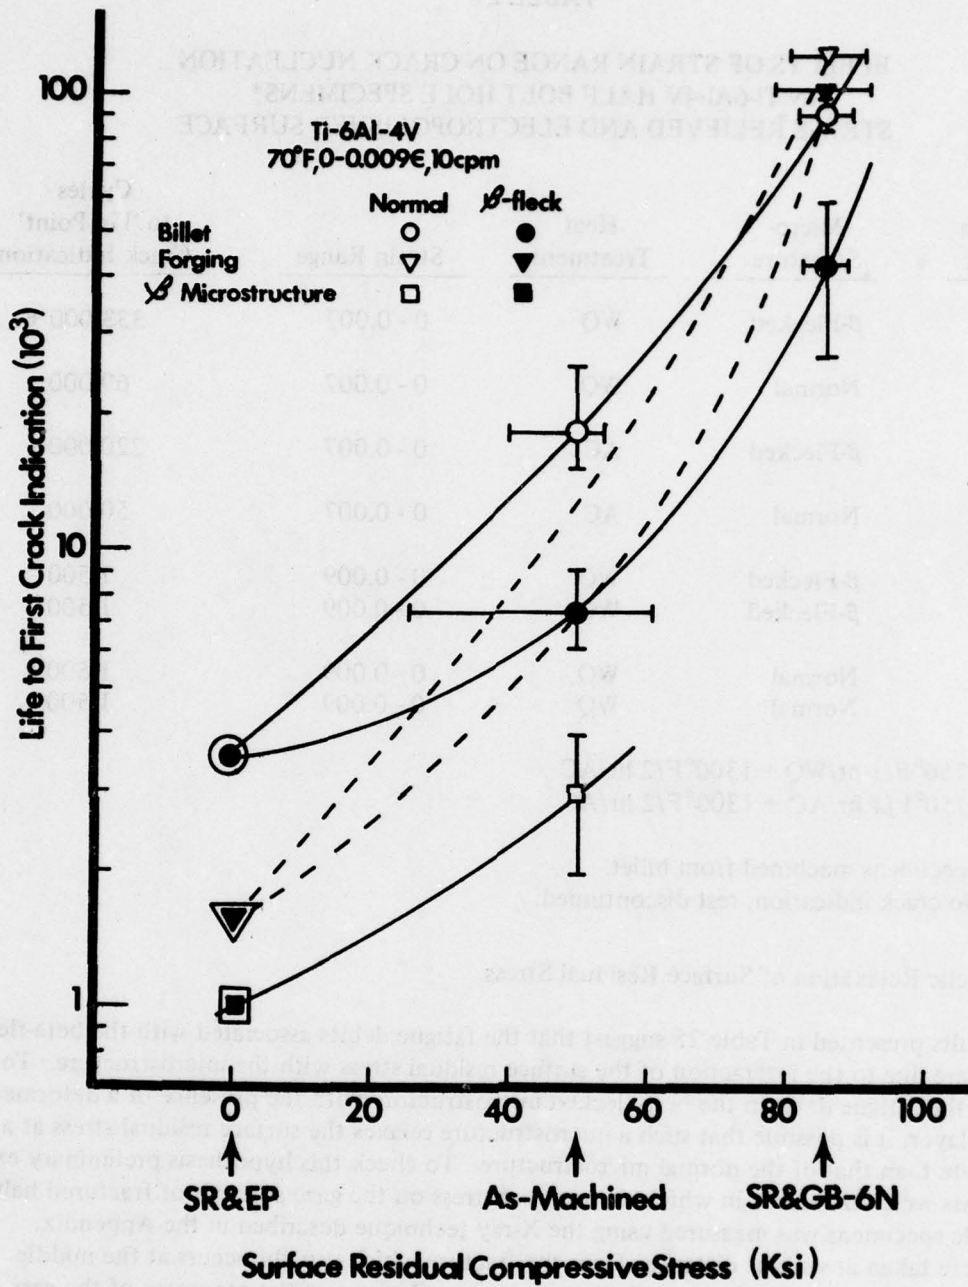
Figure 62 Fatigue Crack Initiation Lives of Normal and Beta-Flecked Ti-6Al-4V as a Function of Surface Preparation. The specimens were tested in strain-controlled LCF at 0.9%e.

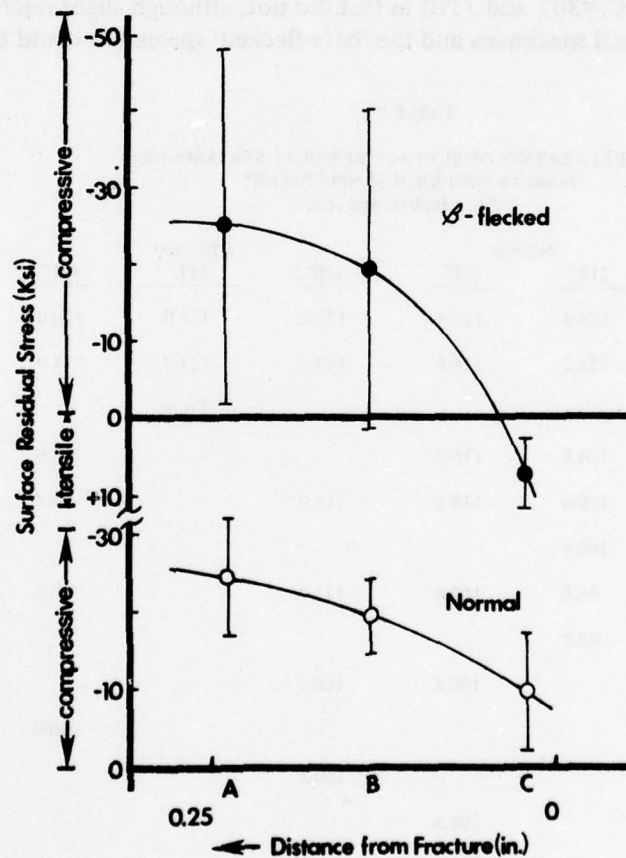
Figure 63 Surface Residual Stresses at Various Distances From the Fracture Surface of Half Bolt Hole Specimens With and Without Beta-Fleck Defects

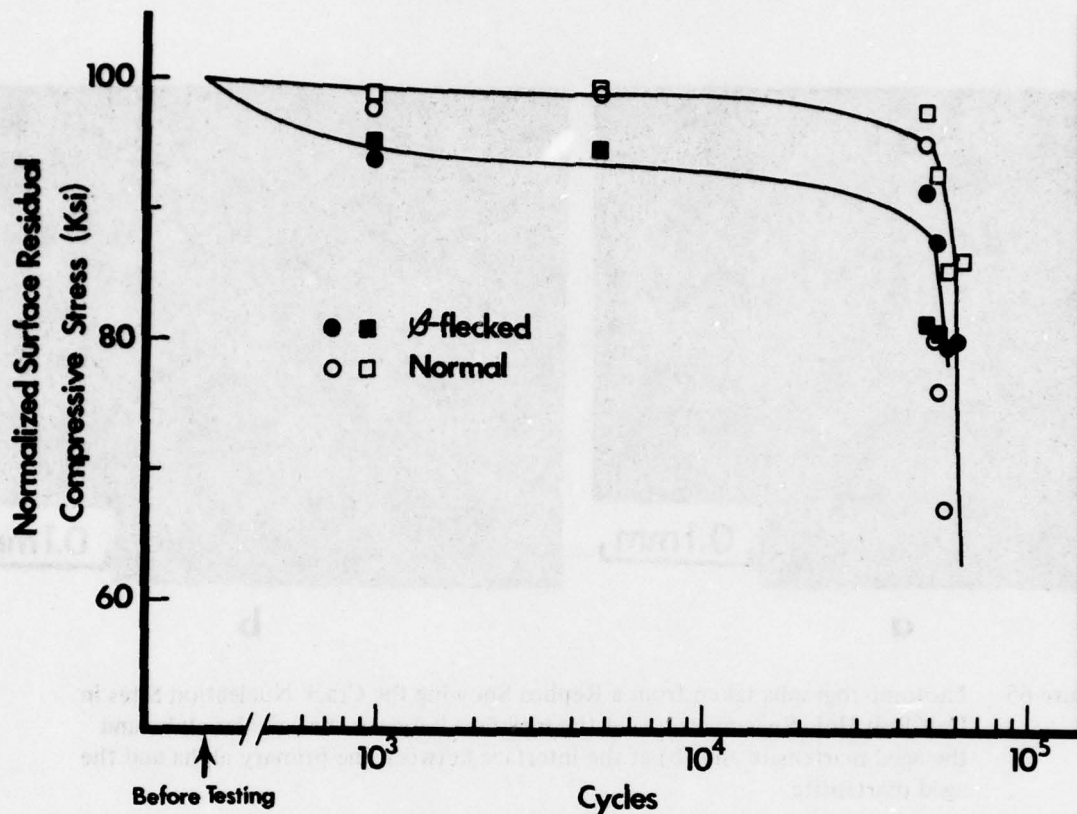
Figure 64 Cyclic Relaxation of Surface Residual Stress in Mini Krouse Specimens

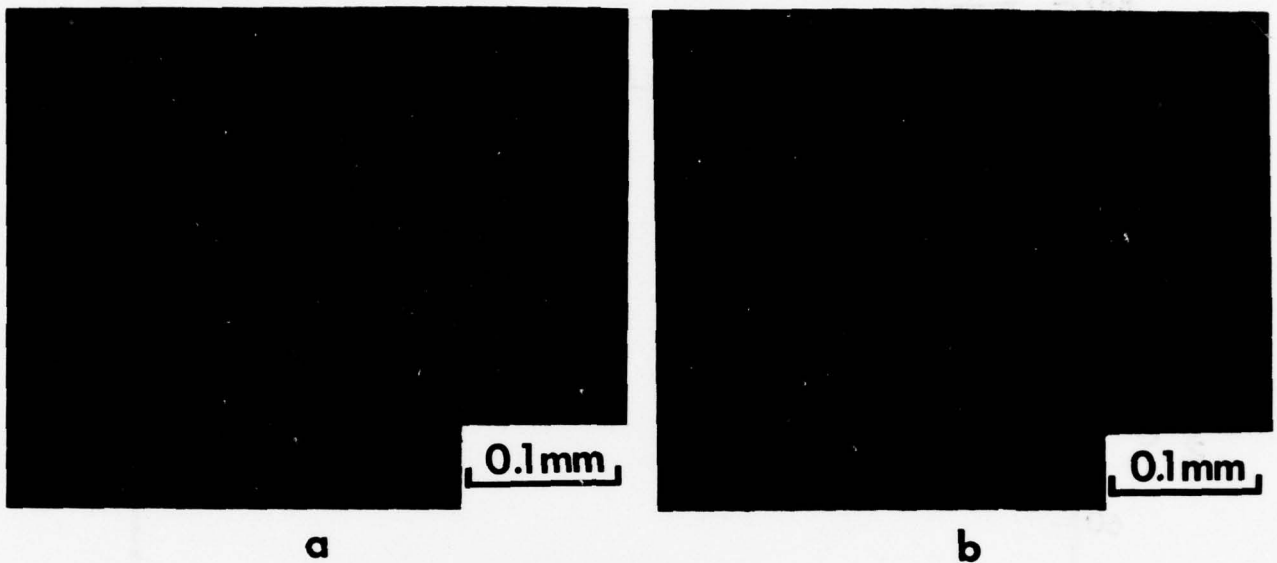
Figure 65 Photomicrographs taken from a Replica Showing the Crack Nucleation Sites in Half Bolt Hole Specimens, (a) at the interface between the acicular alpha and the aged martensite and (b) at the interface between the primary alpha and the aged martensite.

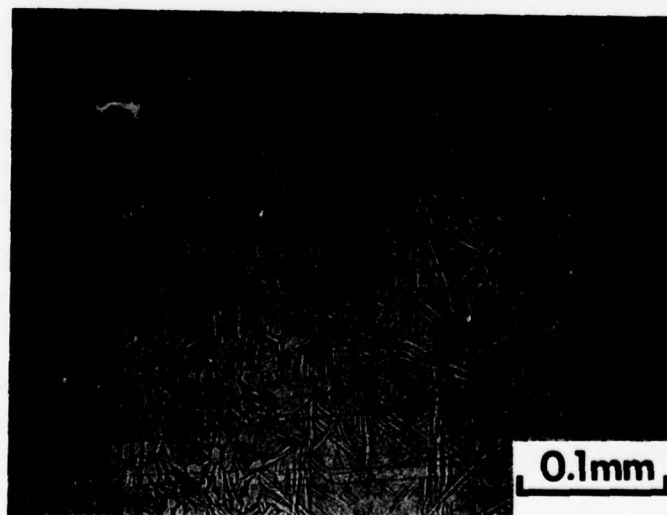
Figure 66 Photomicrographs taken from a Replica Showing a Crack Nucleated in a Normal Region Rather than at the Adjacent Beta-Fleck Defect.

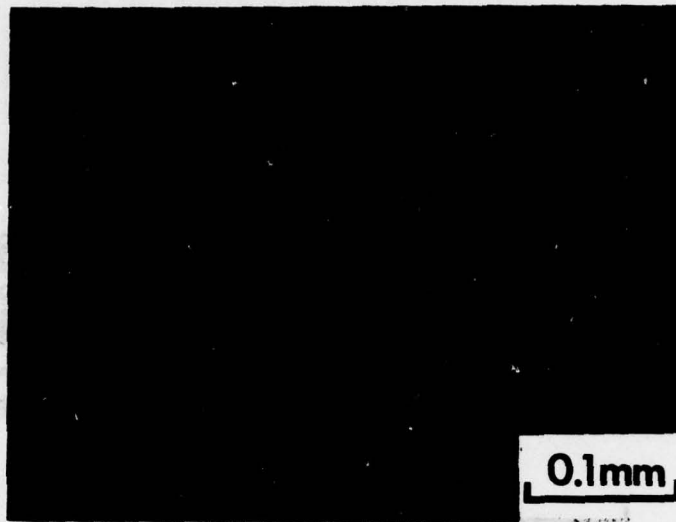
Figure 67 Photomicrograph Taken from a Replica Showing Crack Nucleation at Slip Bands Normal to the Acicular Alpha Phase, at a Prior Beta-Boundary and at Alpha-Beta Interfaces

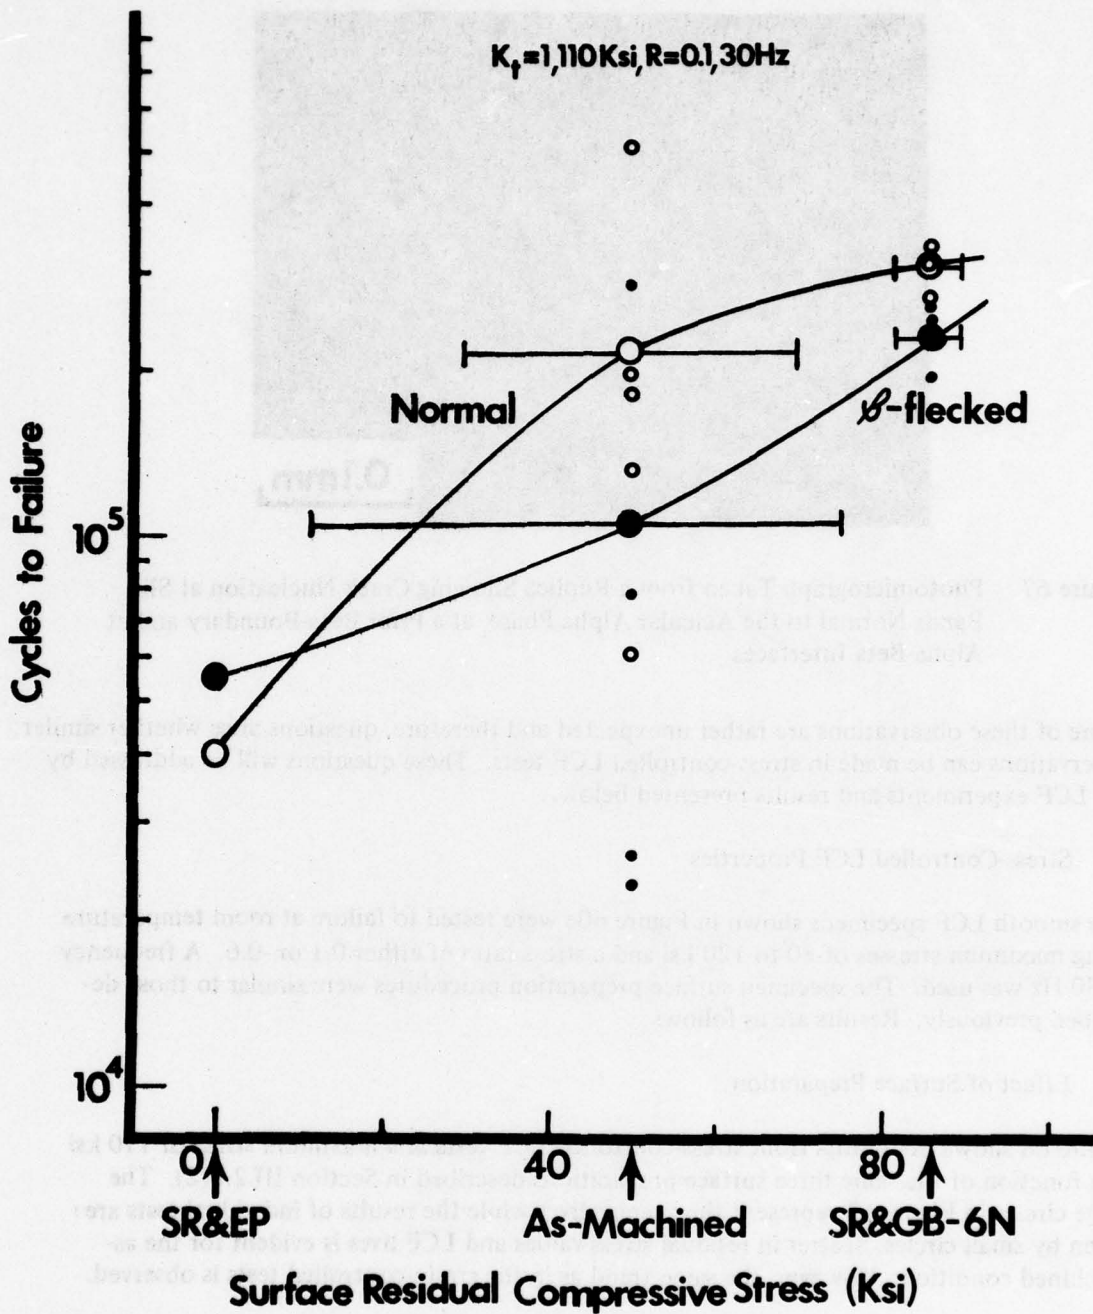
Figure 68 Effect of Surface Preparation on Fracture Life of Normal and Beta-Flecked Specimens in Stress-Controlled LCF Tests

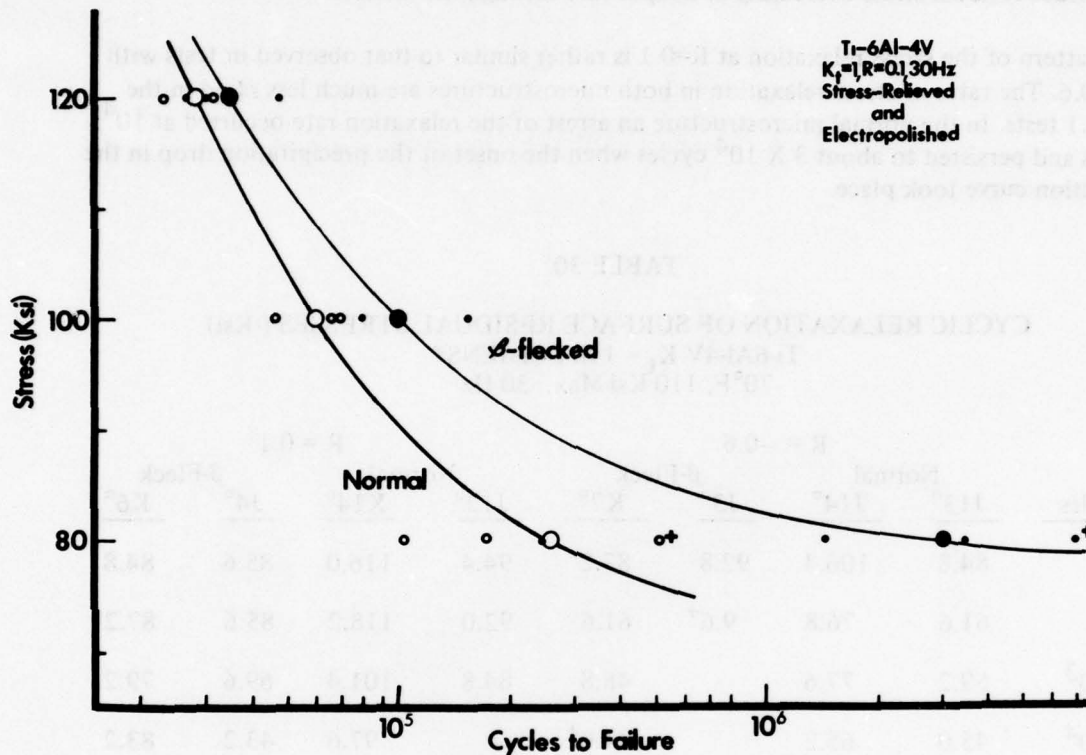
Figure 69 S-N Curves for Normal and Beta-Flecked Specimens With Stress-Relieved Surfaces

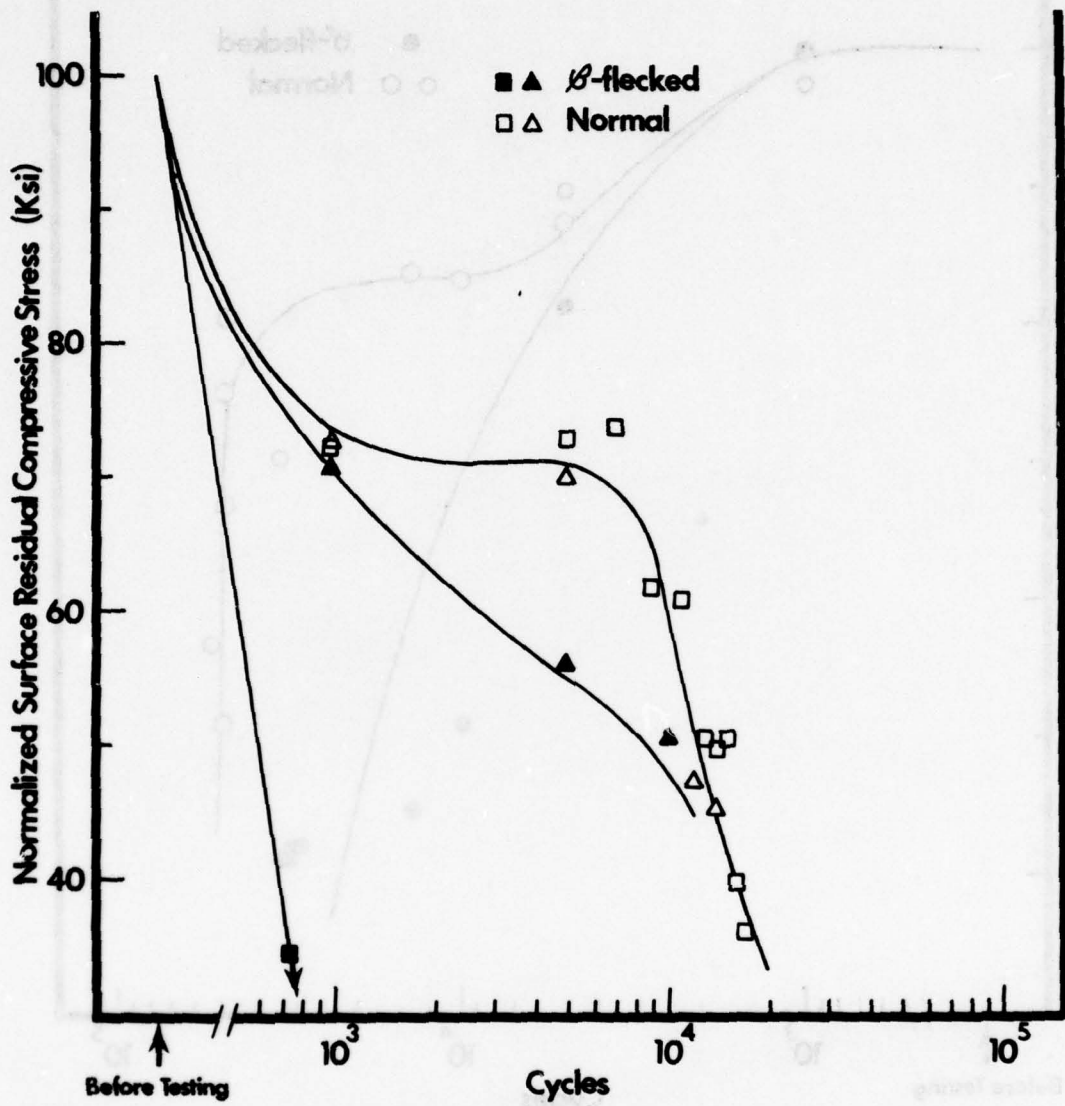
Figure 70 Cyclic Relaxation of Surface Residual Stress in Normal and Beta Flecked Specimens at R = -0.6.

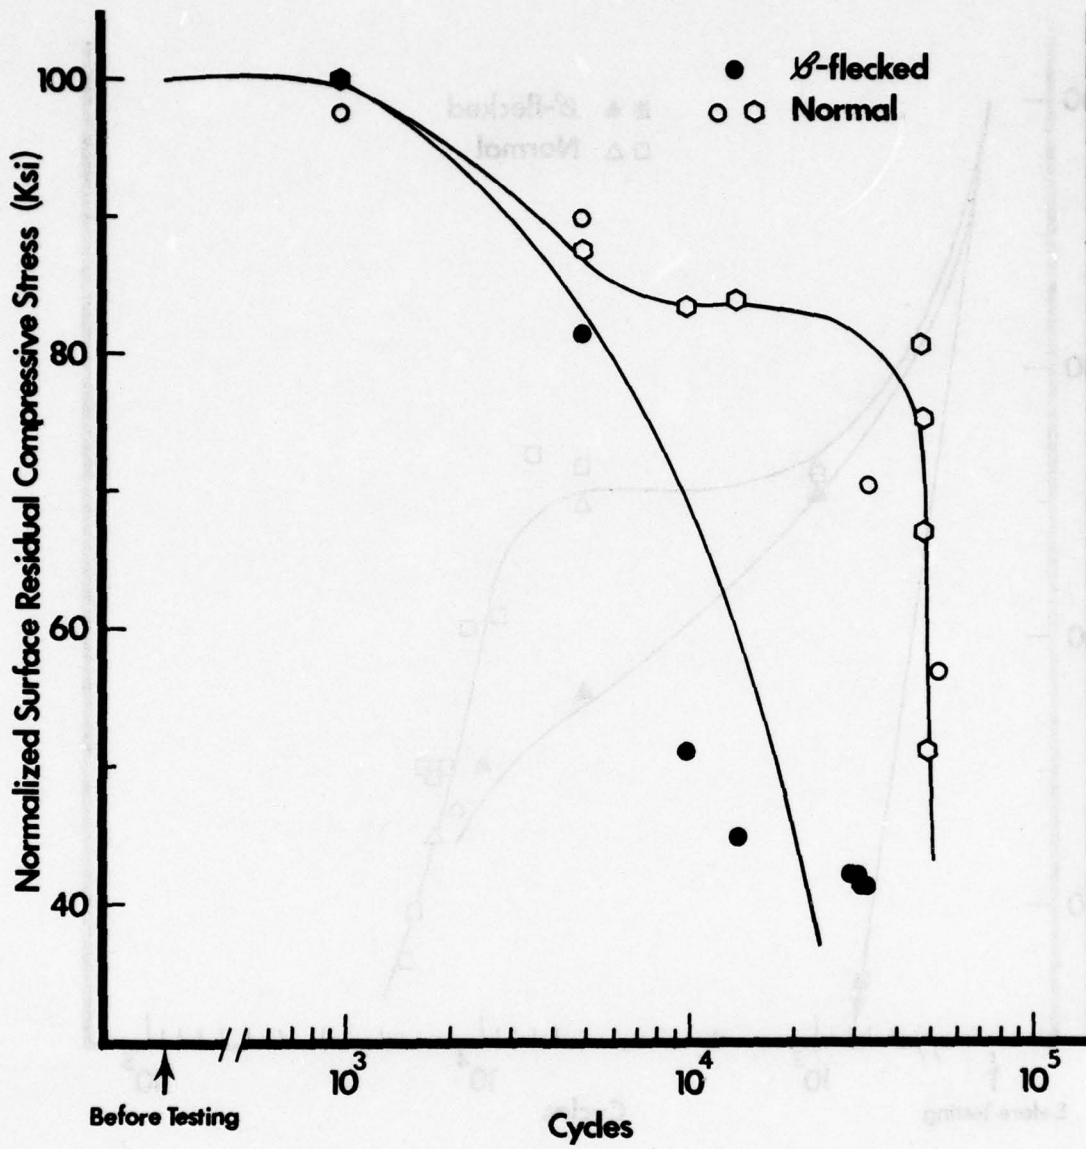
Figure 71 Cyclic Relaxation of Surface Residual Stress in Normal and Beta Flecked Specimens at R = 0.1.

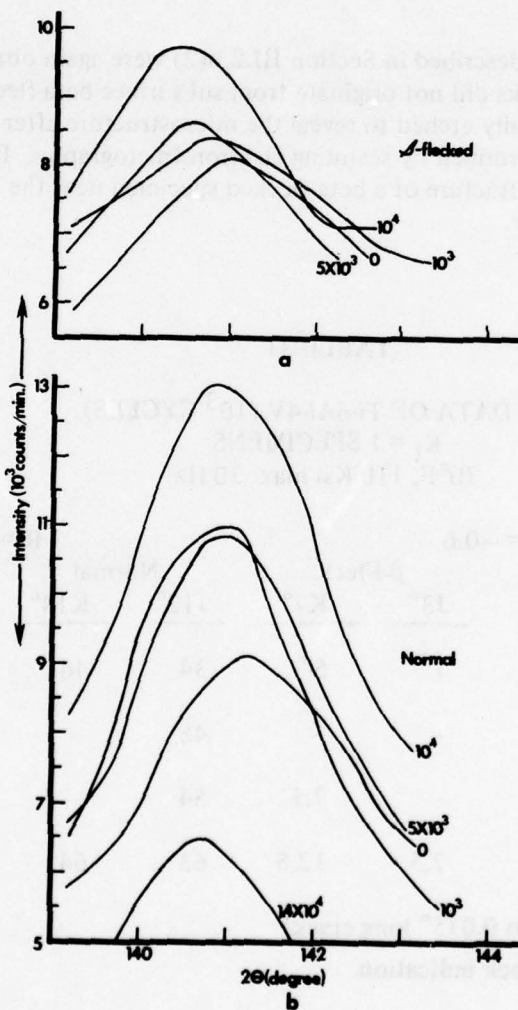
Figure 72 X-Ray Diffraction Peak Profiles of (a) Beta-Flecked Specimen (b) Normal Specimen After Various Numbers of Stress Cycles at $R = -0.6$.

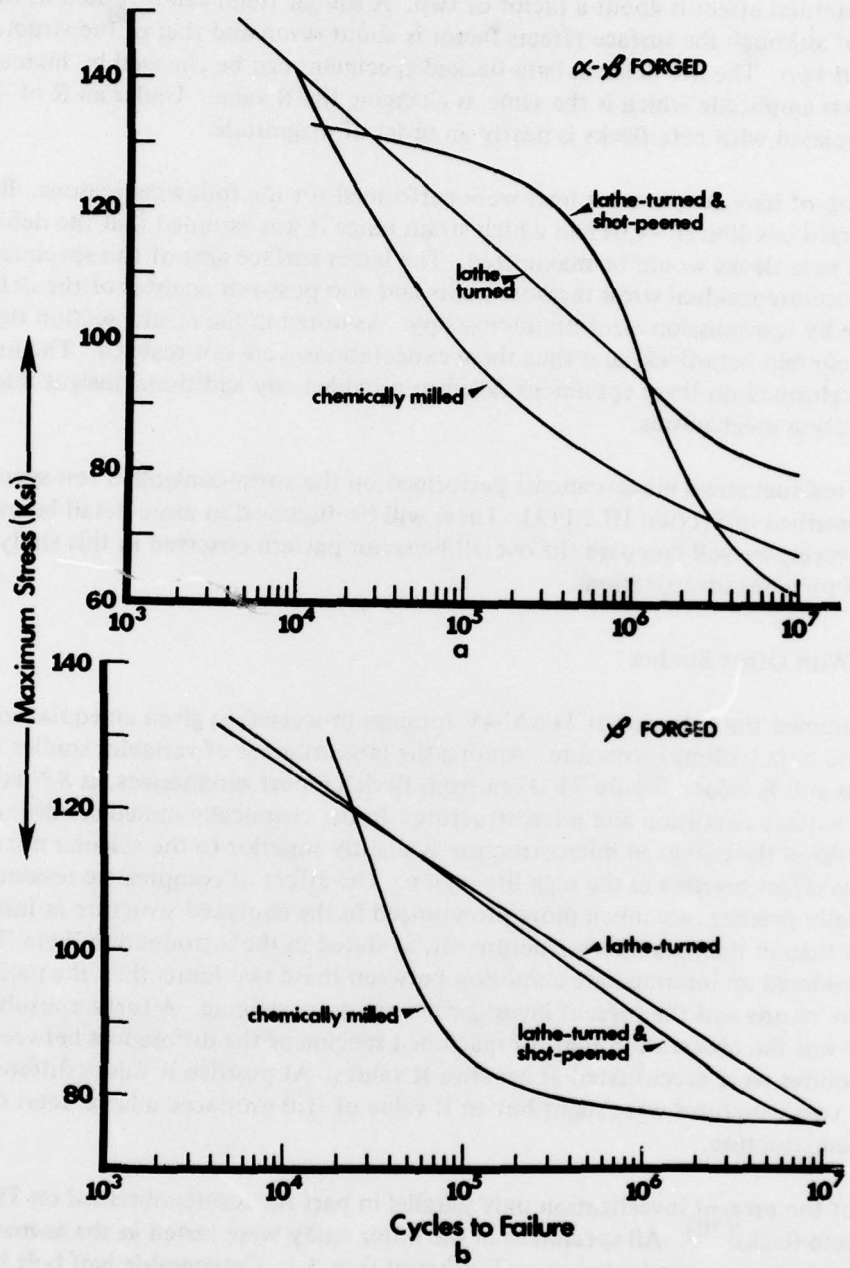
Figure 74 S-N Curves of (a) Alpha-Beta Finish Forged, (b) Beta Finish Forged Ti-6Al-4V With Various Surface Finishes (Ref. 28).
