DEGRADATION OF COATING ALLOYS IN SIMULATED MARINE ENVIRONMENTS

R.H. Barkalow and F.S. Pettit Pratt & Whitney Aircraft Division United Technologies Corporation 400 Main Street East Hartford, Connecticut 06108

15 June 1978

Final Report: 1 March 1976 to 1 March 1978

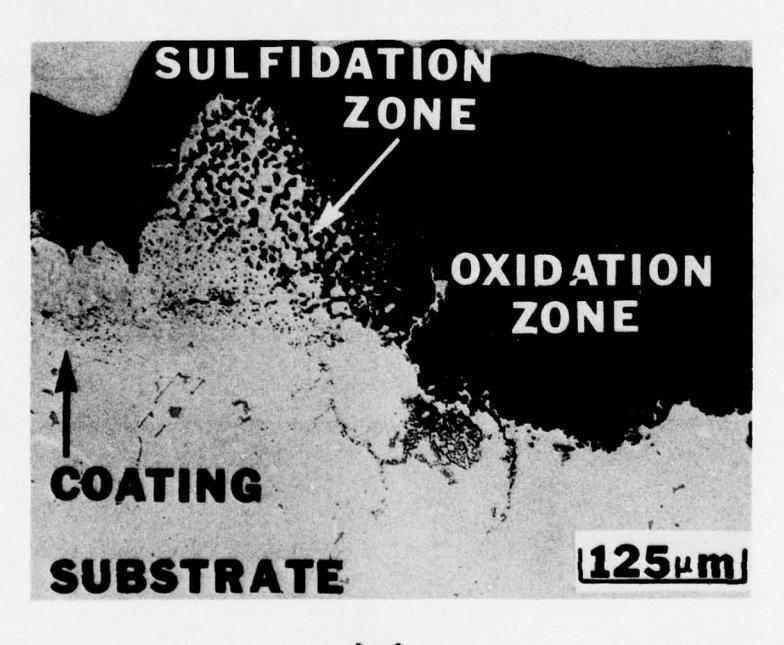
Figure 5. Additional photomicrographs showing typical microstructural features developed in engine operation of CoCrAlY-coated turbine blades: (a) oxidized leaders are sometimes associated with nodular attack, (b) cut-edge degradation may be observed at sites of coating penetration.

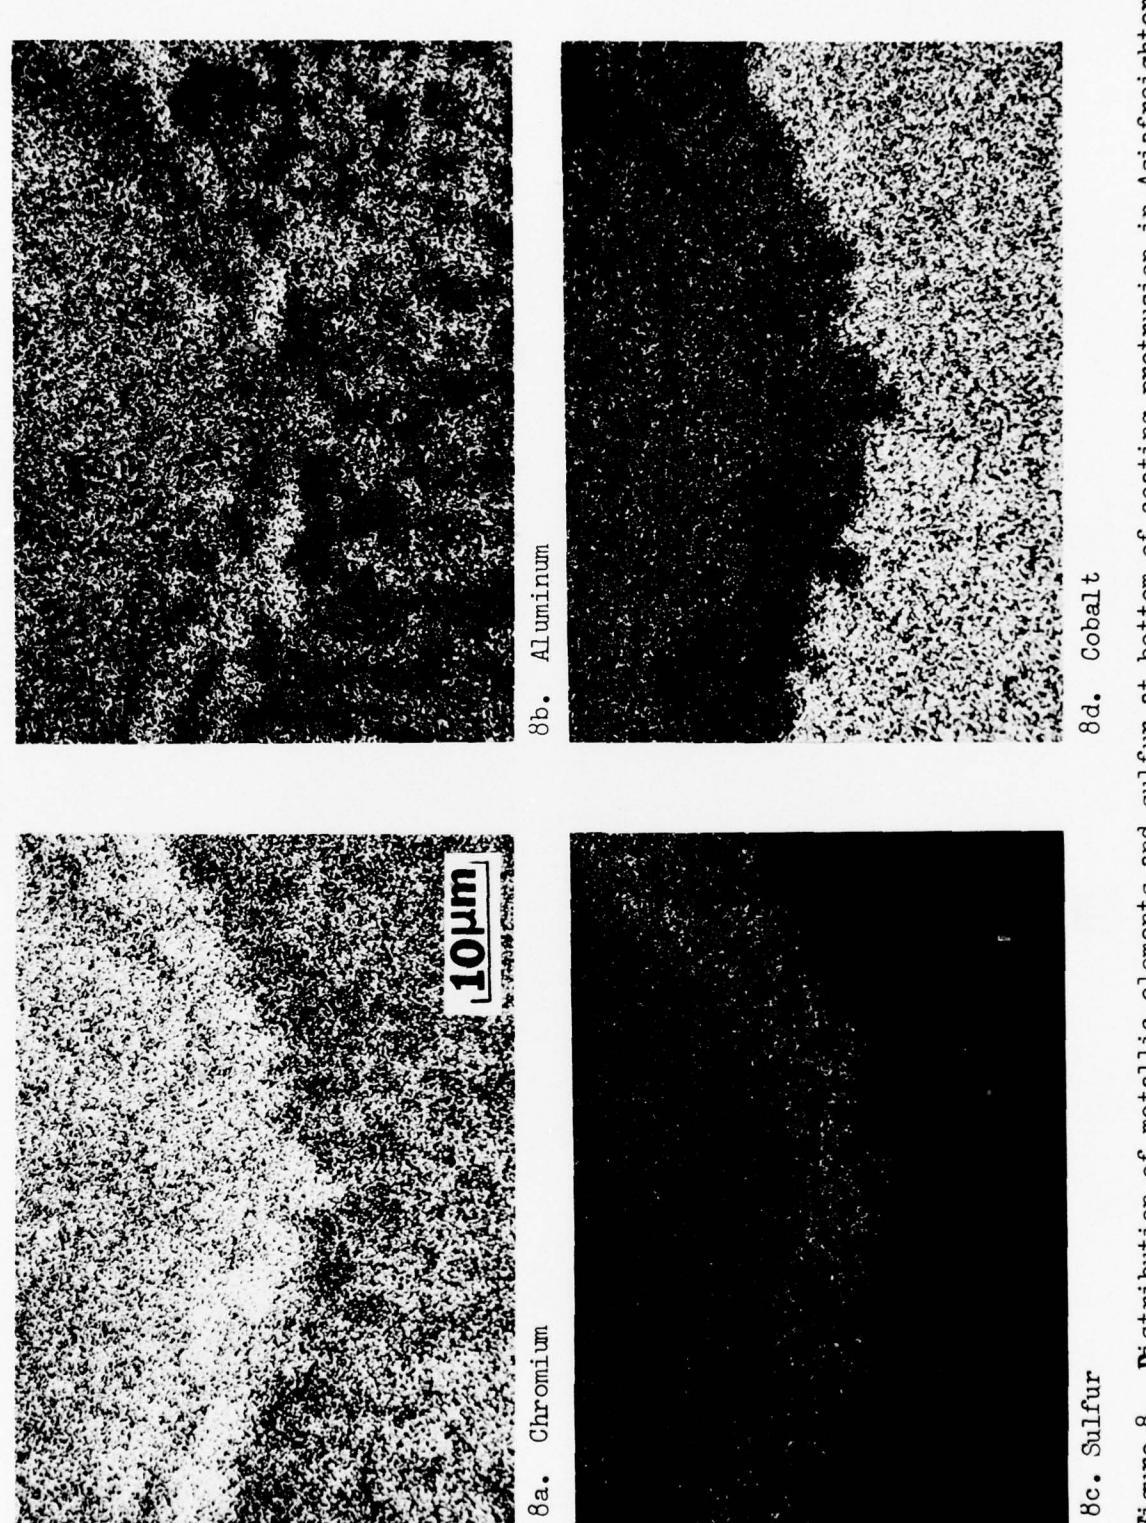
Figure 8. Distribution of metallic elements and sulfur at bottom of coating protrusion in Asiafreighter vane. Sample was prepared by dry cutting and polishing with kerosene lubricant.

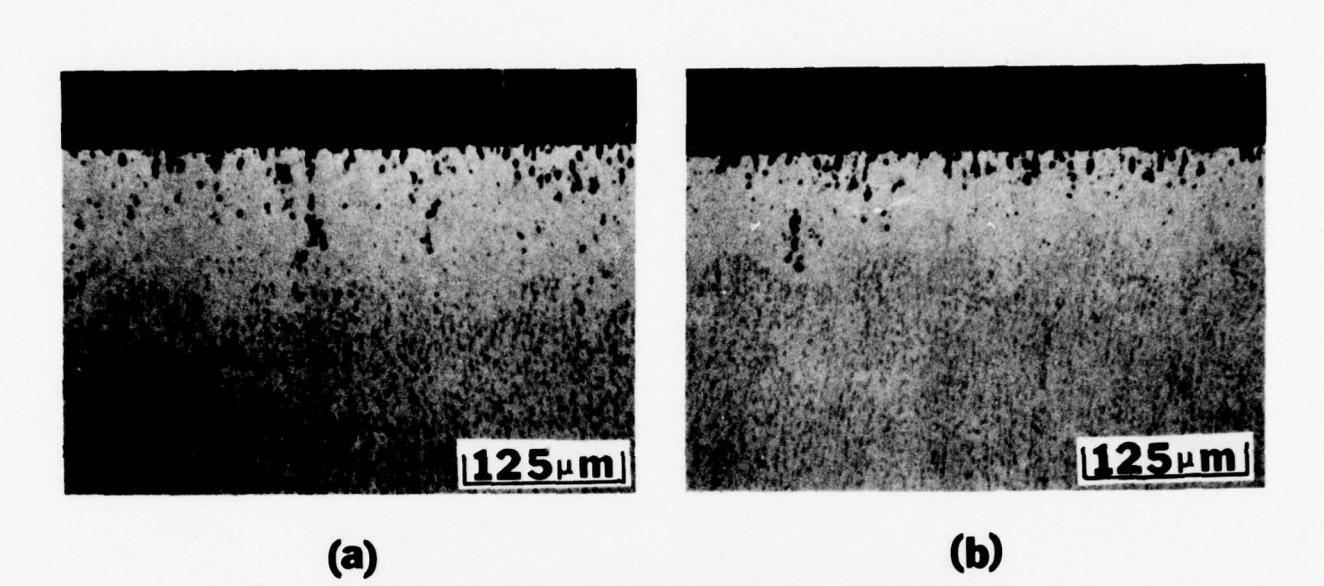
Figure 9. Surface microstructure of Co-25Cr-6Al-0.5Y after cyclic hot corrosion testing for 500 hours at 649° C (1200°F). Salt deposits were (a) 100% Na₂SO₄, (b) Na₂SO₄ - 1% NaCl, and (c) Na₂SO₄ - 10% NaCl.

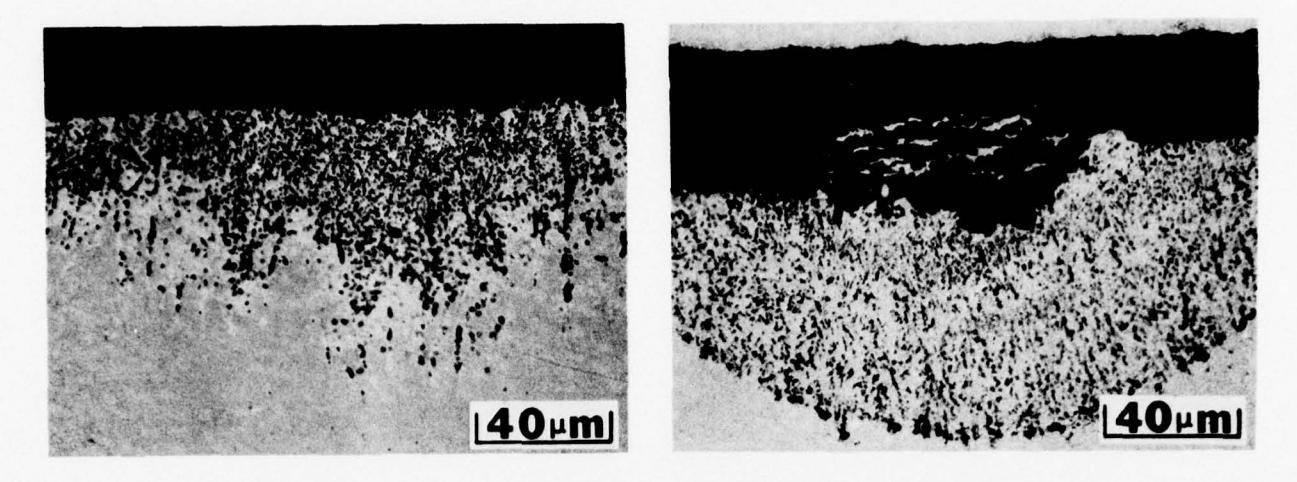
Figure 10. Surface microstructure of Co-25Cr-6Al-0.5Y after cyclic hot corrosion testing for 500 hours at 899° C (1650°F). Material, test conditions, and salt deposits are the same as those of Fig. 9 except for the higher temperature.

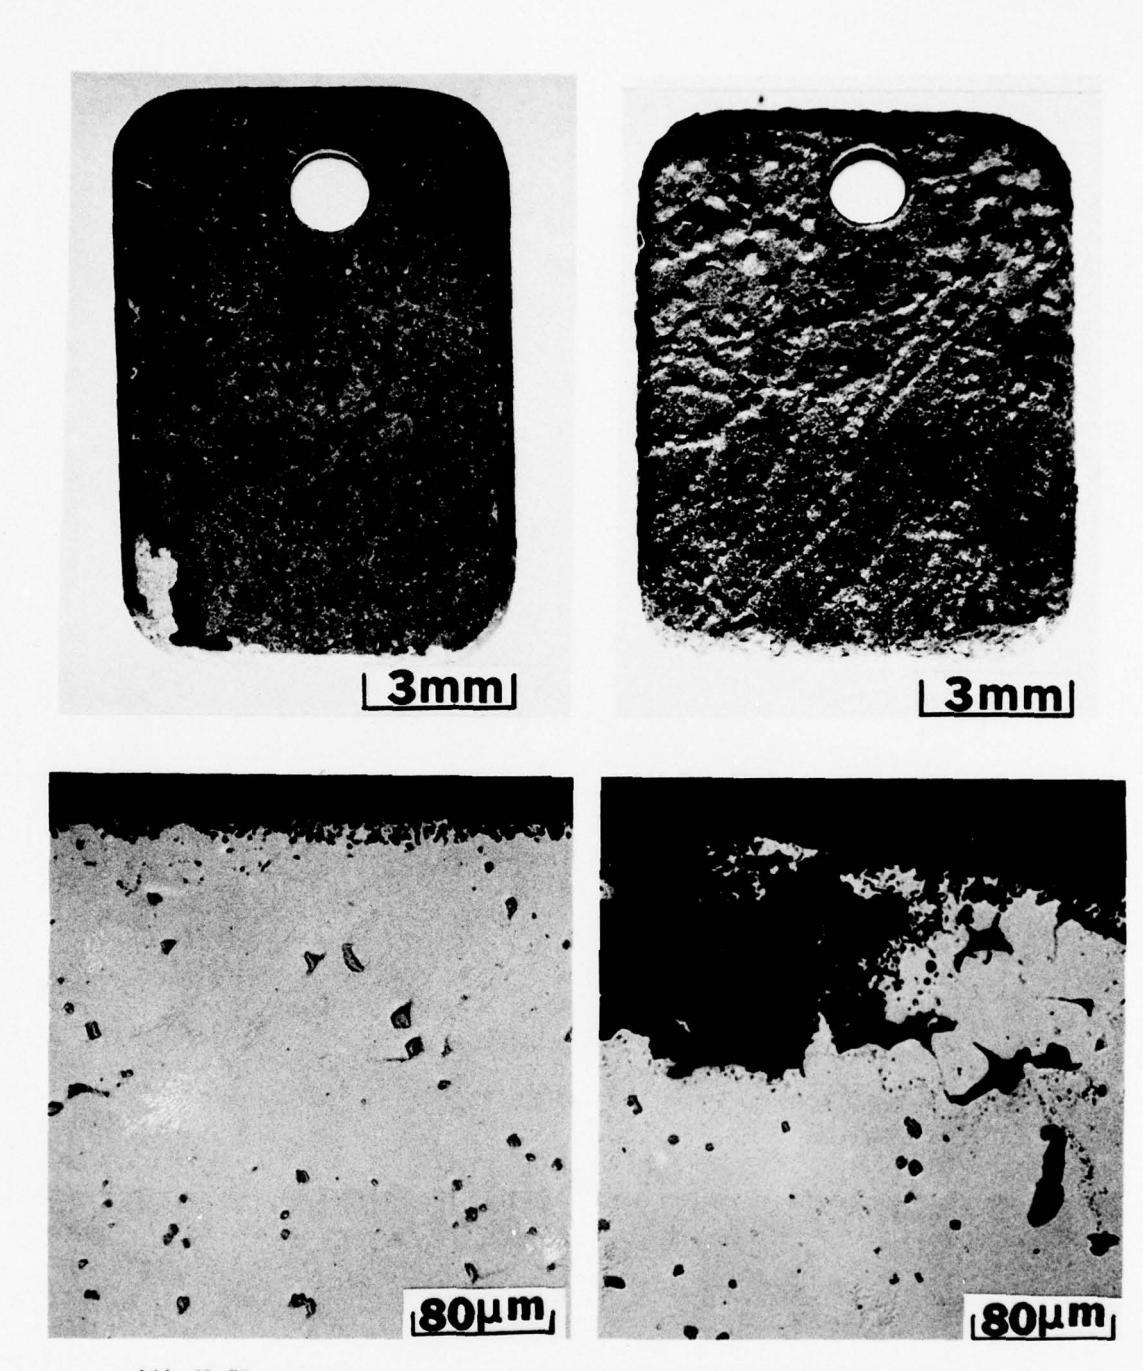
Figure 11. Degradation of state-of-the-art CoCrAlY (PWA 68), NiCrAlY (PWA 267), and NiCoCrAlY (PWA 270) coatings (a, b, and c respectively) and an experimental high-chromium CoCrAlY alloy after cyclic hot corrosion testing for 500 hours at 649° C (1200°F) with Na₂SO₄ - 10% NaCl.

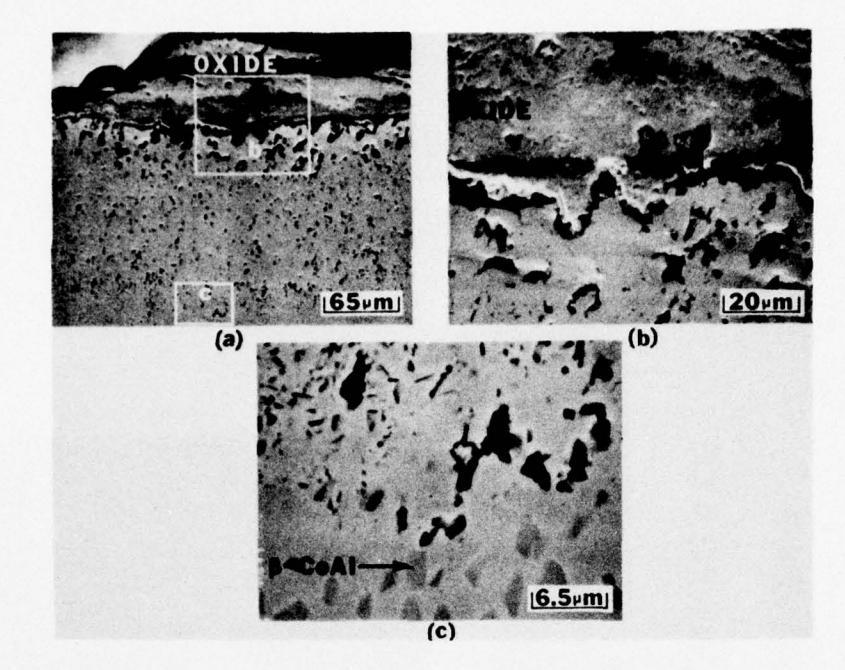
Figure 15. Cross sections through Co-25Cr-6Al-0.5Y after 100 hours in 899° C cyclic hot corrosion test with Na₂SO₄ - 90% NaCl. Boxes in (a) are areas of X-ray images in Figure 16.

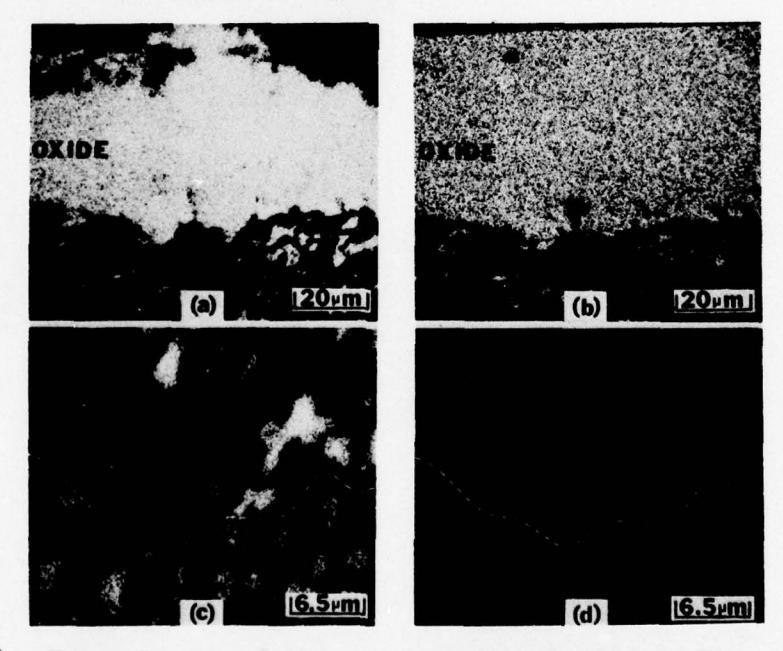
Figure 16. X-ray images of the specimen illustrated in Fig. 15; (a) and (c) are aluminum, (b) and (d) are oxygen. Dashed line in (c) and (d) is interface between innermost zone of internal attack and unaffected alloy. Al-rich areas in top half of (c) are believed to be Cl-containing pores.

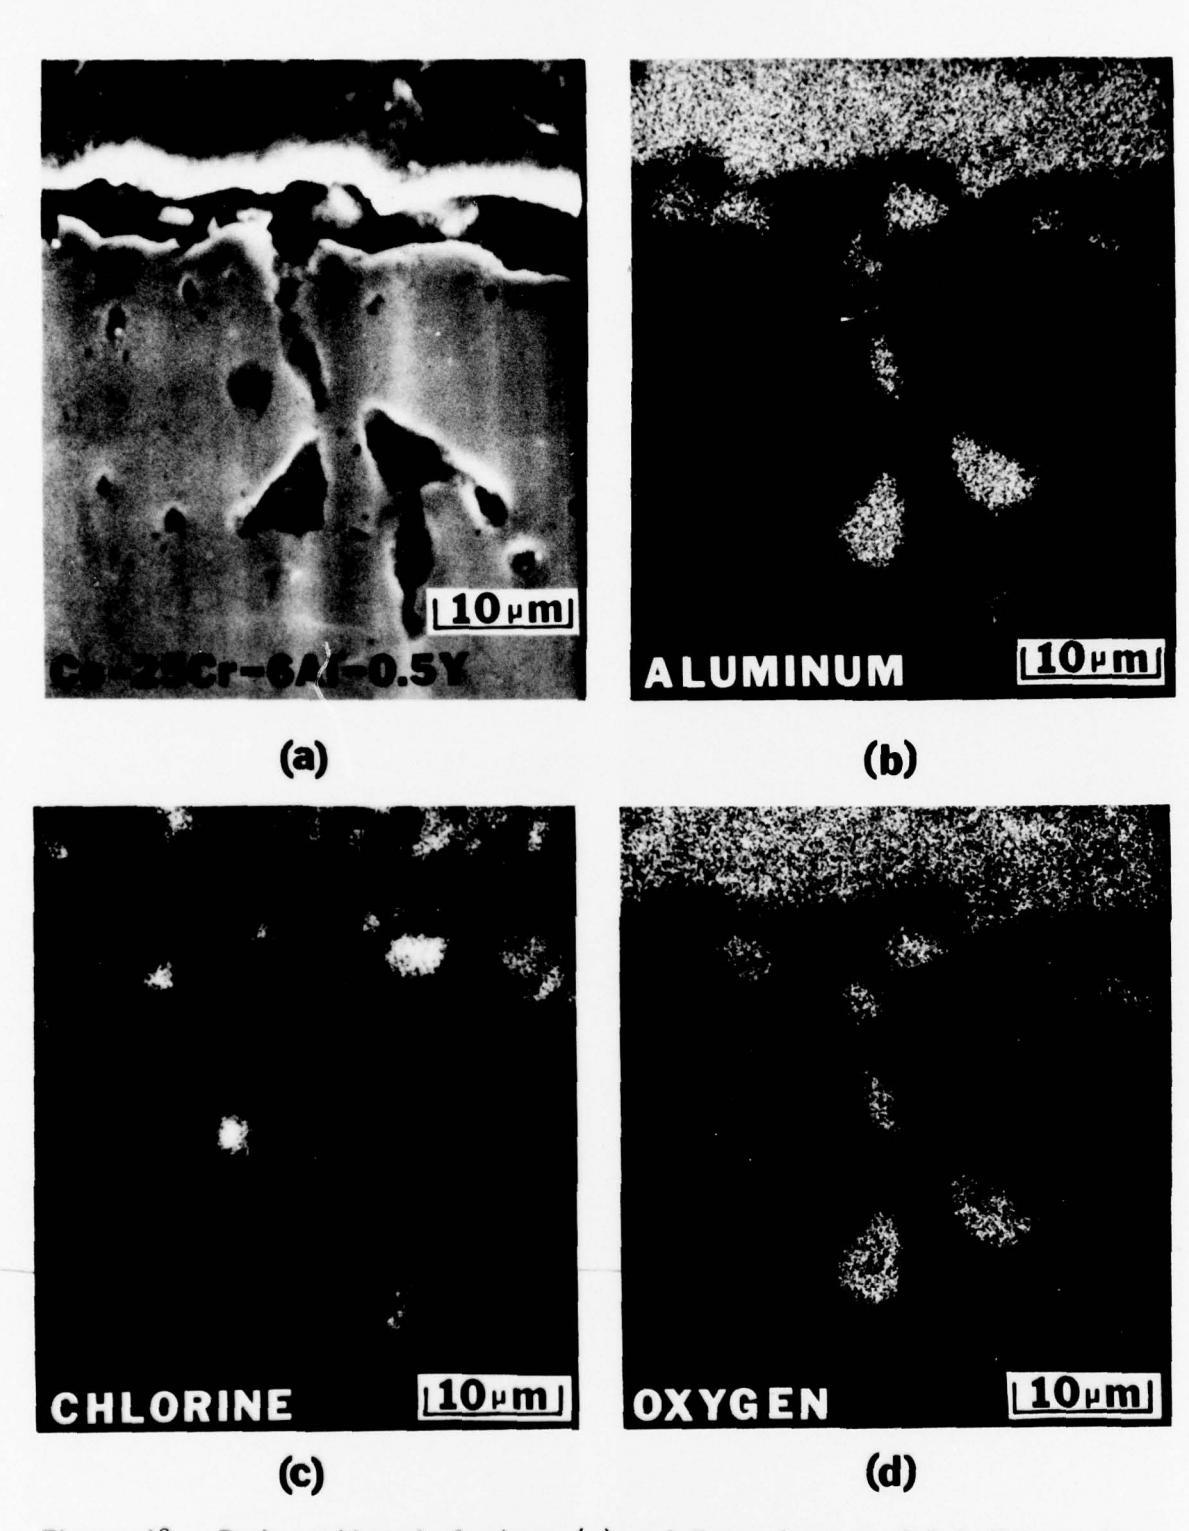
Figure 18. Back scattered electron (a) and X-ray images of CoCrAlY specimen exposed 20 hours at 899° C in crucible hot corrosion test with Na₂SO₁ - 90% NaCl salt. Note cavities filled with nonmetallic reaction product containing Al, Cl, and O.

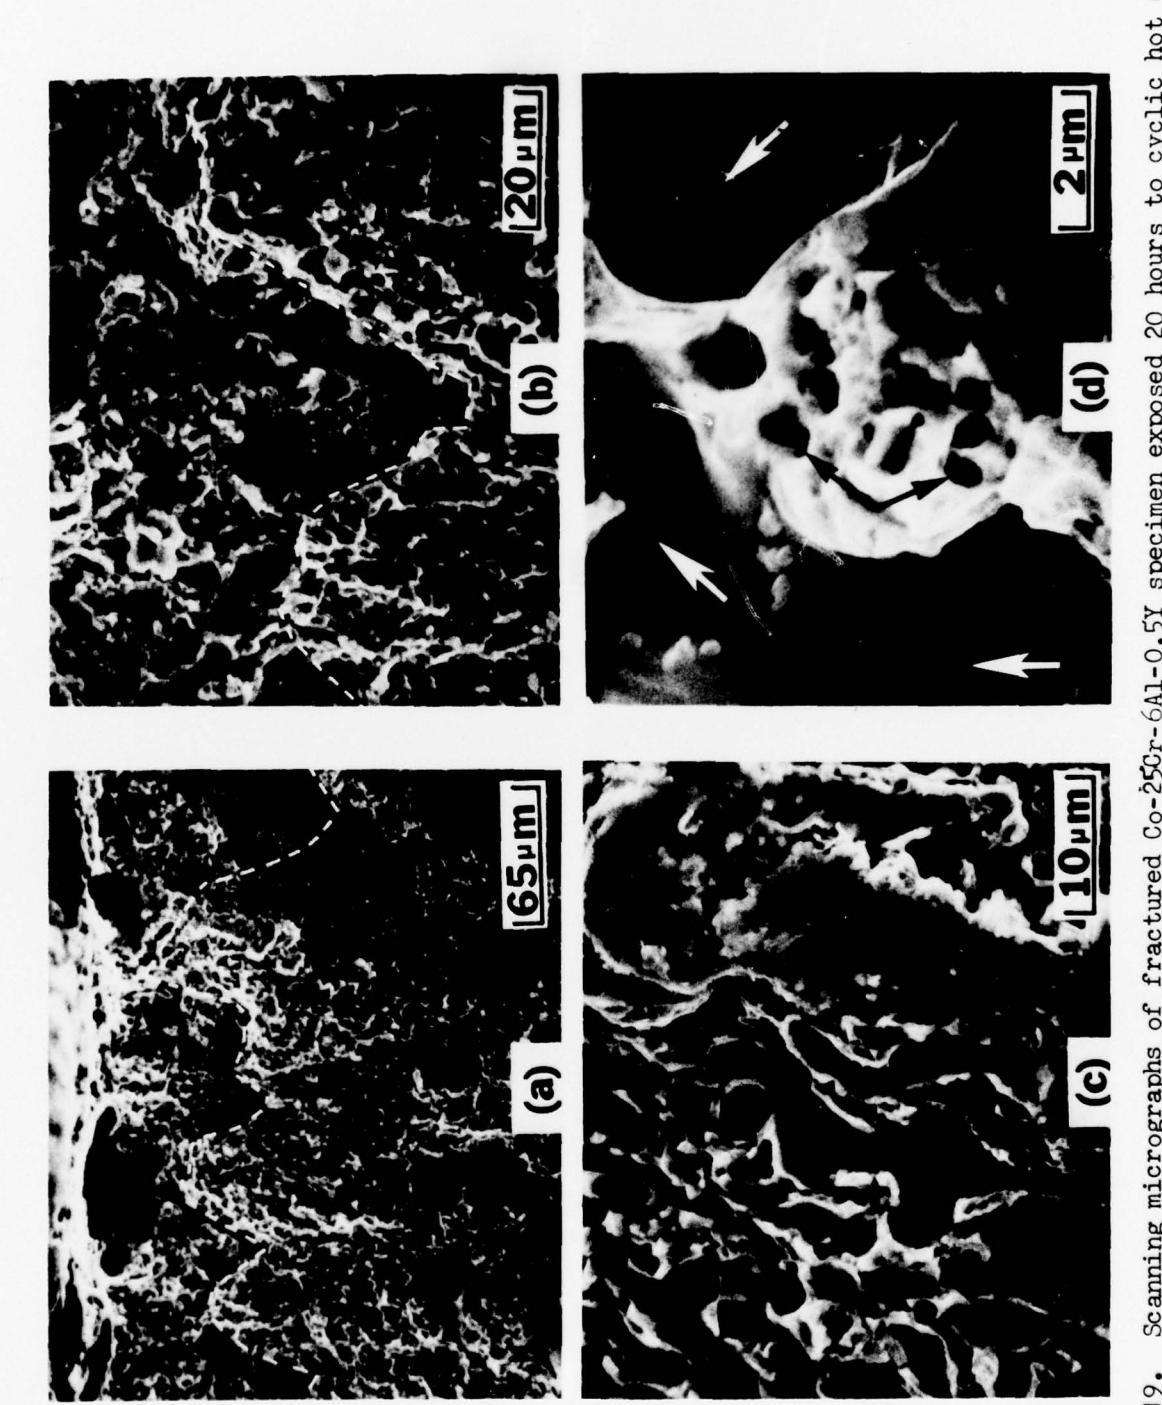
Figure 19. Scanning micrographs of fractured Co-25Gr-6Al-0.5Y specimen exposed 20 hours to cyclic hot corrosion at 899°C. Dashed lines in (a) and (b) mark extent of porous zone of internal attack. The pores appear to form a continuous network (c) which includes both large and very small pores (arrows in d).

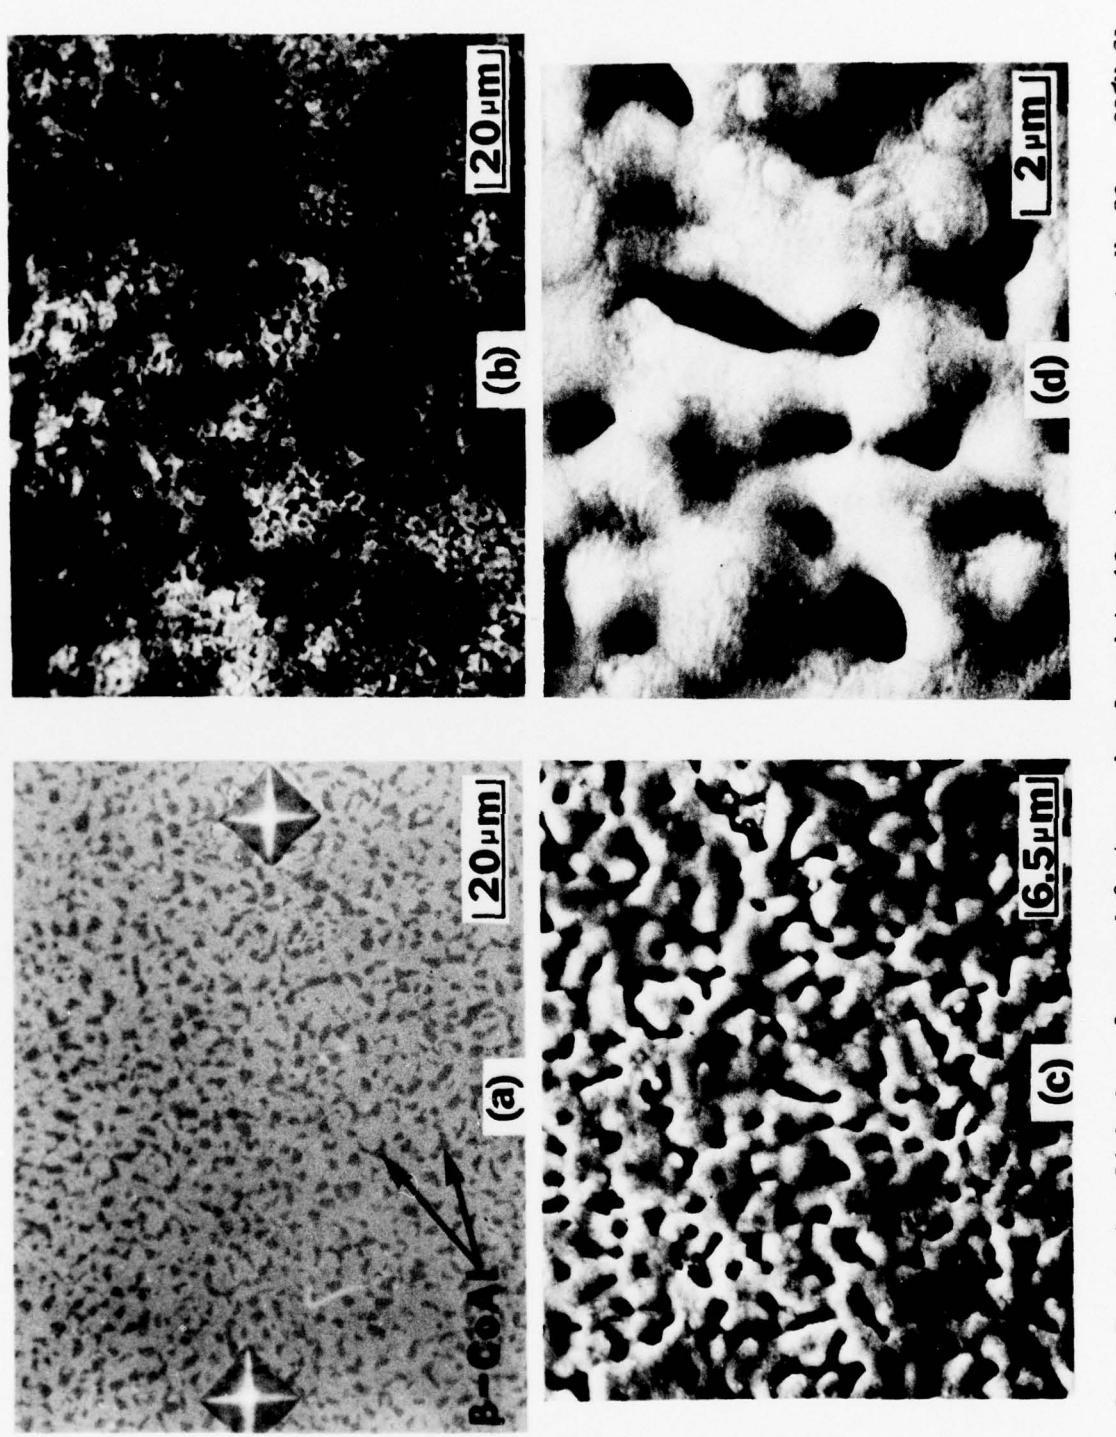
Figure 20. Pre-test polished surface and features developed in 10 minute exposure to Na_2SO_1 - 90%NaCl at 899°C. Numerous pores are evident, the size and distribution of which are similar but not identical to the distribution of the B-CoAL phase in the pre-test microstructure.

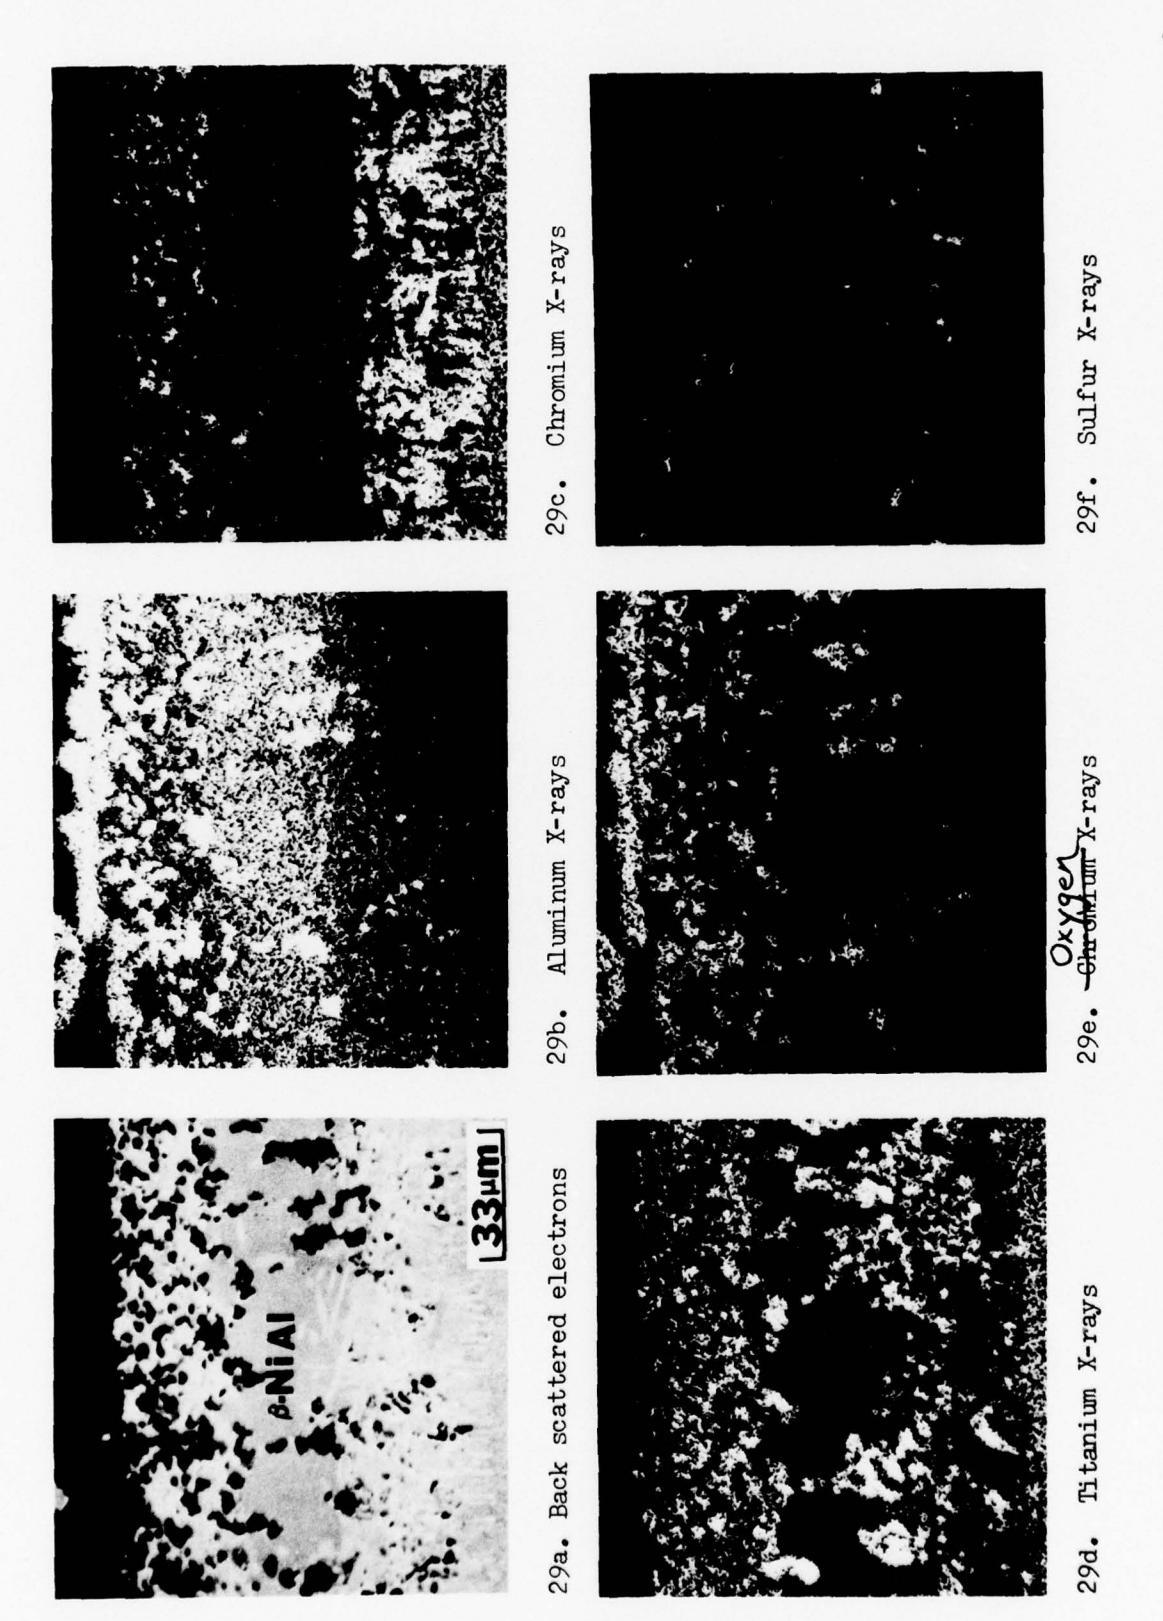
Figure 29. Typical microstructure of PWA 273 coating after 500 hours cyclic hot corrosion testing at 899°C. Note retention of substantial amounts of B-NiAl phase, as shown in BSE and Al X-ray images.

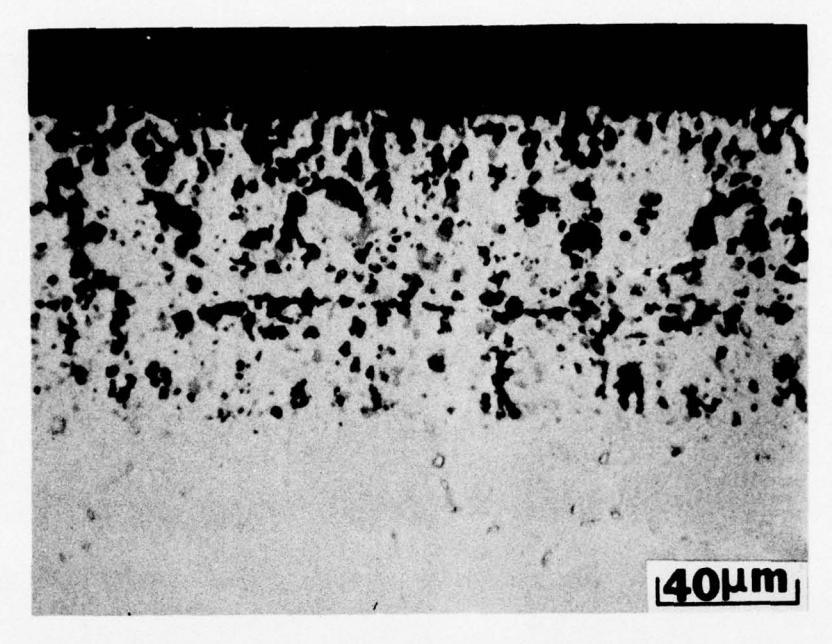
30a. Typical extent of dealloying and sulfide precipitation

Figure 30. Microstructure of LDC-2A platinum modified diffusion aluminide coating after 500 hours in the $899^{\circ}C$ (1650°F) cyclic hot corrosion test with Na_2SO_4 - 50% NaCl. Note different magnification of 30a and 30b.

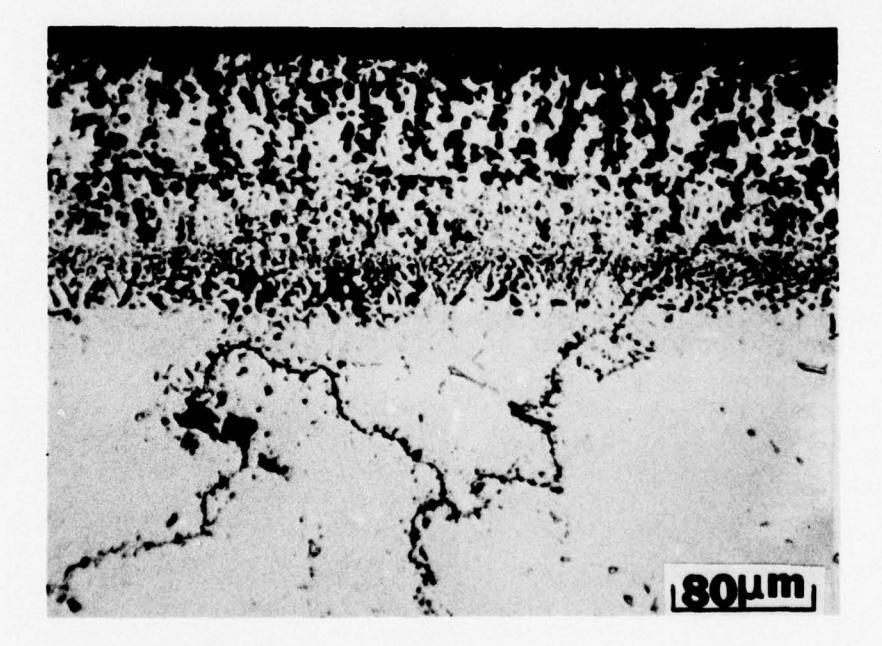
30b. Coating failure and substrate attack

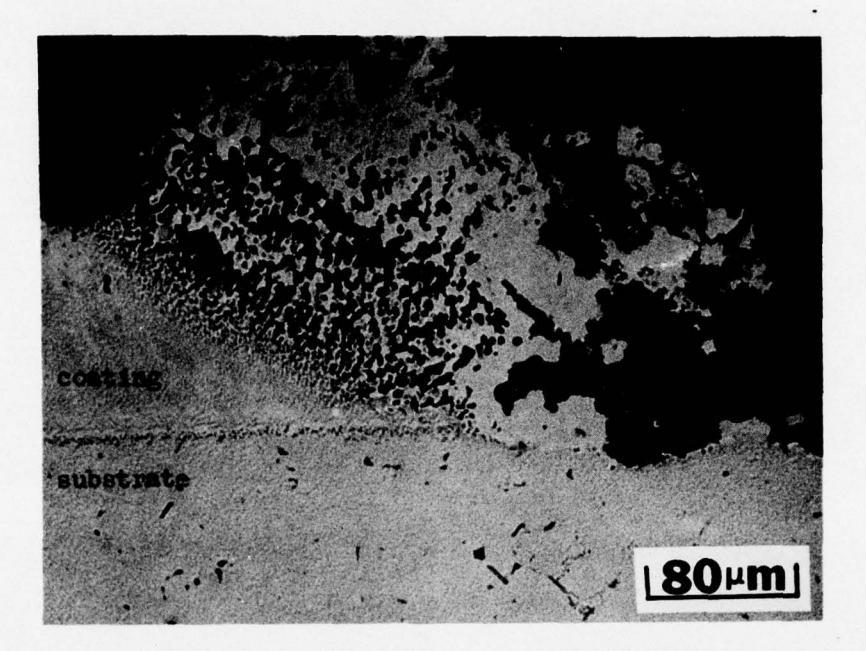
Figure 31a. Sidewise consumption of PWA 68 emanating from massive edge failure.

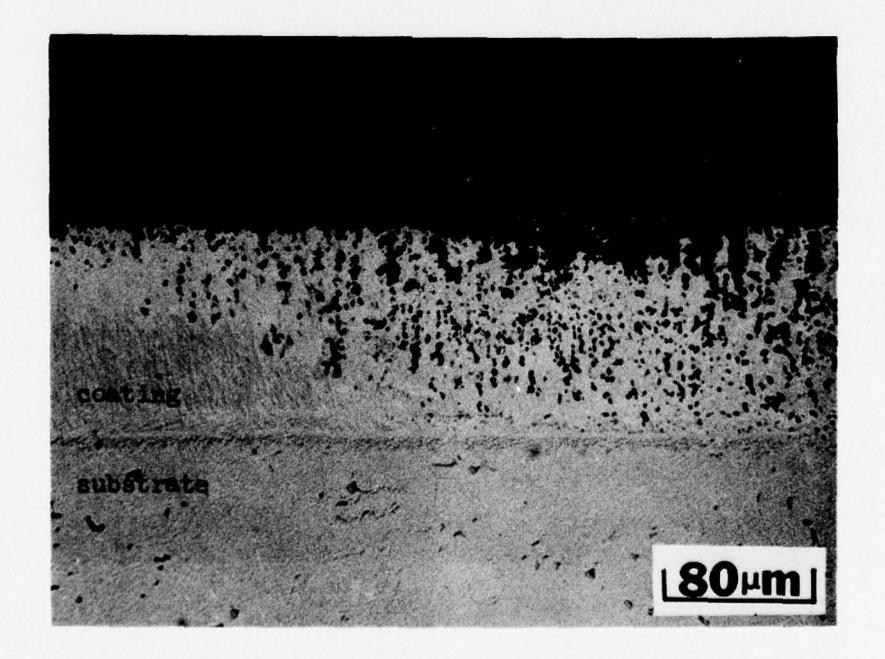
Figure 31b. Localized dealloying and internal oxidation of PWA 68, apparently the mechanism of coating penetration.

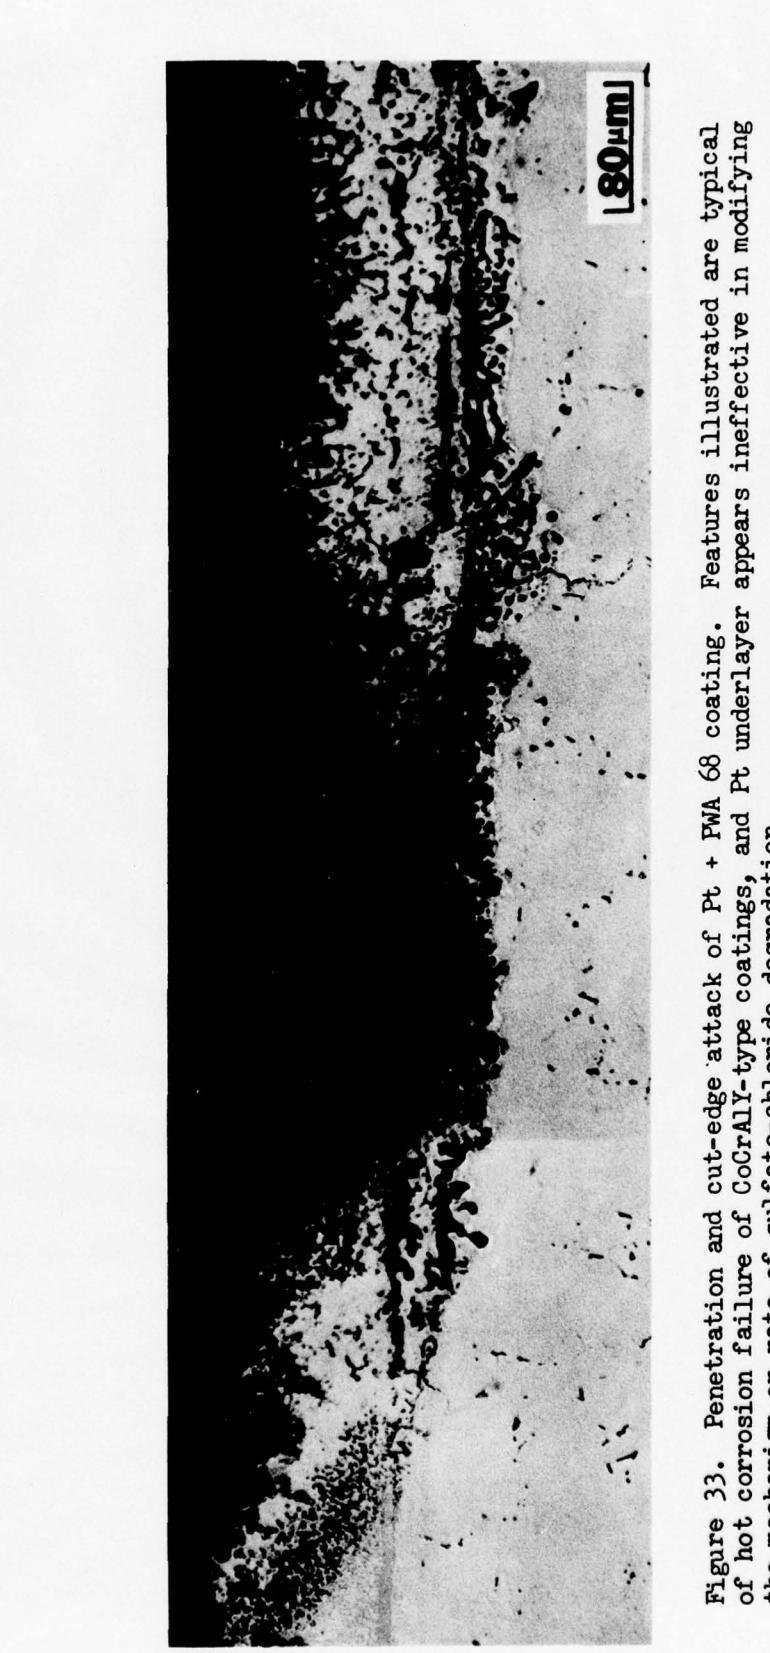
Figure 33. Penetration and cut-edge attack of Pt + FWA 68 coating. Features illustrated are typical of hot corrosion failure of CoCrAlY-type coatings, and Pt underlayer appears ineffective in modifying the mechanism or rate of sulfate-chloride degradation.

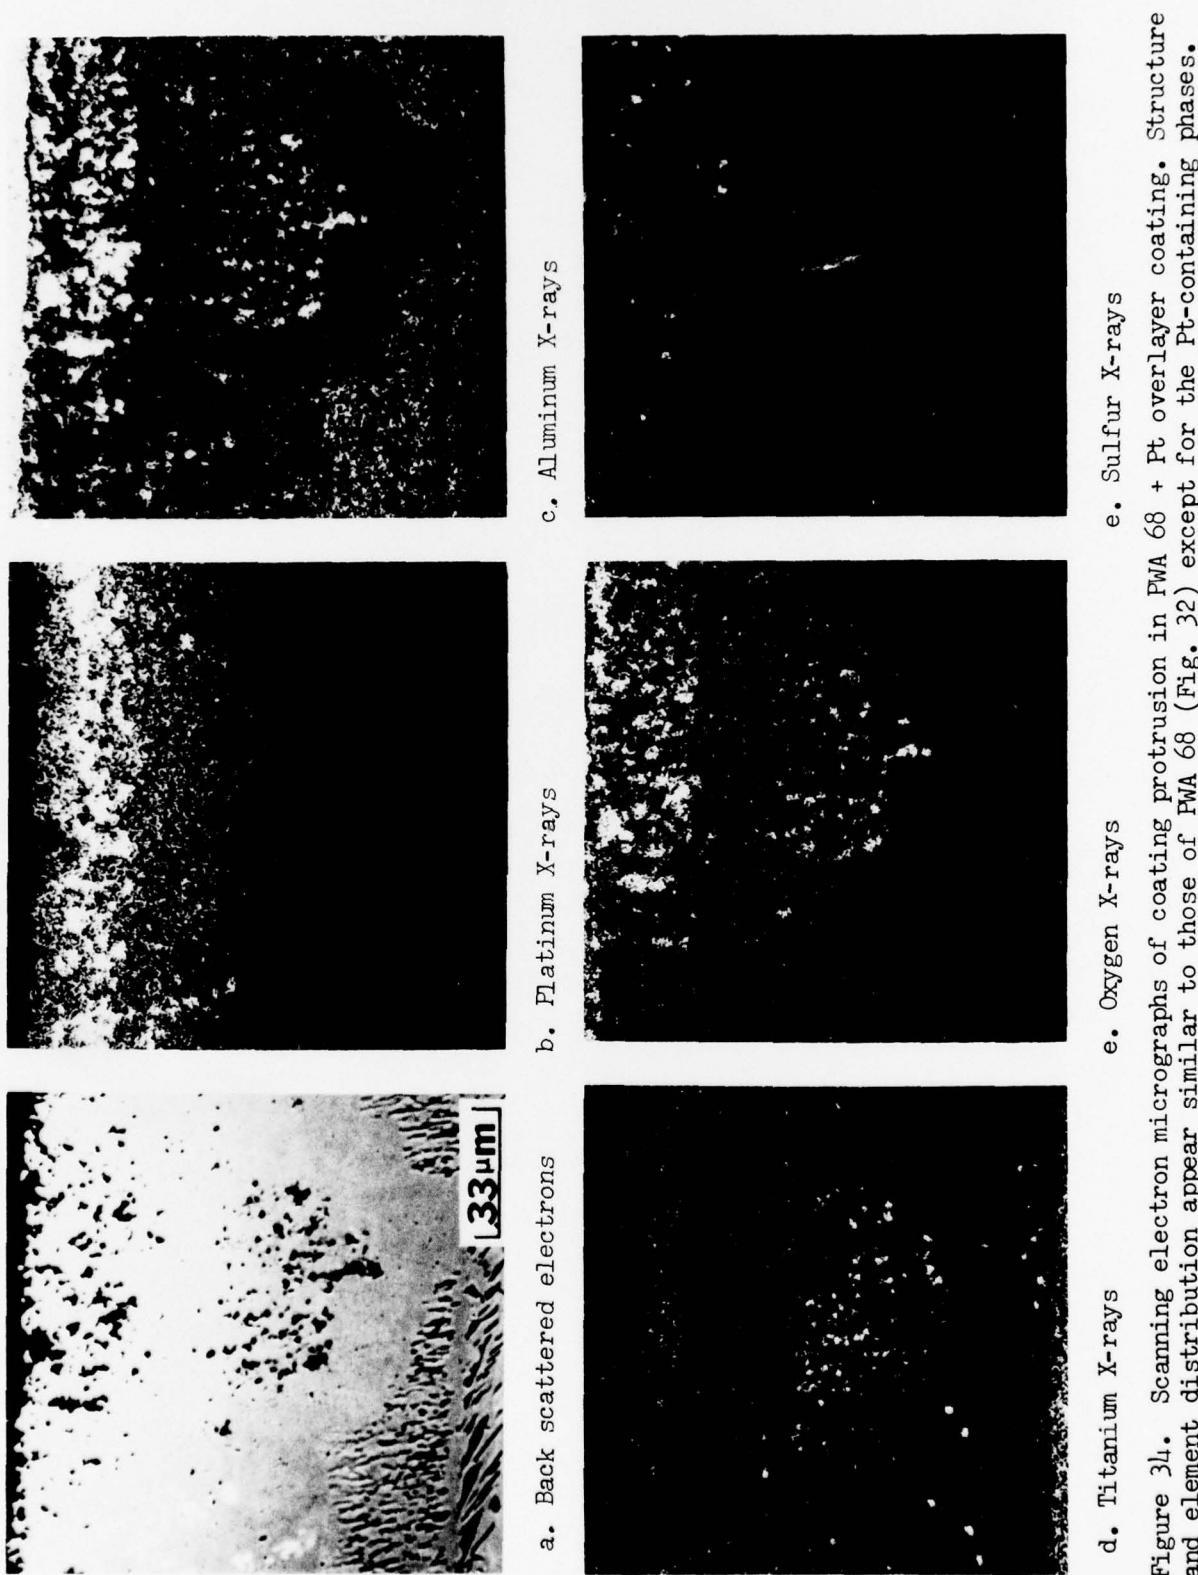
Figure 34. Scanning electron micrographs of coating protrusion in PWA 68 + Pt overlayer coating. Structure and element distribution appear similar to those of PWA 68 (Fig. 32) except for the Pt-containing phases.

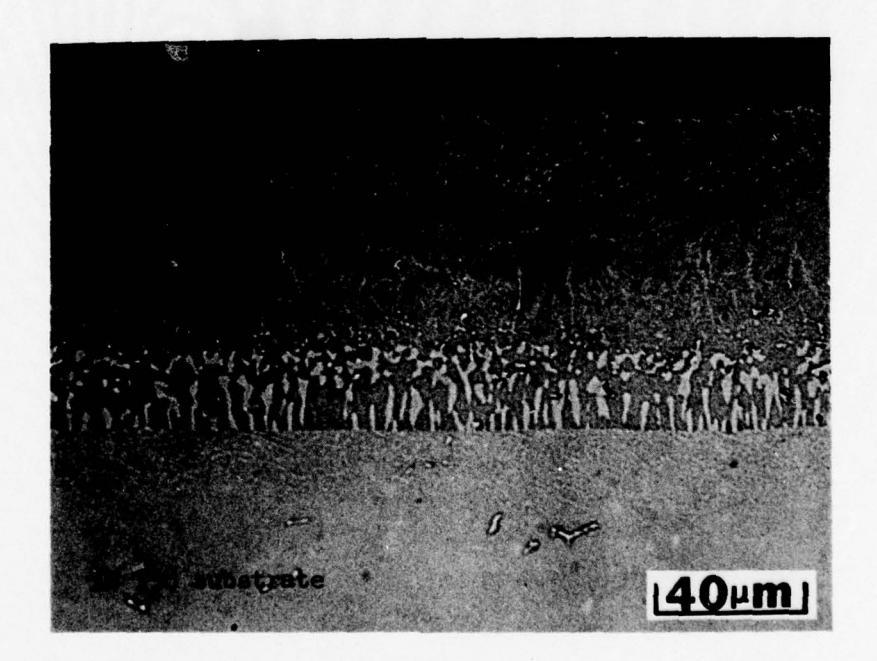
36b. Typical microstructure away from edge effect

Figure 36. FWA 273 diffusion aluminide coating after 1000 hours in 649°C cyclic hot corrosion test with Na₂ SO₄ - 50% NaCl.

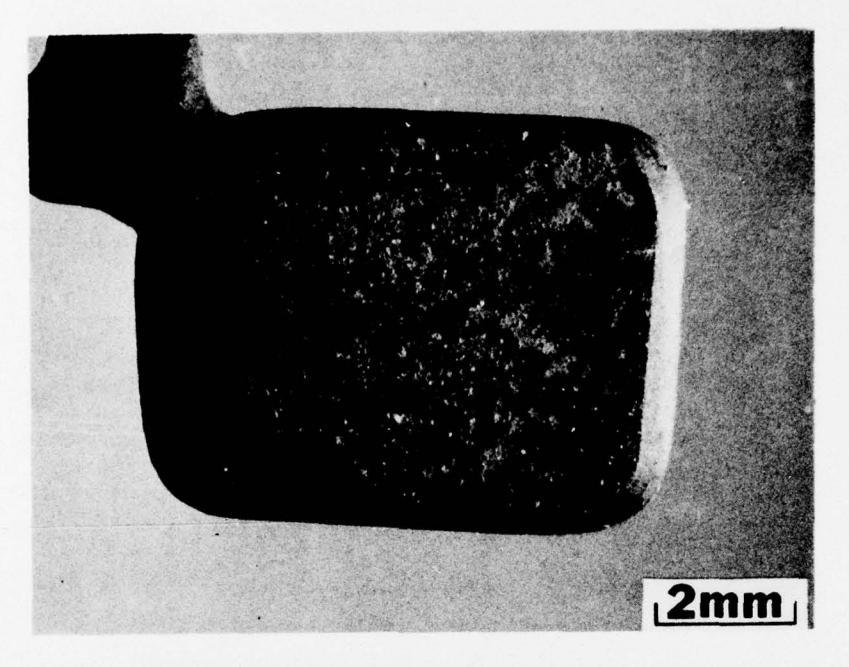
37a. Surface appearance

Figure 37. Surface degradation of FWA 273 diffusion aluminide coating after 2000 hours of cyclic hot corrosion testing at $649^{\circ}C$ with Na₂SO₄ - 50%NaCl salt.

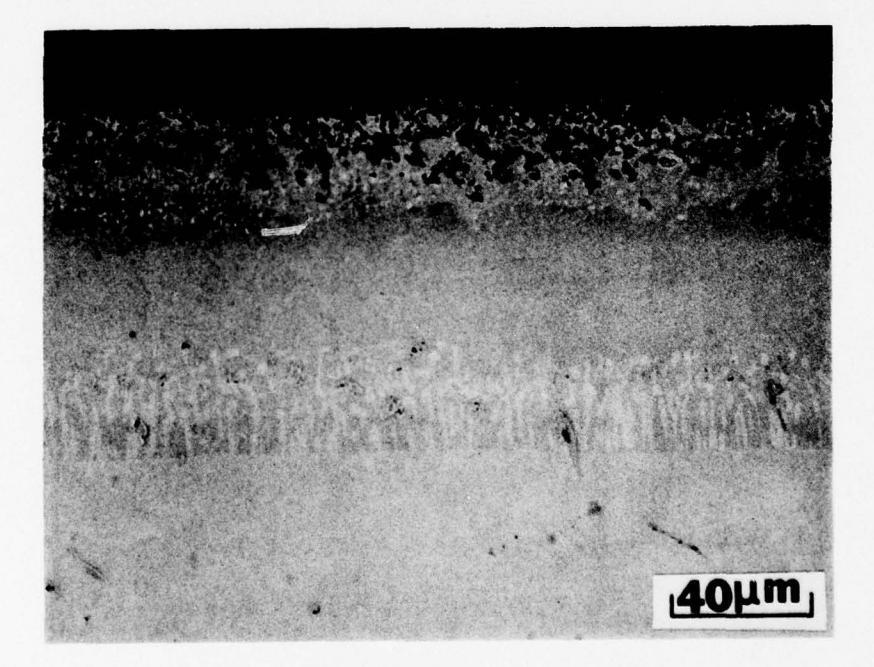
37b. Typical microstructure

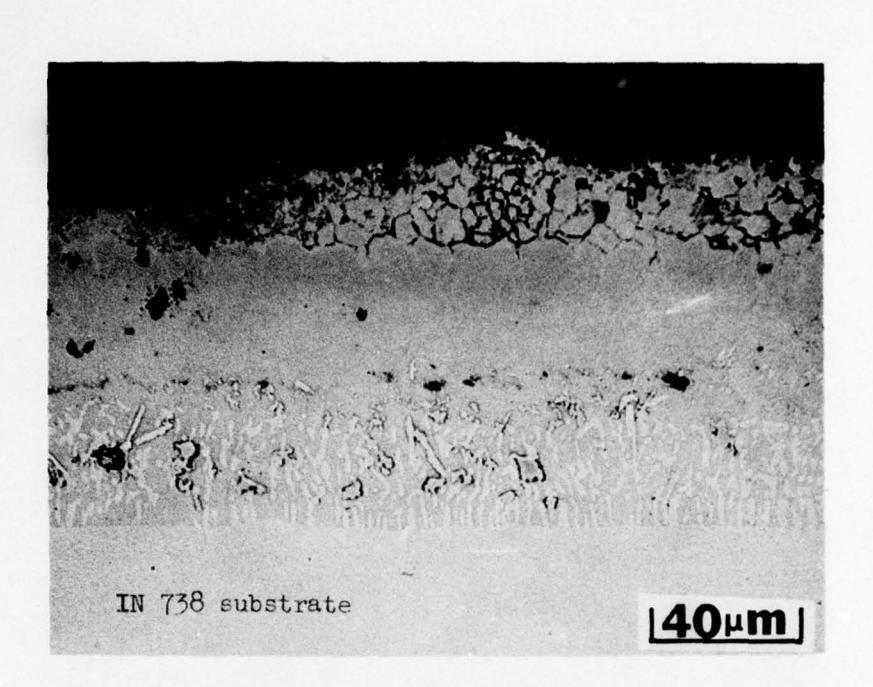
Figure 38. LDC-2A platinum modified diffusion aluminide. Surface microstructure was noticeably degraded in comparison with FWA 273, but there was no incidence of coating failure.

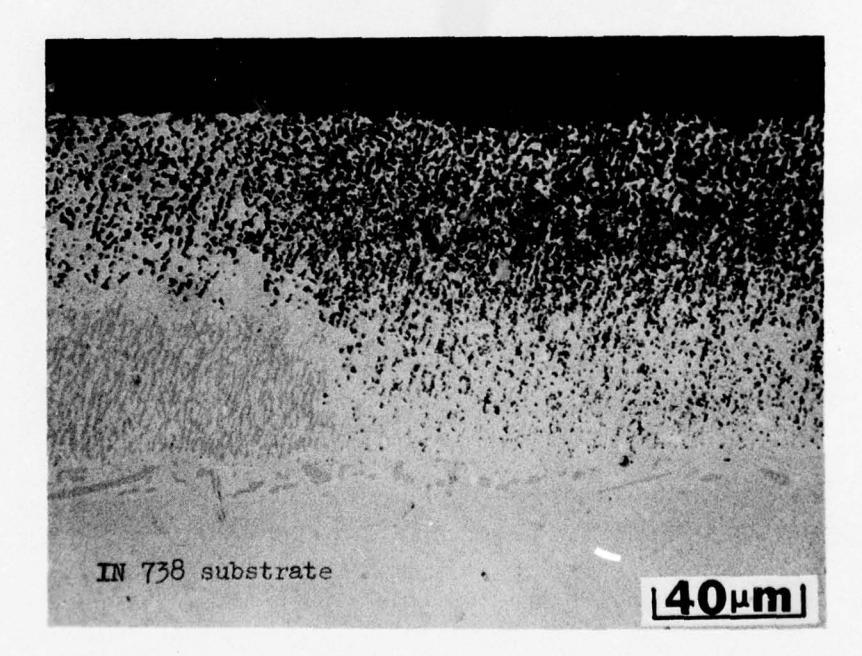
Figure 39. FWA 68 CoCrAlY after 1000 hours in 649°C cyclic hot corrosion showed general surface degradation and many areas of dealloying and precipitation of Al₂O₃ through entire coating thickness.
