DEGRADATION OF COATING ALLOYS IN SIMULATED MARINE ENVIRONMENTS

R.H. Barkalow and F.S. Pettit Pratt & Whitney Aircraft Division United Technologies Corporation 400 Main Street East Hartford, Connecticut 06108

15 June 1978

Final Report: 1 March 1976 to 1 March 1978

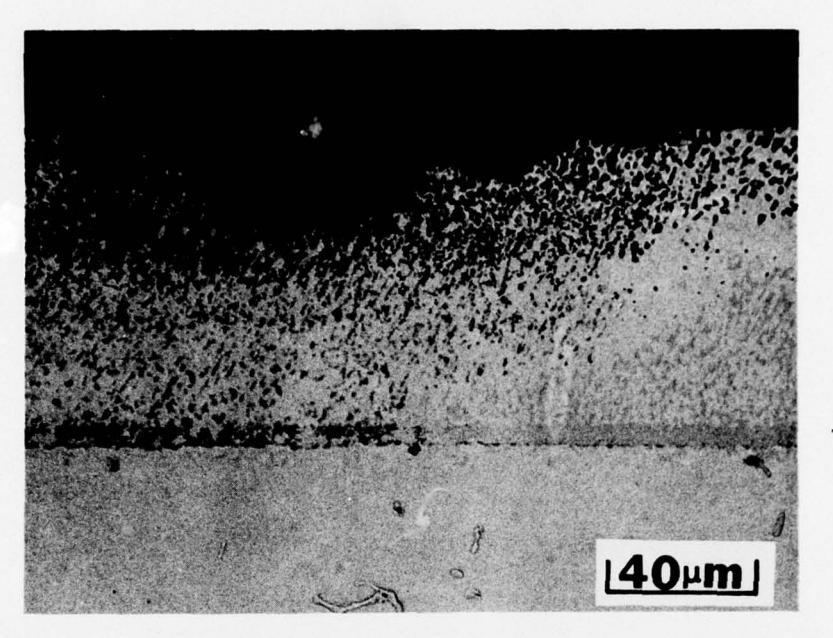
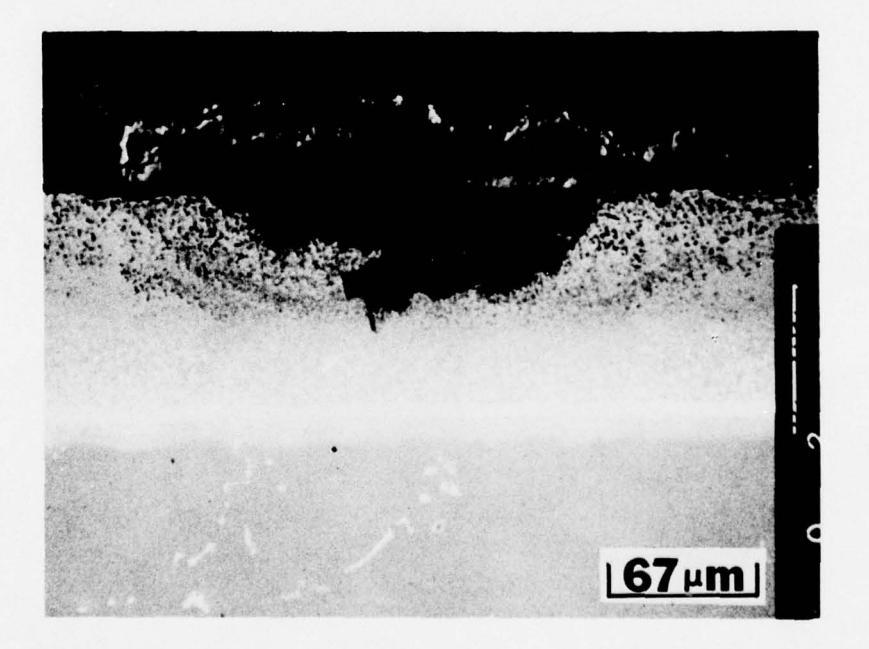
40b. Back scattered electron image of coating protrusion shown in Fig. 4. (Platinum underlayer and Pt-containing diffusion zone appear white due to high average atomic number).

Figure 40. Platinum underlayer between IN 738 substrate and FWA 68 CoCrAlY coating had no apparent effect on typical surface degradation or incidence of localized coating protrusions.

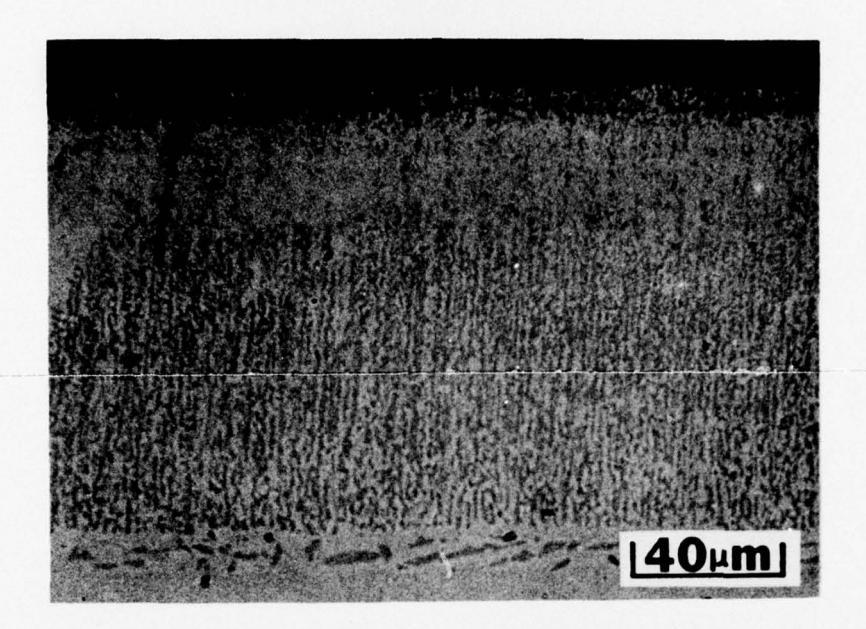
42a. PWA 68 coating with platinum overlayer suffered minimal degradation in 1000 hour cyclic hot corrosion test at 649° C. Microstructures shown in Figs. 39 and 40 were produced by the same exposure of PWA 68 without the platinum overlayer.

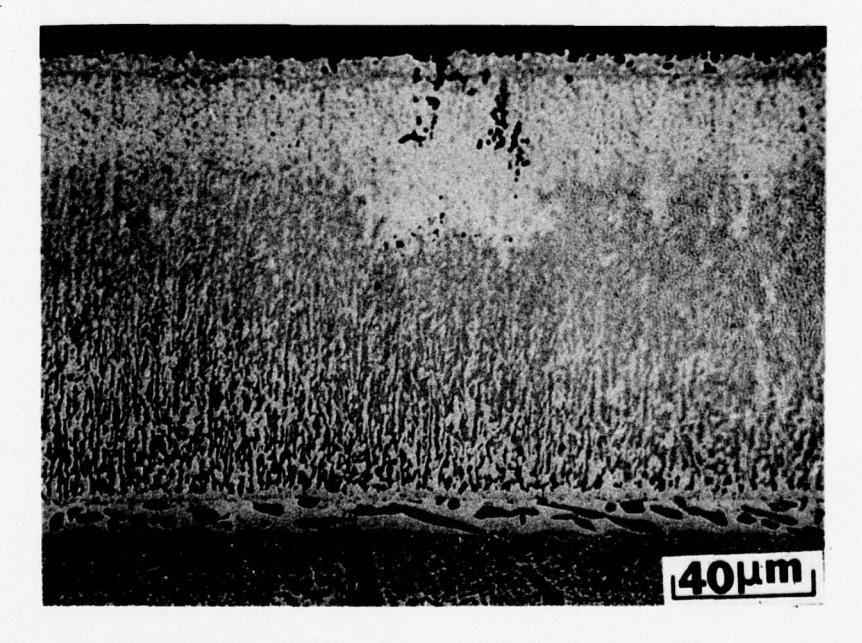
42b. Microstructure of FWA 68 + Pt after 2000 hours at 649°C

Figure 42. Minimal degradation of microstructure of PWA 68 + Pt coating was observed in the 649° C cyclic hot corrosion test with Na₂SO₁ - 50% NaCl.

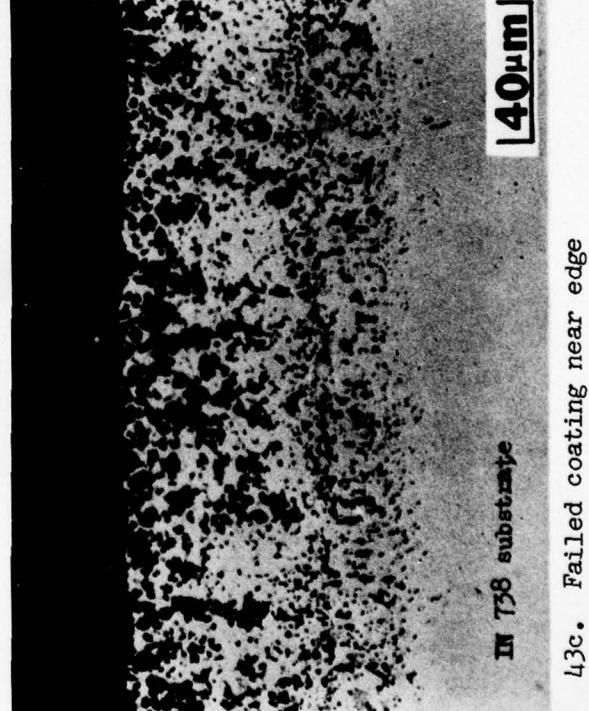
Figure 43. Surface condition and microstructure of PWA 73 diffusion aluminide coating after 120 hours in 899°C cyclic hot corrosion test with Na_SO₄ - 50% NaCl. Test was terminated due to general surface degradation and corner failure.

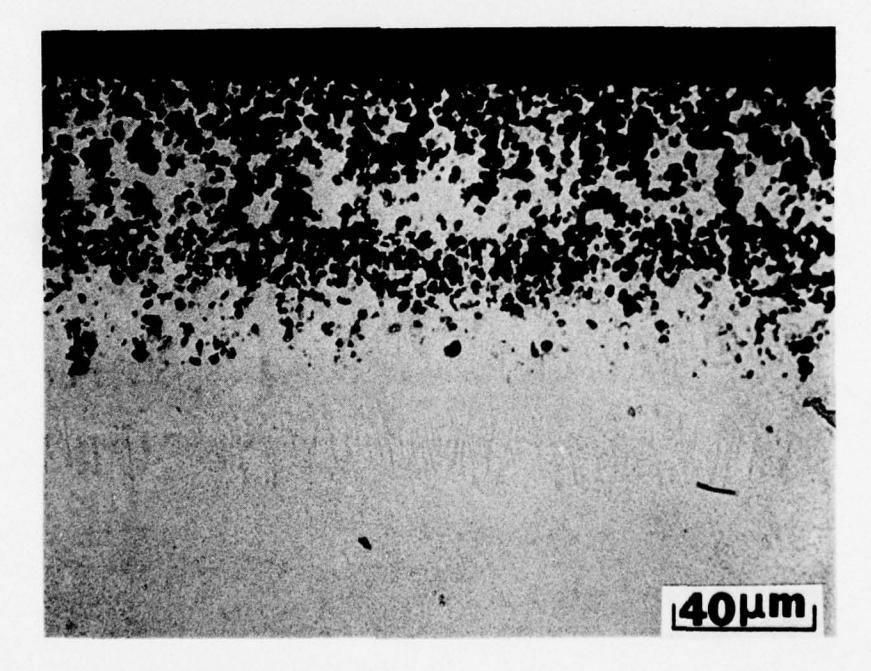
44b. 700 hours

Figure 44. Microstructural degradation of PWA 273 diffusion aluminide coating in $899^{\circ}C$ (1650°F) cyclic hot corrosion test with Na₂SO₄ - 50% NaCl.

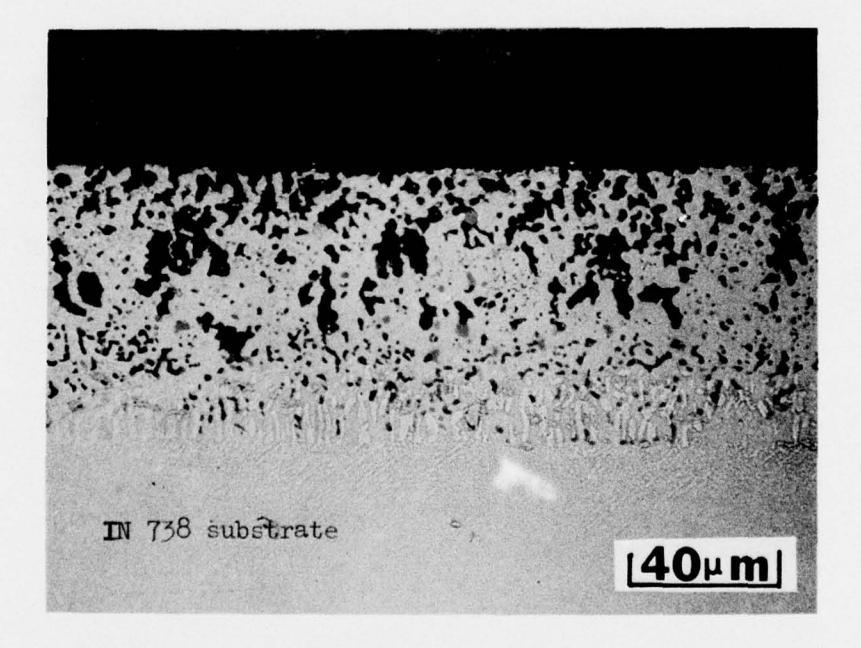
Figure 45. Surface condition and typical microstructure of chromized and aluminized (PWA 70 + PWA 73) IN 738 after 80 hours in 329° C cyclic hot corrosion test with Na₂SO₄ - 50% NaCl.

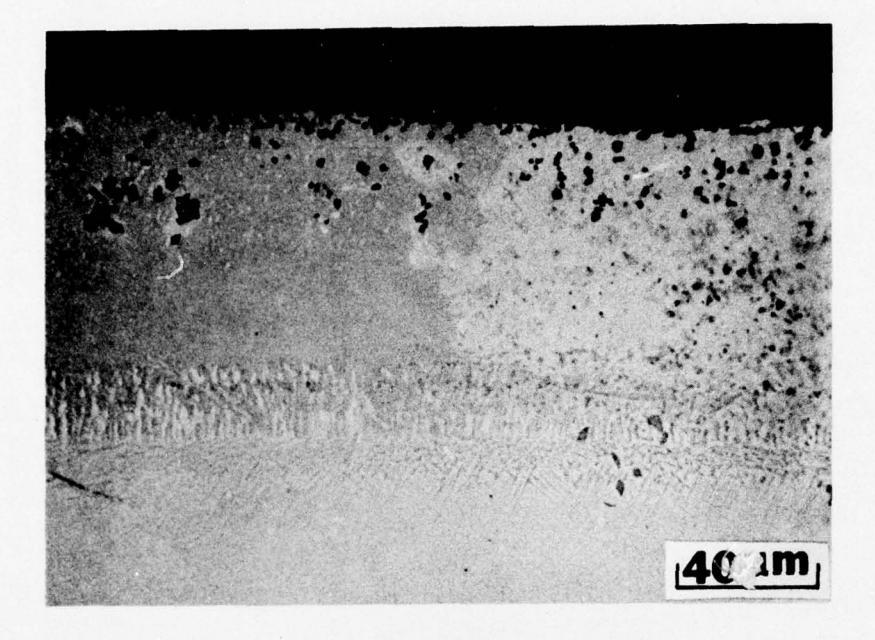
47a. Sharp transition in extent of dealloying

Figure 47. Variable microstructural degradation of sputtered Pt + PWA 273 coating in 1000 hour 899°C cyclic hot corrosion test.

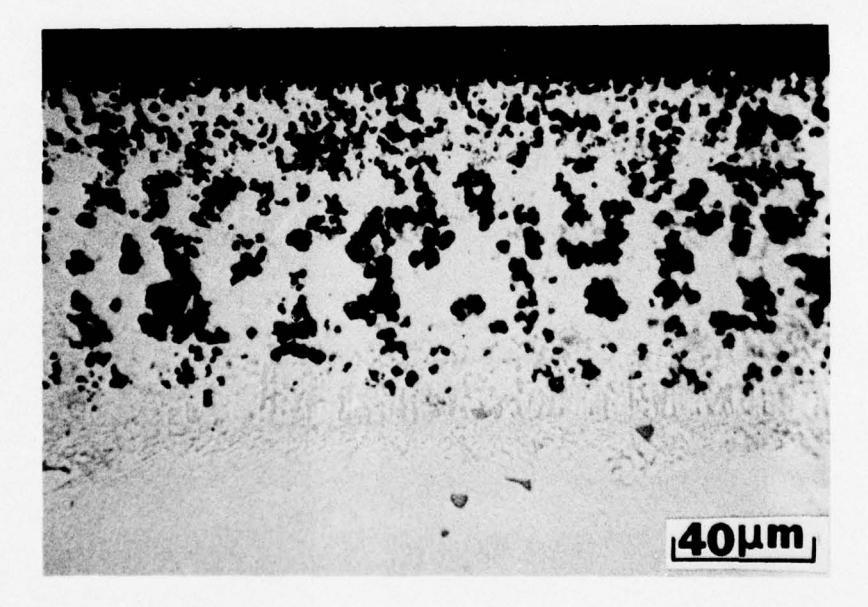
47b. Internal oxidation of entire coating thickness

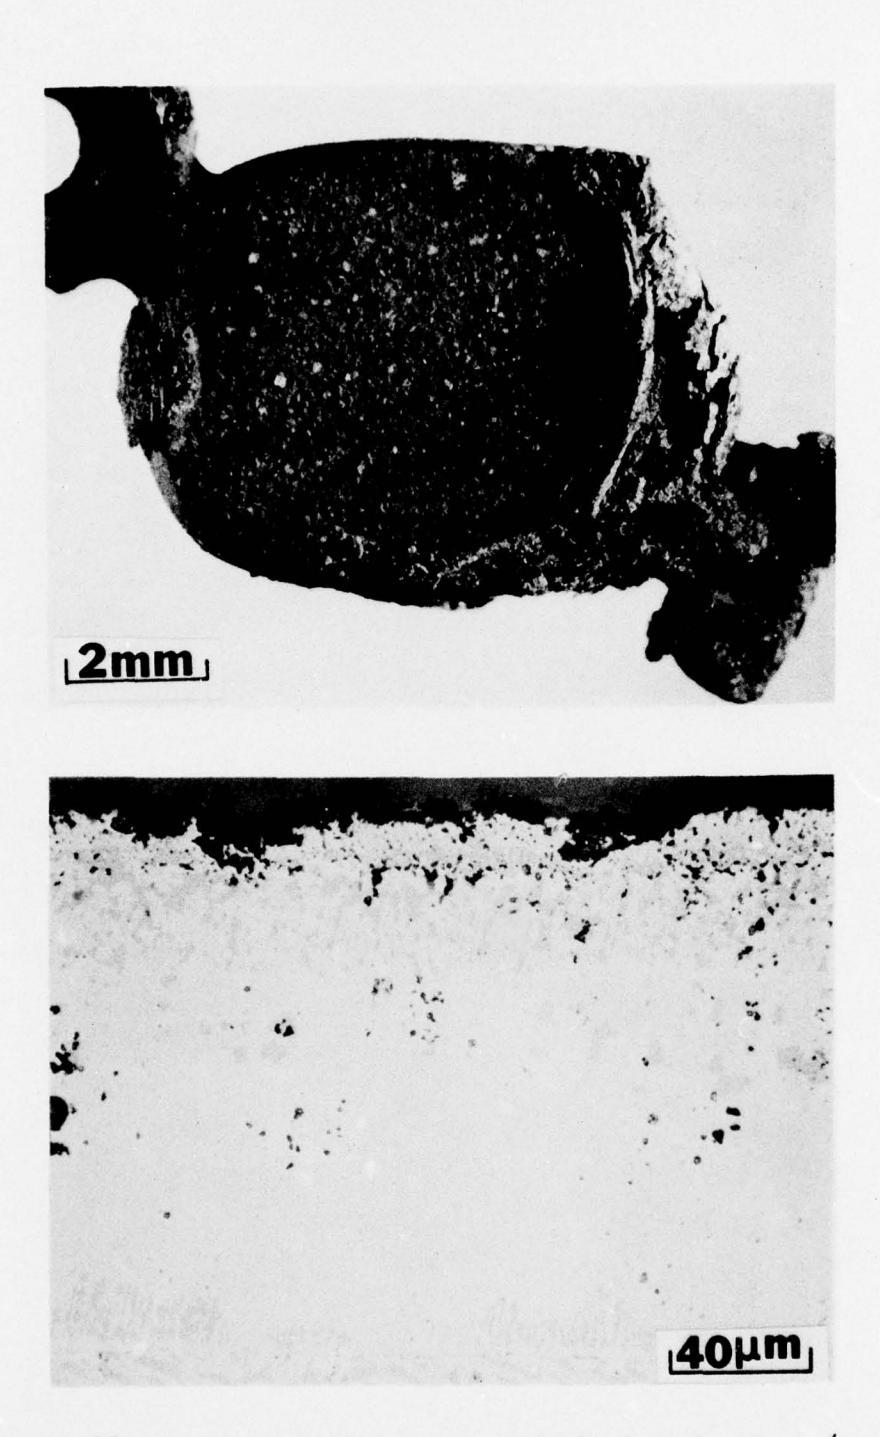
Figure 48. Surface condition and typical microstructure (away from cut edge attack) of PWA 68 coating with 6µm platinum overlayer; exposure time = 720 hours at 899°C.

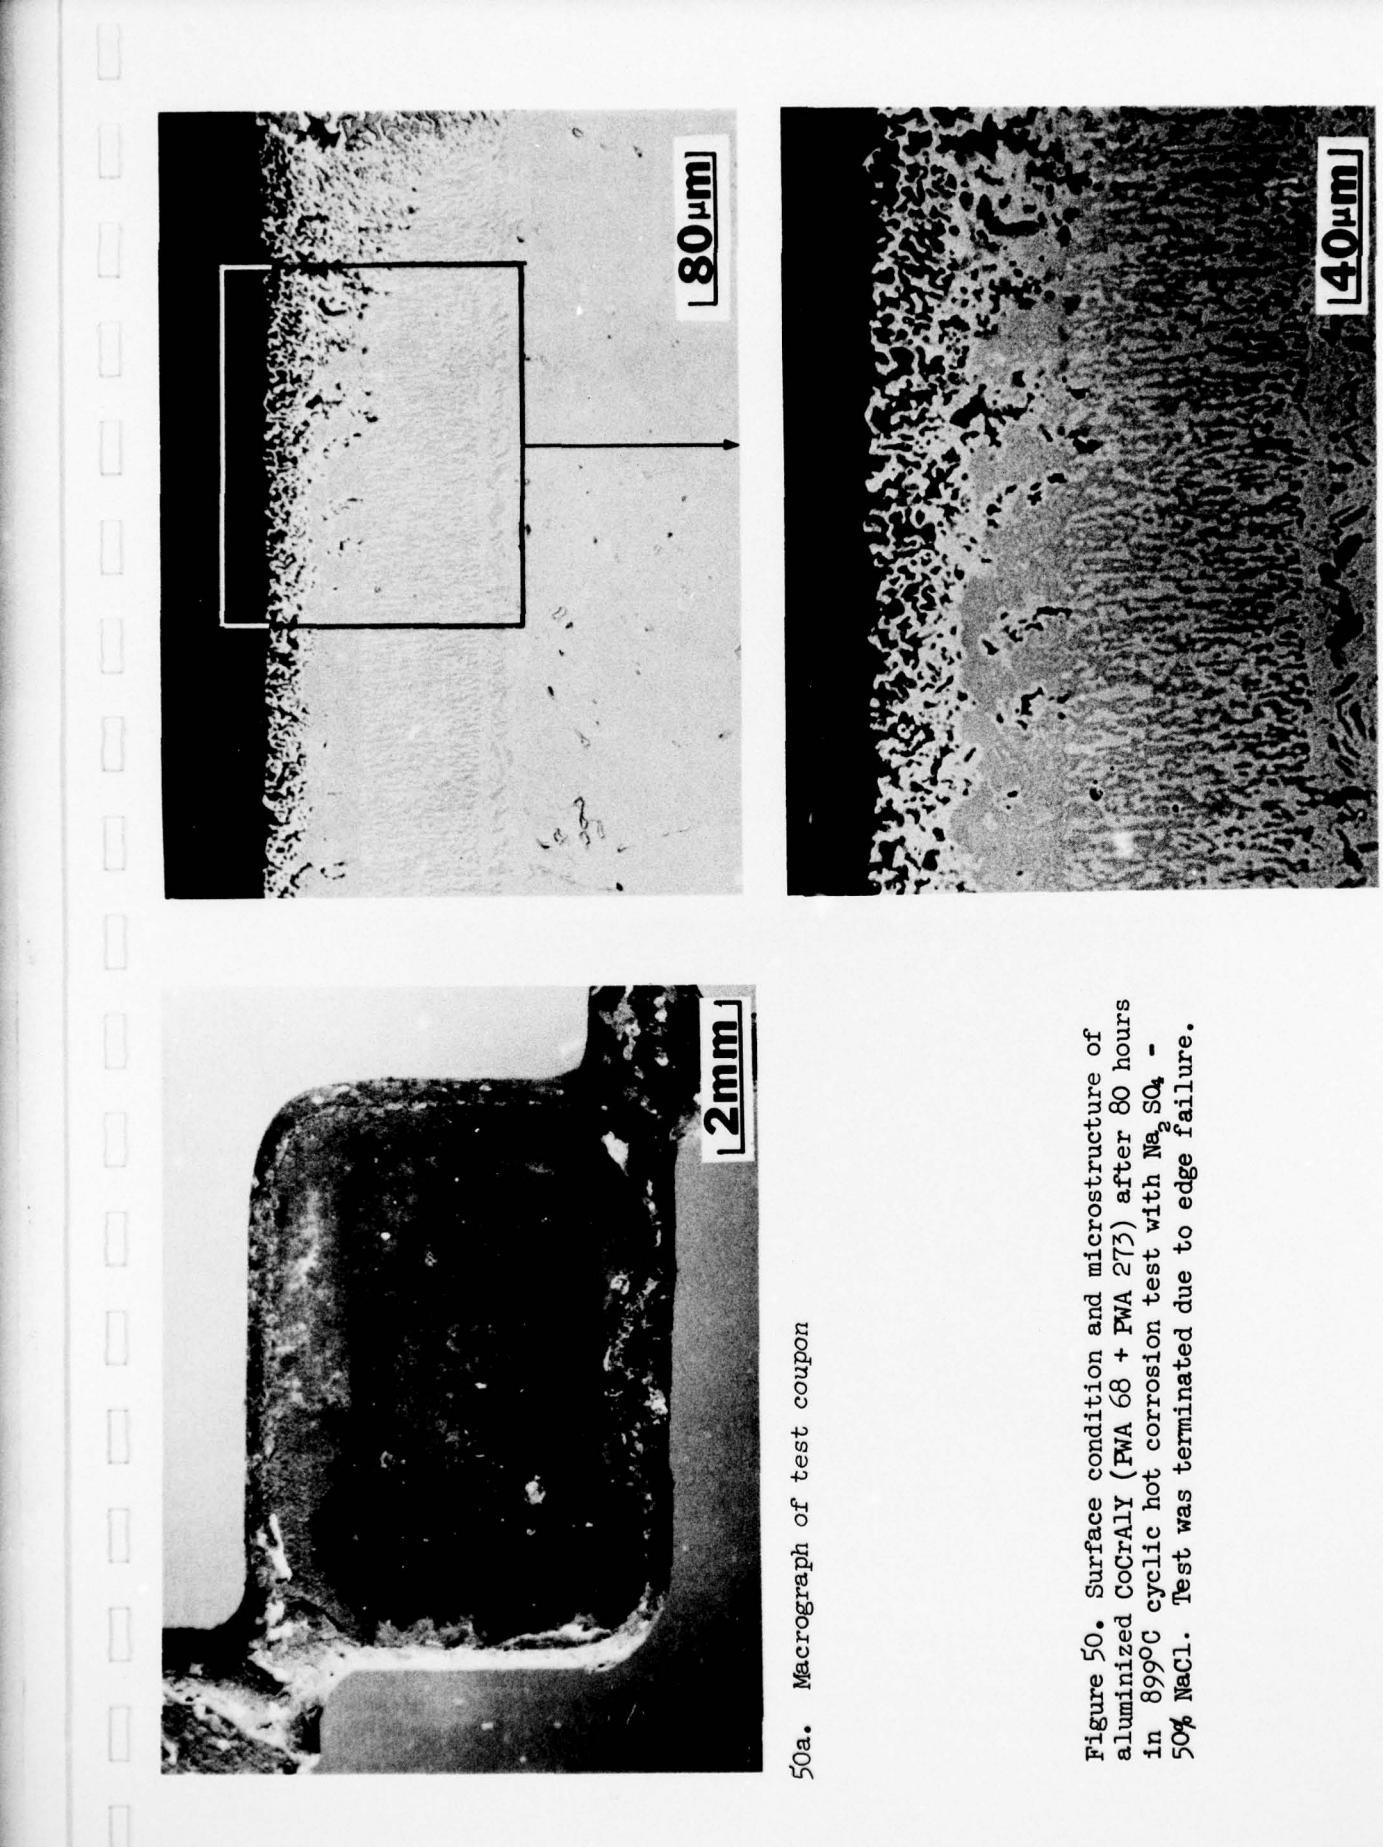
50b. Edge failure and uniform surface attack

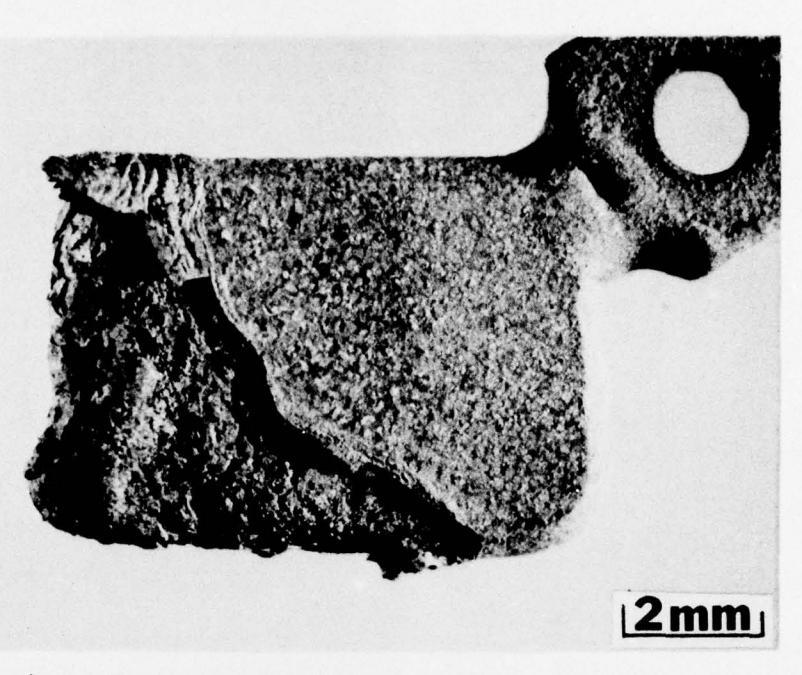
51a. Surface condition

Figure 51. Surface condition and microstructural degradation (away from cut-edge effect) of PWA 68 + Pt overlayer + PWA 273 coating; exposure time = 520 hours in 899° C cyclic hot corrosion. Uniform depth of attack on other face of coupon was about half that shown in 51b.

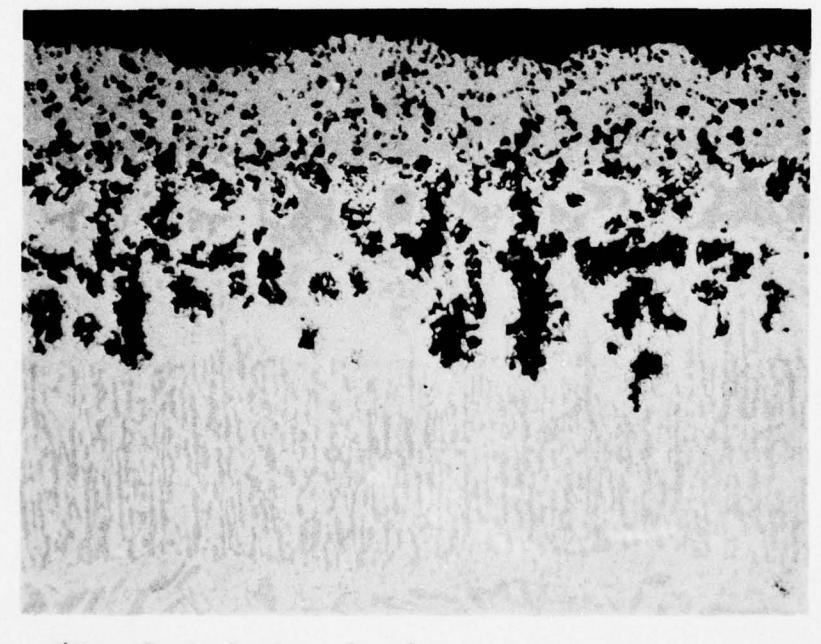
51b. Typical microstructure

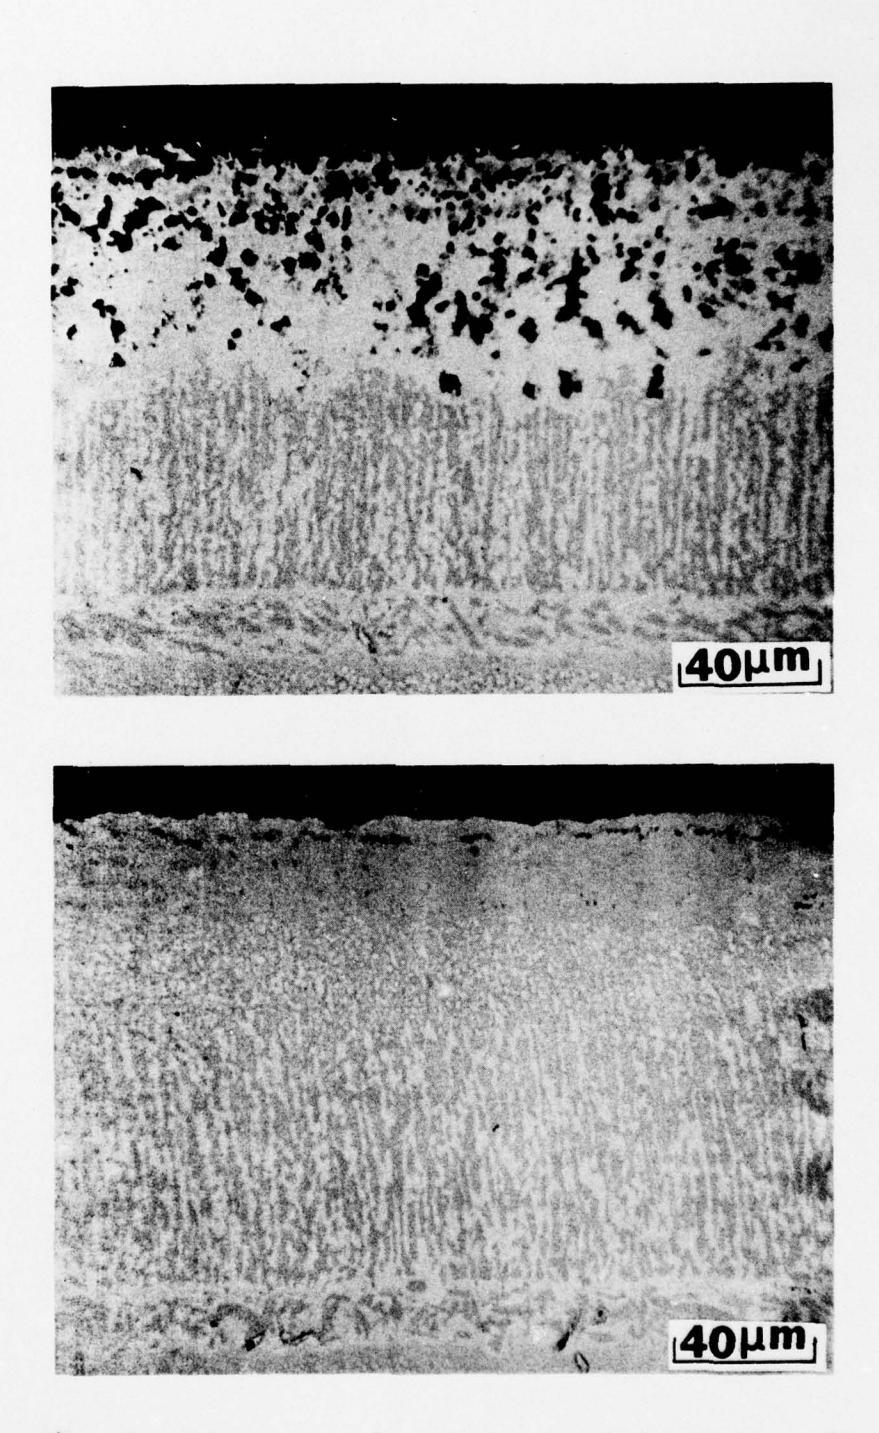
Figure 52. Variable extent of microstructural degradation after 940 hours exposure of FWA 68 + Pt + FWA 273 coating in 899° C cyclic hot corrosion.

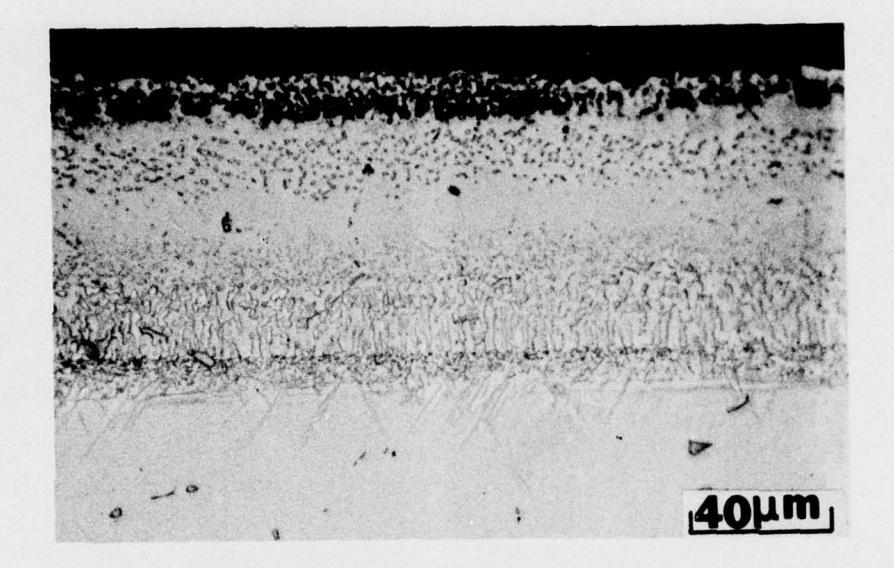
Figure 54. Microstructure of Ti-modified PWA 273 (6µm layer of sputtered titanium applied prior to aluminizing) after 1000 hours of cyclic hot corrosion testing at 899° C with Na₂SO₄ - 50% NaCl

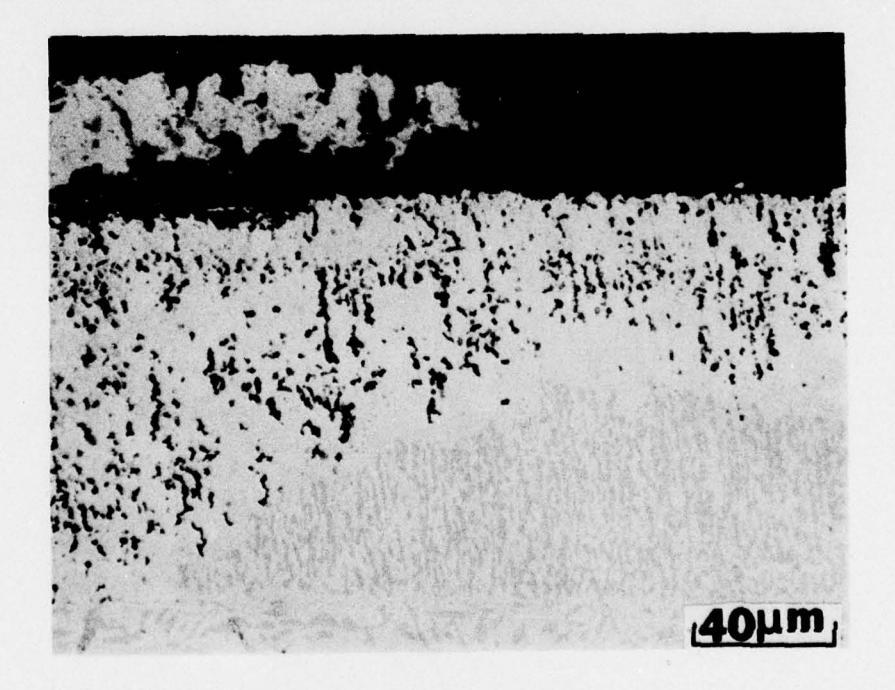
Figure 55. Oxidation of Ni overlayer and dealloying of PWA 68 after 80 hours exposure in 899°C cyclic hot corrosion test.

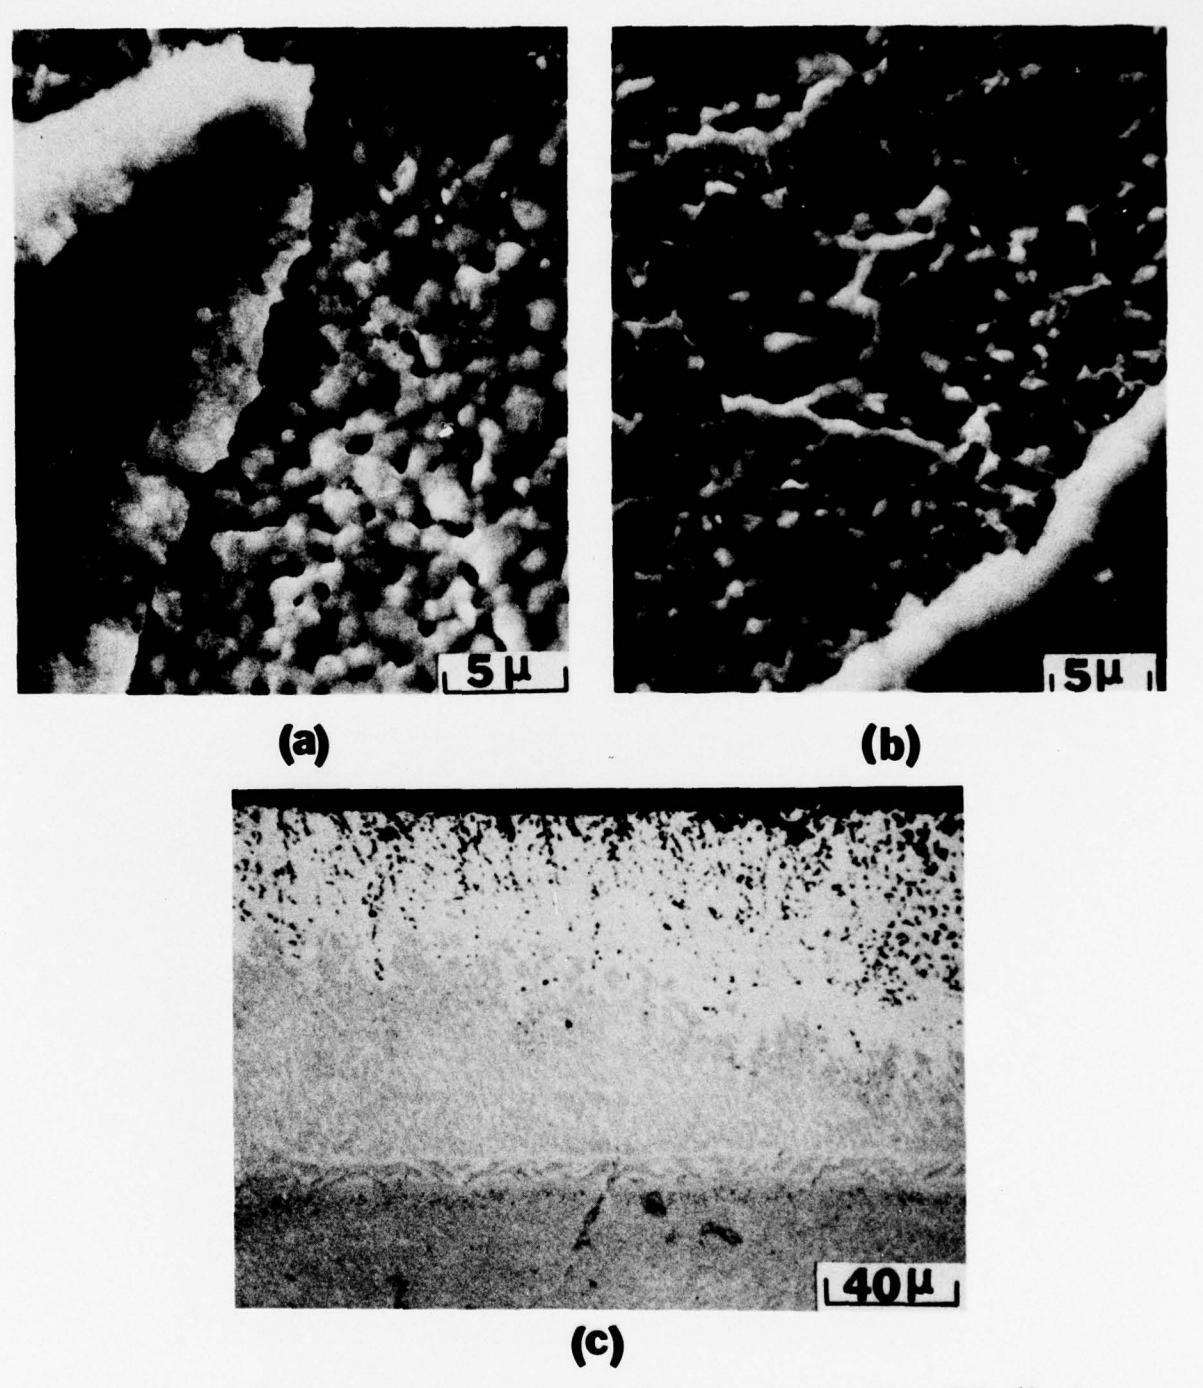
Figure 56. Surface and microstructural features developed on PWA 68 after exposure to Na_2SO_{\downarrow} - 50% NaCl at 899°C (1650°F). (a) Surface pores are evident after 20 minutes. (b) Pores are larger and more numerous after exposure for 1 hour. (c) Transverse section after 22 hours shows that the porous zone of internal attack extends deeply into the coating.

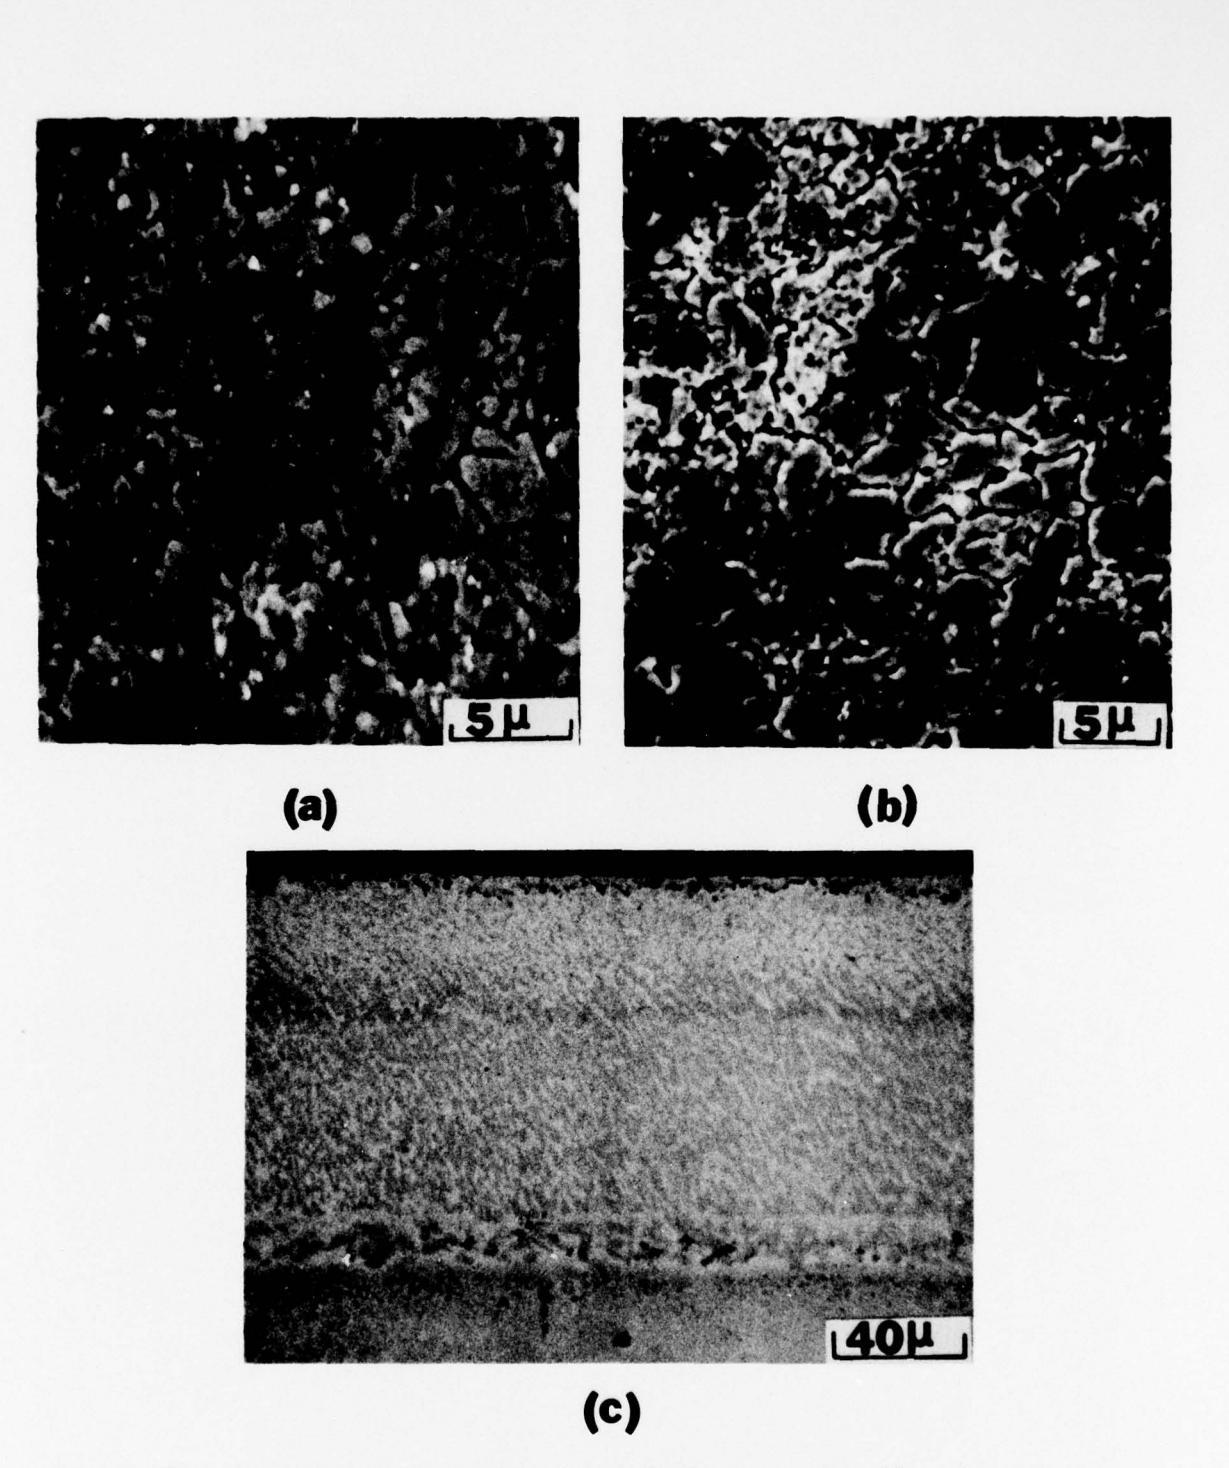
Figure 57. Surface and microstructural features on FWA 68 + Pt tested concurrently with the specimen of Fig. 56. (a) Scanning microscopy after 20 minutes shows preferential attack, apparently at grain boundaries of the Pt overlayer. (b) Re-examination after 1 hour shows no additional attack. (c) Transverse section after 22 hours shows negligible degradation of microstructure; compare with extensive dealloying and internal oxidation in Fig. 56c.

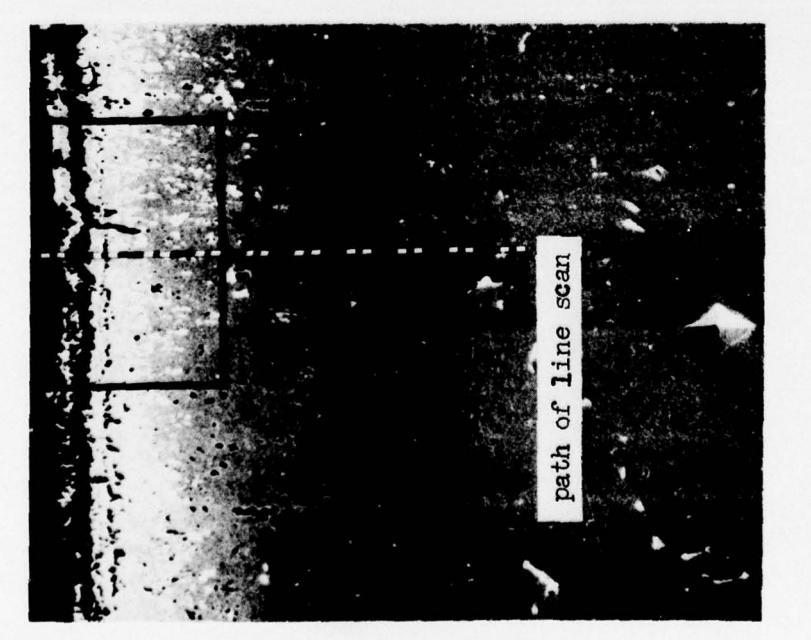
Figure 59. Degradation of Pt overlayer + FWA 68 coating produced by 700 hours in the cyclic hot corrosion test at 899° C. Break-up of originally cortinuous platinum aluminide phase in the overlayer (see Figs. 57c, 58) apparently exposes the CoCrAlY to dealloying by the sulfate-chloride melt, as shown by θ -dissolution, pore formation, and Al line scans through the coating.

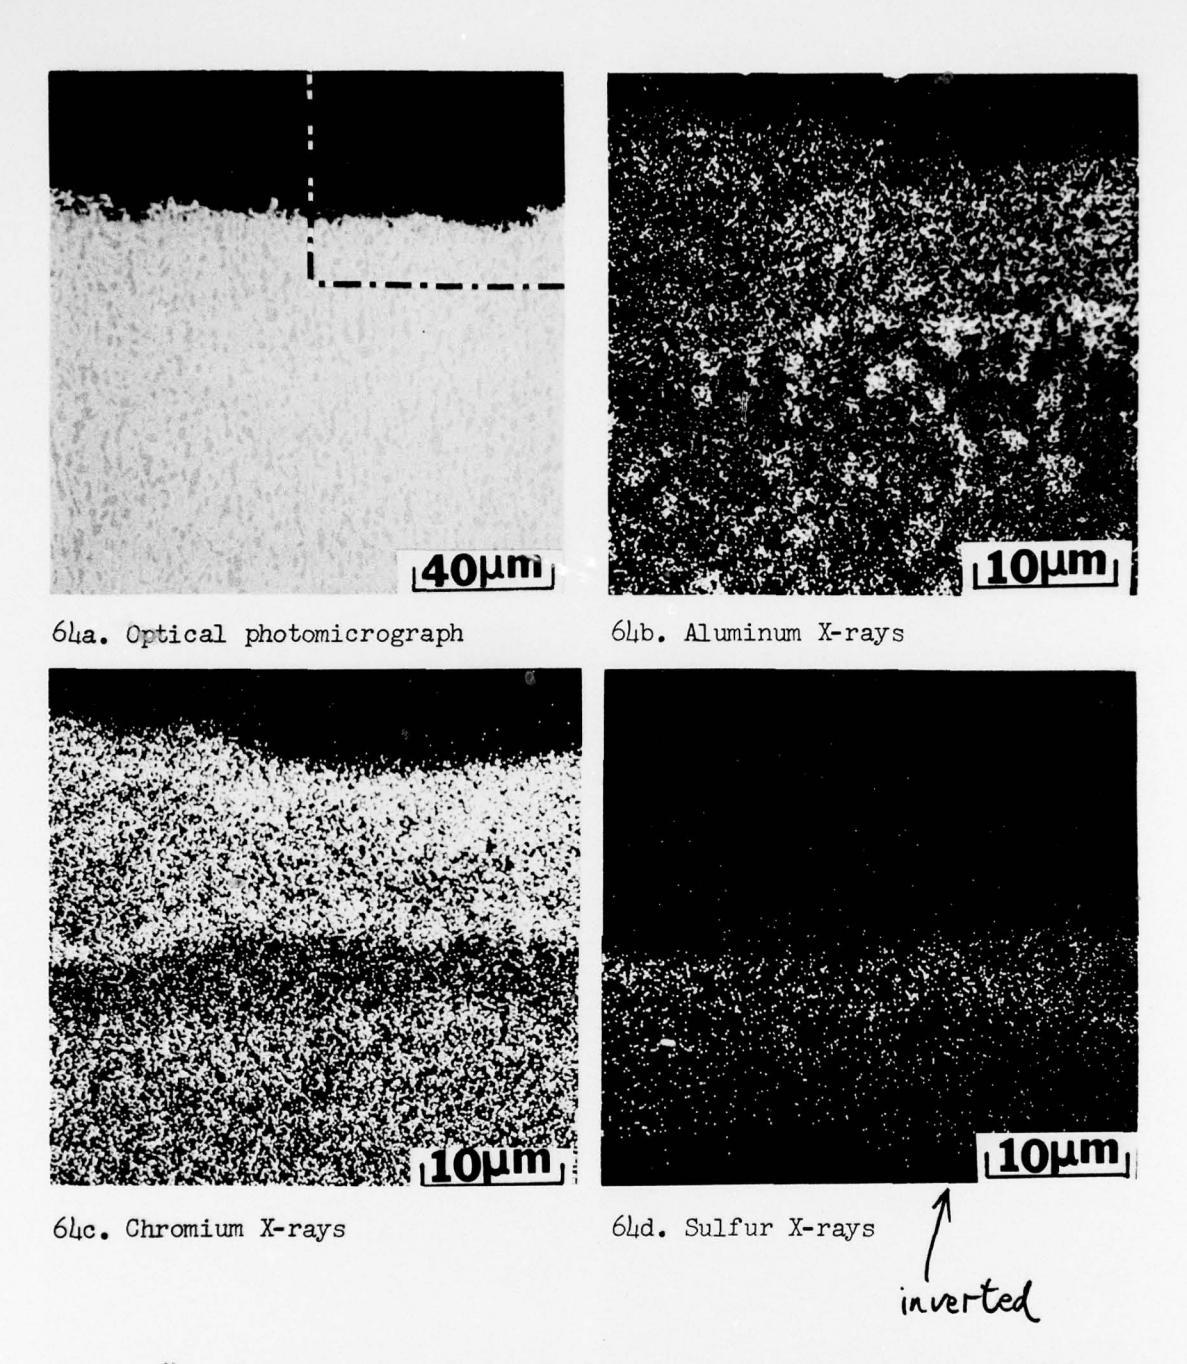
Figure 64. Hot corrosion observed with same material and test conditions as in Fig. 63 except that salt deposit was Na SO_1 - 50% NaCl. The salt mixture instead of 100% Na SO_1 did not produce a discernable difference in severity of attack or microstructure and element distribution at the attack front.

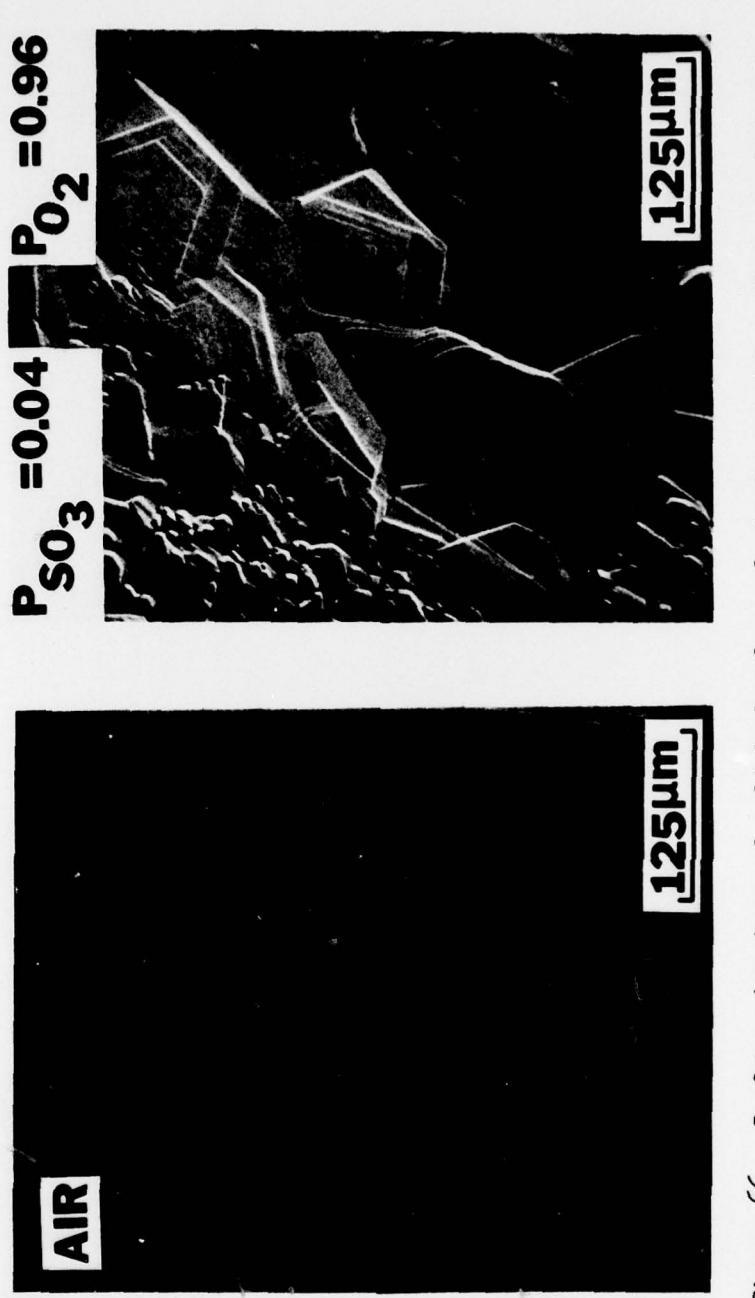
Figure 66. Surface structure of polished wafers of single-crystal α -Al₂0, coated with 1 mg/cm² Na₂SO₁ and exposed for l_1 hours at $6l_9^{0C}$ (1200⁰F). No change in weight or surface structure was observed on the sample heated in air. The sample exposed to SO₃ gas showed a weight loss after water washing, and Al ions were detected in the wash solution.

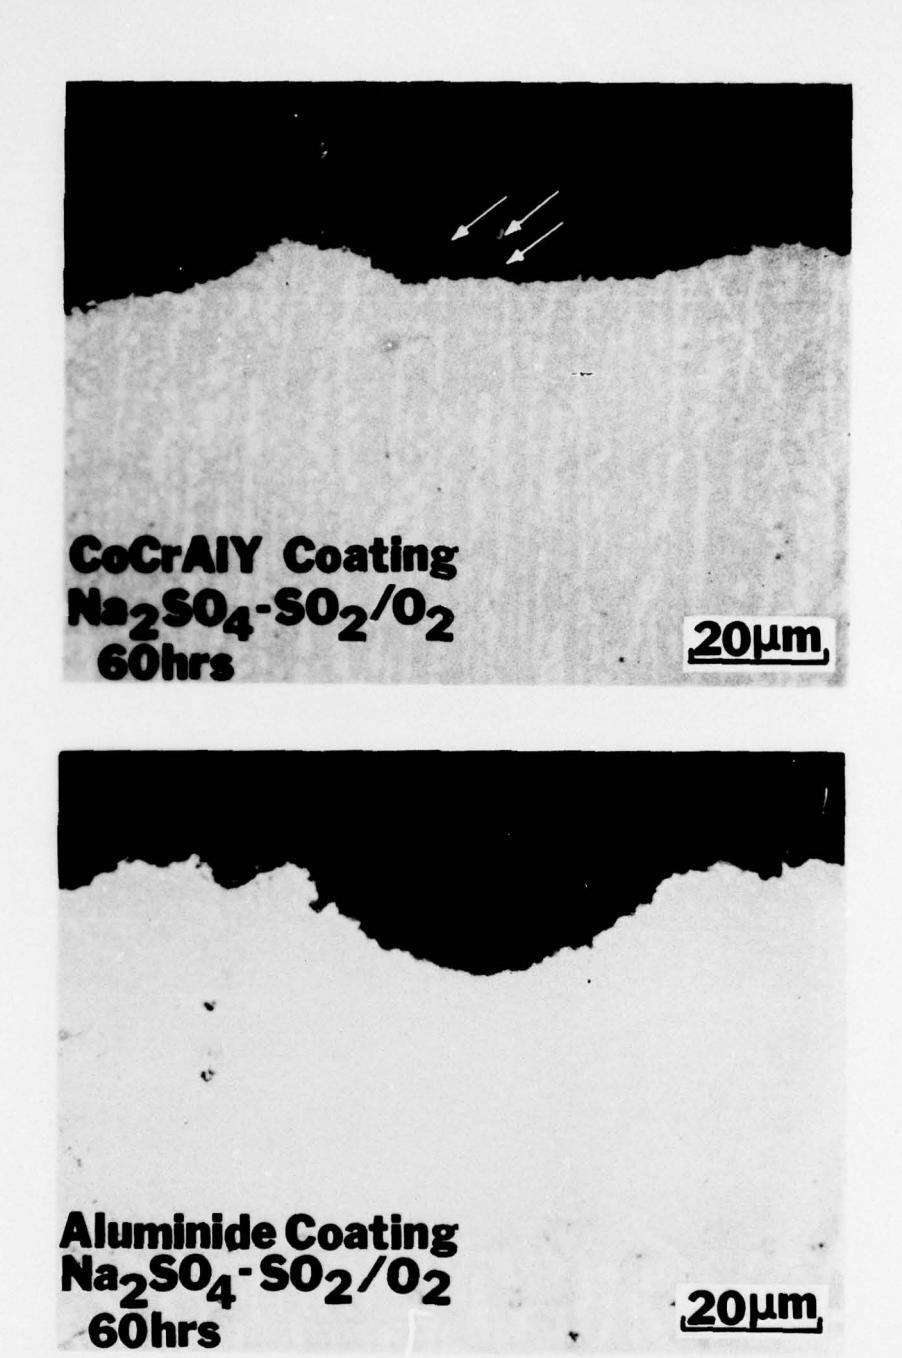
Figure 67. Attack of PWA 68 CoCrAlY and PWA 273 diffusion aluminide at 649° C produced by 1 mg/cm² Na₂SO₁ salt deposit and 0.04 atm SO₃ pressure (from equilibration of mixture of flowing SO₂:0, at the test temperature). White arrows mark features which appear to be small metallic globules sometimes observed in the inner layer of the scale.

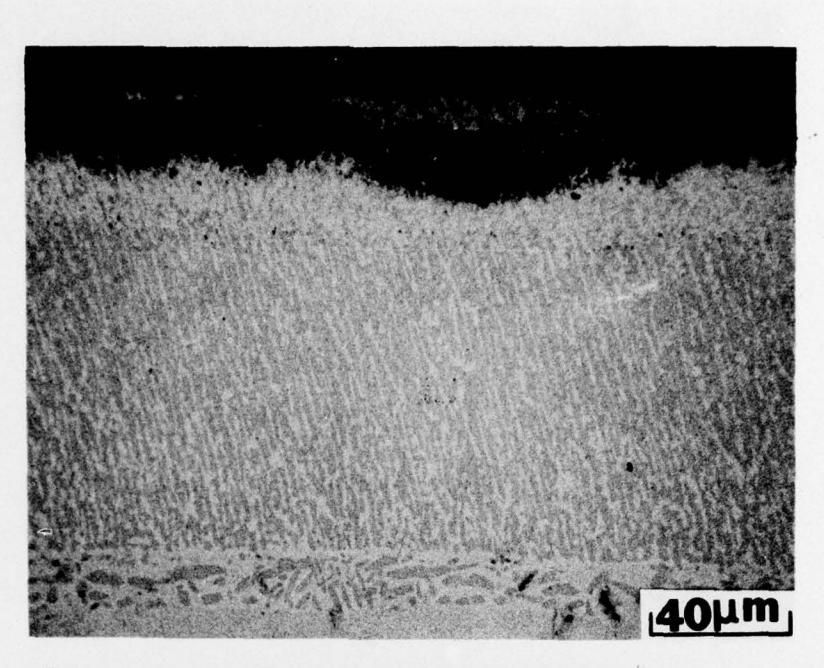
68a. typical extent of surface degradation

Figure 68. FWA 68 + Pt overlayer coating exposed 100 hours at 649° C (1200°F) with Na₂SO₄ salt deposit and SO₃ gas.

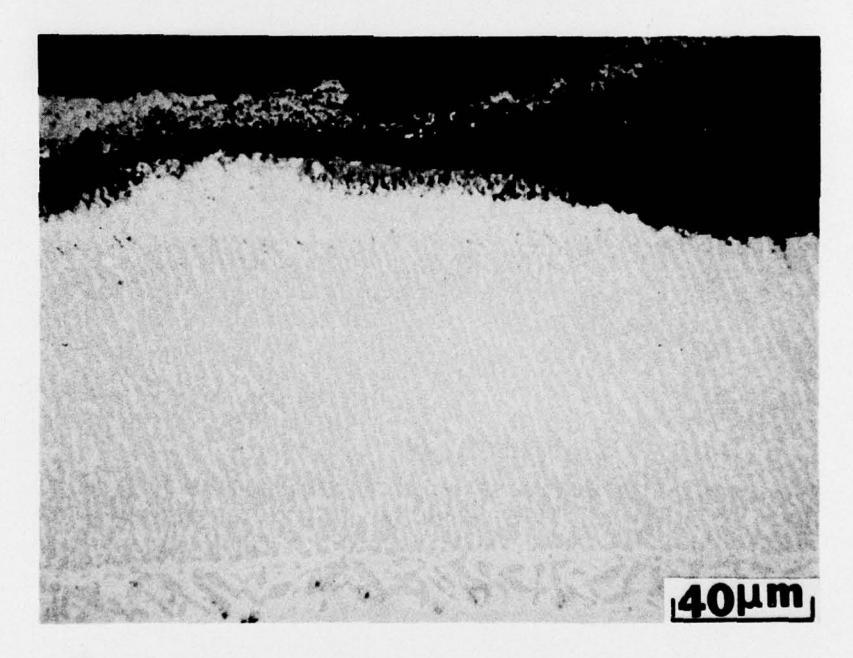
68b. spallation of oxidized overlayer
