PASSAIC RIVER BASIN

³ RAYMOND DAM

PHASE I INSPECTION REPORT NATIONAL DAM SAFETY PROGRAM

3 (NJ 00213)

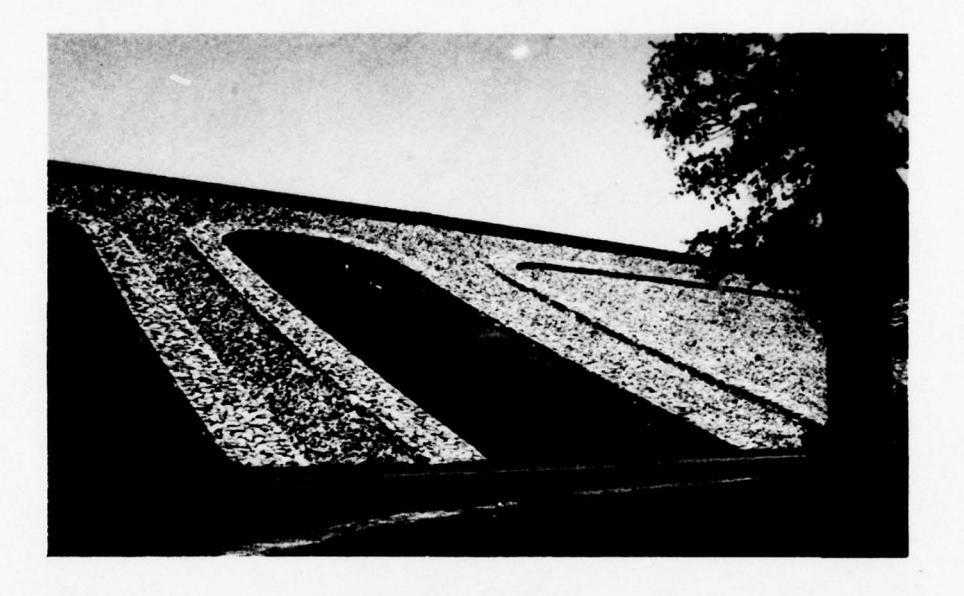
MOWING OF GRASS NEAR LEFT ABUTMENT BY RESIDENT MAINTENANCE CREW

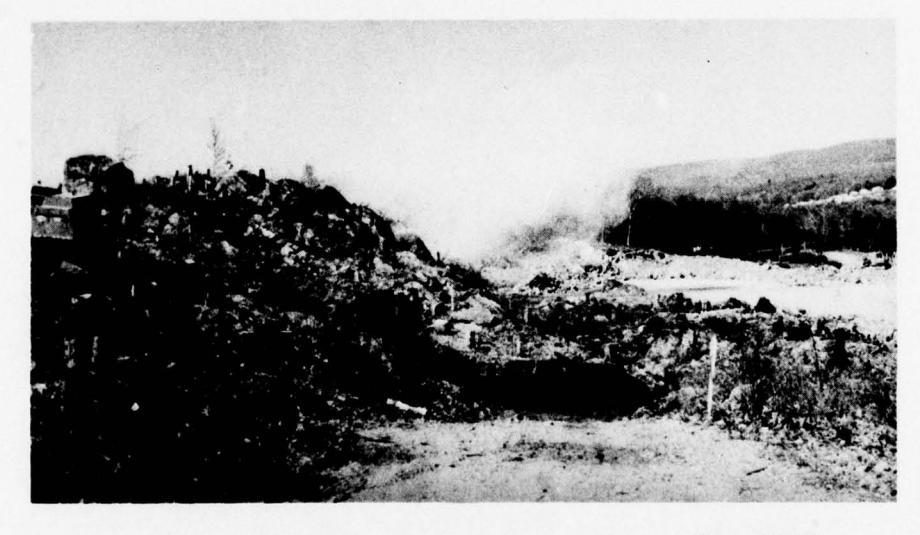
DUST FROM BLASTING AT NEW FILTRATION PLANT SITE 0.3 MILES SOUTHWEST OF DAM - VIEW LOOKING NORTHEAST

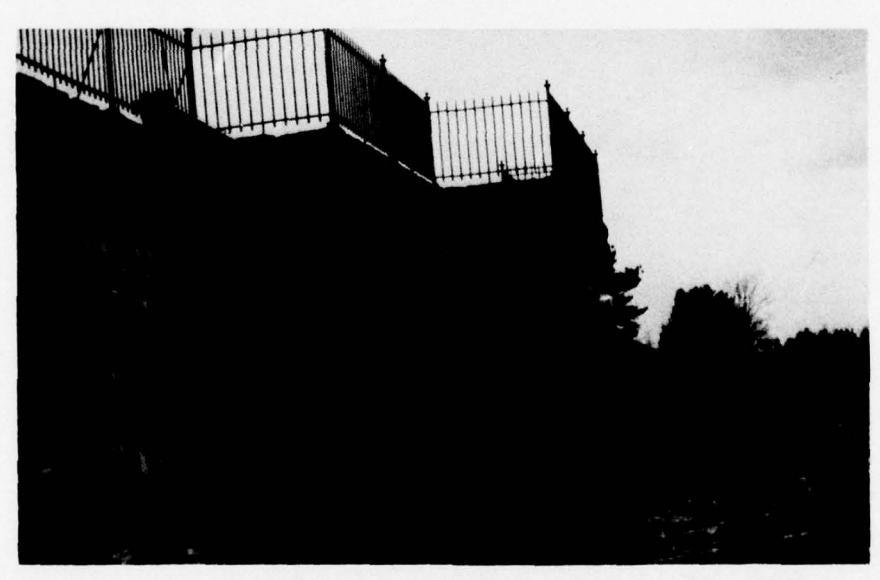
3.1.3 <u>Appurtement Structures</u>: There was some surface scaling and deposits on the reservoir side of the Upper Gate House. The conduits were full of water and could not be inspected. Repairs were being made to the gate hoist mechanisms in the Upper Gate House at the time of the inspection. According to a representative of the owner, the gates were operated after a thick layer of deposits had built up on the stems and resulted in some twisting-off of retaining brackets for the stem.

SURFACE DETERIORATION AT UPPER GATE HOUSE

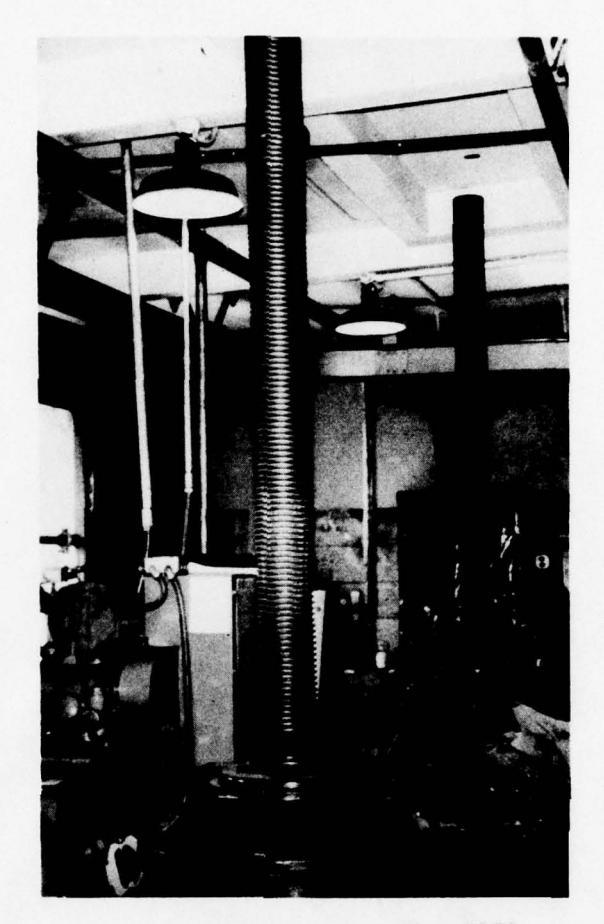
UPPER GATE HOUSE - TWO GATE OPERATORS ON RIGHT

At the time of the inspection, 5/11/78, all four gates were inoperable due to corrosion in the stem guide at each gate. Two of the gates were in the process of having their corroded brass stem guides replaced with stainless steel. The remaining two gates are scheduled to have their guide replaced after completion of the work on the first two.

It is recommended that a monthly maintenance operating schedule be installed to operate each of the four sluice gates through a complete close open cycle. This will show that all electrical, mechanical and hydraulic components of the gate system are in operating condition.
