GRIFFIN DAM

NDS ID No. 188

PHASE I INSPECTION REPORT

NATIONAL DAM INSPECTION PROGRAM

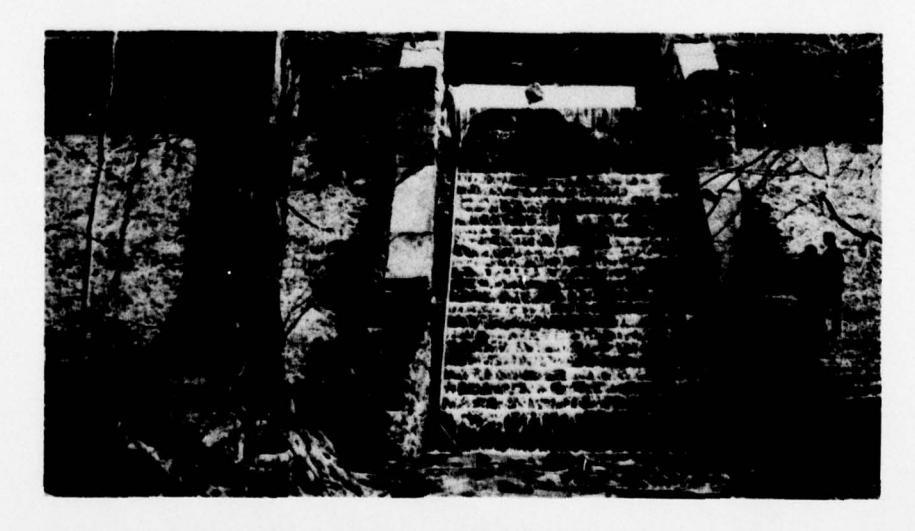
(2) Downstream of the stepped cascade, mortar has deteriorated over the upper half of the masonry spillway walls. The small auxiliary dry masonry wall on the right side of the spillway has tilted backwards (Photograph D). It makes an angle of about 45° with the vertical. This wall has a maximum height of about 2 feet. There are signs of erosion under the wall. Each masonry block in the right and left spillway training walls, that are located directly above the spillway crest, has a fine diagonal crack about 6 inches long. At the junction of the right spillway approach wall and the intake structure, there appears to be an open joint; this area was not accessible for close inspection. At the junction of the left spillway wall with the masonry gravity structure of the dam, there is seepage through the masonry joints below spillway crest. The masonry blocks in this area were wet, but there was insufficient seepage to cause flowing water.

(4) The operation of the 8-inch diameter siphon was not observed (Photograph D). Before operation, the siphon would have to be manually primed by allowing water to enter a plug at the high point of the pipe. Both this plug and the stem to operate the valve, which is at the toe of the spillway cascade, would be submerged during high spillway flows.

D. Spillway Looking Upstream

(6) Repair dry masonry wall at right of spillway.
