GREATER JOHNSTOWN WATER AUTHORITY DAM (SALT LICK DAM)

PHASE I INSPECTION REPORT

NATIONAL DAM SAFETY PROGRAM

PHASE 1 INSPECTION REPORT NATIONAL DAM SAFETY PROGRAM GREATER JOHNSTOWN WATER AUTHORITY-SALT LICK DAM ID NO. PA 429 (PA 11-8)

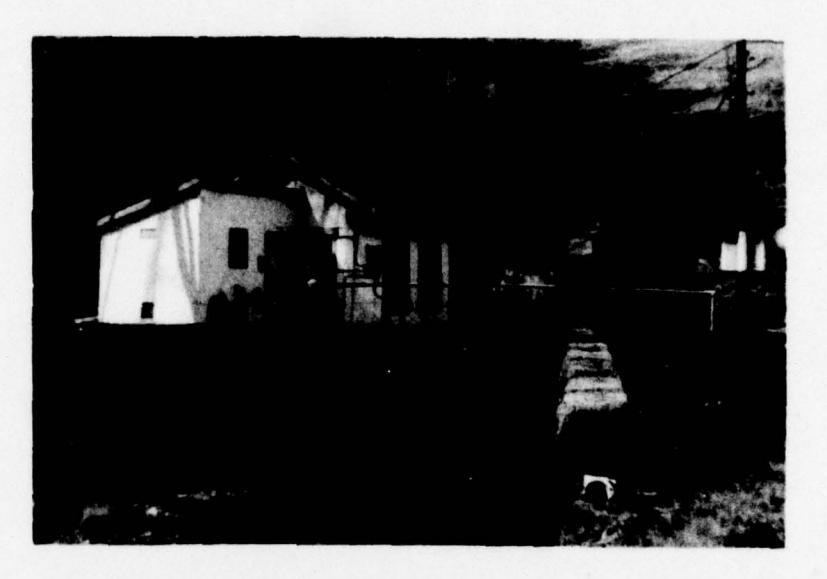
(4) The concrete retaining wall at the outlet end of the access conduit is badly spalled and in need of repairs. The stone masonry wall against the right abutment is buldging and ready to fail. The meter and chlorination house is partially blocking this outlet channel.

(6) The concrete conduit under the dam has a wooden bulkhead at the outlet end, with double doors and a lock. Within the conduit, siltation about 1-2 inches appears to have covered the bottom and appears to be fairly distributed throughout the entire length. At the upstream end of the tunnel, the leakage of the conduit increases more but still not of any great amount. It is estimated that the water flow at one location is about 1/4 inch \pm in diameter. Dam reports indicate the tunnel always did leak, but there were no current reports on the inspection of the conduit. The amount of silt and the uniformity of it on the invert and slopes of the invert appears to be too much for disposition from infiltration. The distribution is to uniform and regular for the amount of seepage. There appears to be no logical reason for its uniformity and warrants further review.

VIEW OF CONTROL HOUSE AND DAM CONDUIT

(3) The Owner initiate a program to make the minor repairs to the end of the weir and the walls of the conduit outlet channel, and improve the flow characteristics of said outlet channel around the meter and chlorination building.

(6) The Owner should investigate the grouting of the outlet conduit so as to stop or reduce the leakage to a minimum; cleanout the silt in the conduit and observe the amount of siltation that takes place, if any, over a period of time.

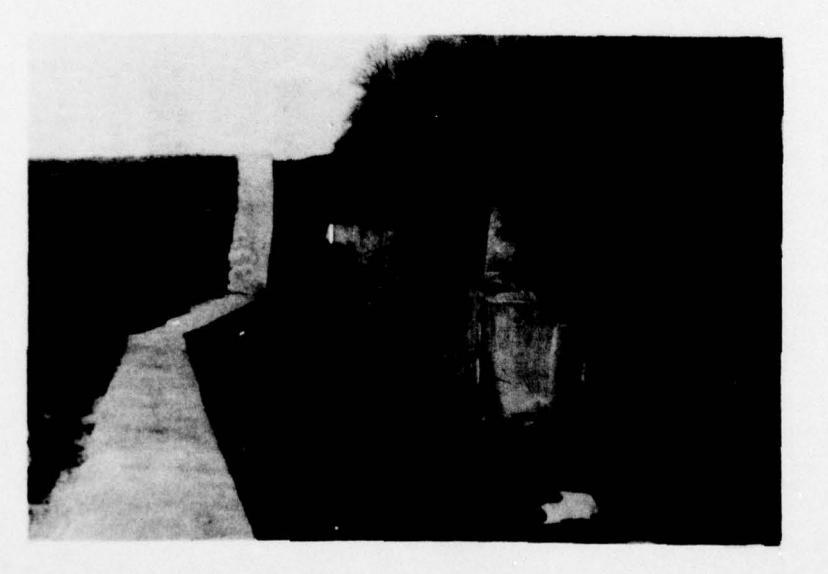
(1) The "bathtub" spillway projects into the lake very near the east abutment. Due to the narrow opening for the water to approach the eastern weir, we question the efficiency of the eastern weir and how much is the approach water restricted. Also, should an earth slide or the east abutment fail at high water, the results could be complete blockage of this portion of the weir. Such a slide if downstream from the weir could also block the spillway.

GENERAL VIEW OF WEIR AND SPILLWAY

(1) The Owner retain a competent engineer to make a complete hydrologic and hydraulic study and analysis of the Salt Lick Dam to determine the capacity of the ogee weir and spillway and the Probable Maximum Flood. The study could include recommendations on how to increase the safety of the dam, should the outlet facilities prove to be too inadequate. Such a study should also include a centerline profile of the top of the dam and spillway and outlet channel. (2) The Owner initiate a method of determining if the 30 inch blow-off value and discharge pipe is operative and can be used to help control the discharge over the spillway during times of emergency.

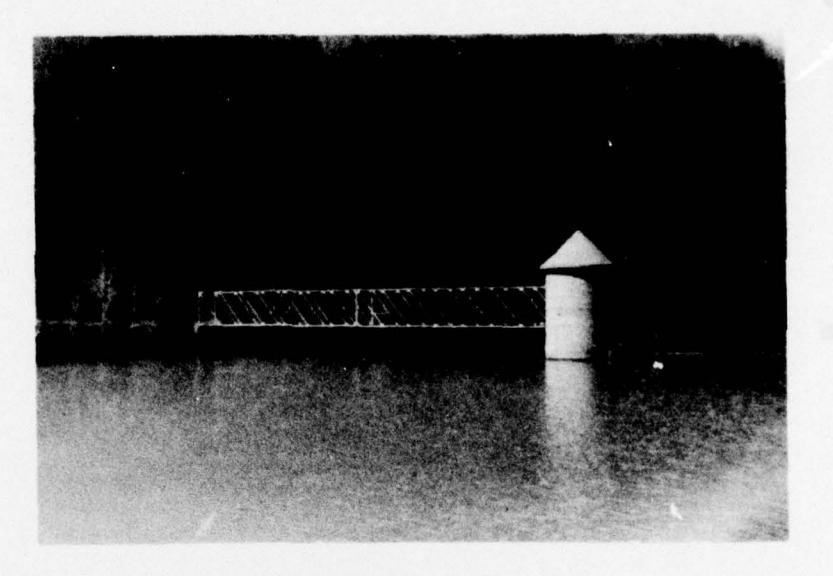
(7) The concrete intake tower appears to be in fairly good condition, and contains a steel core of riveted plates. The amount of rust on the inside or dry side of the steel core is not known; however, we question the safety of the steel ladder.

VIEW OF DAM INTAKE TOWER AND BRIDGE

(5) The Owner should investigate the degree of deterioration of the intake tower ladder and other steel members therein, and prepare the necessary plans and specifications to repair them.

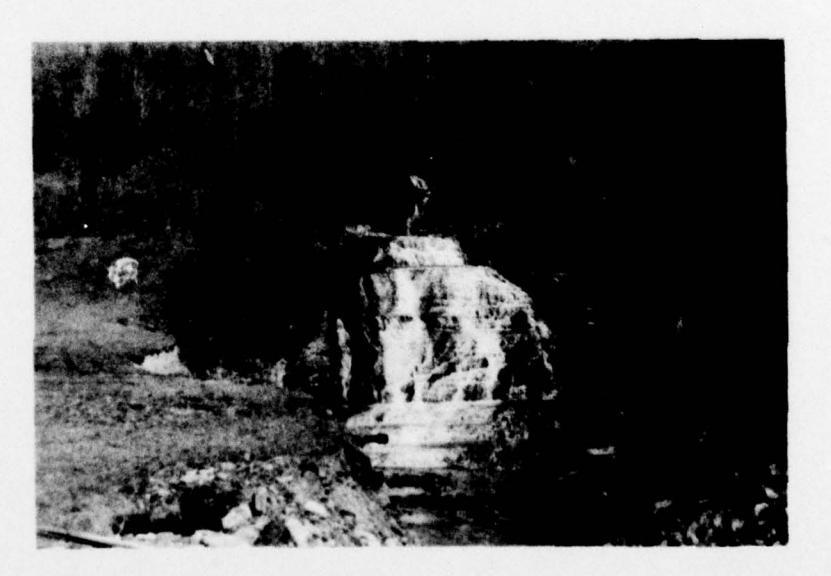
REMARKS OR RECOMMENDATIONS	Scour of outlet channel doesn't seem to affect stability of dam.	Channel slopes should be rip- rapped. Repairs to outlet channel to be performed this year.	- -	
DOWNS I REALL CHANNEL	OBSERVATIONS	Channel from end of spillway badly eroded by July, 1977 flood. Water cascading down bedrock channel has eroded a hole in bottom of channel at least 100 feet wide. Evidence of scour hole already made by past flood.	All slopes and overbank washed out in flood of 1977.	Numerous homes and extensive population downstream from dam.	
	VISUAL EXAMINATION OF	CONDITION (OBSTRUCTIONS, DEBRIS, ETC.)	SLOPES	APPROXIMATE NO. OF HOMES AND POPULATION

VIEW OF DAM OUTLET CHANNEL. NOTE SCOUR FROM FLOOD OF JULY, 1977
