# POTOMAC RIVER BASIN

Name of Dam: Sherando Location: Augusta County, State of Virginia Inventory Number: VA 01520

# PHASE I INSPECTION REPORT

SEPTEMBER 1978

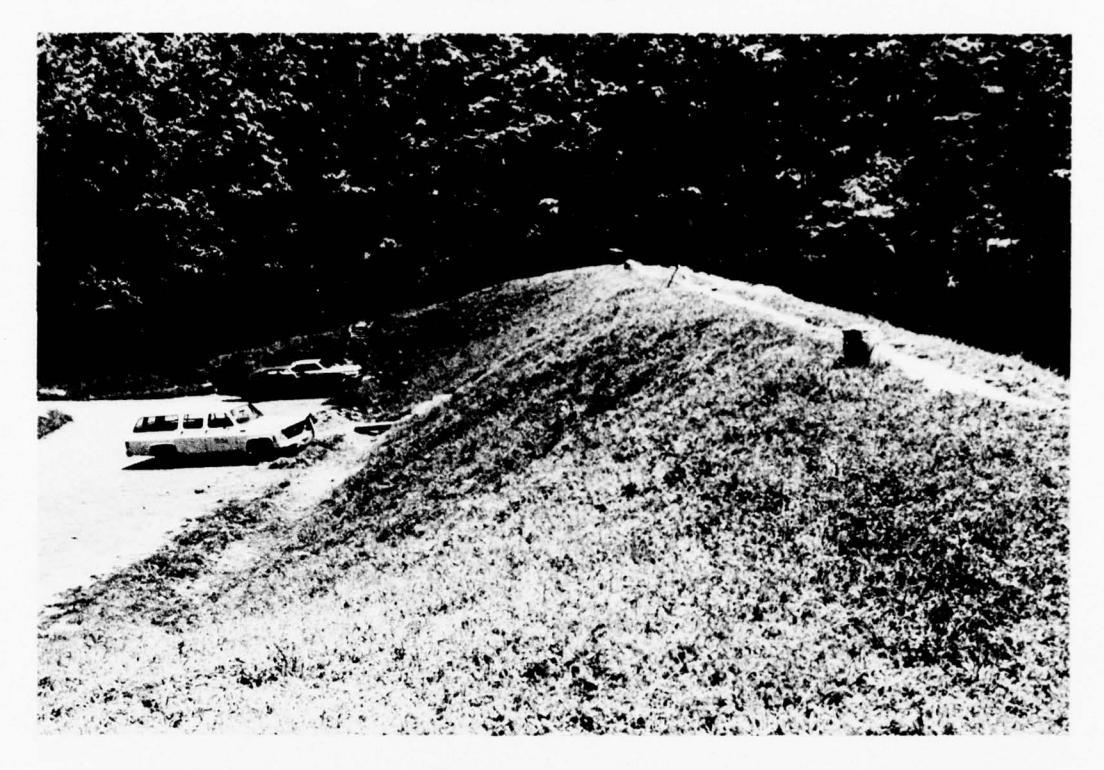
- 3.1.2 <u>Dam</u>: No noticeable seepage was observed in the embankment; however, there is a heavy growth of trees and brush on the downstream face from the parking lot bench area down to the toe.

PHOTO 1. Downstream Slope of Dam With Parking Area Bench

- 3.2.1 Dam: The embankment is in good condition with only minor erosion. However, the heavy growth of trees and brush on the lower downstream slope should be removed during the annual maintenance program and the dam reinspected.
- 3.2.2 <u>Appurtemant Structures</u>: The spalling of the construction joints should be repaired to prevent further erosion and deterioration.

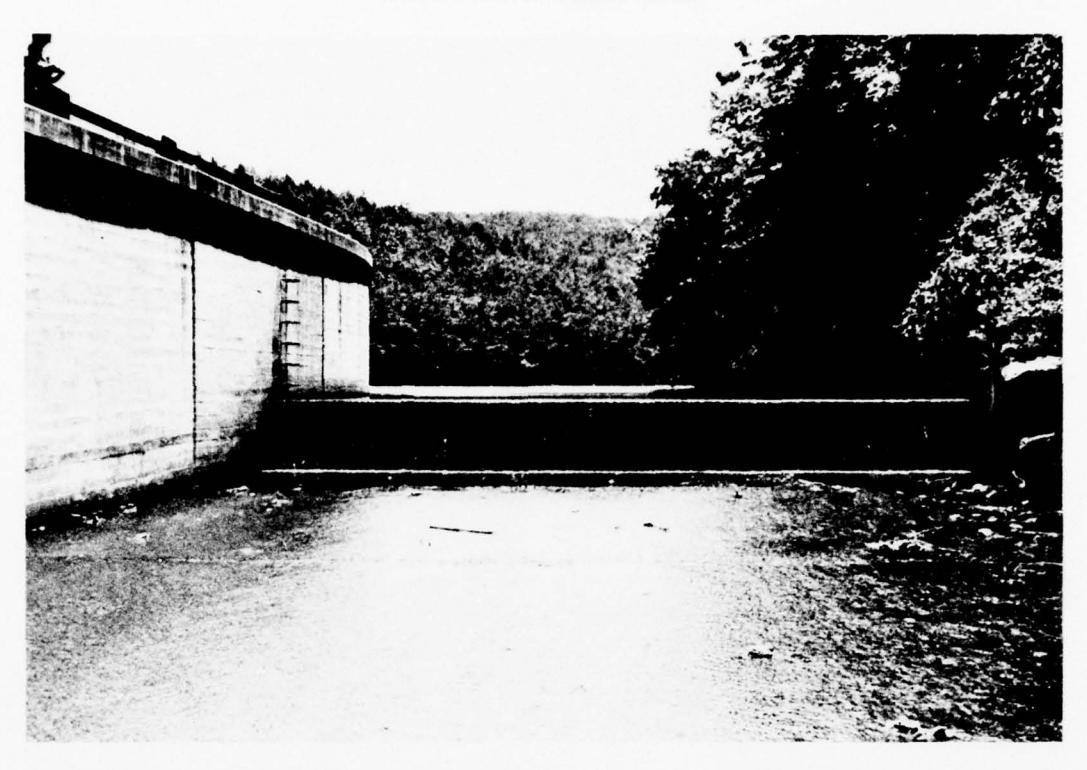
PHOTO 3. Weir in Principal Spillway With Overflow

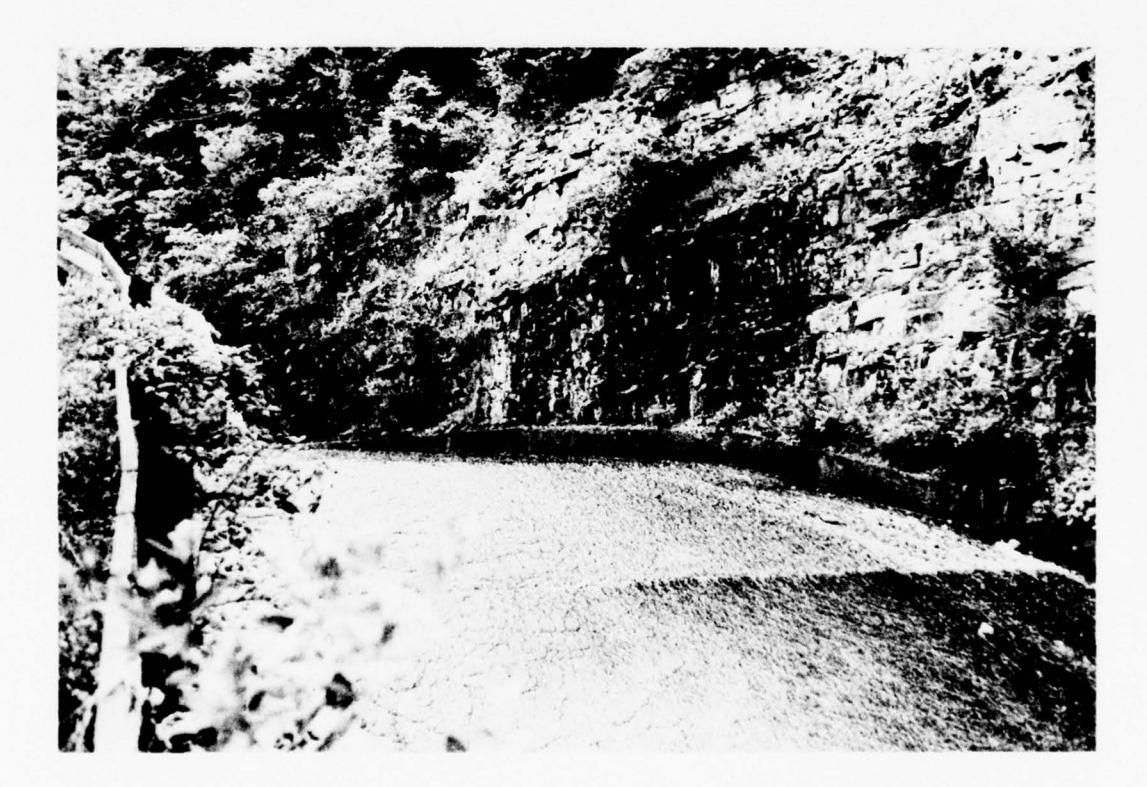
- 3.1.3 <u>Appurtemant Structures</u>: In the principalemergency spillway, the construction joints in the bottom slab of the spillway are spalled up to three inches wide and three inches deep. Clear seepage was observed in the channel downstream of the outlet pipe. The water was spouting one inch high between the stone joints. The quantity of seepage could not be measured.

PHOTO 4. Clear Seepage in Rock Cut for Spillway
## SHERANDO LAKE DAM

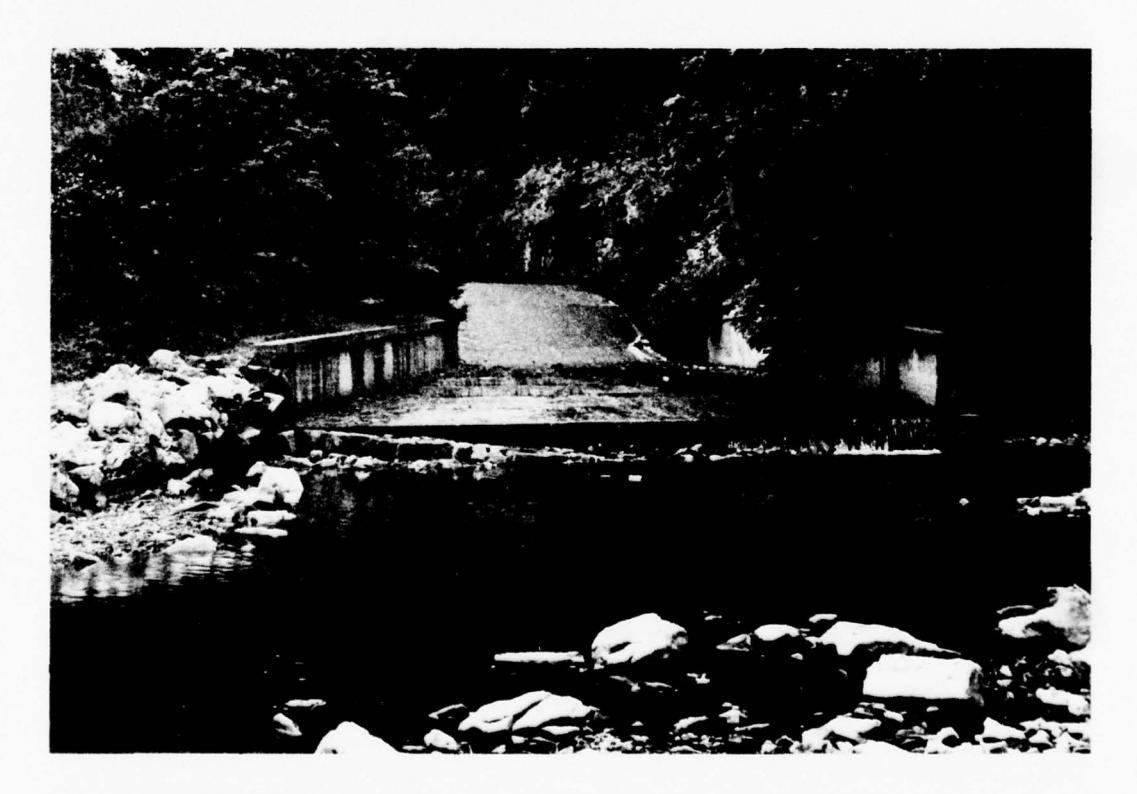
PHOTO 6. Stilling Basin at Outlet of Spillway
