PHASE I REPORT NATIONAL DAM INSPECTION PROGRAM

| Name of Dam: | LAUREL CREEK DAM |
| State & State Number: | PENNSYLVANIA - 44-62 |
| Date of Inspection: | May 12, 1978 |

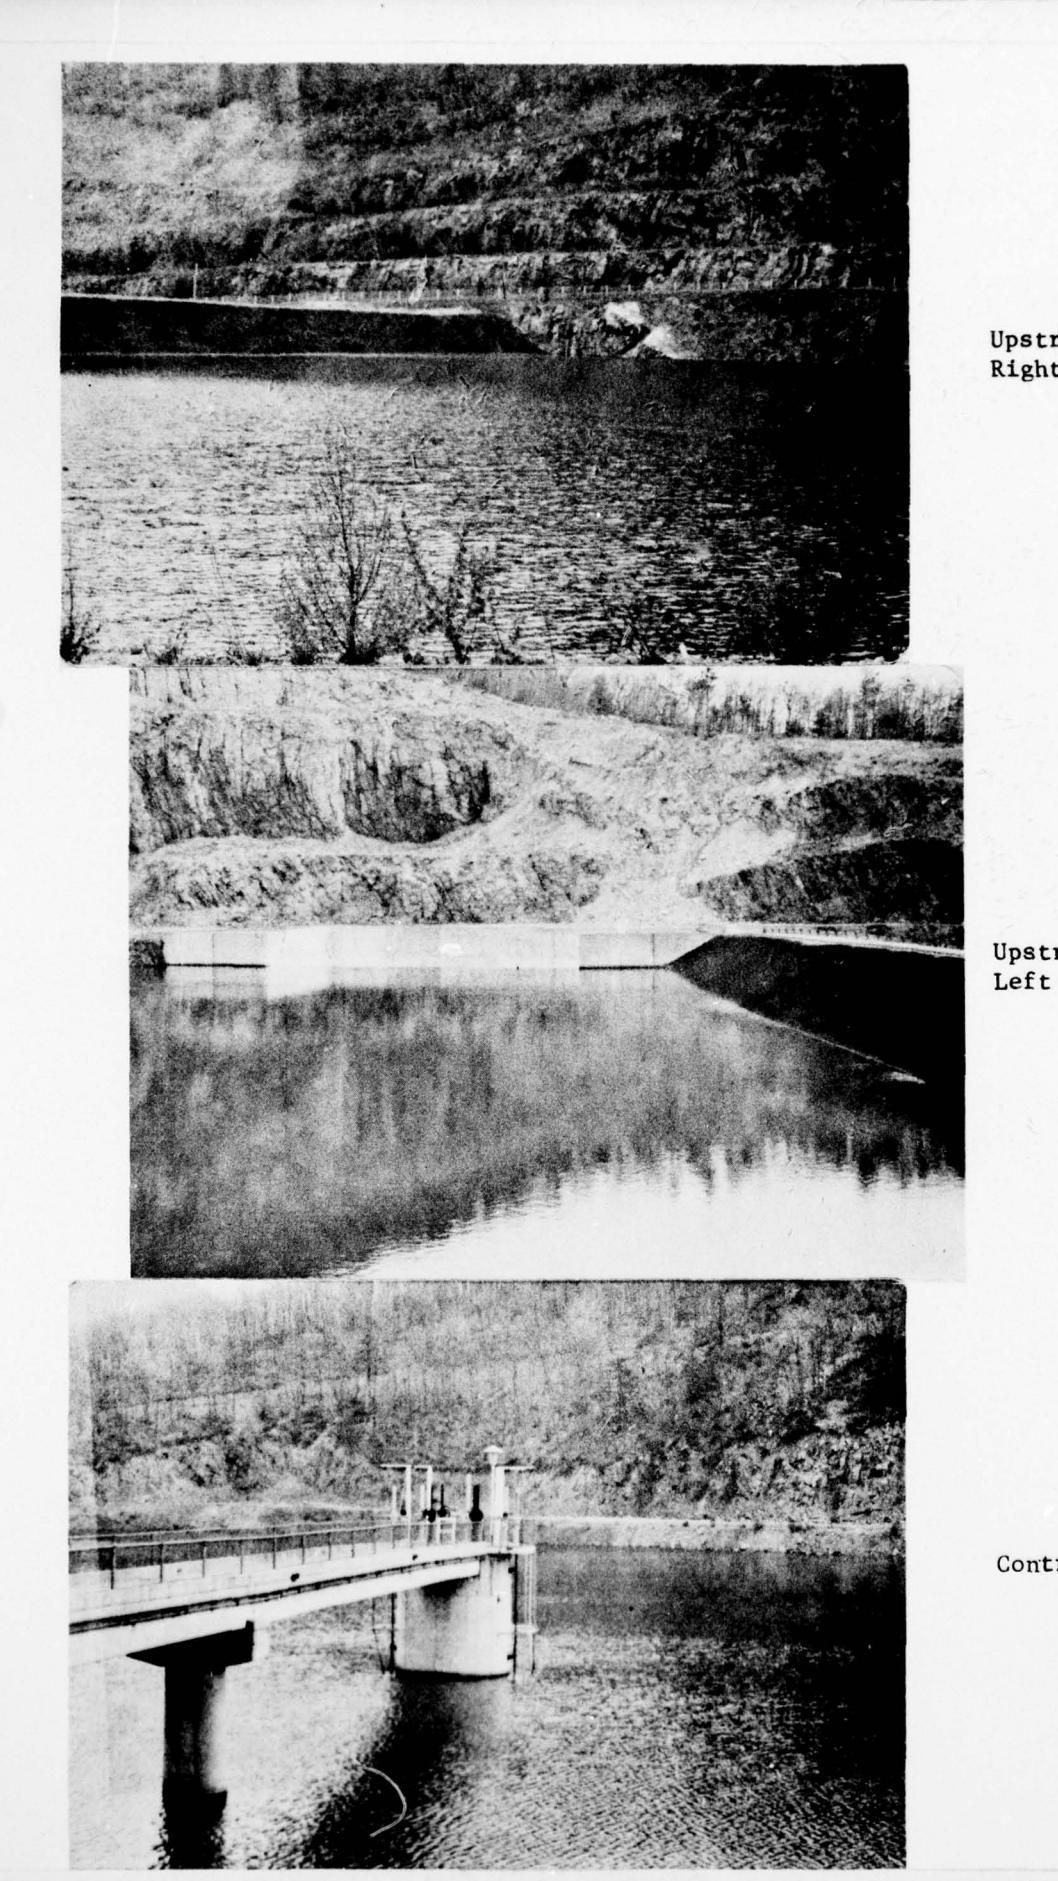
PLATE IV

Upstream Slope Right Abutment

Upstream Left Abutment

Control Tower
