AFWL-TR-77-274

# FRACTURE ANALYSIS OF REENTRY VEHICLE STRUCTURAL MATERIALS

September 1978

Final Report

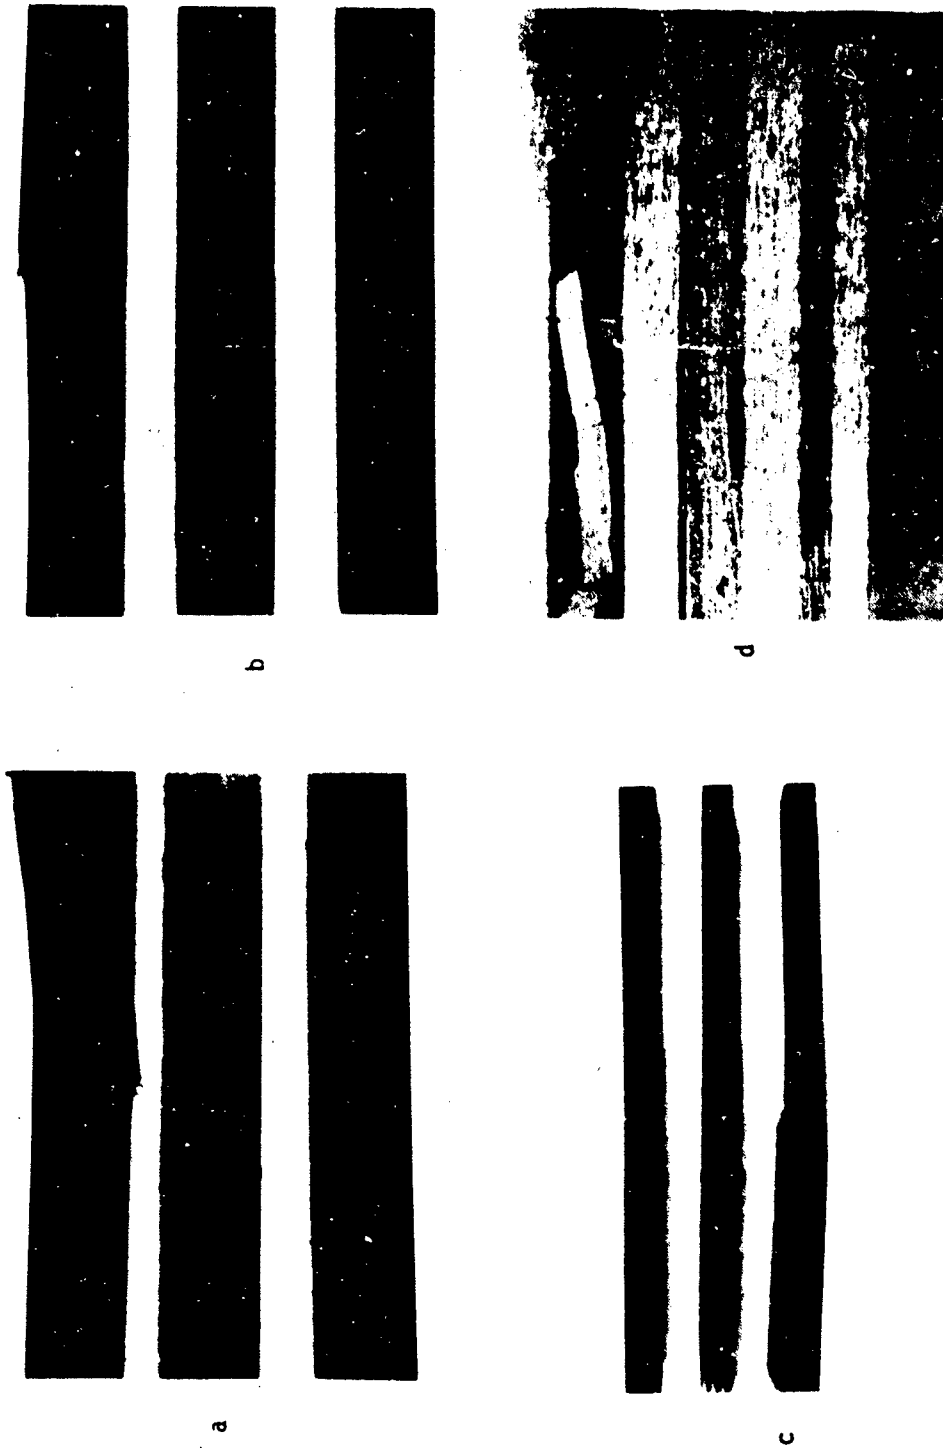
Visual examination of the specimens revealed that the "circumferential" specimens had less damage than the "axial" specimens. In the static test on the "circumferential" specimens, the outermost ply on the tensile side did not always fracture completely. As seen in figure 16, only a longitudinal split occurred on one specimen; on another, there was a transverse crack about one third of the way across the specimen, ending at a longitudinal split; and on the third "circumferential" specimen tested statically, there was a transverse crack across the specimen. All of the "circumferential" specimens tested statically had a transverse crack across the compression side of the specimen directly under where it was loaded. Two of these specimens appeared to have a fair amount of residual strength. Although the statically tested "circumferential" specimens had delamination, it was considerably less than most of the other specimens - less than all the "axial" specimens, and less than the "circumferential" specimens tested dynamically.

Figure 16. G/E Specimens After Test; Virgin Material, Static Test, "Circumferential" Orientation. (a) Tensile Side 2X. (b) Compression Side 2X. (c) Edge View 2X. (d) Edge View 20X.

parts still hung lightly together. There appears to be finer delamination in the dynamically tested specimens versus the statically tested ones - compare figure 17d with figure 16d.

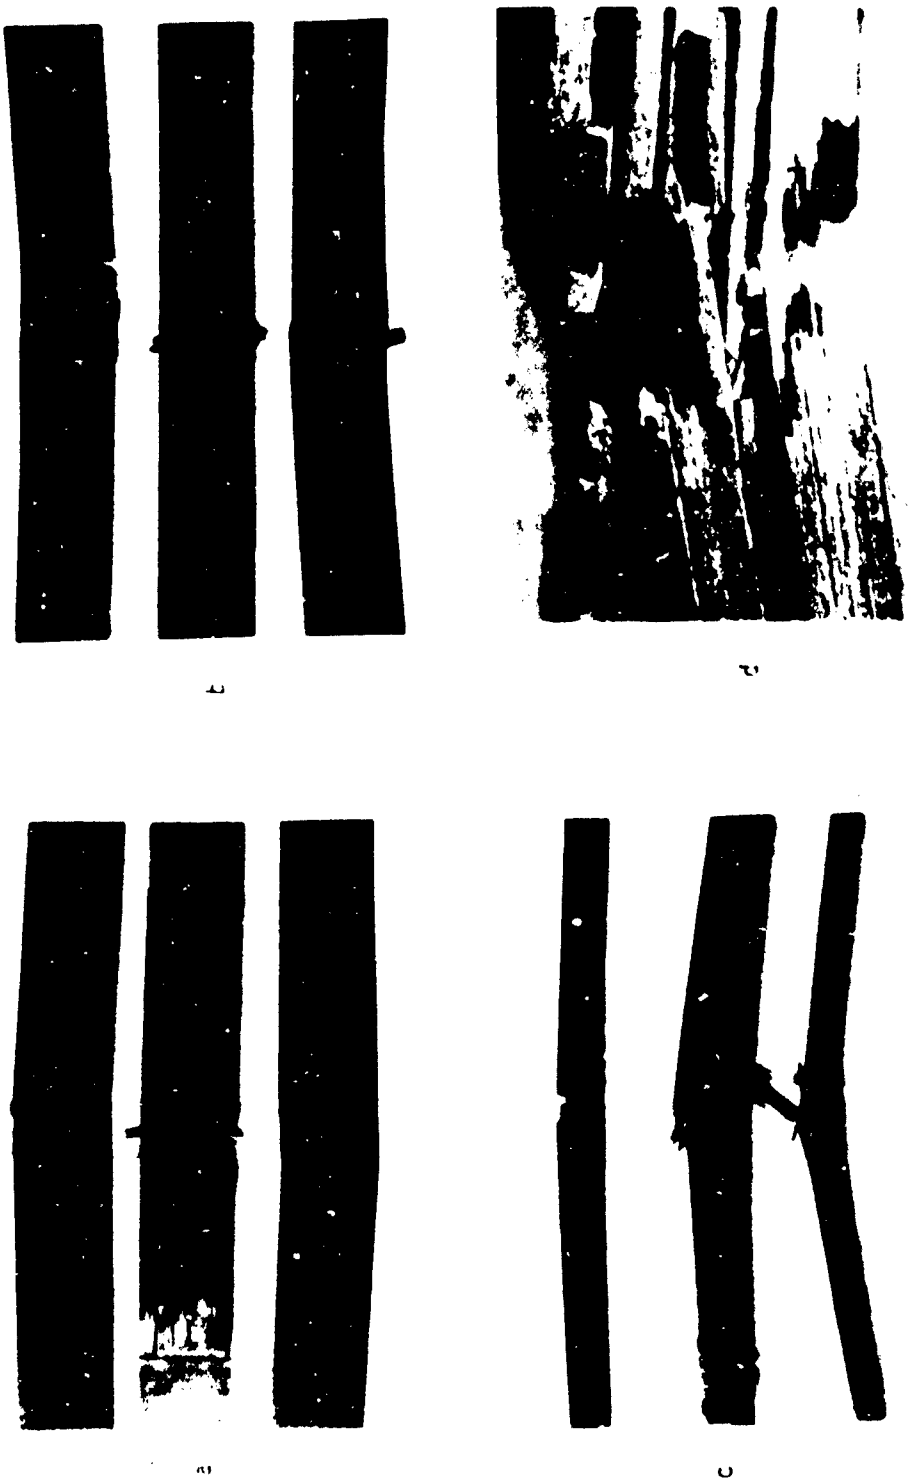
The dynamically tested "circumferential" specimens made of virgin material are shown in figure 17. In all of these specimens, the outermost fiber plies fractured and the specimens essentially broke into two parts although the two

Figure 17. G/E Specimens After Test; Virgin Material, Dynamic Test, "Circumferential" Orientation. (a) Tensile Side 2X. (b) Compression Side 2X. (c) Compression Side 20X. (d) Edge View 20X.

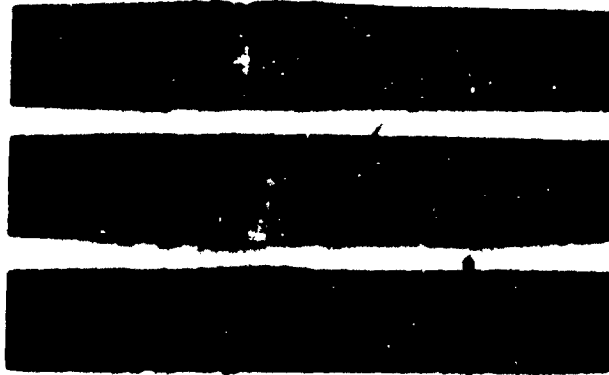
The statically tested "axial" specimens are shown in figure 18 and the dynamically tested "axial" specimens are shown in figure 19. There was not a substantial difference between the visual appearance of the statically tested and dynamically tested "axial" specimens. In all of the specimens, the outermost five plies (one layer of 90° and one layer of 0° plies) remained intact on the compression side and all of the remaining plies fractured. Again, there was a considerable amount of delamination which occurred on all specimens.

Figure 18. G/E Specimens After Test; Virgin Material, Static Test, "Axial" Orientation. (a) Tensile Side 2X. (b) Edge View 2X.

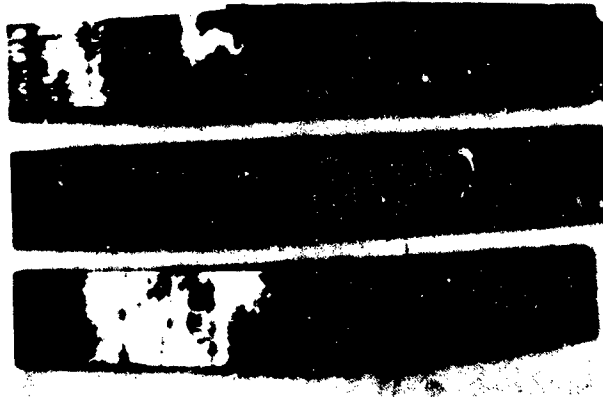
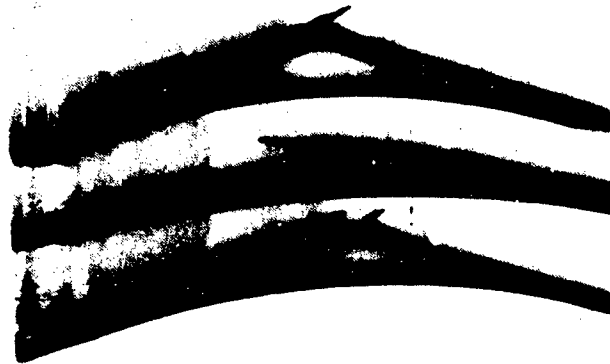
Figure 19. G/E Specimens After Test; Virgin Material, Dynamic Test, "Axial" Orientation. (a) Tensile Side 2X. (b) Edge View 2X.

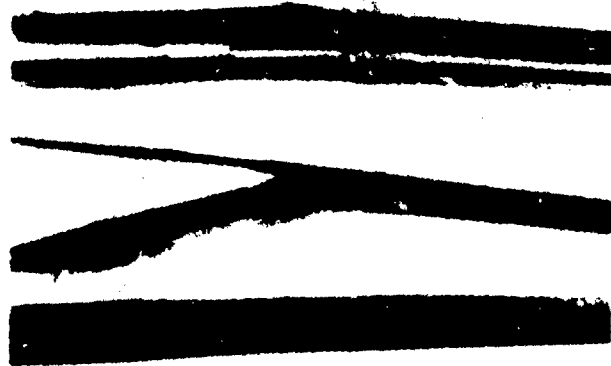
Samples which had been degraded by mechanical impact prior to test are shown in figures 20, 21, 22, and 23 after they had been tested. There appeared to be virtually no difference between the degraded specimens and the specimens made of virgin material. As in the virgin material, the specimens in the "circumferential" orientation broke with finer delaminations when tested dynamically than when tested statically - see figures 20b and 21b. There did not appear to be significant difference between the two test conditions in the "axial" specimens.

Figure 20. G/E Specimens After Test; Degraded Material, Static Test, "Circumferential" Orientation. (a) Edge View 2X. (b) Edge View 10X.

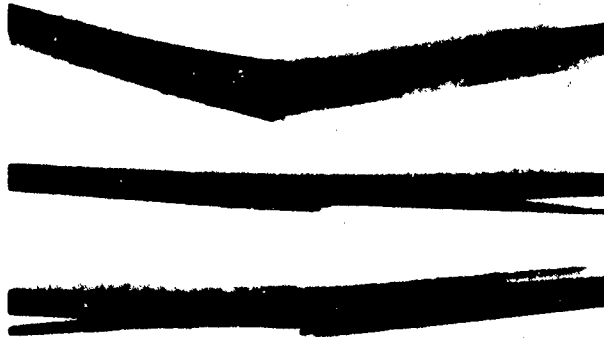
Figure 21. G/E Specimens After Test; Degraded Material, Dynamic Test, "Circumferential" Orientation. (a) Edge View 2X. (b) Edge View 10X.

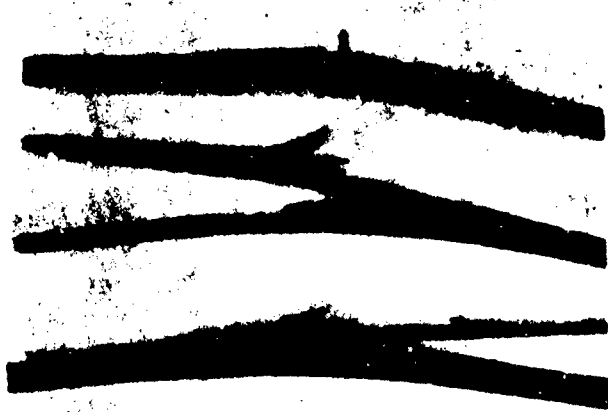
Figure 22. G/E Specimens After Test; Degraded Material, Static Test, "Axial" Orientation. 2X.

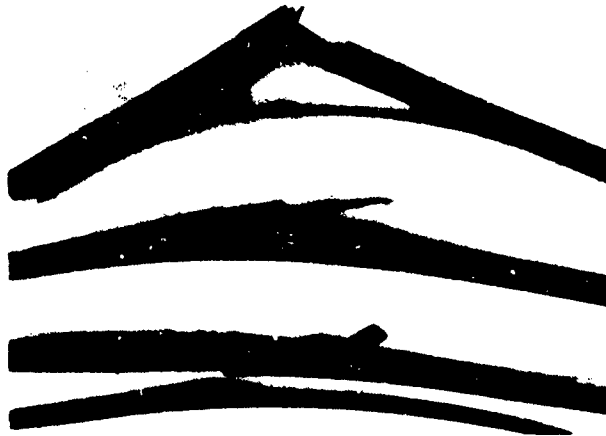
Figure 23. G/E Specimens After Test; Degraded Material, Dynamic Test, "Axial" Orientation. 2X.

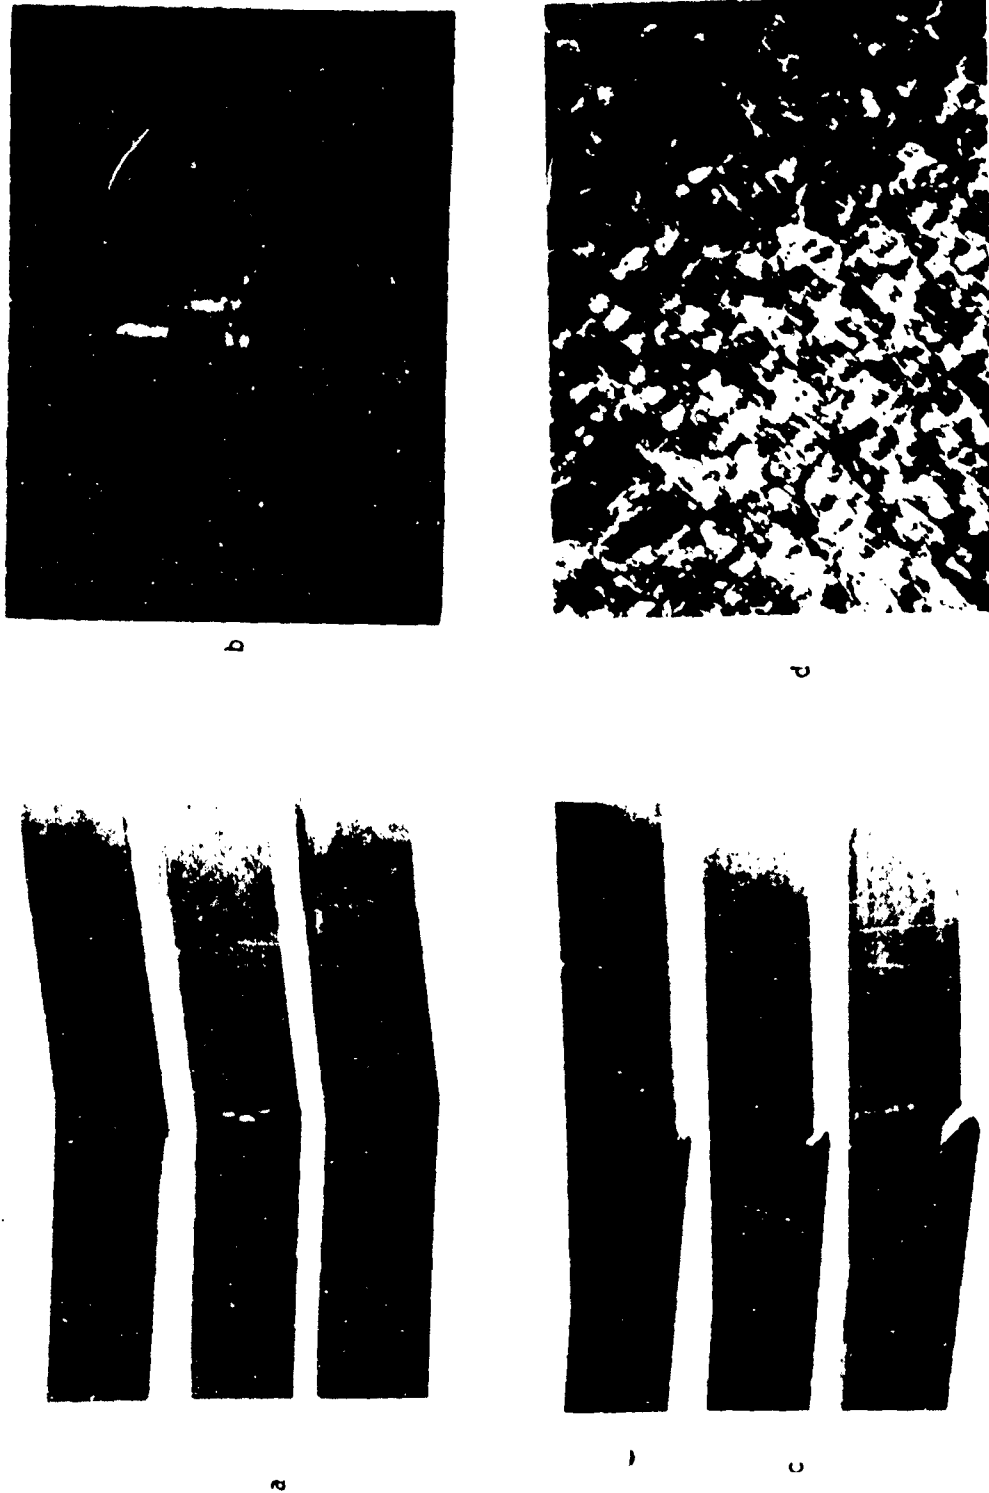
Photographs of the fractured TWCP specimens are shown in figures 29, 30, 31, and 32. As can be seen by comparing figure 29 with figure 30 or comparing figure 31 with figure 32, there is no apparent macroscopic difference between the statically tested and dynamically tested specimens. However, if one compares figure 29c with figure 31c or figure 30c with figure 32c, it can be seen that the fracture path followed a slightly different angle in the degraded material than in the virgin material. The angle (to the axis of the specimen) of the fracture path of the virgin material was 29 to 30° whereas the angle in the degraded material was 23° to 24°.

Figure 29. TwCP Specimens After Test; Virgin Material, Static Test. (a) Edge View of "Circumferential" Orientation Specimens 2X. (b) Closeup of (a) 8X. (c) Edge View of "Axial" Orientation Specimen 2X. (d) Fracture Surface of "Axial" Specimen 8X.

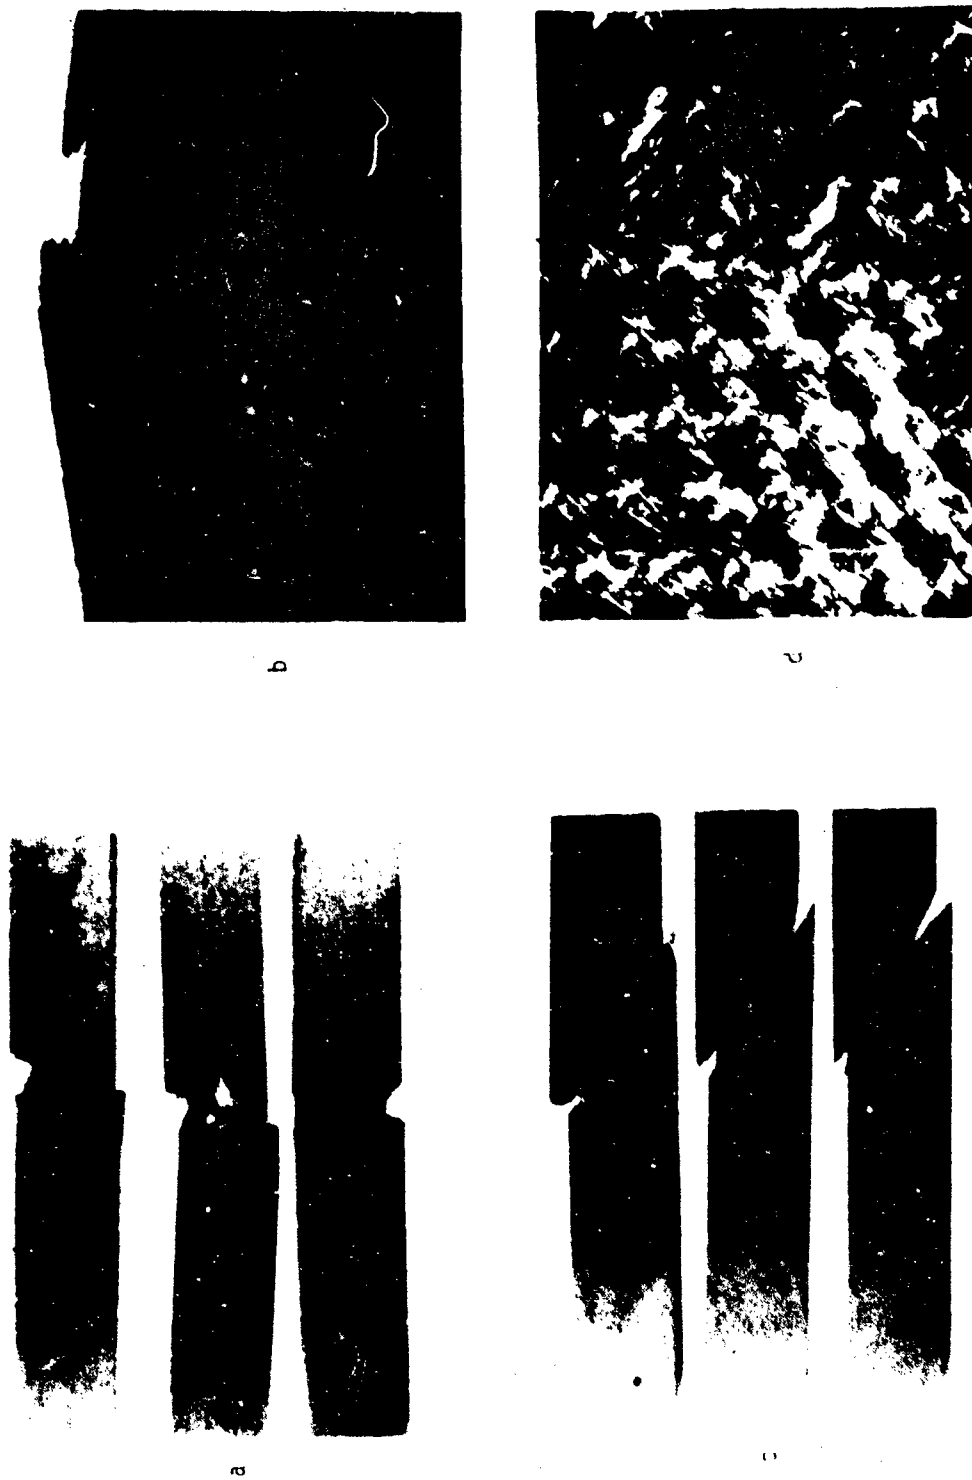
Figure 30. TWC Specimens After Test; Virgin Material, Dynamic Test. (a) Edge View of "Circumferential" Orientation Specimens 2X. (b) Closeup of (a) 8X. (c) Edge View of "Axial" Orientation Specimen 2X. (d) Fracture Surface of "Axial" Specimen 8X.

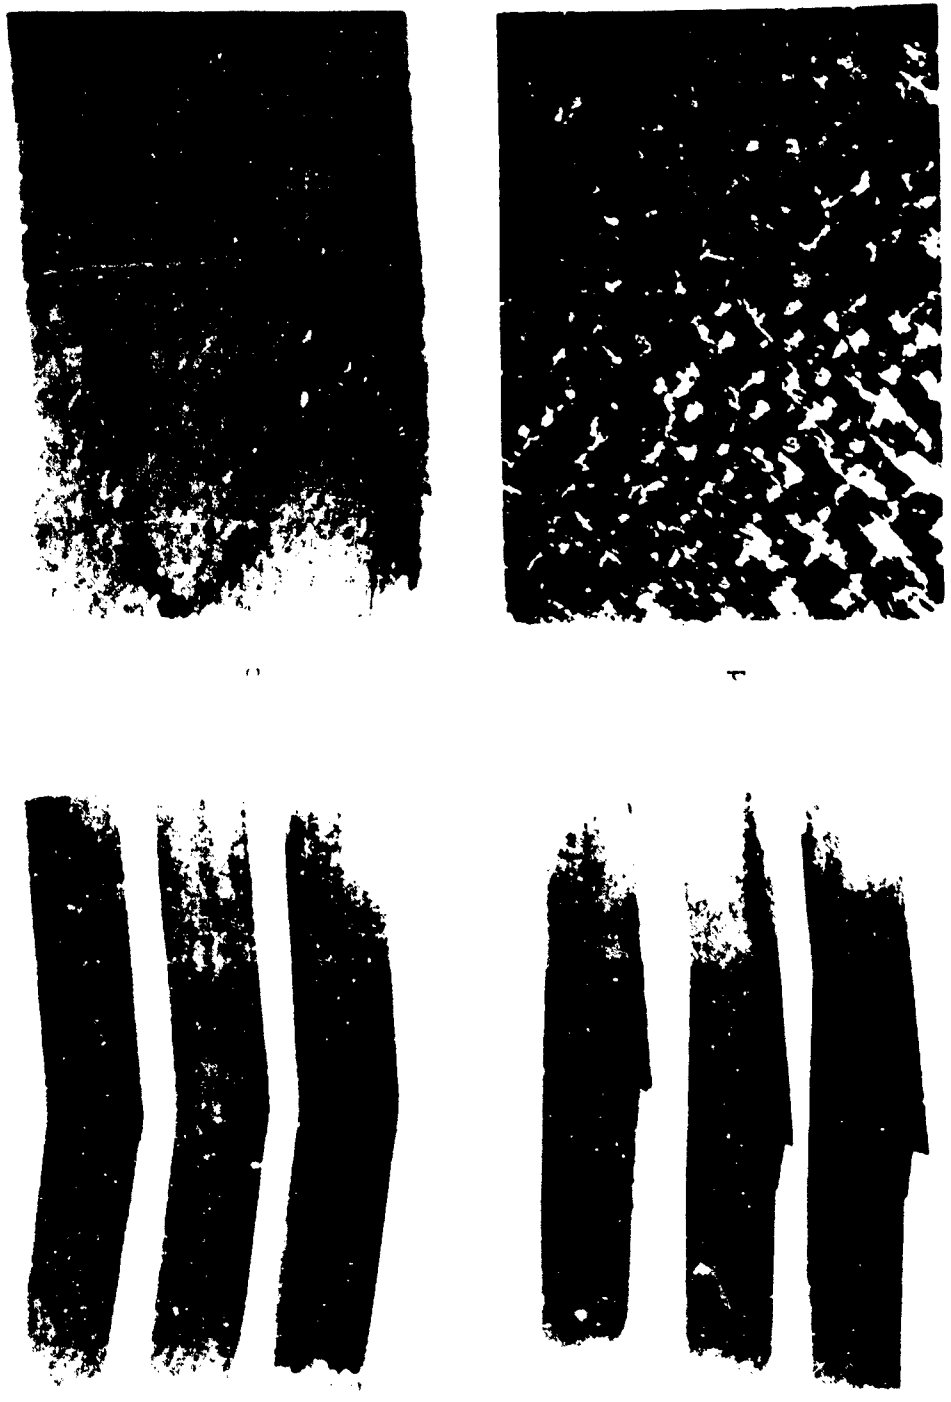
This difference in fracture angle between the virgin material is probably due to the presence of microcracks in the degraded material. Pre-test examination of the degraded material revealed microcracks in a majority of the specimens and it is felt that had the specimens been polished more and/or examined at higher magnification, microcracks would have been observed in all of the specimens. This material was laid up at a 20° angle of the plies to the axis and the interlaminar strength is the weakest. Thus, the angle of weakest material is 20°, but the angle of maximum stress in a three point bend test is 90° to the axis. Thus, the actual fracture path occurs somewhere between these two extremes and apparently resolved itself to approximately 30° for the virgin material. In the degraded material, on the other hand, microcracks formed on the interlaminar planes as a result of the one-dimensional shock loading from the simulated X-ray exposure. These microcracks made the already weakest plane

Figure 31. TWCP Specimens After Test; Degraded Material, Static Test. (a) Edge View of "Circumferential" Orientation Specimens 2X. (b) Closeup of (a) 8X. (c) Edge View of "Axial" Orientation Specimen 2X. (d) Fracture Surface of "Axial" Specimen 8X.

still weaker. Thus, the fracture path would be expected to follow a path closer to the layup than it did in the virgin material. This agrees with the observed value of  $23^\circ$  to  $24^\circ$  for the degraded compared with  $29^\circ$  to  $30^\circ$  for the virgin material.

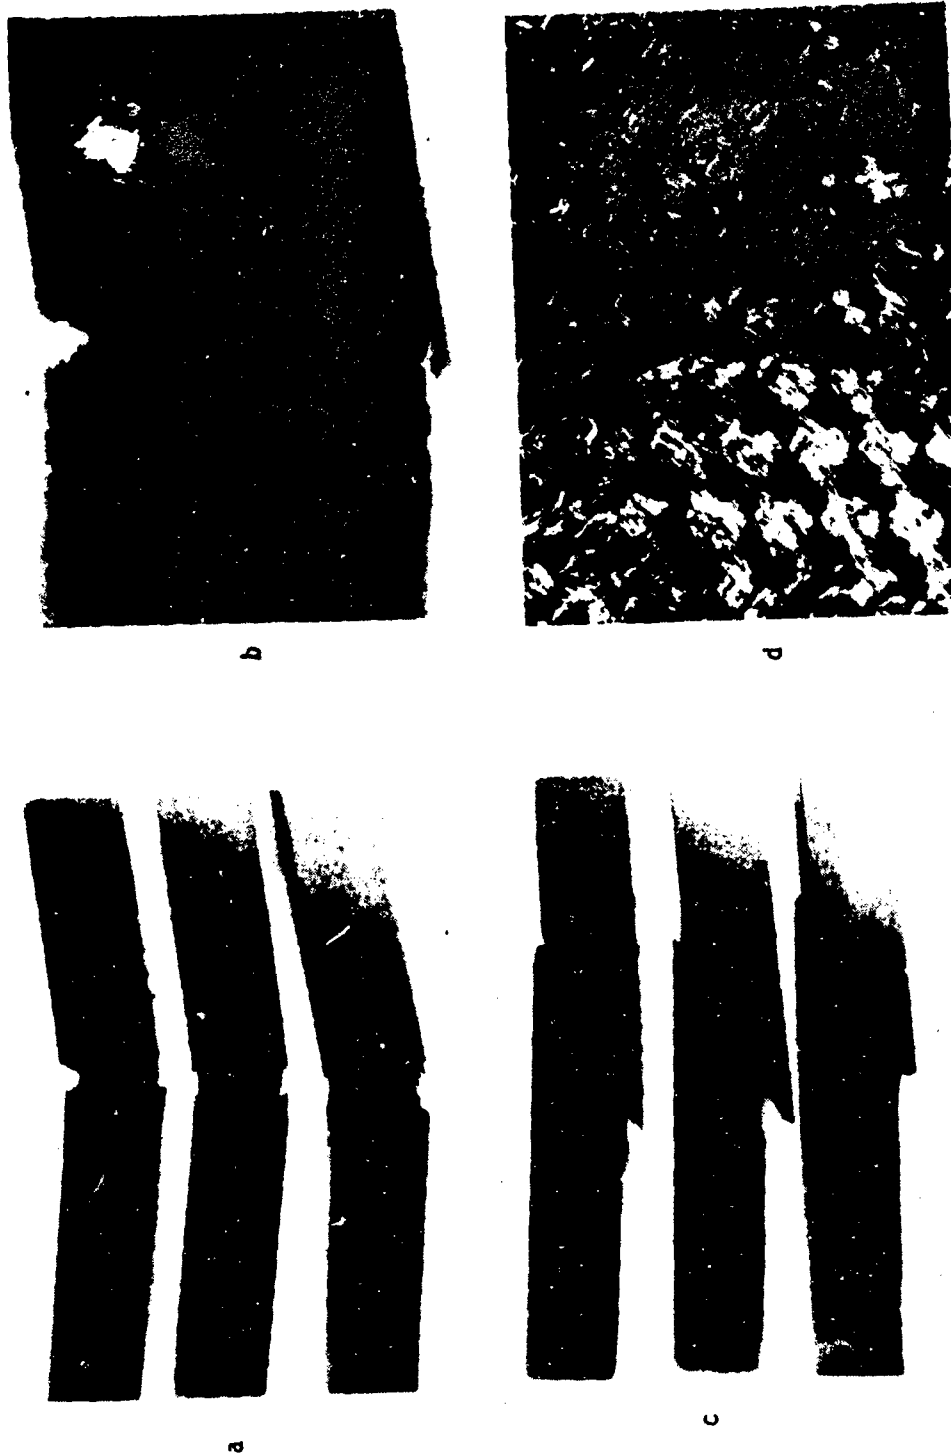
Figure 32. TWCP Specimens After Test; Degraded Material, Dynamic Test. (a) Edge View of "Circumferential" Orientation Specimens 2X. (b) Closeup of (a) 8X. (c) Edge View of "Axial" Orientation Specimen 2X. (d) Fracture Surface of "Axial" Specimen 8X.
