REPORT DOCUMENTATION PAGE		
REPORT NUMBER 2. GOVT ACCESSION NO		BEFORE COMPLETING FORM D. 3. RECIPIENT'S CATALOG NUMBER	
100057			
TITLE (and Subtitie)		5. TYPE OF REPORT & PERIOD COVERED	
Phase I Inspection Report National Dam Safety Program Manahawkin Lake Dam Ocean County, N.J. AUTHOR(a) Richard J. McDermott, P.E.		FTNAL

MANAHAWKIN LAKE DAM (NJ00057)

PHASE I REPORT NATIONAL DAM SAFETY PROGRAM

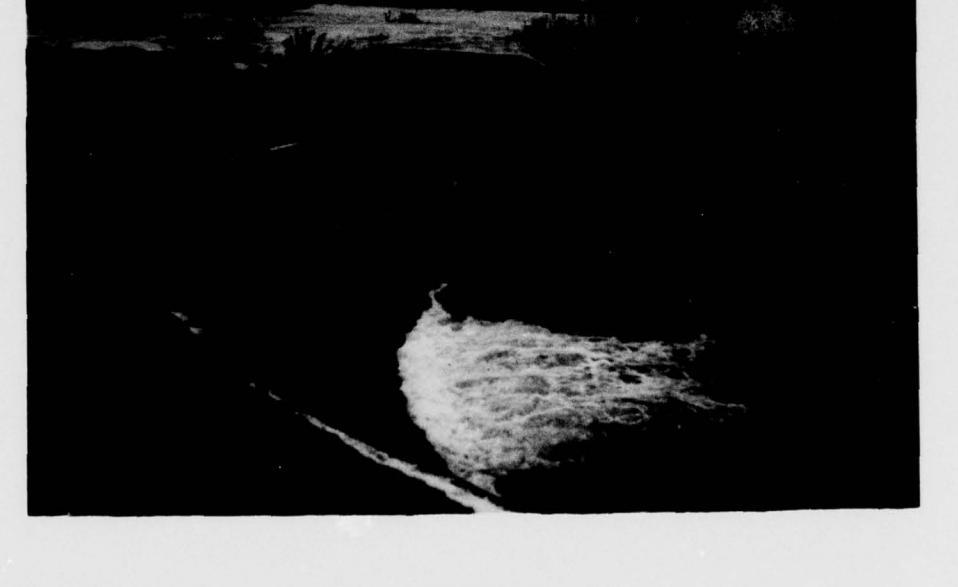
PHOTO 1 SPILLWAY

The concrete spillway appears to be structurally sound, although its surface appears to be slightly eroded. The spillway surface should be protected and any cracks and spalls not visible at the time of inspection should be repaired in the near future by sand blasting, grouting where needed and coating with epoxy.

REMARKS OR RECOMMENDATIONS Aligned true to plans. Surface of weir and downstream face eroded; aggregate some-what exposed. No cracks or spalls observed. 1 Refer to downstream channel OBSERVATIONS · UNCATED SPILLWAY N. A. N.A.. VISUAL EXAMINATION OF DISCHARCE CHANNEL BRIDCE AND PIERS APPROACH CHANNEL CONCRETE WEIR

- The concrete spillway should be thoroughly inspected and repaired as outlined below:
 - a. Drain the lake to an elevation equal to the invert of the outlet pipe.
 - b. Sand blast all concrete, pressure grout any major cracks and patch all spalls and eroded surfaces.
 - Apply an epoxy preservative coating to all surfaces.

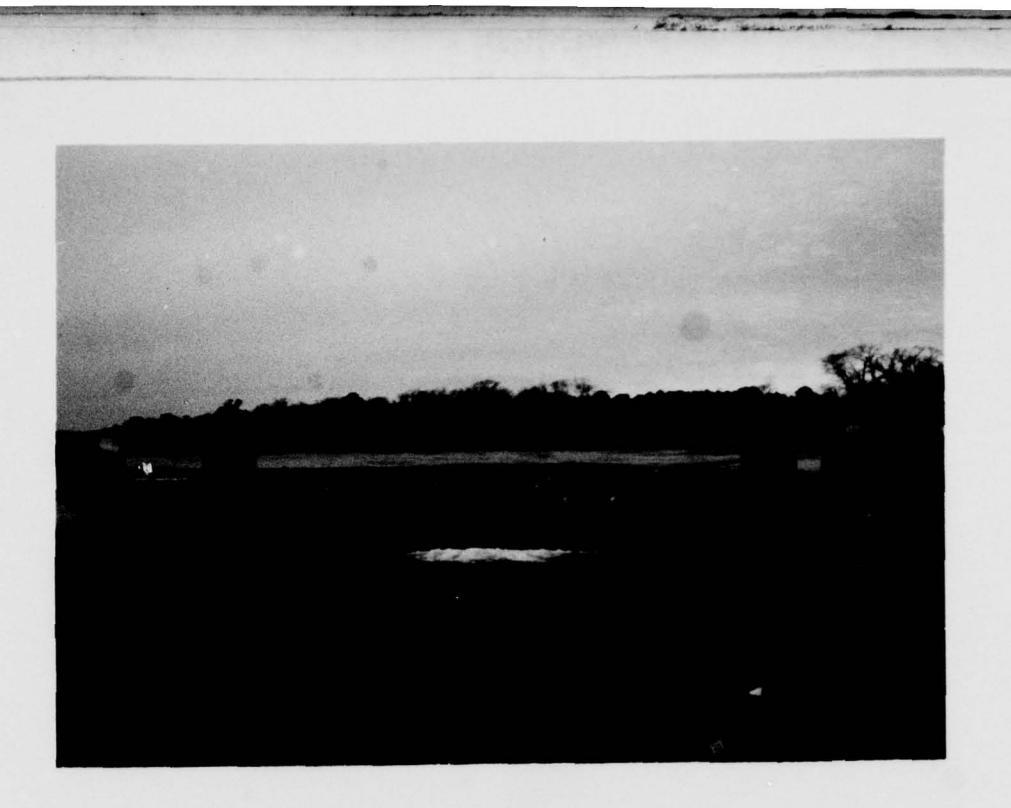
РНОТО 2

CONCRETE MANHOLE FOR SLIDE GATE. OUTLET PIPE IN SPILLWAY DOWNSTREAM FACE.
