# DELTA DAM

ONEIDA COUNTY, NEW YORK INVENTORY NUMBER NY 6

# PHASE 1 INSPECTION REPORT NATIONAL DAM SAFETY PROGRAM

BERT KIMBALL and ASSOCIATES W. Highland Ave. Ebensburg, Pa.

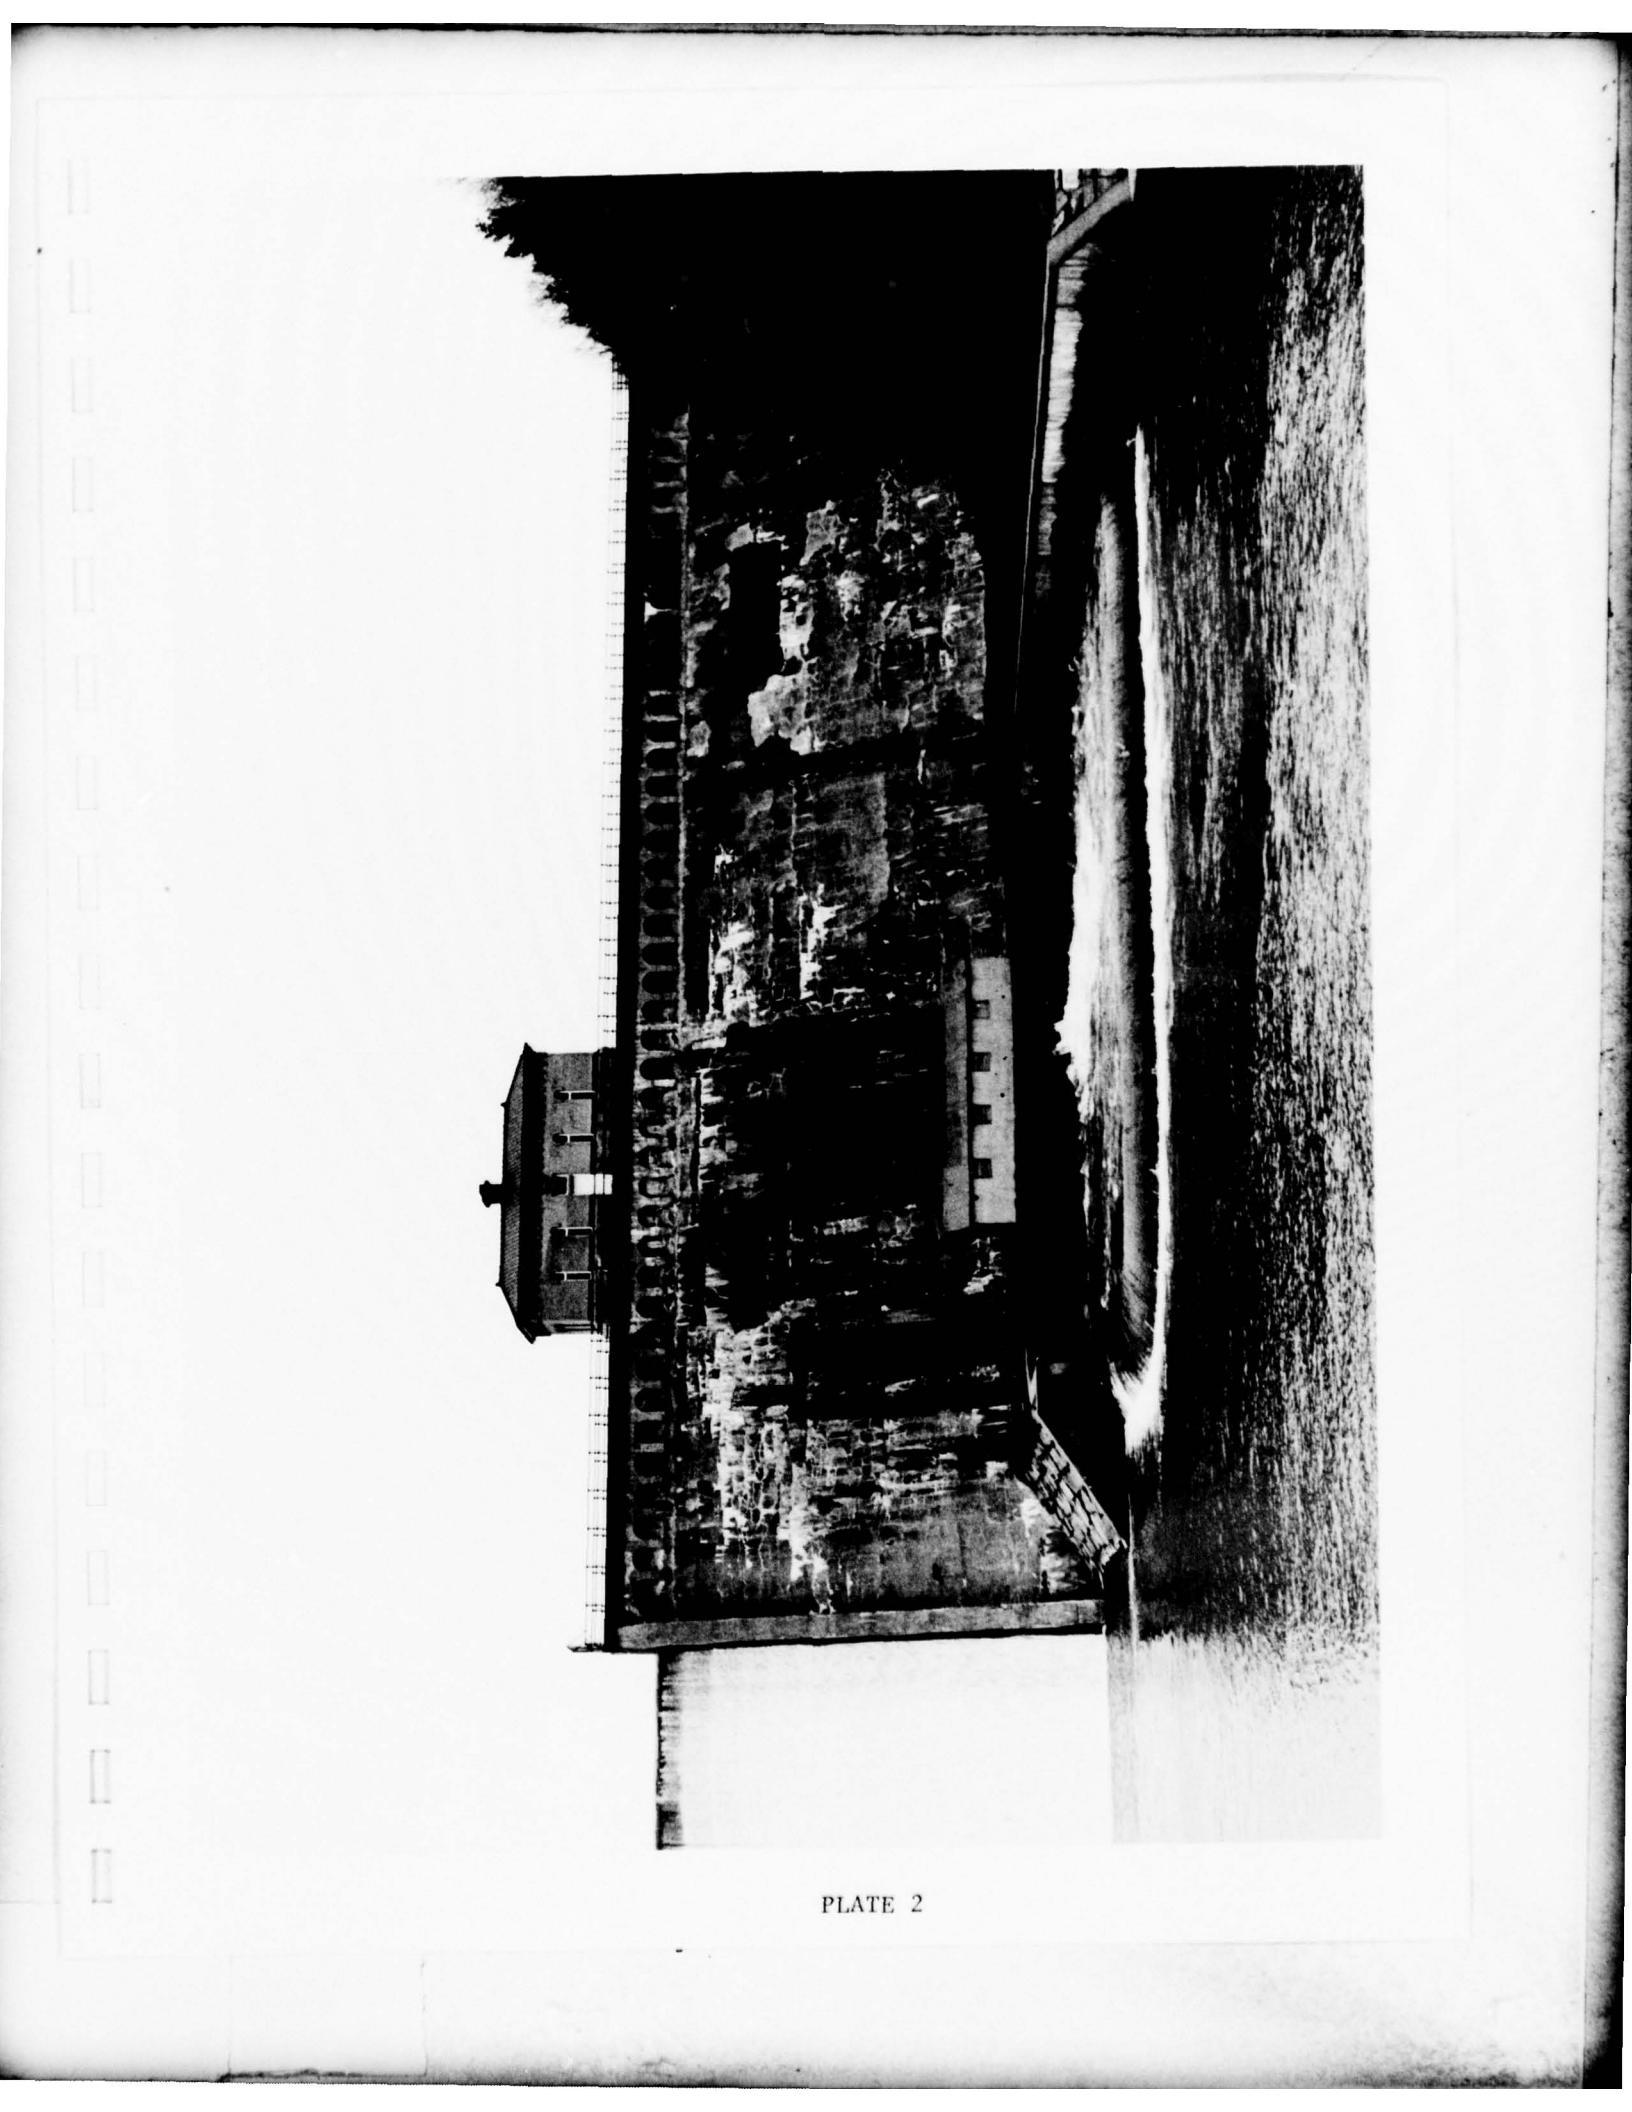
- Left abutment portion of dam from downstream. <u>Note</u>: Deterioration of gunite facing, seepage. <u>Visible</u>: Old gate house at toe, stilling pools for principal and emergency spillway.

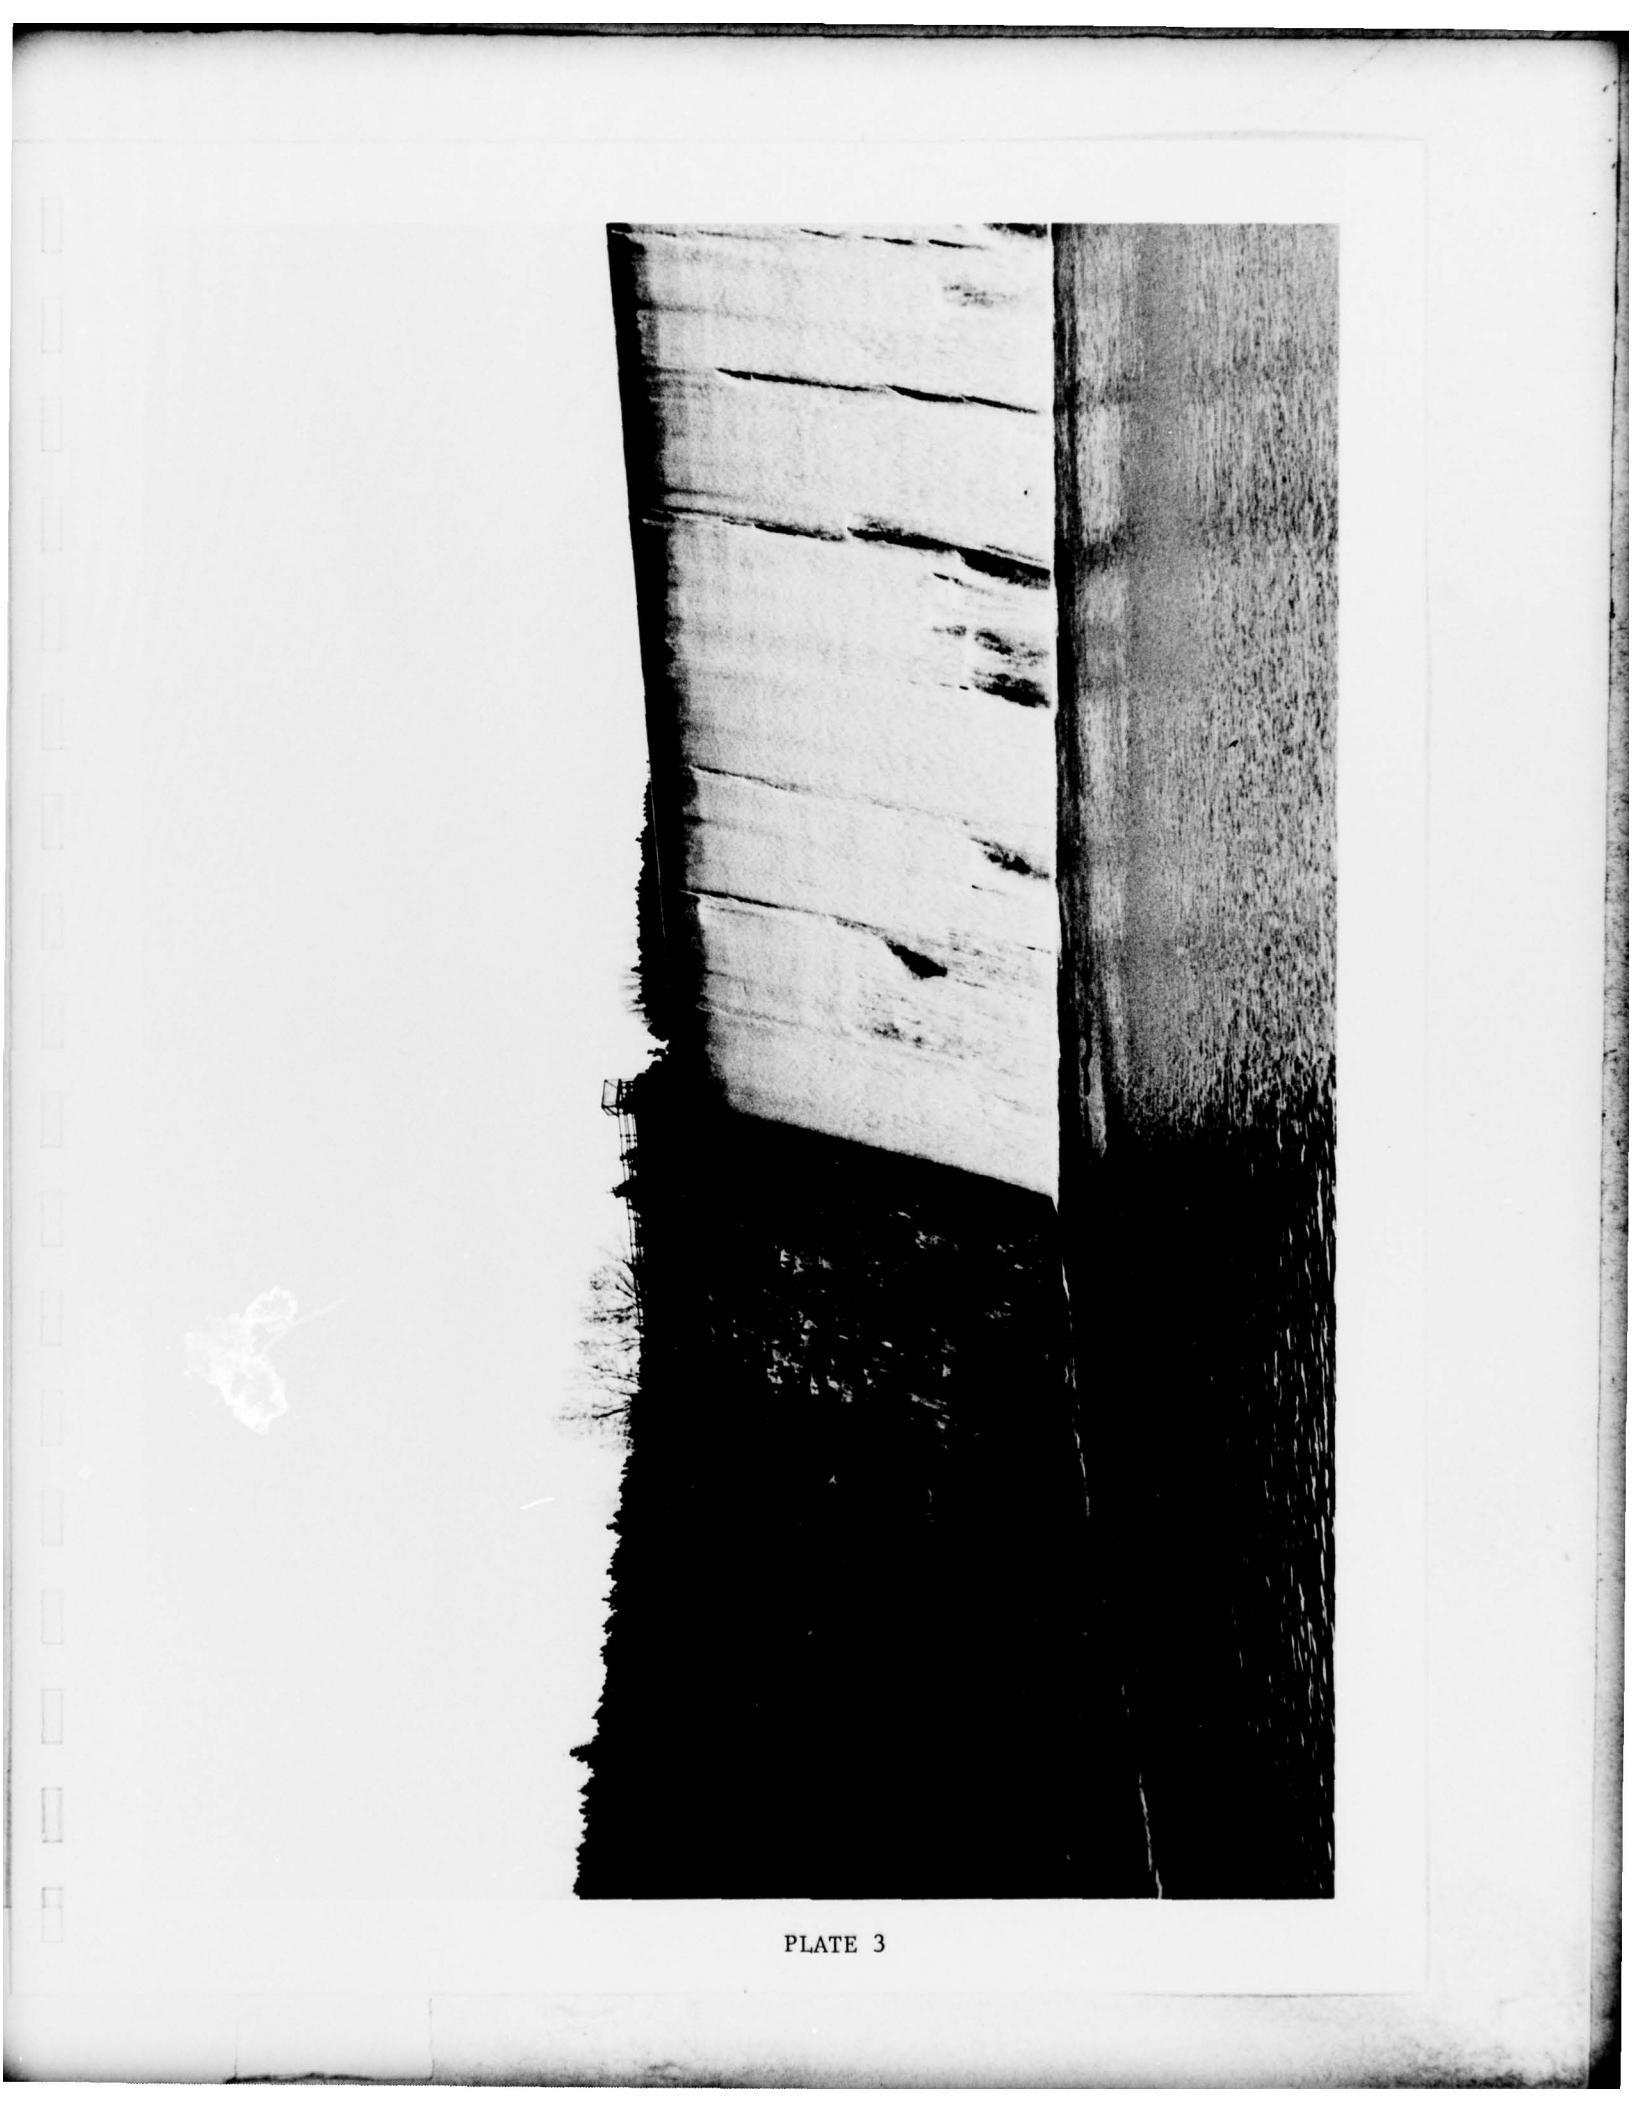
- 3. Right portion of dam from downstream. <u>Note</u>: Deterioration of gunite facing, sprays in spillway apparently caused by deterioration in concrete. Visible: Stilling pool, rip rap protection.

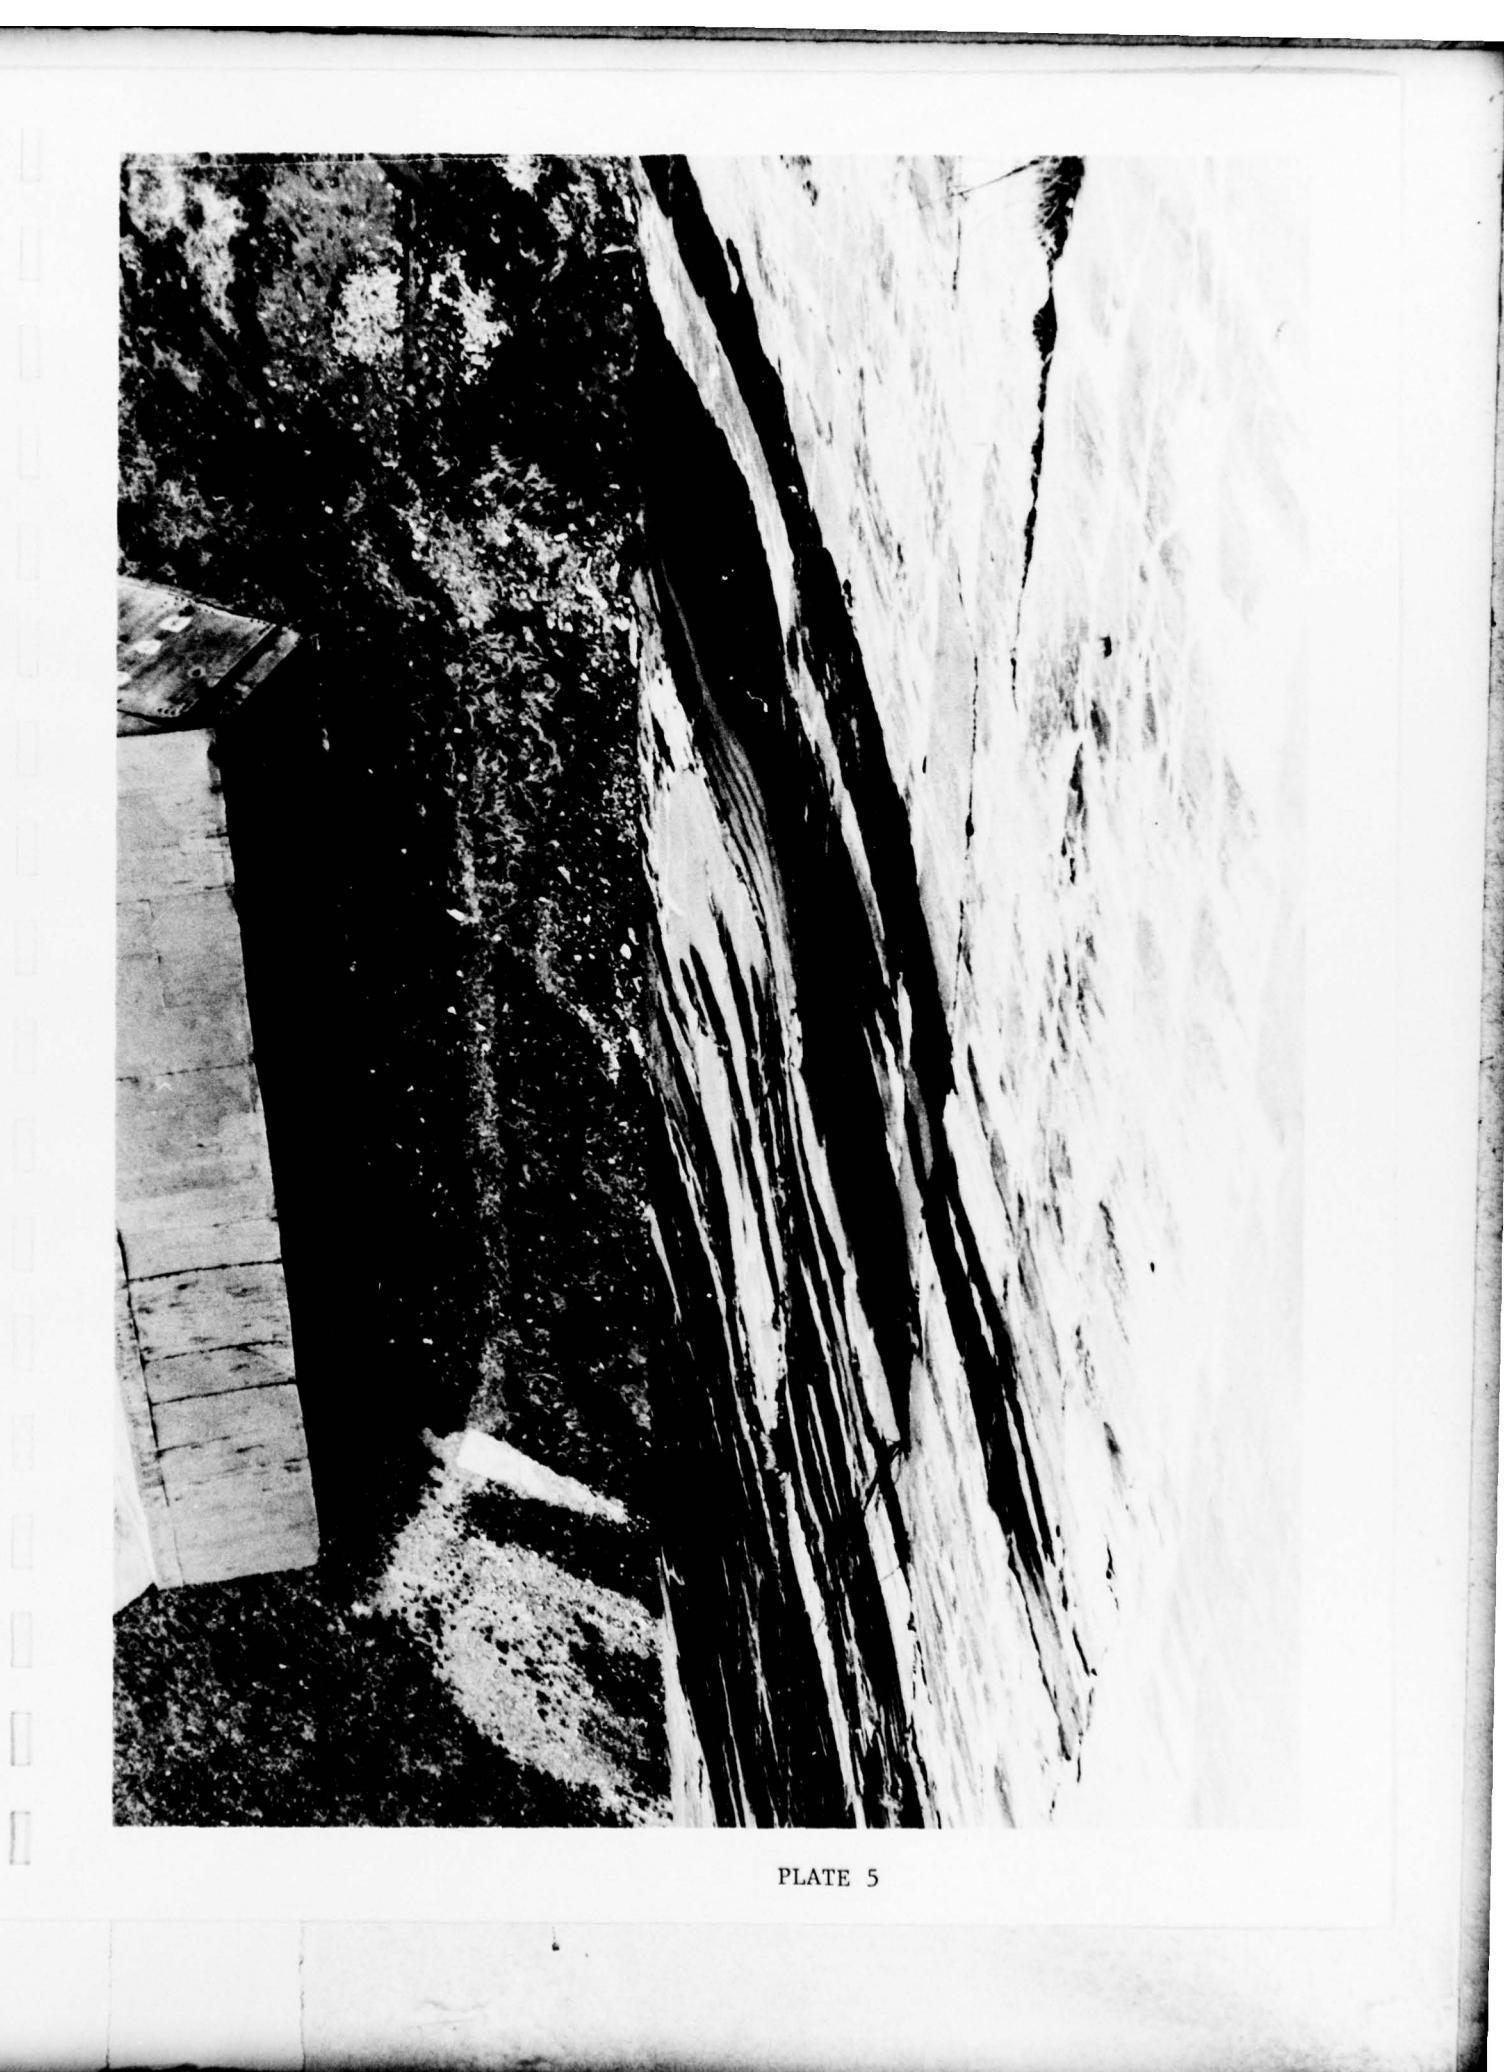
- Close up of deterioration of gunite facing on downstream face of left abutment of dam.
- 9. Upstream face and gate house from left abutment.
- Upstream face from gate house. Note: Erosion of concrete on upstream face at water line.
