NSWC/DL-TR-3904

4. TITLE (and Subtitle) FABRICATION AND ASSEMBLY OF A SHIPBOARD MULTI-FUNCTIONAL WASTE INCINERATOR (MFI). PHASE II	5. TYPE OF REPORT & PERIOD COVERED Final rept.	6. PERFORMING ORG. REPORT NUMBER

11. CONTROLLING OFFICE NAME AND ADDRESS Naval Sea Systems Command Washington, DC 20362	12. REPORT DATE April 1979	13. NUMBER OF PAGES 53
14. MONITORING AGENCY NAME & ADDRESS (if different from Controlling Office) 1252p.	15. SECURITY CLASS. (of this report) UNCLASSIFIED	15a. DECLASSIFICATION/DOWNGRADING SCHEDULE

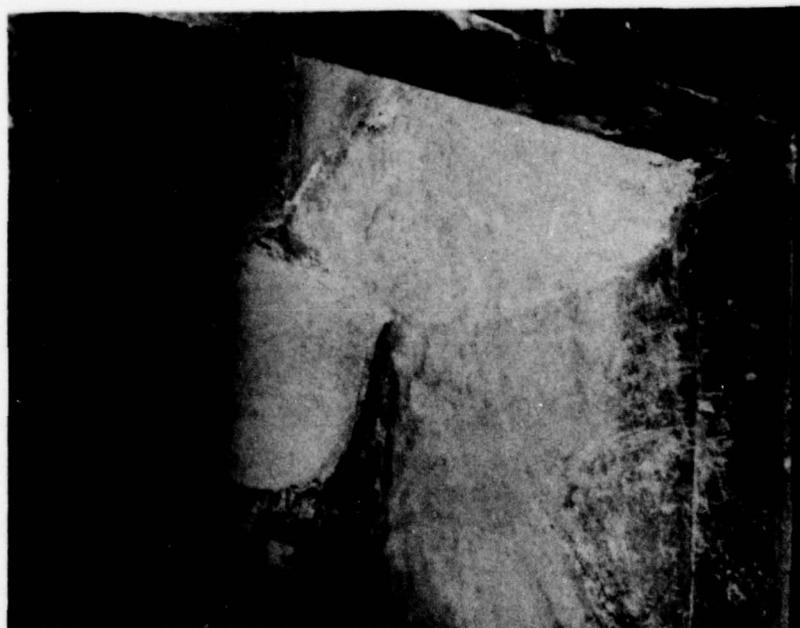
Figure 13. Dressing of Refractory Edge at Afterburner Section Outlet

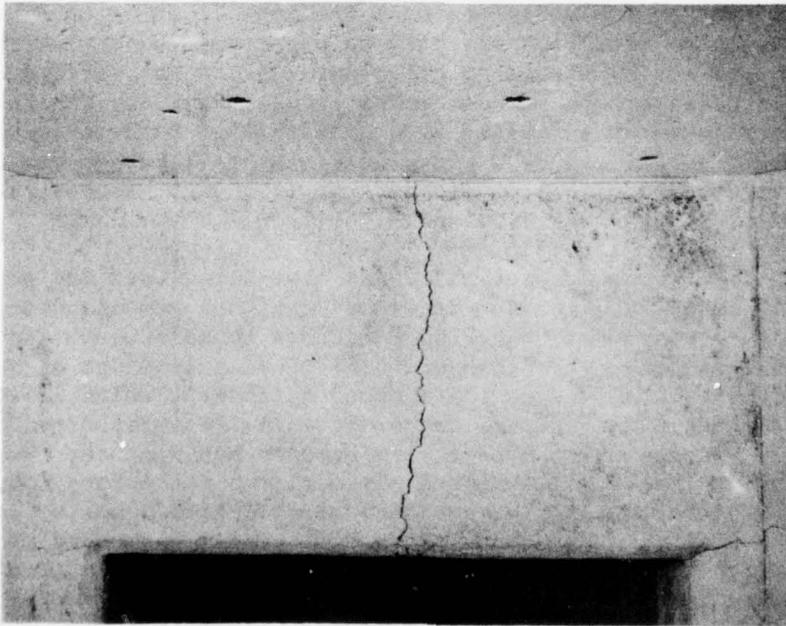
Figure 28. Cracking in Front Wall of Firebox After Curing

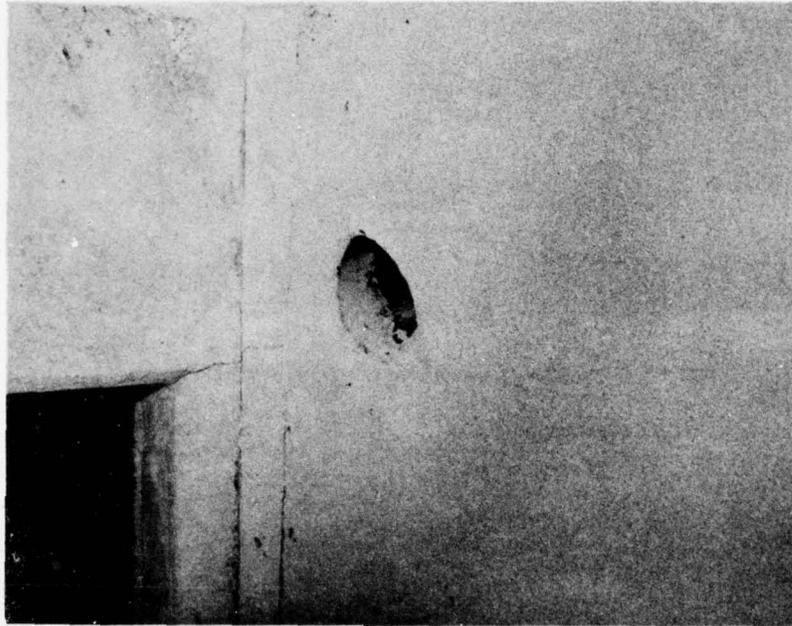
Upon completion of the 88-hr cure period, photodocumentation was again made of the incinerator interior. Figures 29 through 36 show the cracking of the refractory. Several cracks not exceeding 1/16-in. in width were observed primarily above the feed door and in the sewage chamber roof panel. Very minute hairline cracking was observed in the two extra tops (Figures 37 and 38). Figure 37 shows the top cast using NAVSEC Philadelphia design sliding anchors; and Figure 38 shows the top (identical with the top construction on the incinerator) cast with the standard A. P. Green SS anchors.

Figure 29. Left Interior Wall of Firebox After Curing

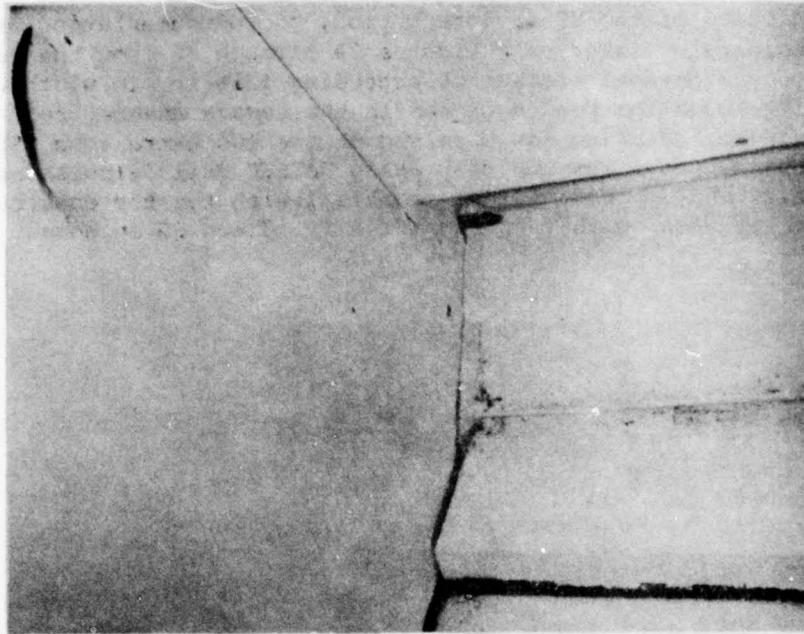
Figure 30. Ash Drawer Assembly After Curing

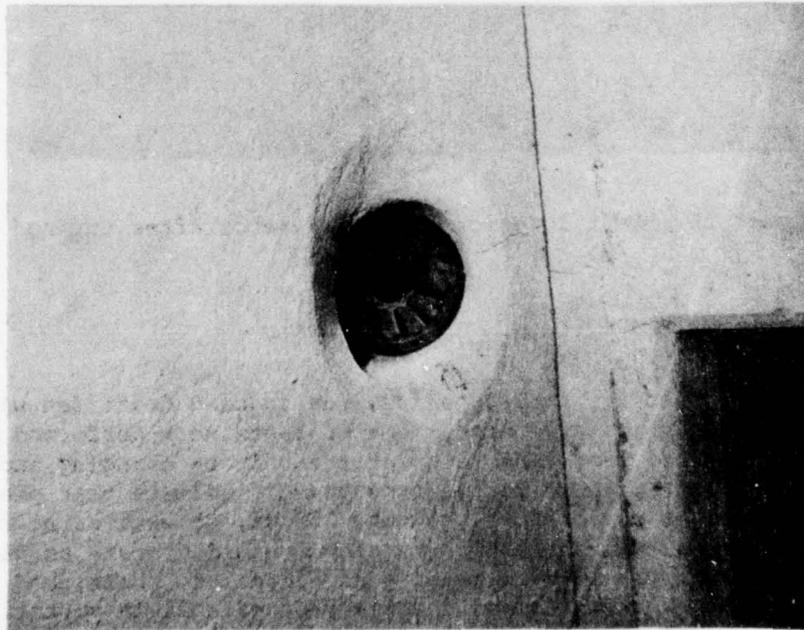
Figure 31. Right (Burner Side) Interior Wall of Firebox After Curing

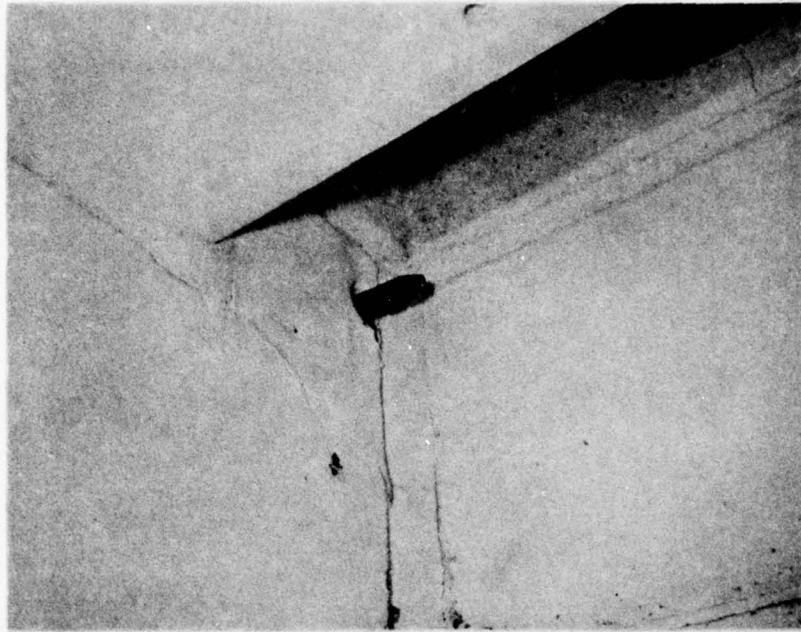
Figure 32. Entrance to Sewage Chamber After Curing

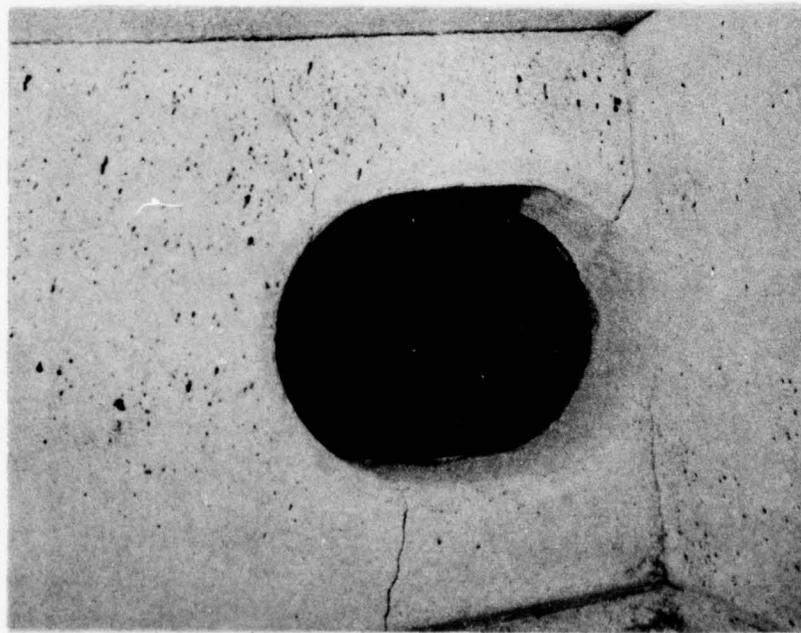
Figure 33. Sewage Chamber Access Port After Curing

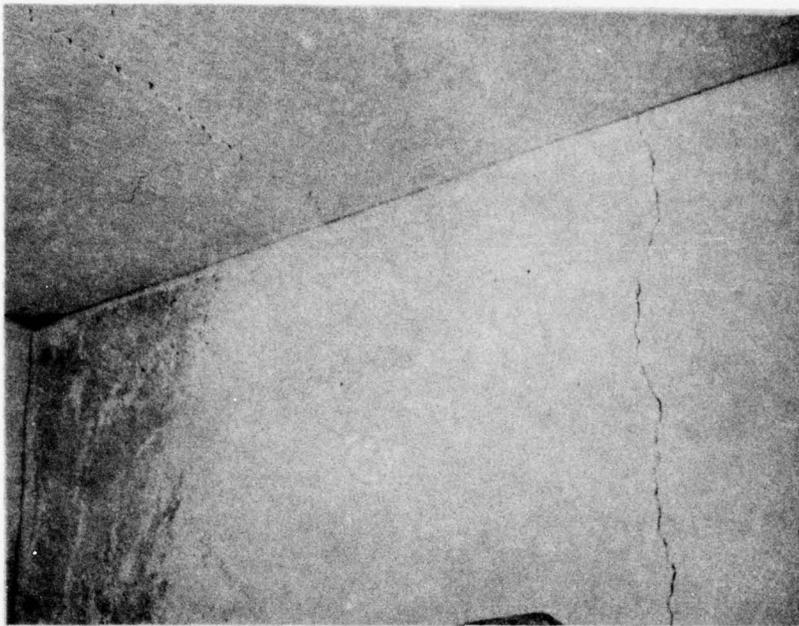
Figure 34. Right Wall of Sewage Chamber After Curing

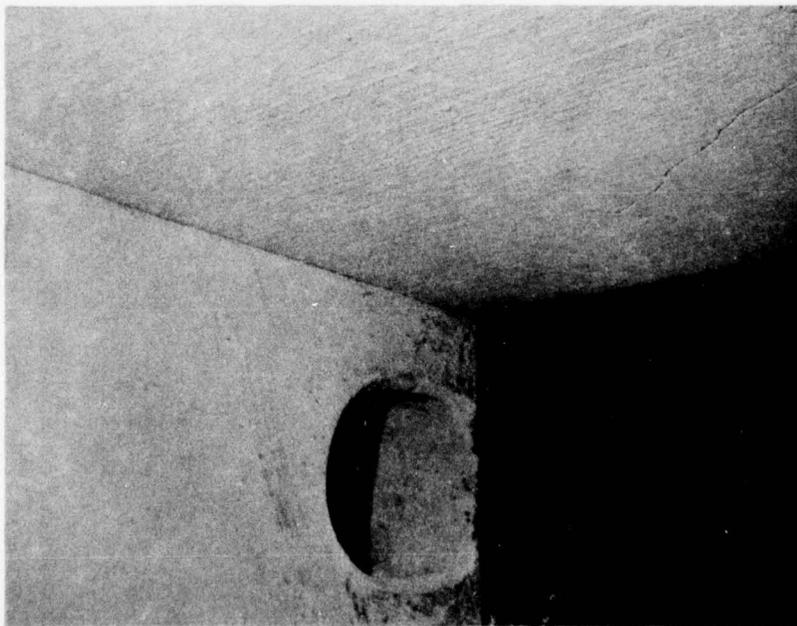
Figure 35. Jade Pak on Rear Wall of Sewage Chamber After Curing

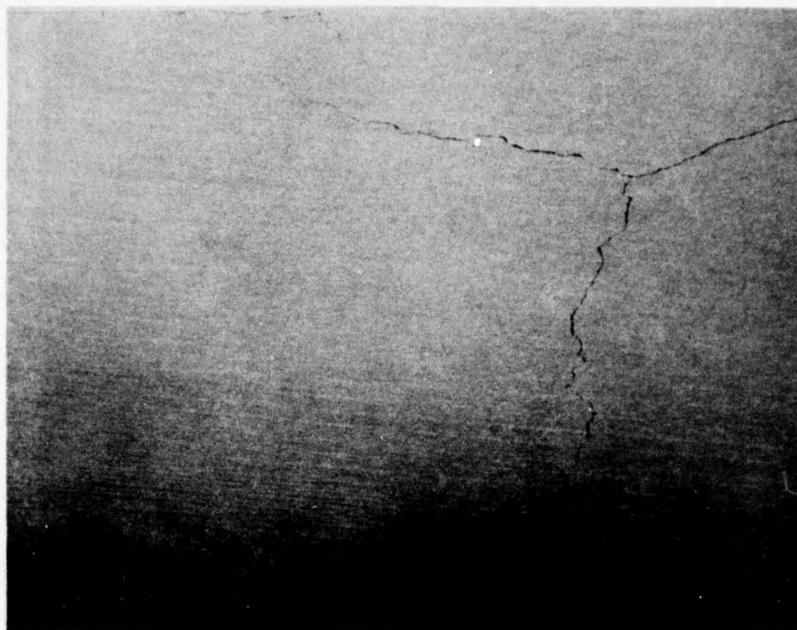
Figure 36. Sewage Chamber Roof Panel After Curing

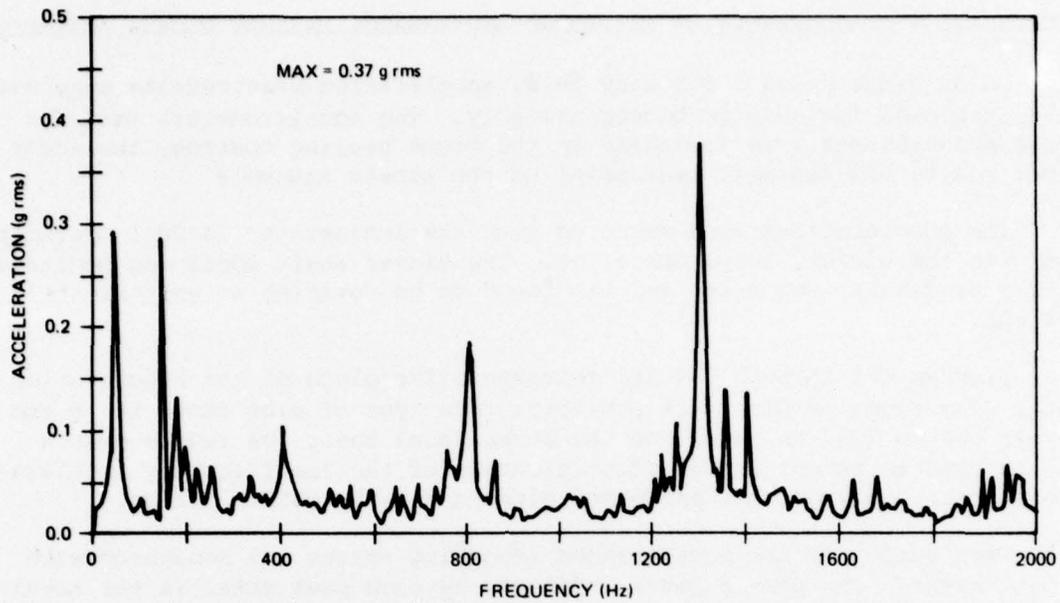
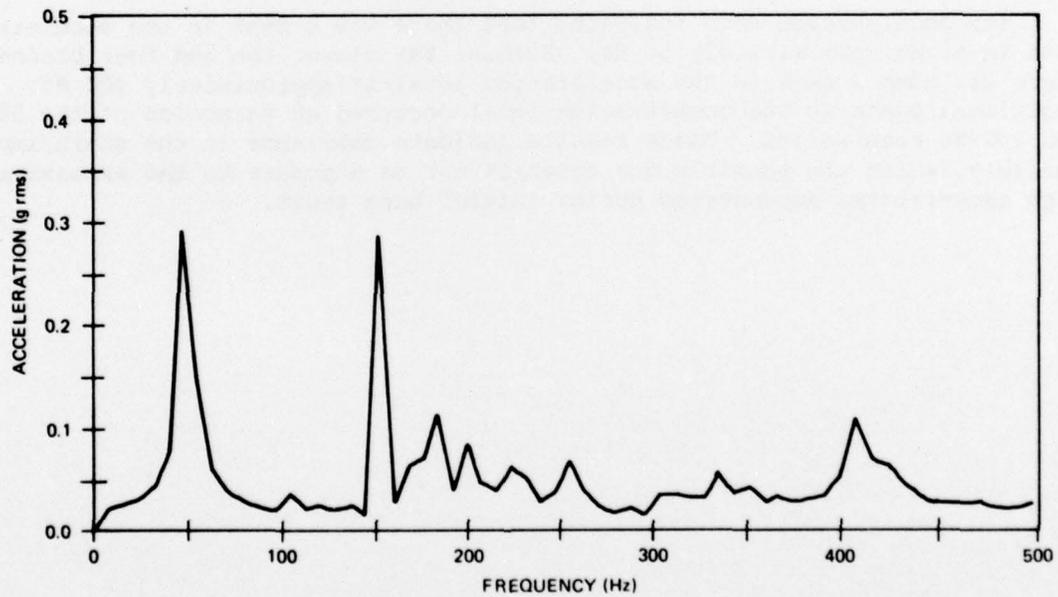
The acceleration data indicated that there was a peak in the acceleration level at approximately 50 Hz. Because the blower fan had four blades, there was also a peak in the acceleration level at approximately 200 Hz. Additional peaks in the acceleration level occurred at harmonics of the 50- and 200-Hz frequencies. These results indicate unbalance in the shaft/impeller assembly, which was possibly due to shaft set on exposure to the excessively high temperatures encountered during initial burn tests.

NOTE: THE OVERALL g LEVEL WAS 2.55 g PEAK (1.8 g rms)

Figure C-1. Acceleration on Bearing Housing With Only the Blower Operating

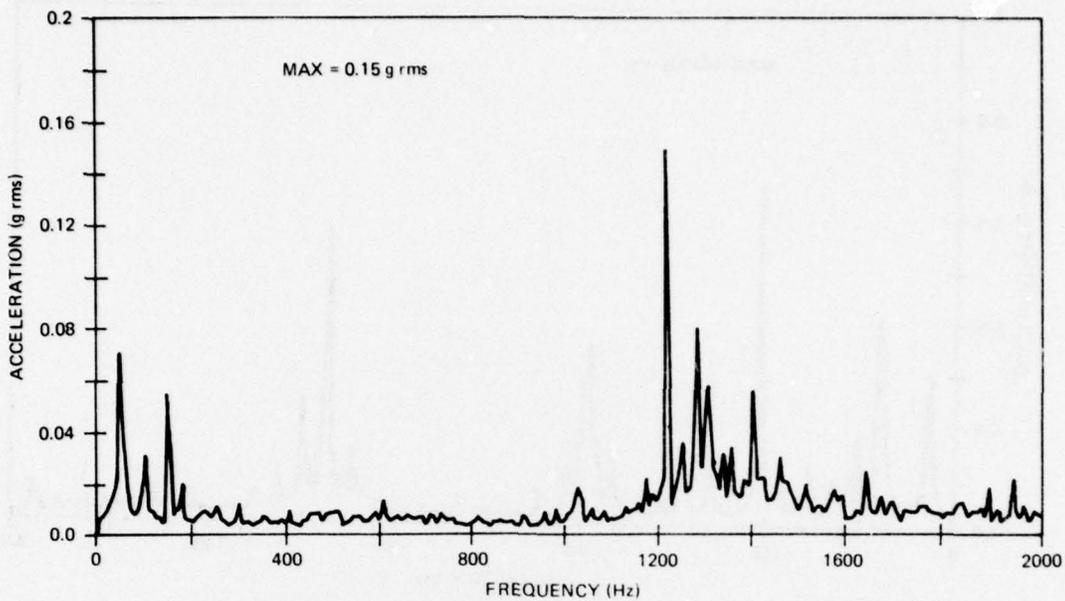
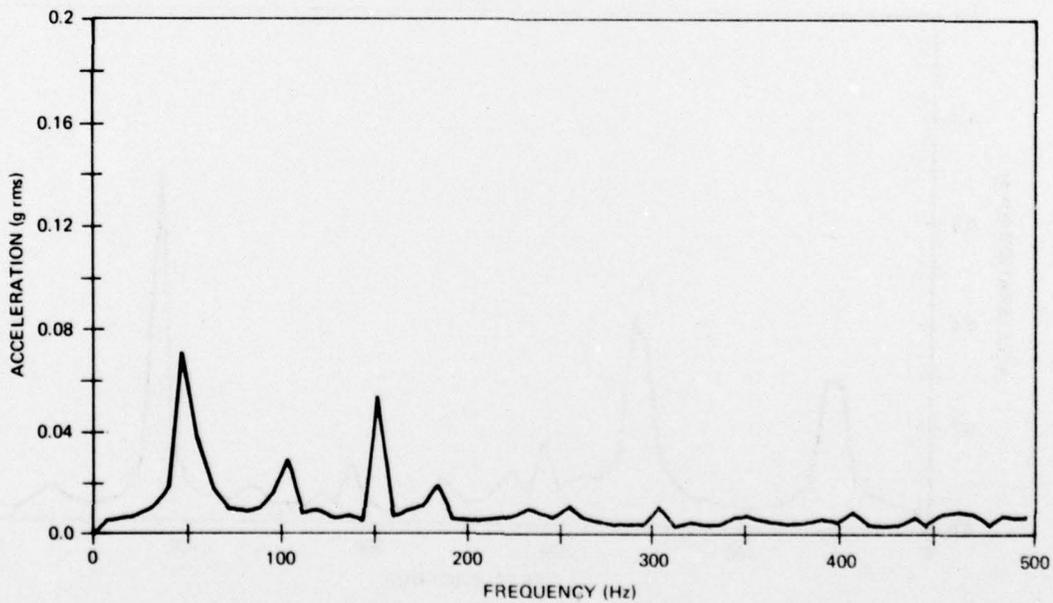
NOTE: THE OVERALL g LEVEL WAS 0.4 g PEAK (0.28 g rms)

Figure C-2. Acceleration on Right Front Motor Mount
With Only the Blower Operating

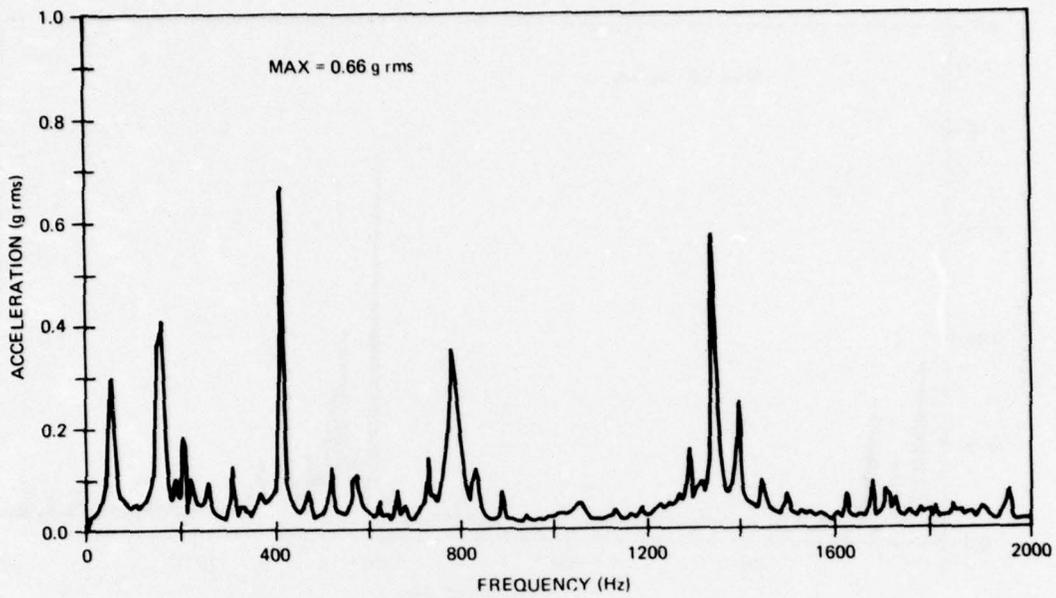
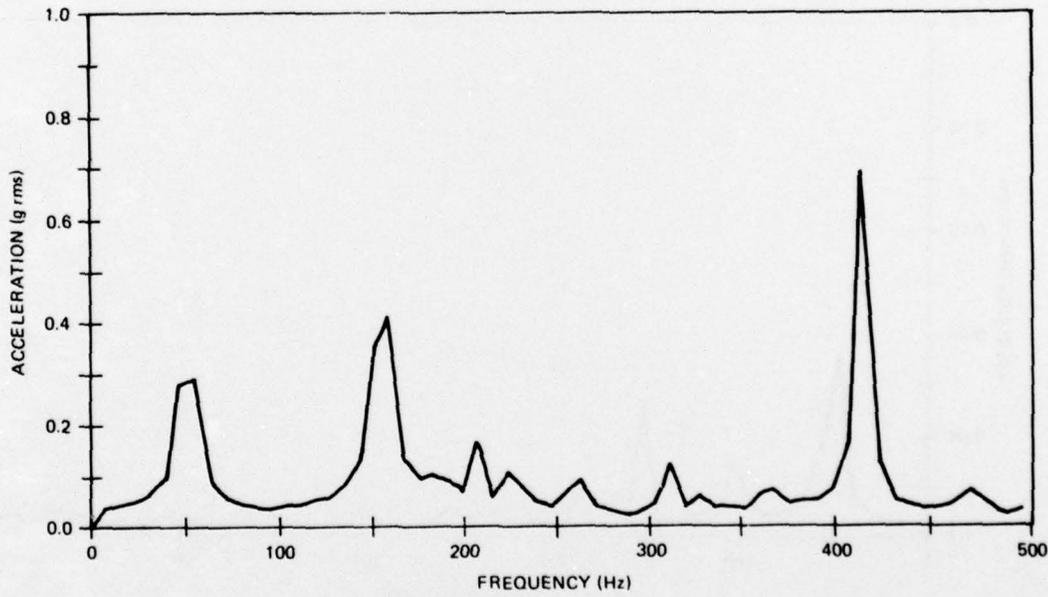
NOTE: THE OVERALL g LEVEL WAS 3.0 g PEAK (2.12 g rms)

Figure C-3. Acceleration on the Bearing Housing With the Incinerator in Full Operation

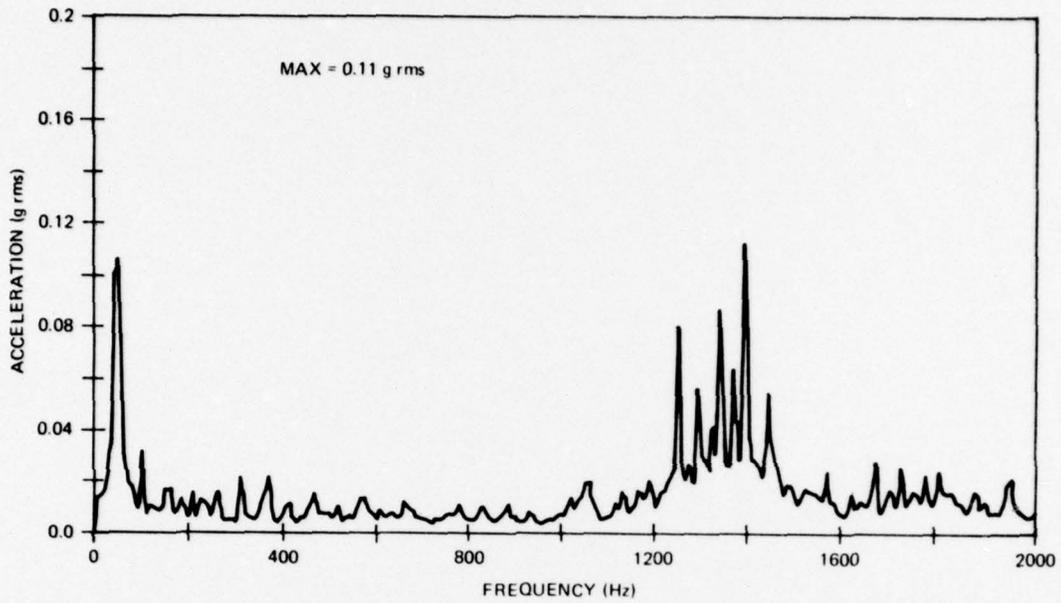
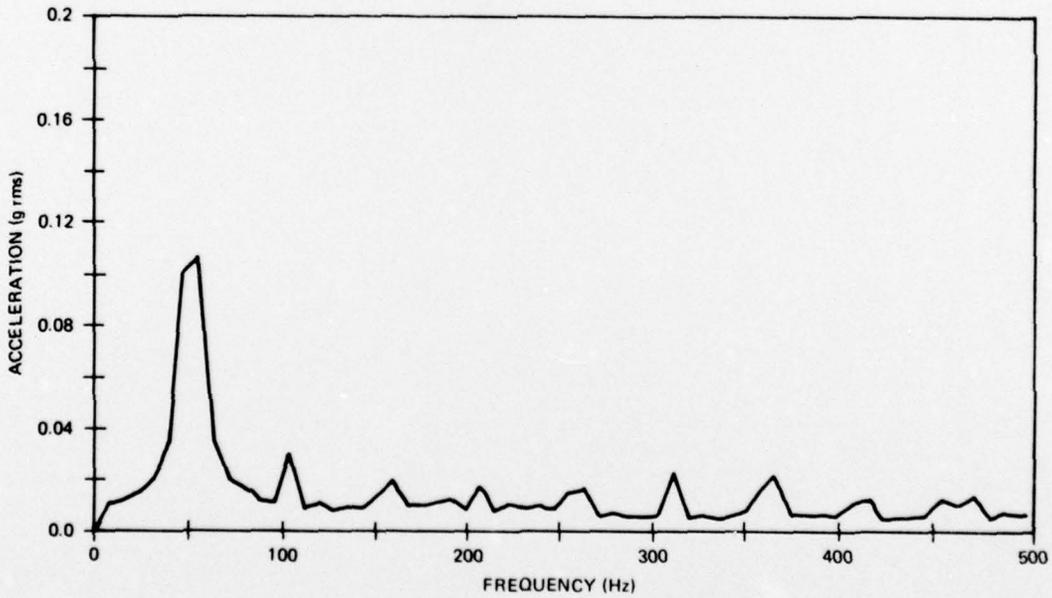
NOTE: THE OVERALL g LEVEL WAS 0.5 g PEAK (0.35 g rms)

Figure C-4. Acceleration on the Right Front Motor Mount With Incinerator in Full Operation
