CERL-TR-M-264

TECHNICAL REPORT M-264
July 1979

DURABILITY AND FIRE-SPREAD ASPECTS
OF PLASTIC PIPE SYSTEMS

by
Alvin Smith
R. Brady Williamson

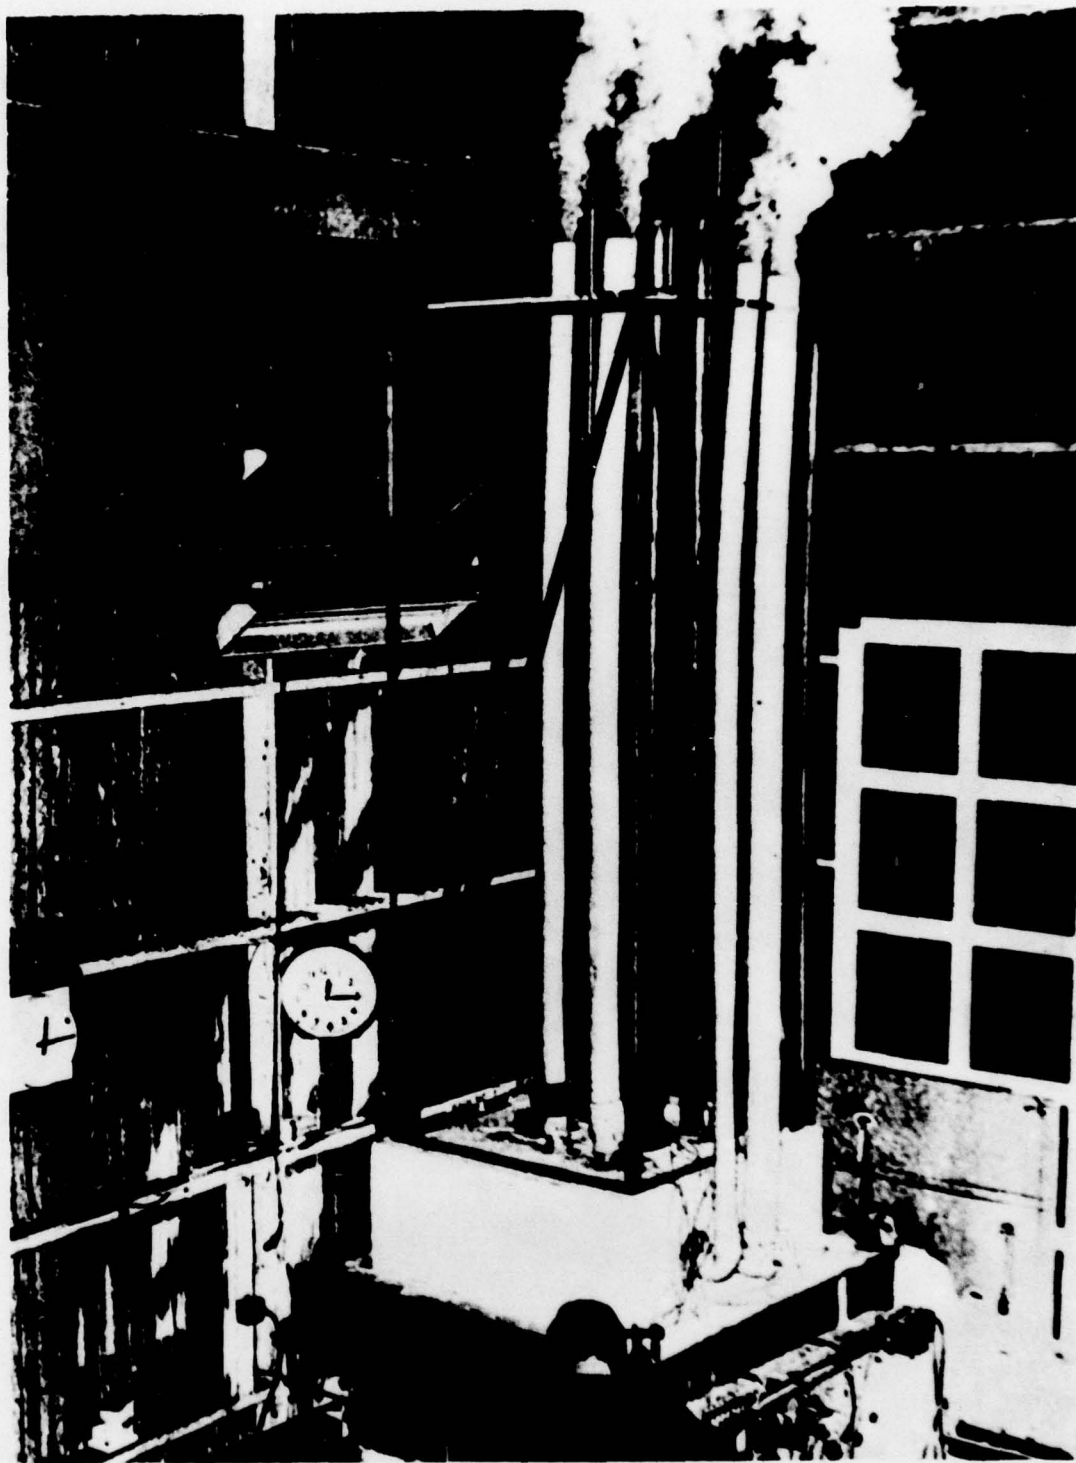
Figure A21. A view of the Australian test conducted on July 21, 1975 at approximately 15 minutes. Note there is some softening of the PVC pipes and there is smoke issuing from each vent. It should be recognized that plumbing systems are normally trapped within the buildings, and thus the smoke visible in this photograph would be vented outside the building under actual fire conditions.

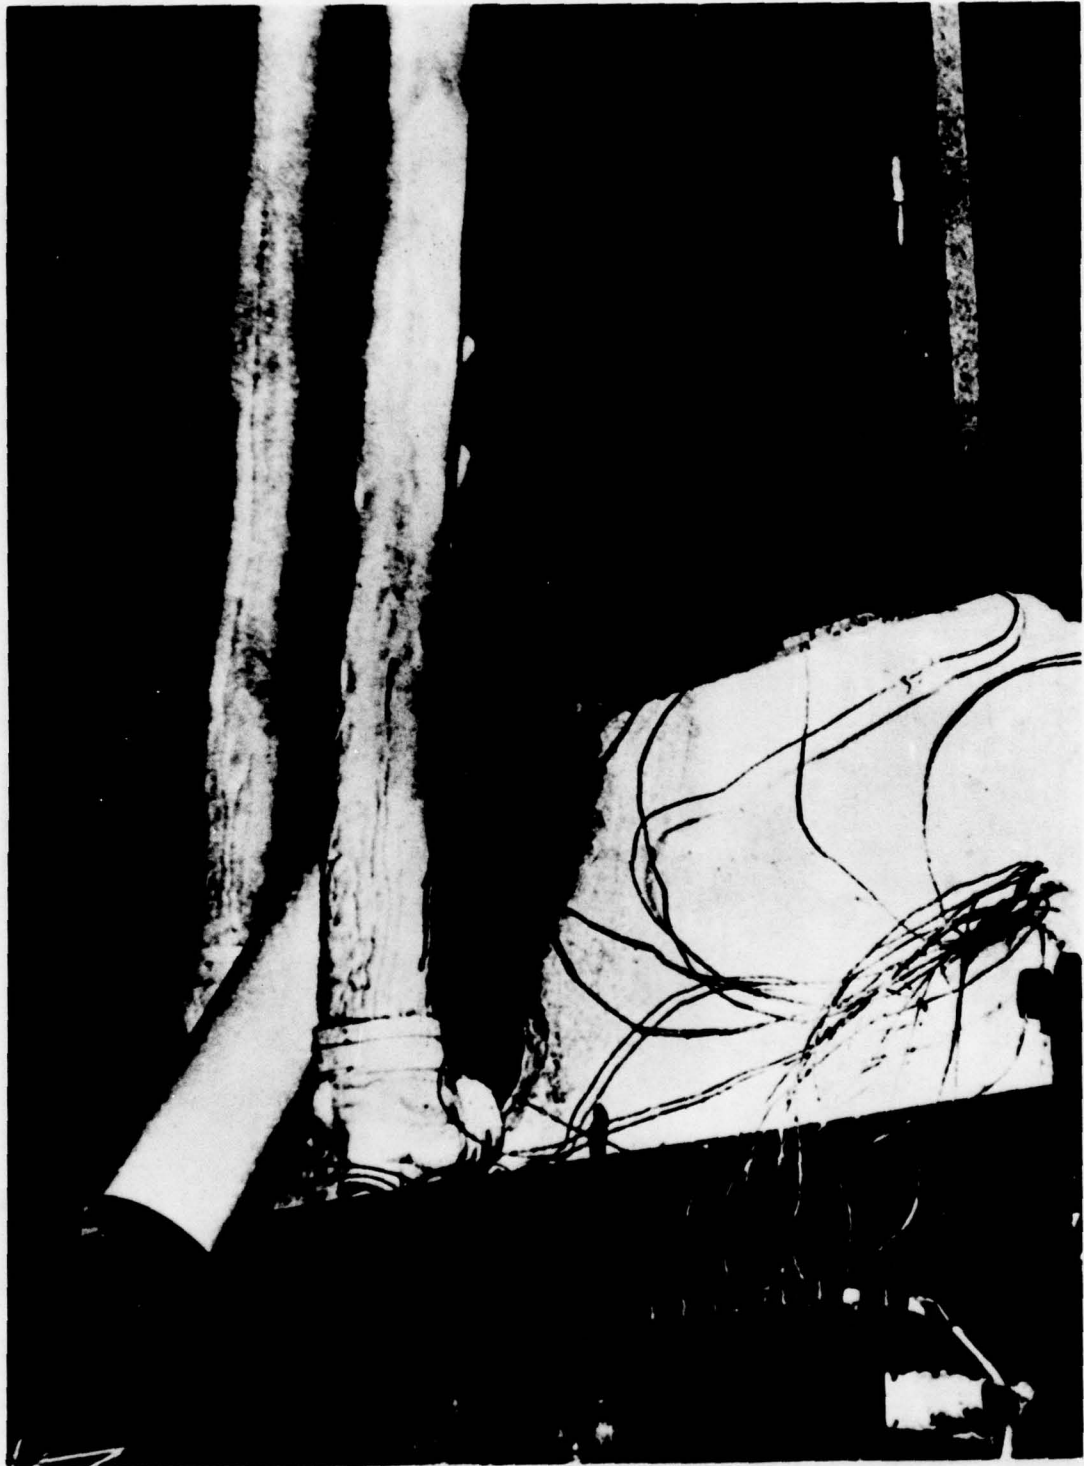
Figure A22. At approximately 30 minutes into the July 21st test, there was collapse of one pipe and considerable softening of the other pipes. Note that one pipe has fallen away from the sidewall and left an open hole.

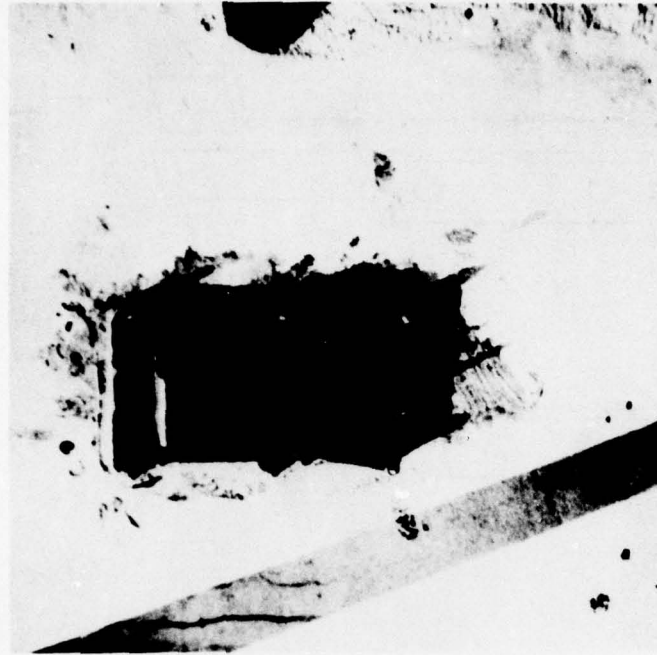
Figure 1A-2. Vertical Fire Valve Installed in Furnace Wall
 (a) Unexposed face during test showing guillotine action of valve on pipe.
 (b) After test the pipe has been moved and it is apparent that the valve has closed the gap in the wall.
