The purpose of this program is to develop high frequency ultrasonic evaluation techniques capable of detecting defects in the 10 to 100 μ m (0.0004 to 0.004 inch) size range in gas turbine quality ceramics, such as silicon nitride and silicon carbide. The present contract is the third one-year contract in this program. In the first year's contract (Ref. 1), a high frequency (25-45 MHz), longitudinal wave mode, pulse-reflection technique was developed and applied to a range of candidate gas turbine ceramics. This technique was shown to be capable of detecting voids at least as small as 25 μ m (0.001 inches) and also high density inclusions, although of a somewhat larger size. It was also shown to be capable of detecting the porosity in a material that is not fully dense, such as reaction bonded silicon nitride. In the second year's contract (Ref. 2), a 45 MHz shear wave technique was developed which provides improved sensitivity, reduces the back surface deadband to 40 μ m (0.0016 inches) and provides correlation between inspection results and four-point-bend test data.

Effort under this contract was directed towards developing a high frequency (45 MHz) surface wave inspection tech

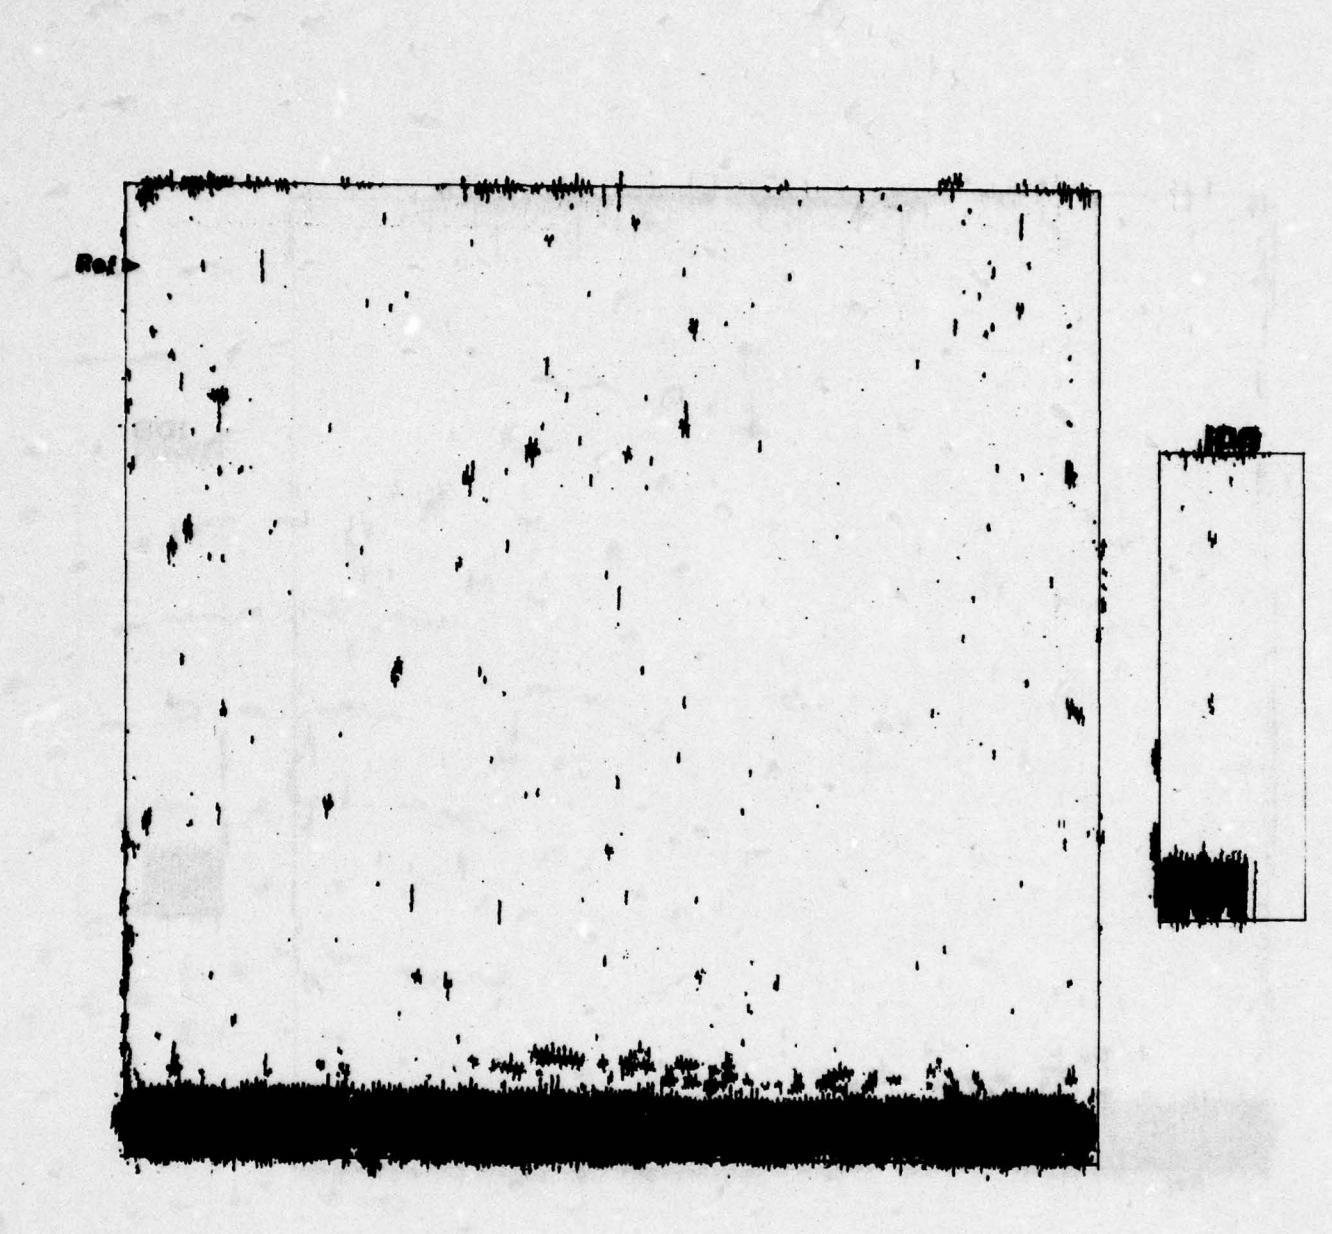
The C-scan recordings of the 45 MHz shear wave inspections of the billet of Ceralloy 147A are shown in Figures 12 through 15. As with previous samples of this material, these scans show a large number of defect indications. Figures 16 through 19 show the corresponding surface wave inspections. These scans also show large numbers of indications. The two types of scans were compared by means of transparencies. Since the shear wave inspection is performed from the opposite side of the surface than the surface wave inspection, the transparency of the shear wave C-scan is turned over on the surface wave C-scan so that the reference notches coincide. This type of comparison revealed that only a few of the defect indications correspond between the two types of scans. Most of the defects detected by the surface wave technique were not detected by the shear wave technique.

Figure 12. C-scan Recording of 45 MHz, 11^o Shear Wave Inspection of Billet of Ceralloy 147A Hot Pressed Silicon Nitride (Notch Down).

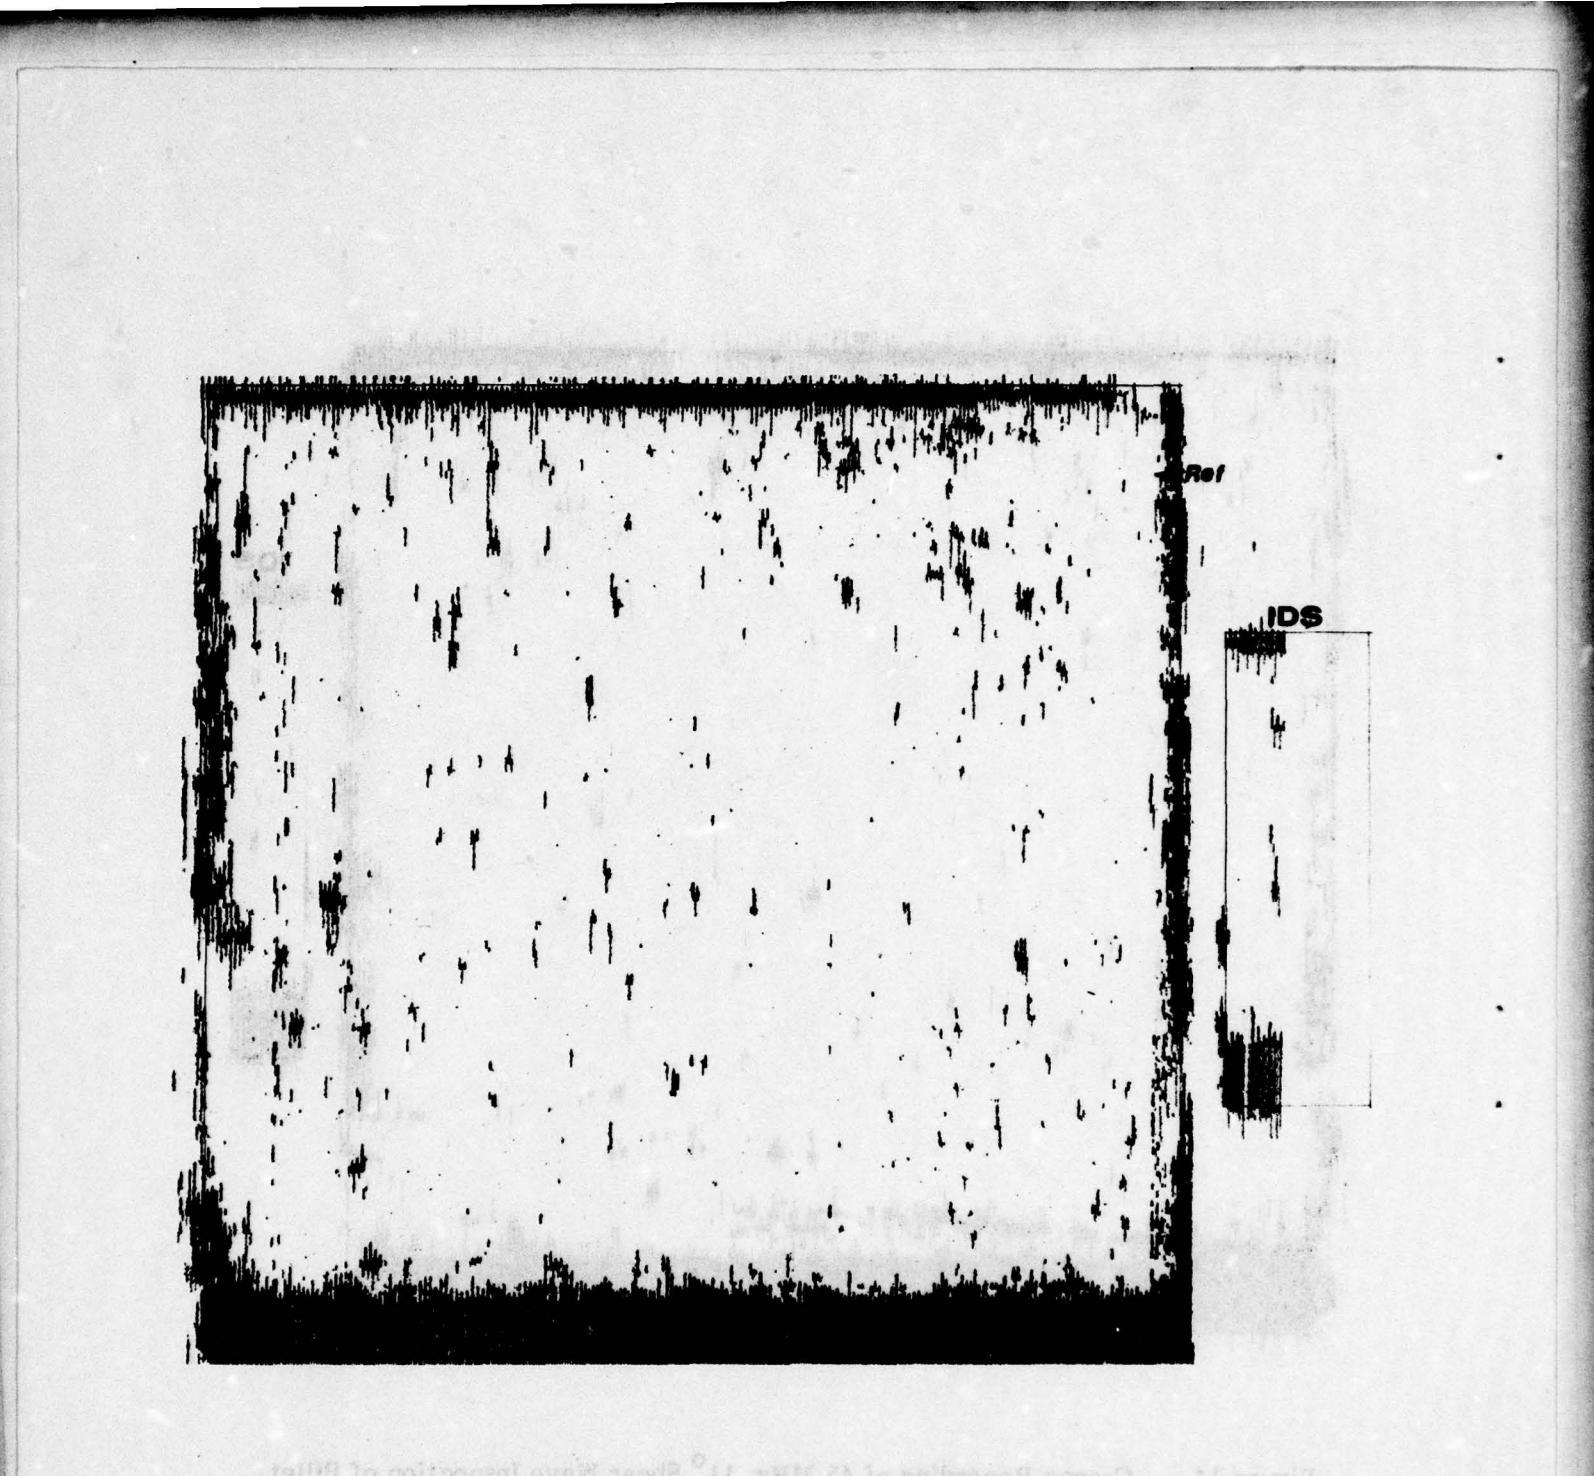
Figure 15. C-scan Recording of 45 MHz, 11^o Shear Wave Inspection of Billet of Ceralloy 147A Hot Pressed Silicon Nitride (Rotated 90^o, Notch Up).

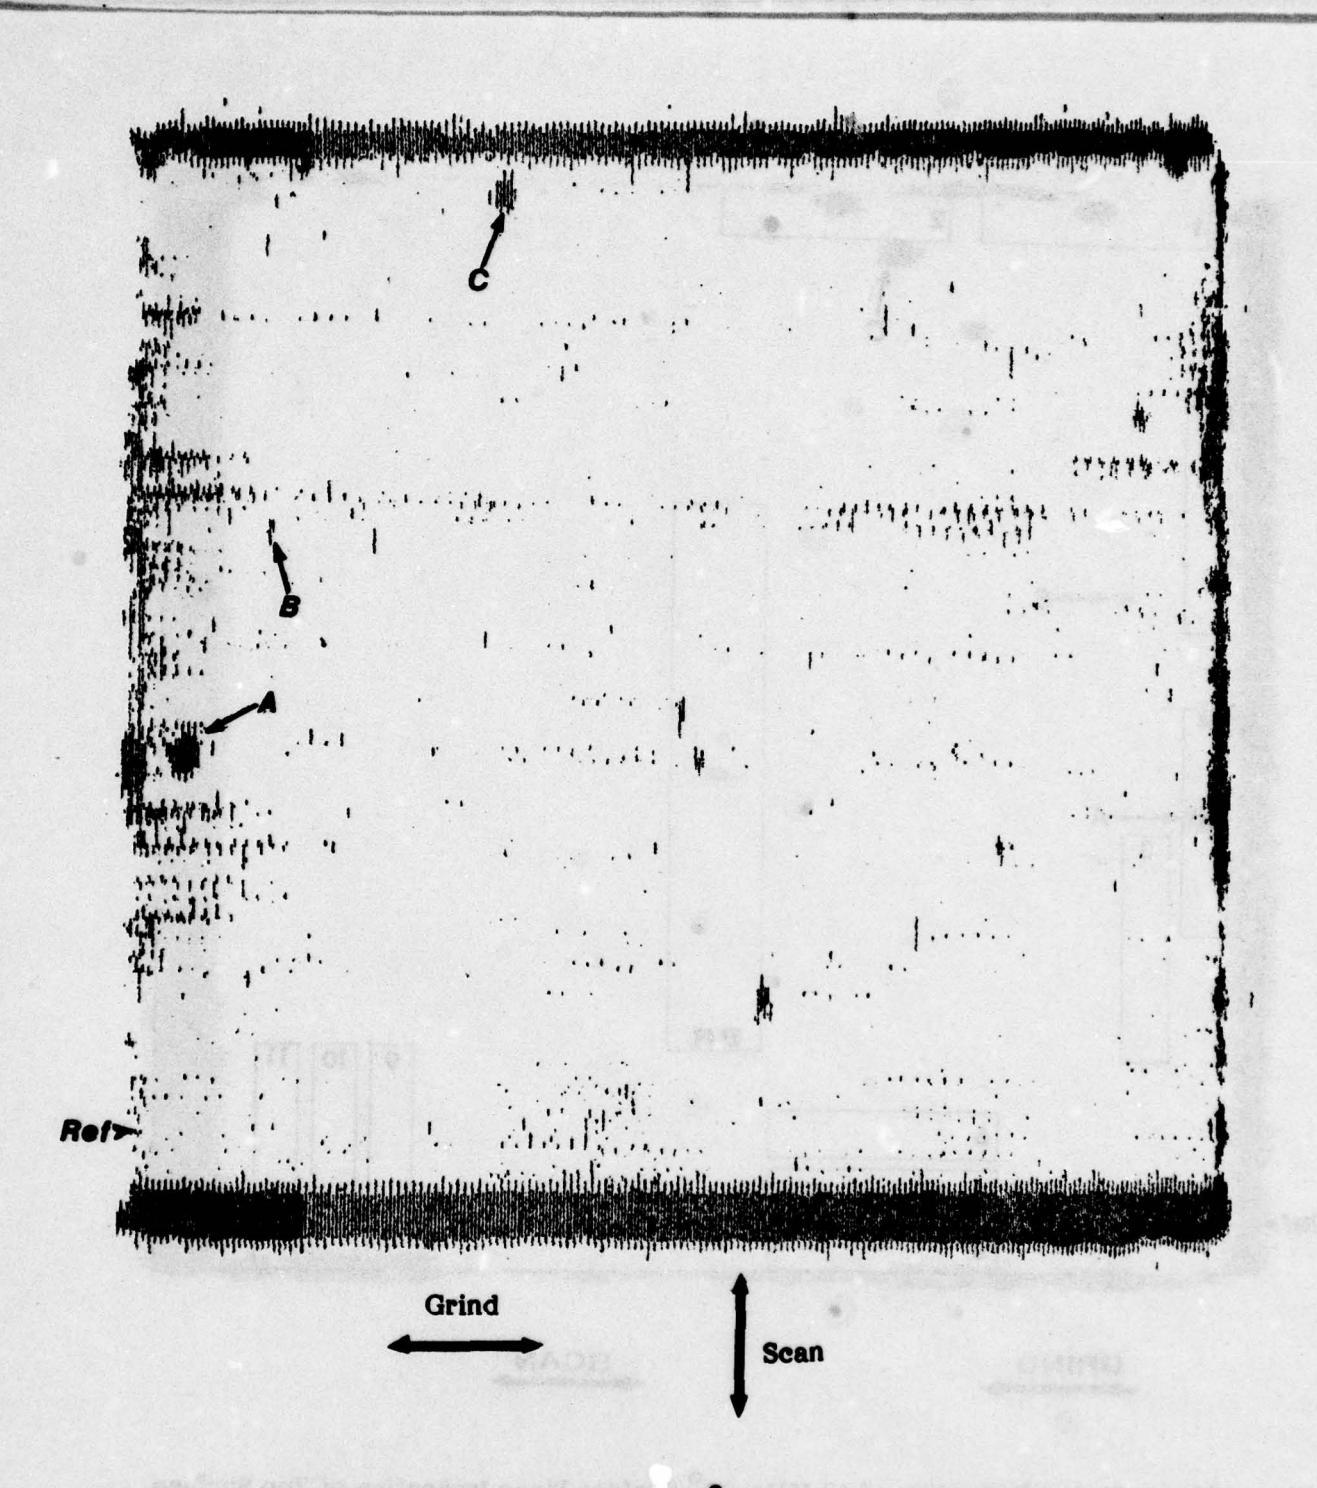
Figure 21.

C-scan Recording of 45 MHz, 18⁰ Surface Wave Inspection of Top Surface of Billet of Ceralloy 147A HPSN After Machining (Scan Perpendicular to Grinding Direction).

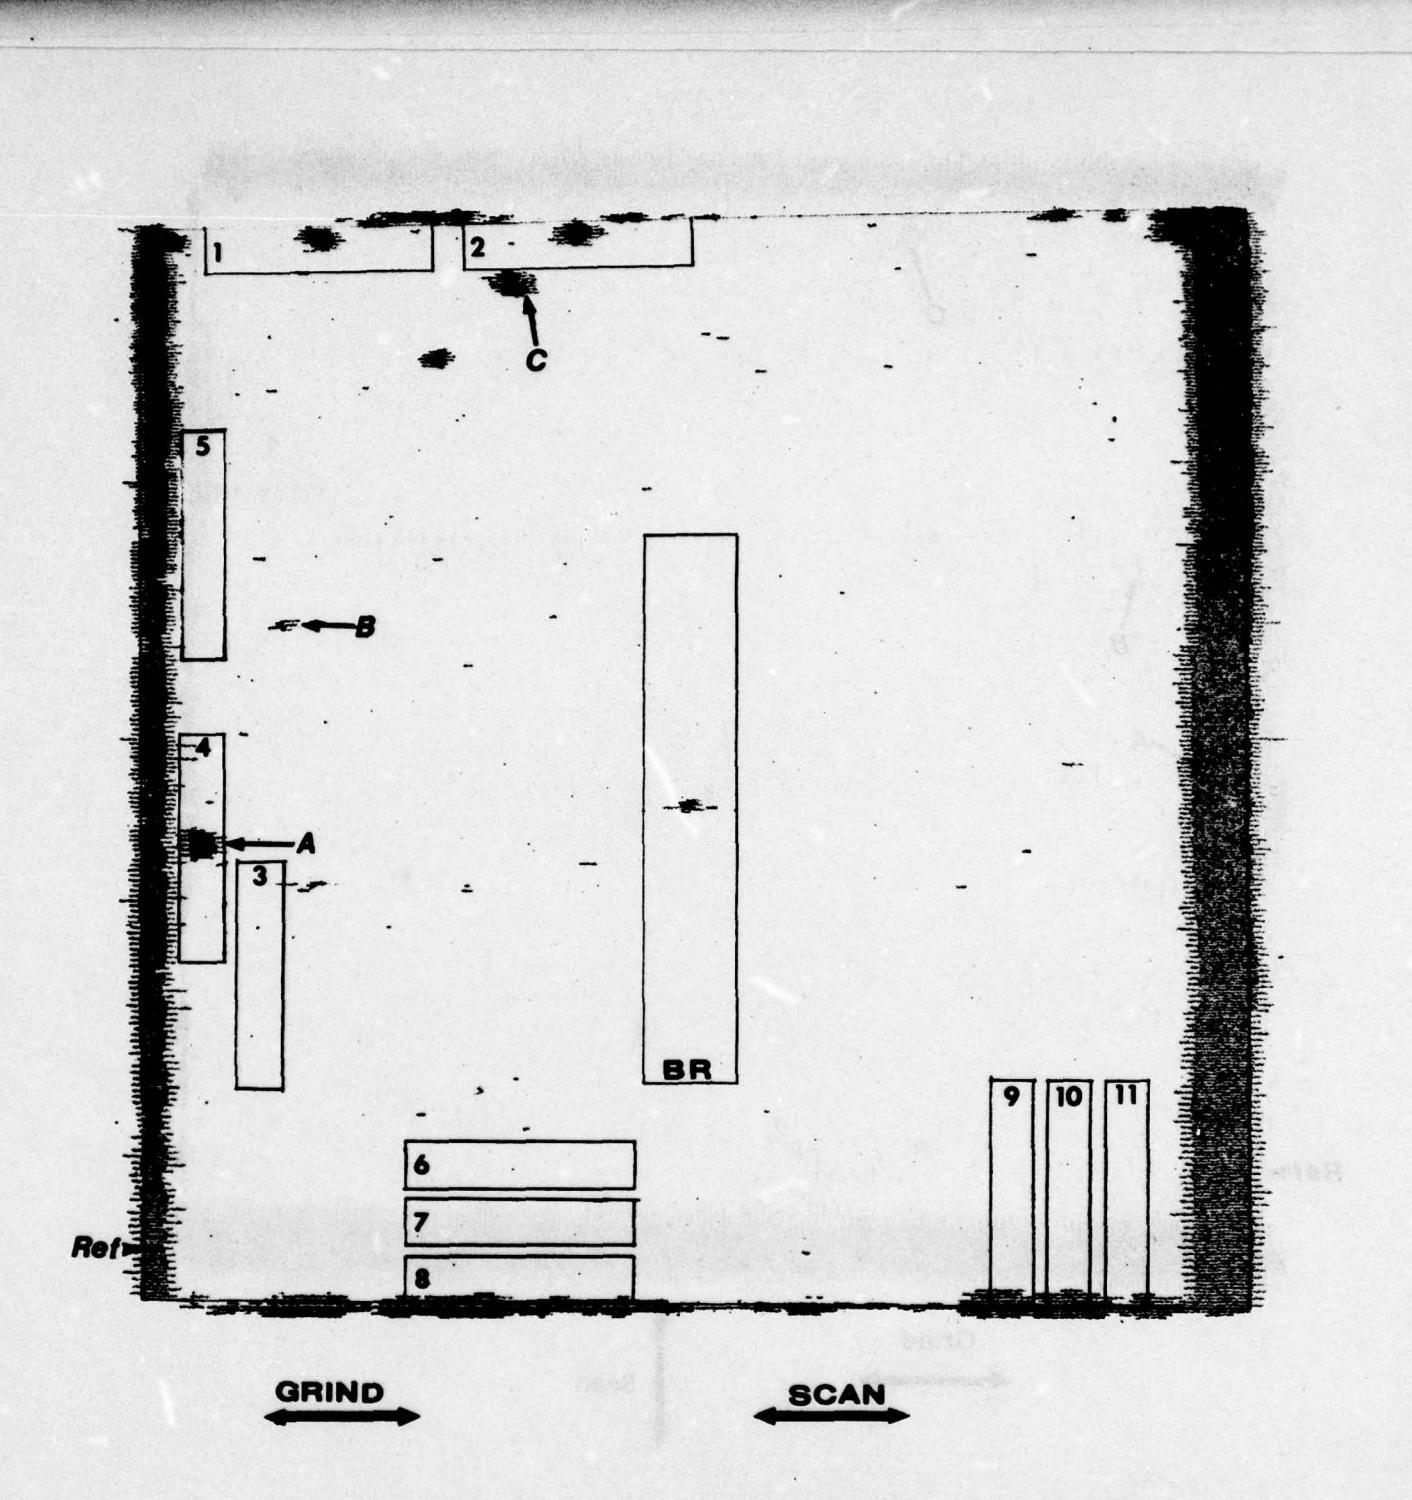
Based on the surface wave inspection results after machining, areas of the billet were selected for burner rig testing and for four-point-bend testing. Figures 22 and 24 show how these specimens relate to the inspection results on the two sides of the billet. In Figure 22 it can be seen that four-point-bend specimens were machined

Figure 22. C-scan Recording of 45 MHz, 18⁰ Surface Wave Inspection of Top Surface of Billet of Ceralloy 147A HPSN After Machining (Scan Parallel to Grinding Direction).

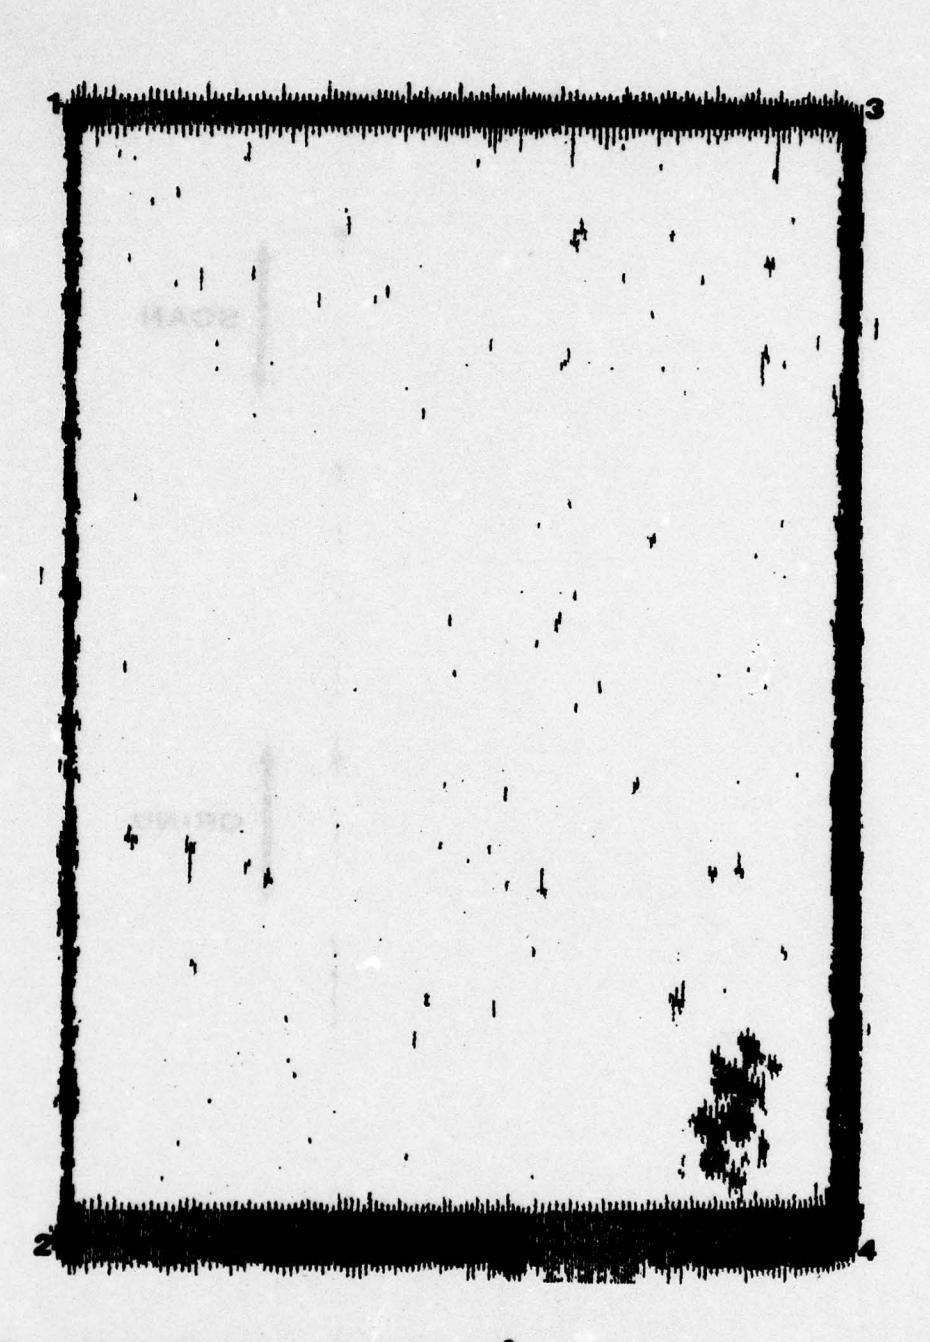
Figure 26 shows a C-scan recordings of a surface wave inspection of the billet of NC-132 HPSN. The cluster of defects in corner No. 4 are shallow surface pits. This corner was cut off and used as a burner rig specimen. Figures 27 through 30 show Cscan recordings of surface wave inspections of both sides of the remainder of the billet from two orientations each. Other than of few small indications in Figure 29, the only defects detected were the grinding marks. The location of four-point-bend specimens made from this billet are indicated in Figures 29 and 30. Specimens 1, 2 and 3 were centered around very small defect indications, as shown in Figure 29. Specimens 4, 5, and 6 run parallel to the grinding damage and specimens 7, 8 and 9 run perpendicular to the grinding damage, as is shown in Figure 30. The C-scan recording of the surface wave inspection of the tensile surface of the individual specimens is shown in Figure 31 prior to machining to final thickness.

Figure 26. C-scan Recording of 45 MHz, 18⁰ Surface Wave Inspection of Top Surface of Billet of NC-132 Hot Pressed Silicon Nitride.

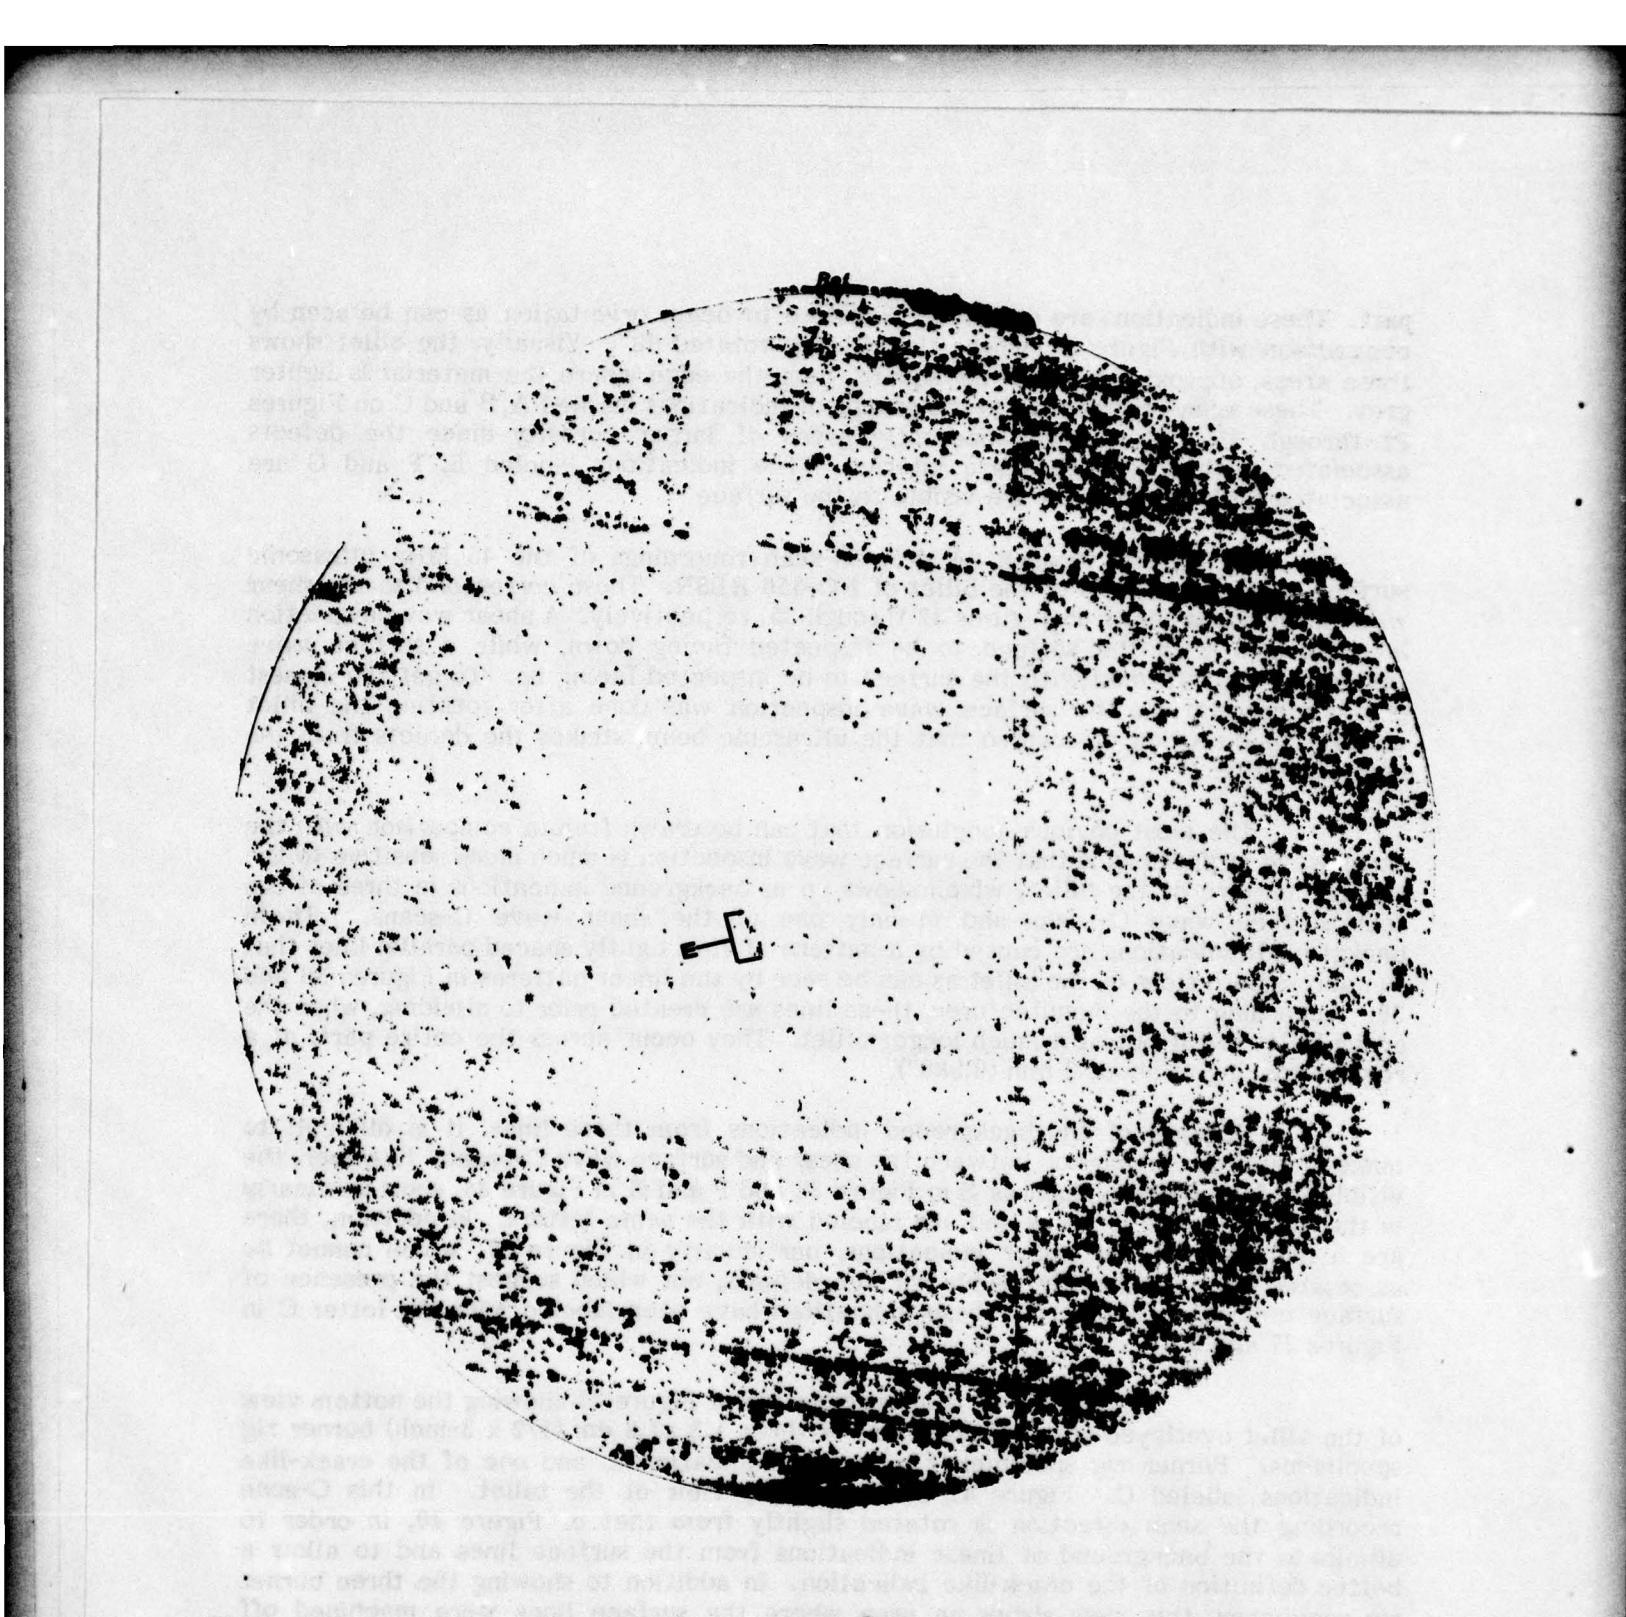
Figures 36 through 39 show C-scan recordings of the 45 MHz ultrasonic surface wave inspections of the billet of NC-350 RBSN. These correspond to the shear wave inspections shown in Figures 32 through 35, respectively. A shear wave inspection is performed with the surface to be inspected facing down, while a surface wave inspection is performed with the surface to be inspected facing up. To get the closest possible correlation, the surface wave inspection was done after rotating the billet around the direction of scan so that the ultrasonic beam strikes the defects from the same direction.

The most obvious conclusion that can be drawn from a comparison with the shear wave inspections is that the surface wave inspection is much more sensitive to the surface texture of the billet, which shows up as background indications in three of the four surface wave C-scans and in only one of the shear wave C-scans. These background indications are caused by a pattern of fine tightly spaced parallel lines that run across both sides of the billet as can be seen by the linear patterns in Figures 36 and 39. According to the manufacturer, these lines are created prior to nitriding, when the green billet is cut out of a much longer billet. They occur across the entire part, at a regular spacing of about 2 mm (0.080").

Figure 36. C-scan Recording of 45 MHz, 18⁰ Surface Wave Inspection of Billet of NC-350 Reaction Bonded Silicon Nitride (Notch on Bottom Side at 12 O'clock).

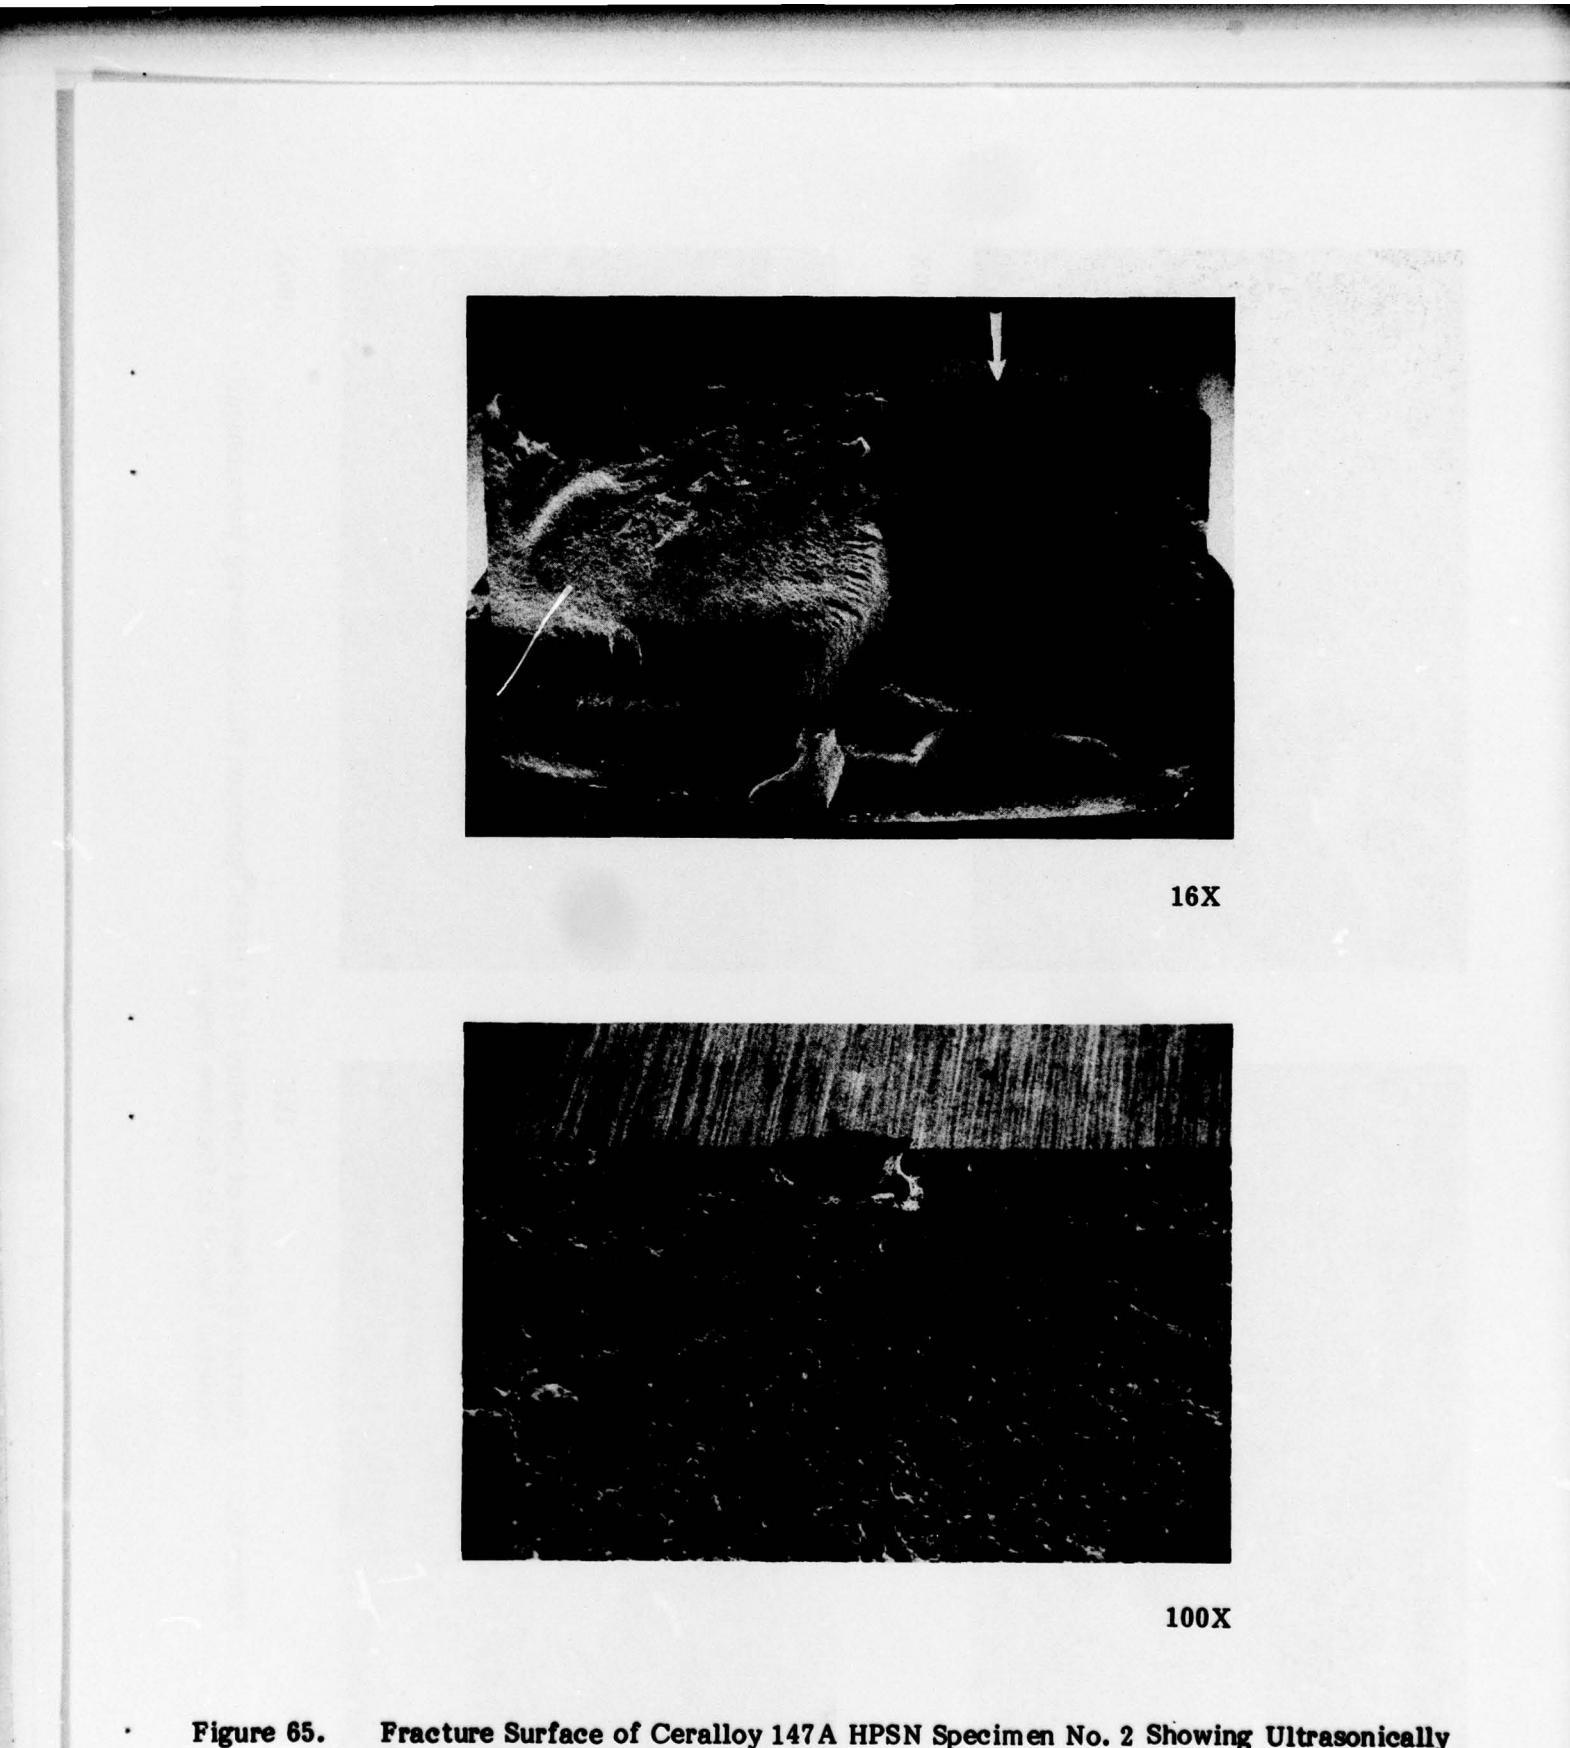
Fracture Surface of Ceralloy 147A HPSN Specimen No. 2 Showing Ultrasonically Detected Defect at Fracture Origin.

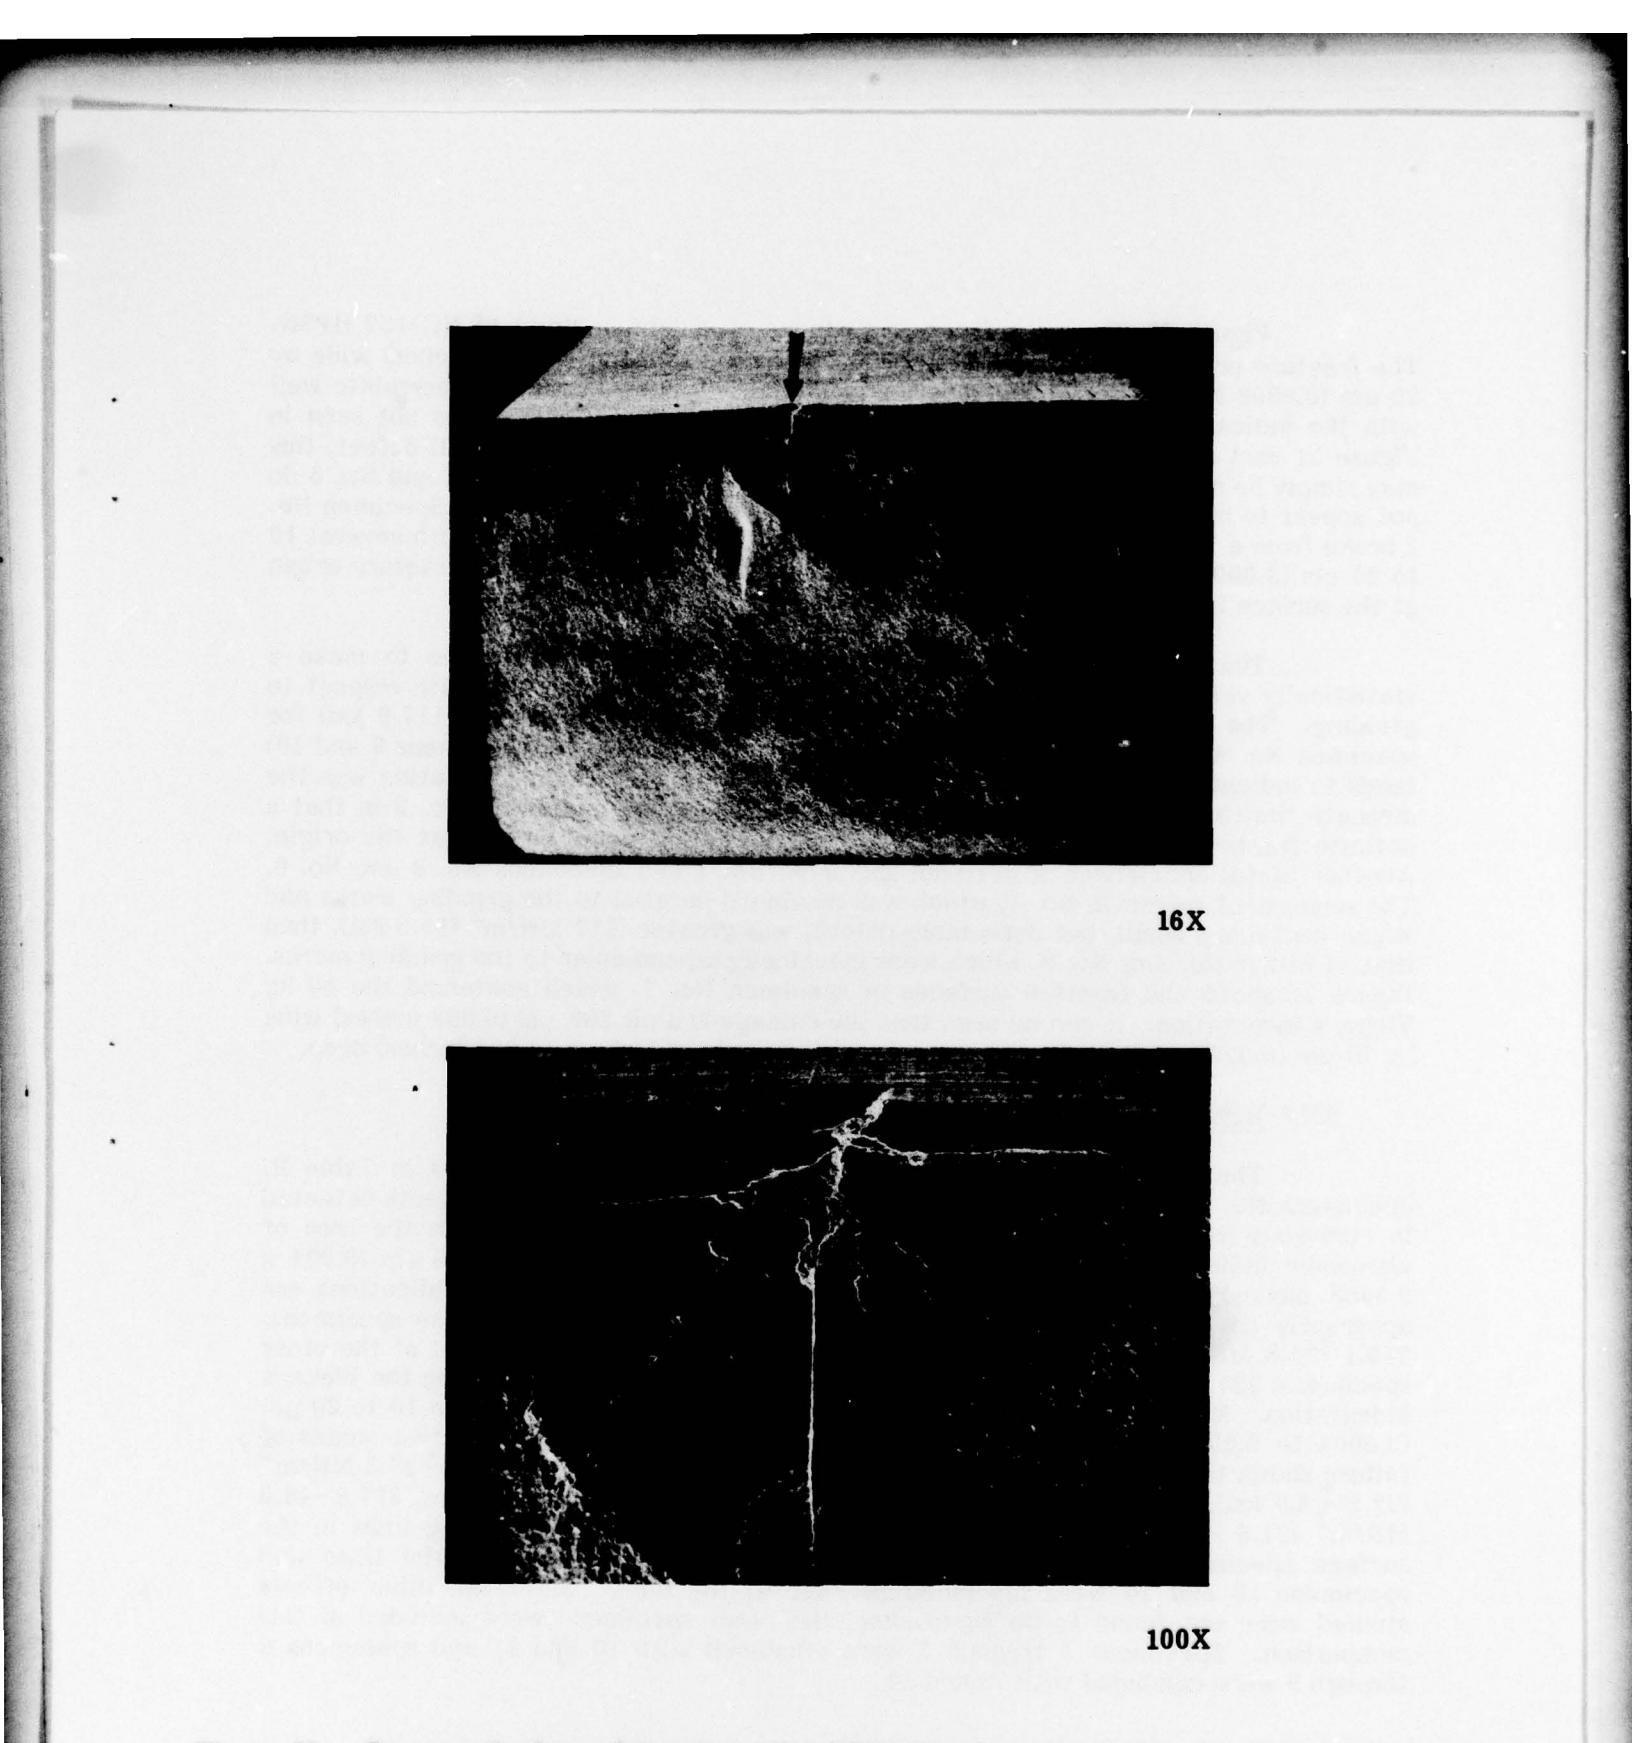
Figure 69. Fracture Surface of Ceralloy 147A HPSN Specimen No. 9, Showing 50 kg Vicker's Indentation at Fracture Origin.

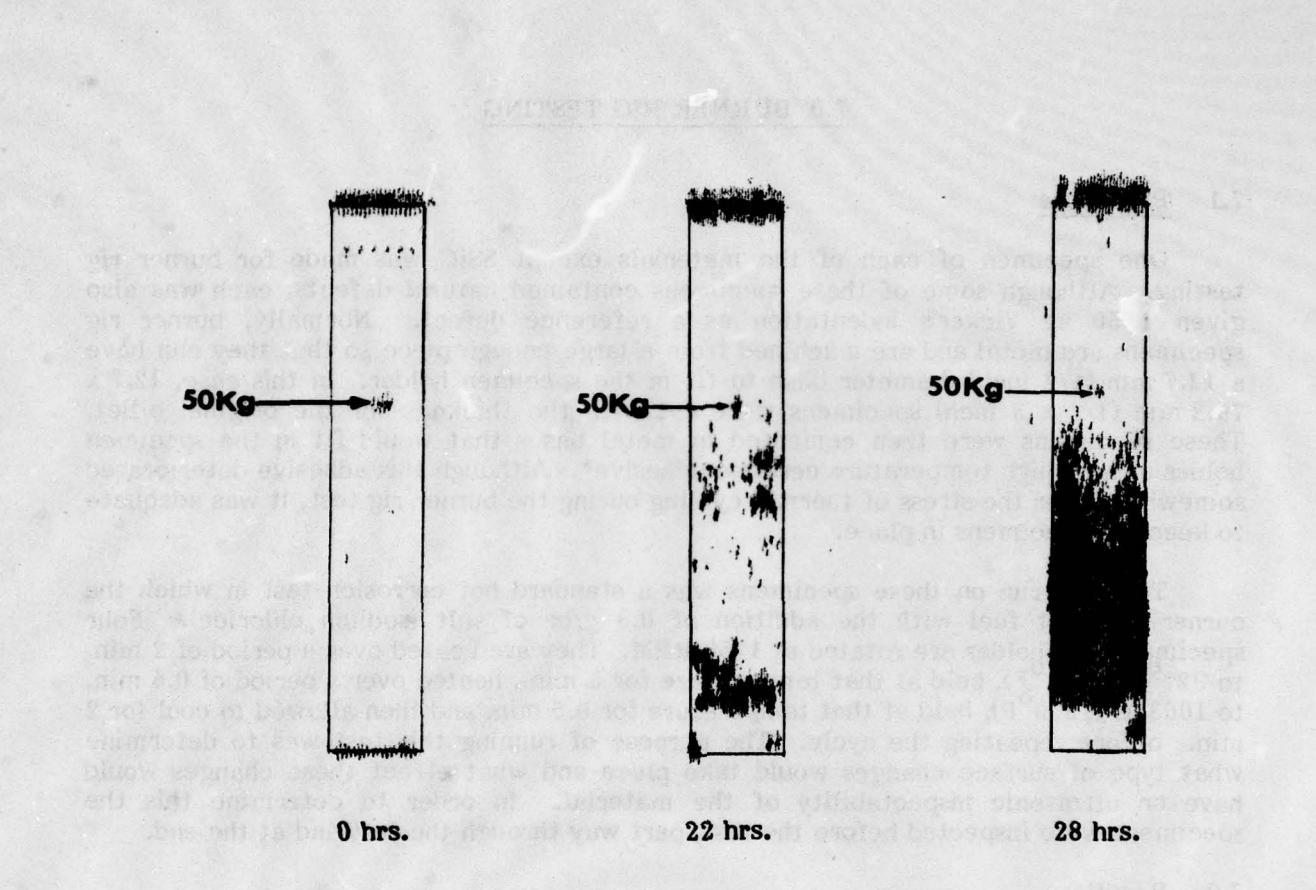
Figure 82. C-scan Recordings of 45 MHz, 18⁰ Surface Wave Inspections of Specimen of Ceralloy 147A HPSN After 0, 22 and 28 Hours Exposure in Burner Rig.

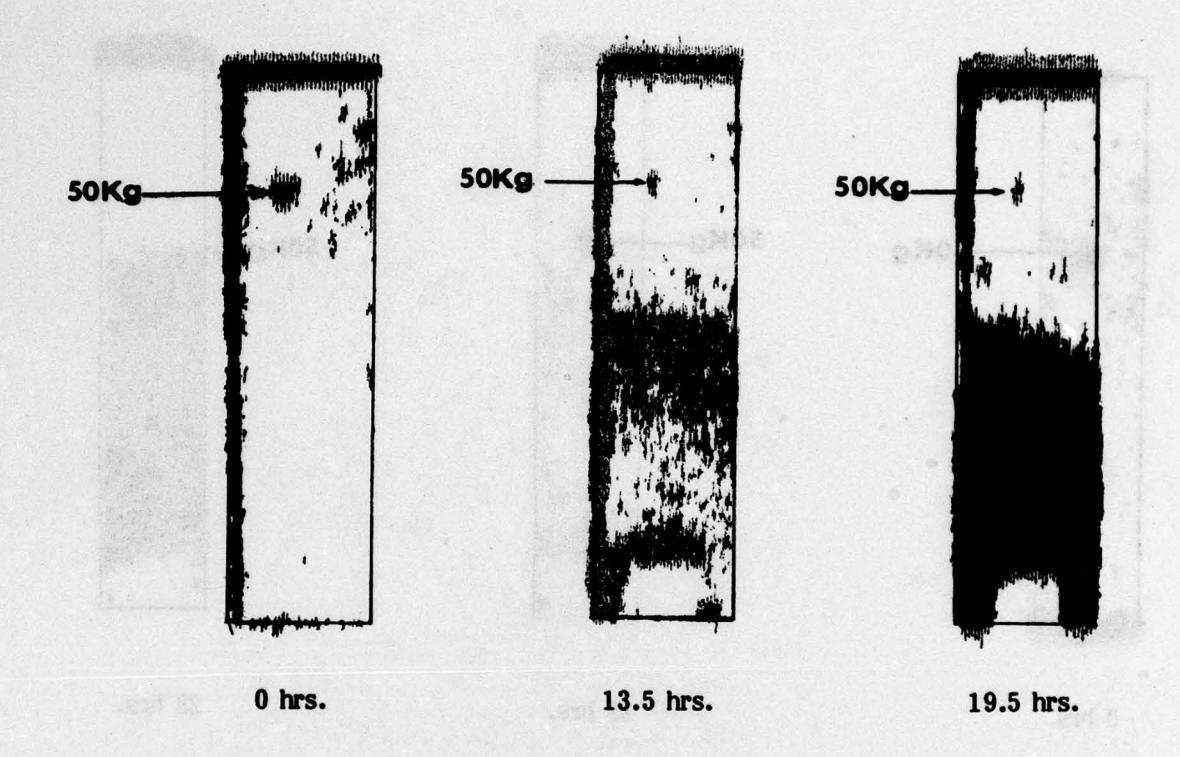
Figure 83. C-scan Recordings of 45 MHz, 18⁰ Surface Wave Inspections of Specimen of NC-132 HPSN After 0, 13.5 and 19.5 Hours Exposure in the Burner Rig.

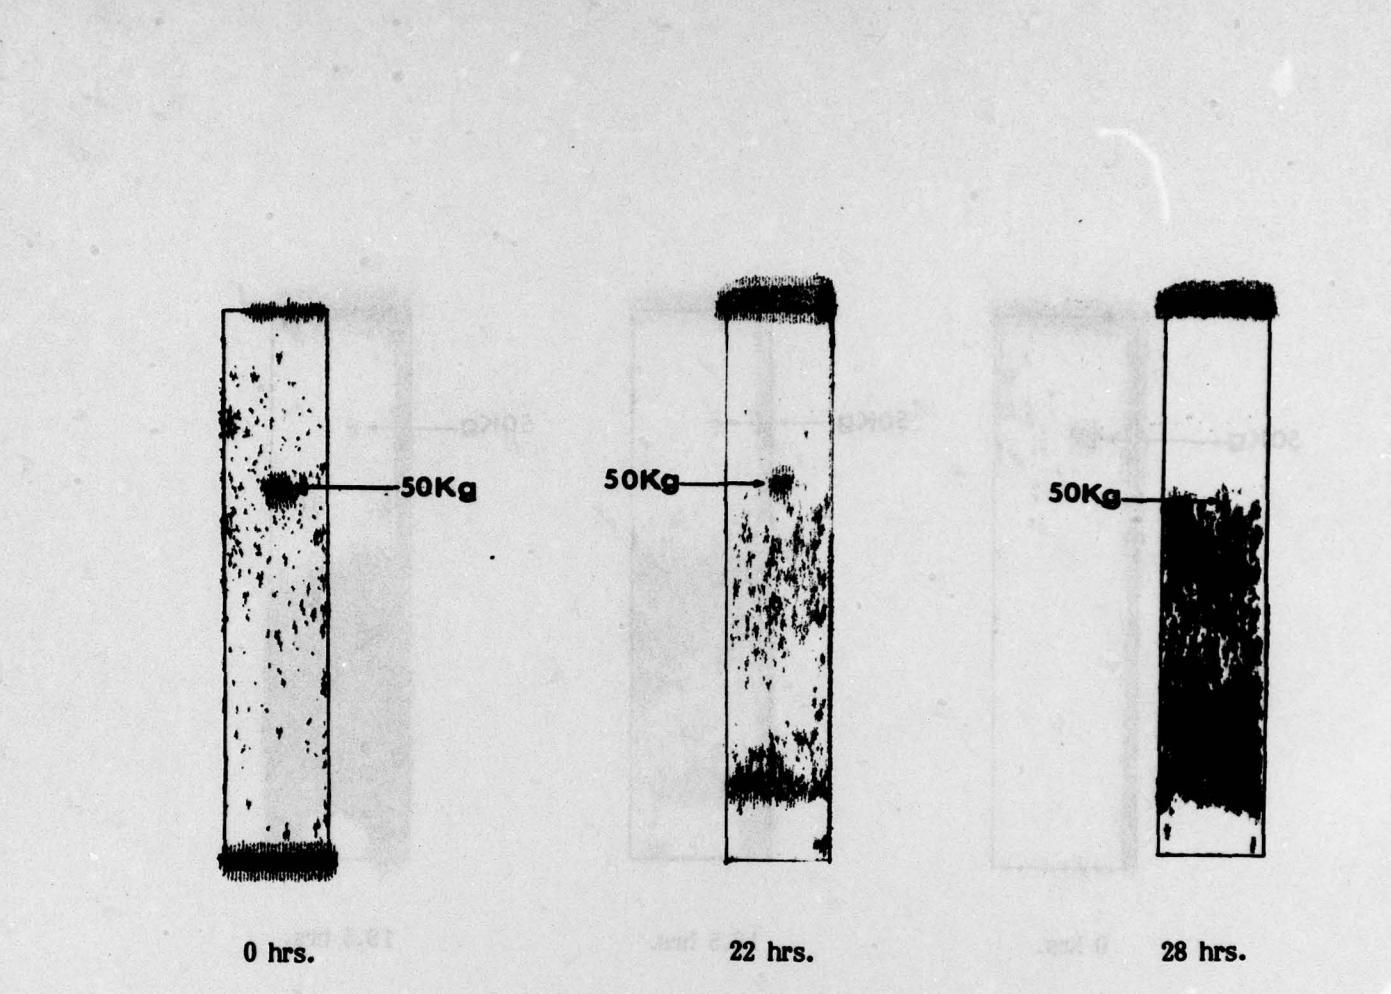
Figure 84. C-scan Recordings of 45 MHz, 18⁰ Surface Wave Inspections of Specimen of NC-350 RBSN After 0, 22 and 28 Hours Exposure in the Burner Rig.
