The purpose of this program is to develop high frequency ultrasonic evaluation techniques capable of detecting defects in the 10 to 100 μ m (0.0004 to 0.004 inch) size range in gas turbine quality ceramics, such as silicon nitride and silicon carbide. The present contract is the third one-year contract in this program. In the first year's contract (Ref. 1), a high frequency (25-45 MHz), longitudinal wave mode, pulse-reflection technique was developed and applied to a range of candidate gas turbine ceramics. This technique was shown to be capable of detecting voids at least as small as 25 μ m (0.001 inches) and also high density inclusions, although of a somewhat larger size. It was also shown to be capable of detecting the porosity in a material that is not fully dense, such as reaction bonded silicon nitride. In the second year's contract (Ref. 2), a 45 MHz shear wave technique was developed which provides improved sensitivity, reduces the back surface deadband to 40 μ m (0.0016 inches) and provides correlation between inspection results and four-point-bend test data.

Effort under this contract was directed towards developing a high frequency (45 MHz) surface wave inspection tech

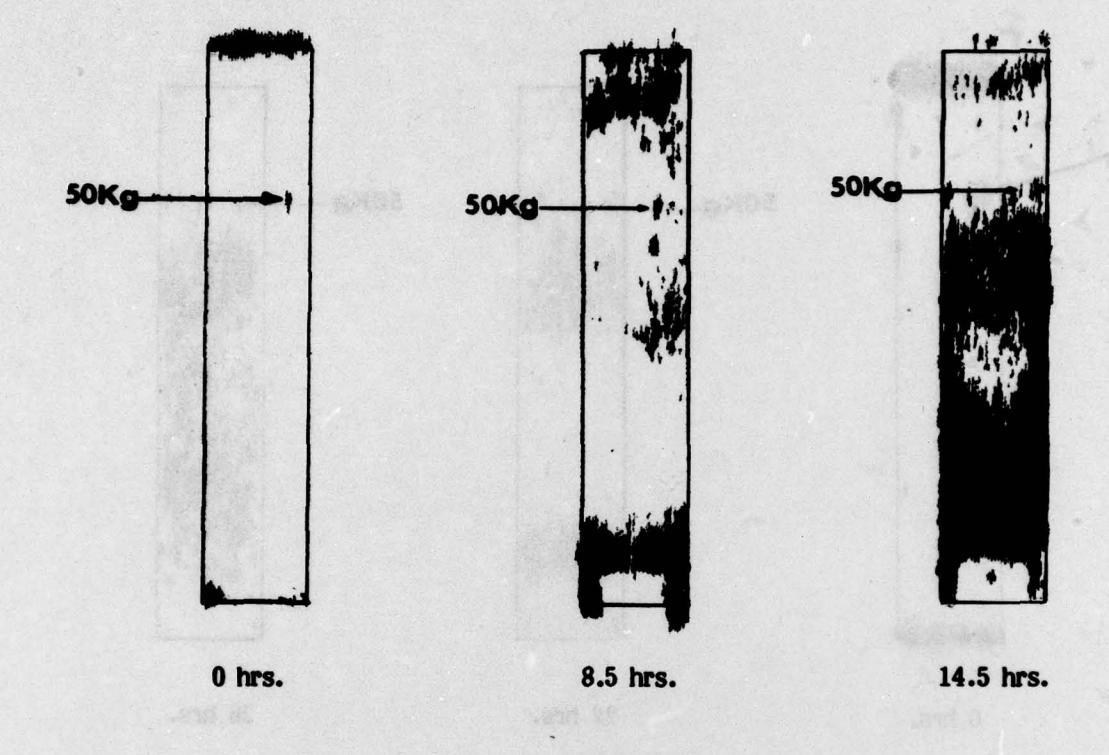
Figure 85. C-scan Recordings of 45 MHz, 18⁰ Surface Wave Inspections of Specimen of Ceralloy 146 HPSiC After 0, 8.5 and 14.5 Hours Exposure in the Burner Rig.

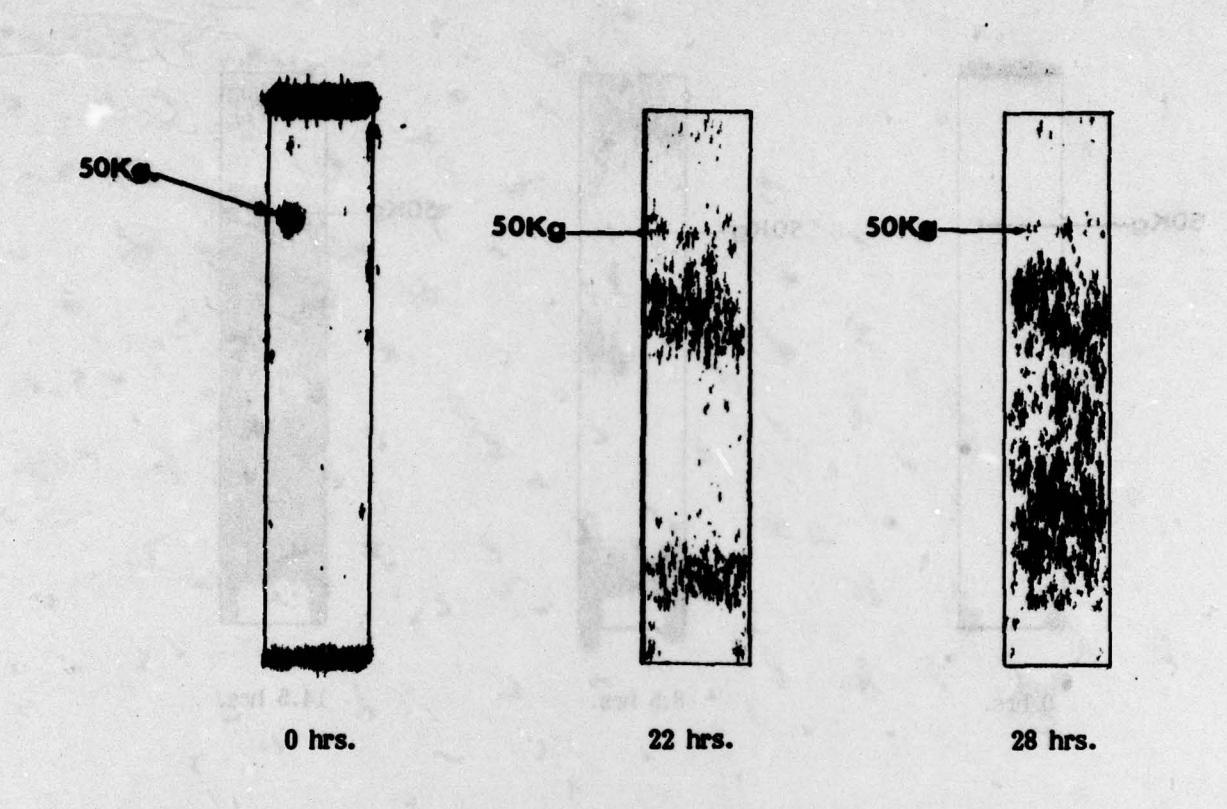
Figure 86. C-scan Recordings of 45 MHz, 18⁰ Surface Wave Inspections of Specimen of NC-230A HPSiC After 0, 22 and 28 Hours Exposure in the Burner Rig.
