Name Of Dam: Location: inventory Number: VA. NO. 16706

GENT BROTHERS DAM RUSSELL COUNTY, VIRGINIA

# PHASE I INSPECTION REPORT NATIONAL DAM SAFETY PROGRAM

SCHNABEL ENGINEERING ASSOCIATES, P.C./ J. K. TIMMONS AND ASSOCIATES, INC.

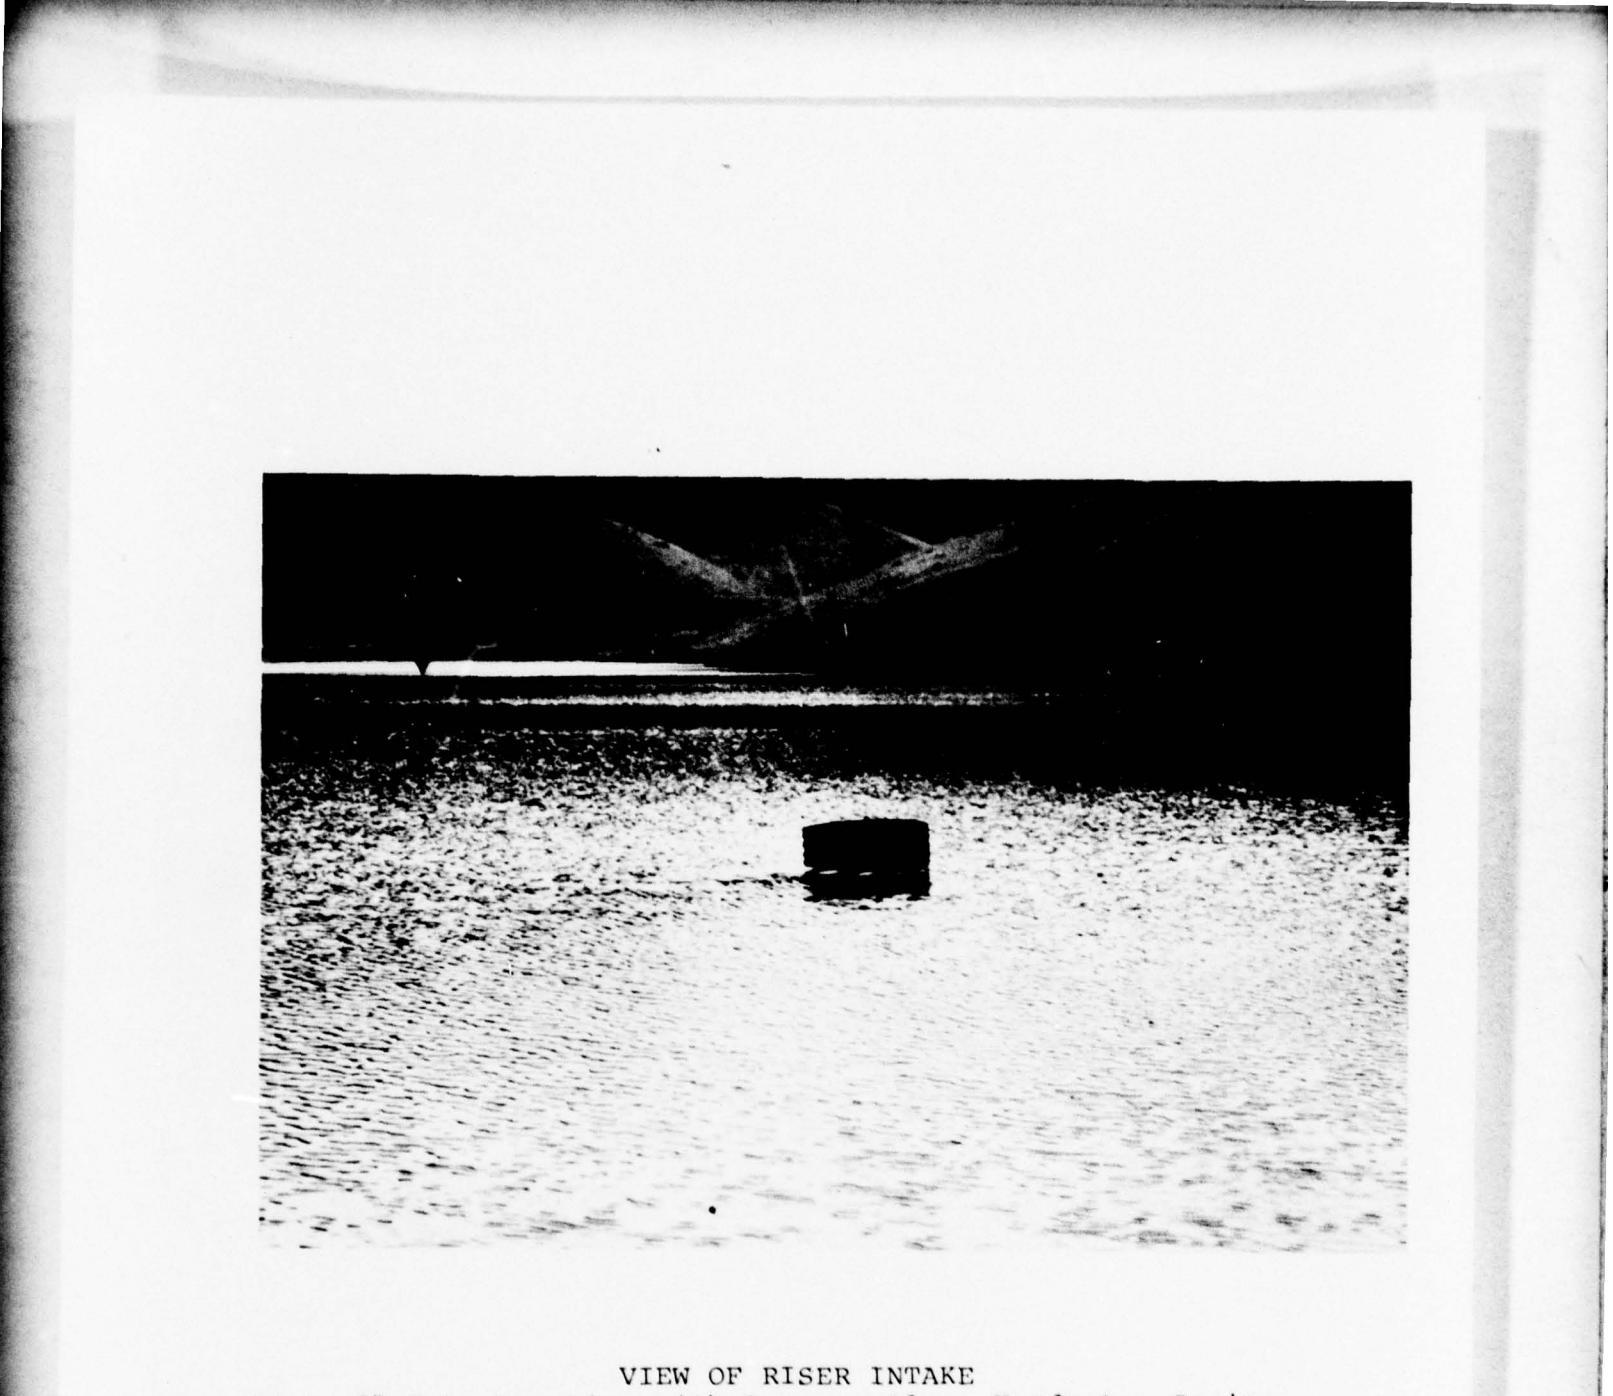
VIEW OF RISER INTAKE (Note 8" Gate Location with Arrow. Also, Headwater Spring Locations in Background at Location of Cattle)
