NRL Memorandum Report 4123

Mechanical Properties of Wrought Iron from Hull Plate of USS MONITOR

November 20, 1979

NAVAL RESEARCH LABORATORY Washington, D.C.

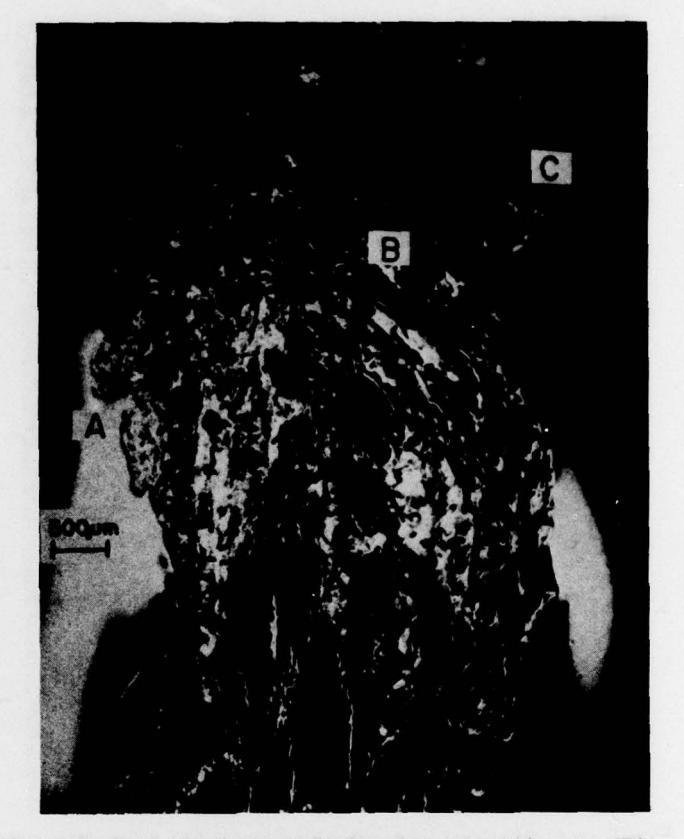
Prior to studying the metal which comprises much of the samples, a piece of the rust and accretion which covered the metal was examined. The primary constituents of the piece were rust, barnacle-like encrustations, a black, waxy material, and silicate particles. The latter are usual constituents of wrought iron. Figure 1 shows the rust piece which is typical of the coating of the plate. Figure 2 shows the layers of rust, wax, and barnacles. Figure 3 shows a two phase silicate particle embedded in the rust.

Fig. 2 – Optical micrograph showing rust (A), wax (B), and barnacles (C)

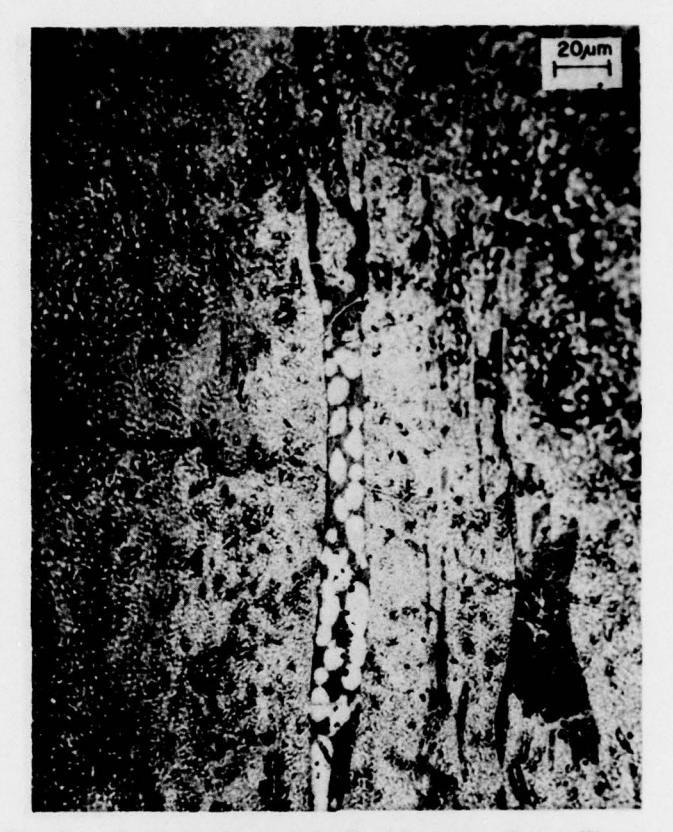
Fig. 3 — Optical micrograph showing two phase silicate particle embedded in rust

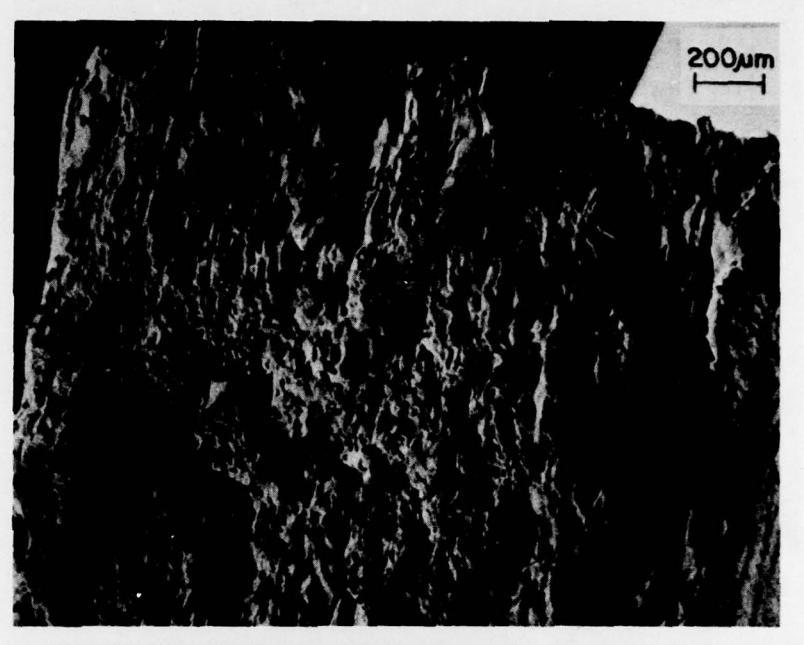
All four specimens exhibited a woody fracture surface and 0404A also exhibited severe delamination. The delaminated surfaces were flat and had rust-colored patches. Flat fracture surfaces on an otherwise ductile material indicate internal corrosion. Each of the eight fracture surfaces was studied in a

high resolution scanning electron microscope. Figure 6 shows a typical woody fracture surface and Figure 7 shows the flat delamination surface. At higher magnifications the fracture surface is composed of dimpled and flat surfaces indicating a combination of microvoid coalescence around inclusion particles, ductile tearing, and shear. The inclusion particles are silicates in the form of spheres and These silicates probably form much of the debris observed on the platelets. surface. Figures 8 and 9 are micrographs of typical fracture surfaces and Figure 10 shows an area of the delaminated surface. Two large silicate platelets lie on the delaminated fracture surface. At higher magnification, in Figure 11, is seen the two phase nature of these particular platelets. Note that the secondary crack passes straight through an embedded particle indicating good bonding at the interface between the particle and the surrounding silicate. Electron/x-ray spectrometry indicates that the small nodules are iron containing a small amount of titanium while the surrounding silicate is composed of iron, silicon, calcium, phosphorous, manganese, and small amounts of titanium, aluminum, and magnesium. The silicate particles observed on the typical fracture surfaces often show solidification structures in voids and dendritic structures as seen in Figures 12 and 13.

Fig. 6 – Woody fracture surface typical of wrought iron. Specimen 0405A.

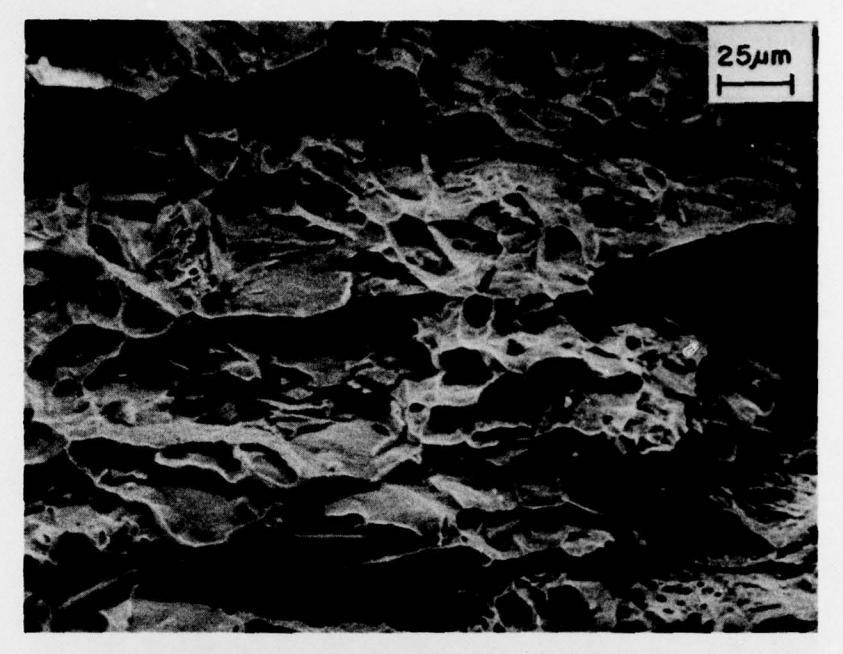
Fig. 8 – Typical fracture surface showing void formation around inclusion particles. Specimen 0405A.

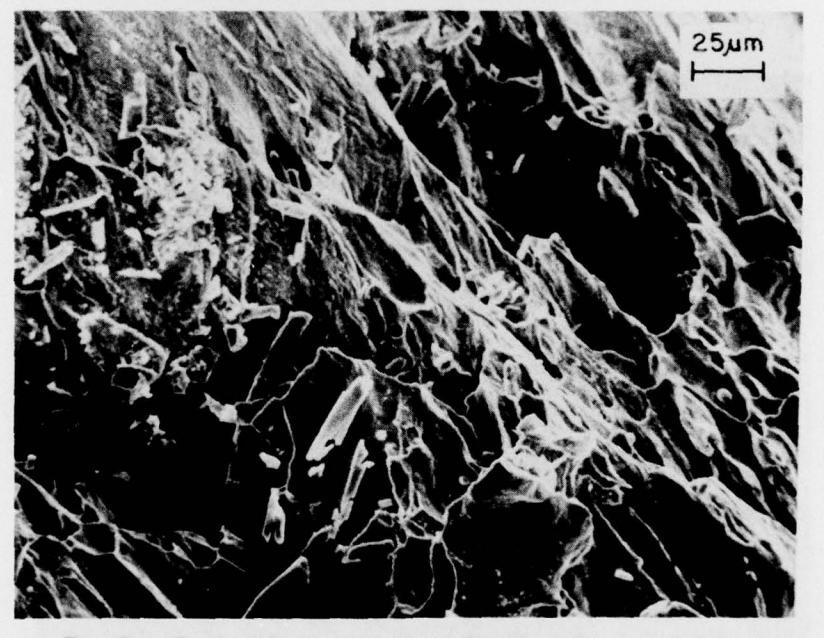
Fig. 9 - Typical fracture surface showing siliceous debris

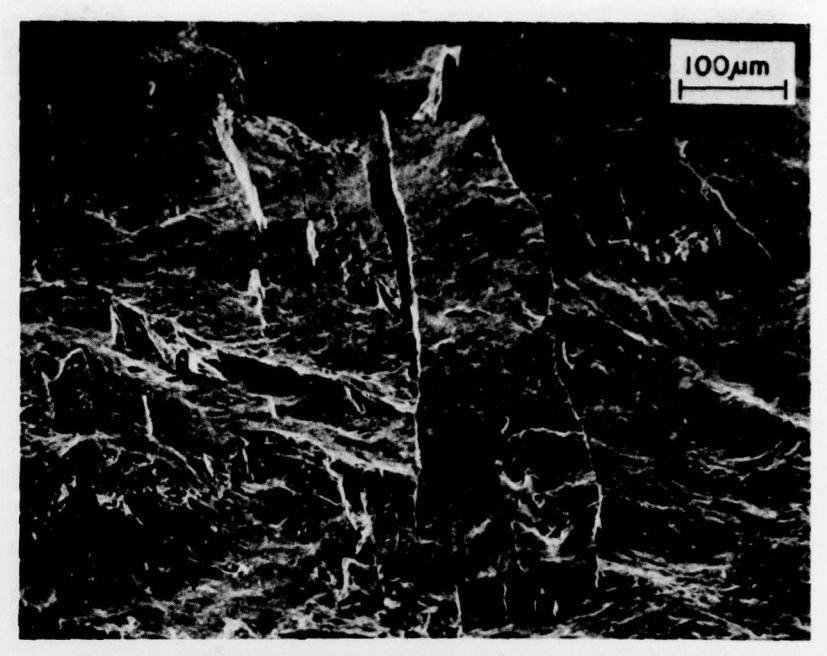
Fig. 10 - Large silicate platelets on delaminated surface. Specimen 0404A.

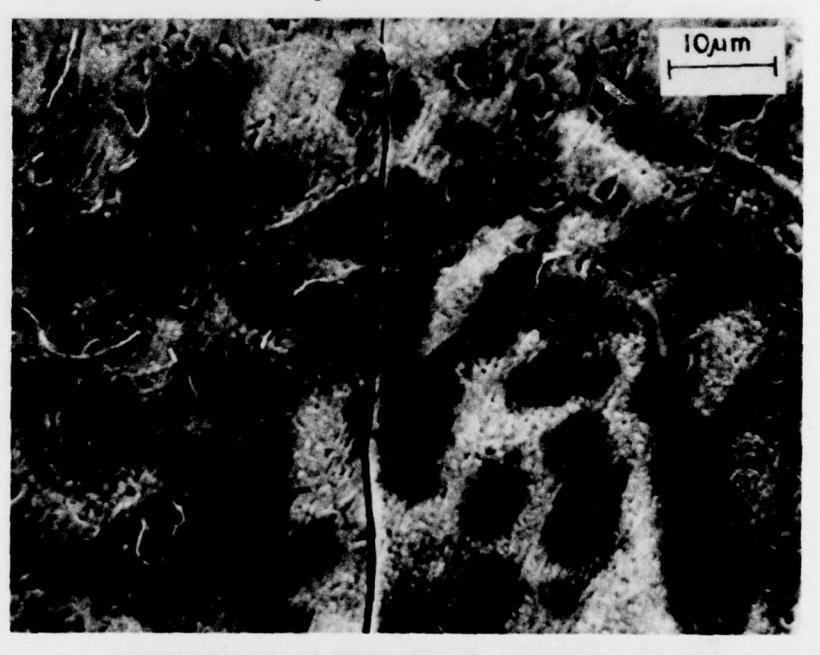
Fig. 11 – Iron particles embedded in silicate platelet on delaminated surface. Higher magnification of Figure 10.

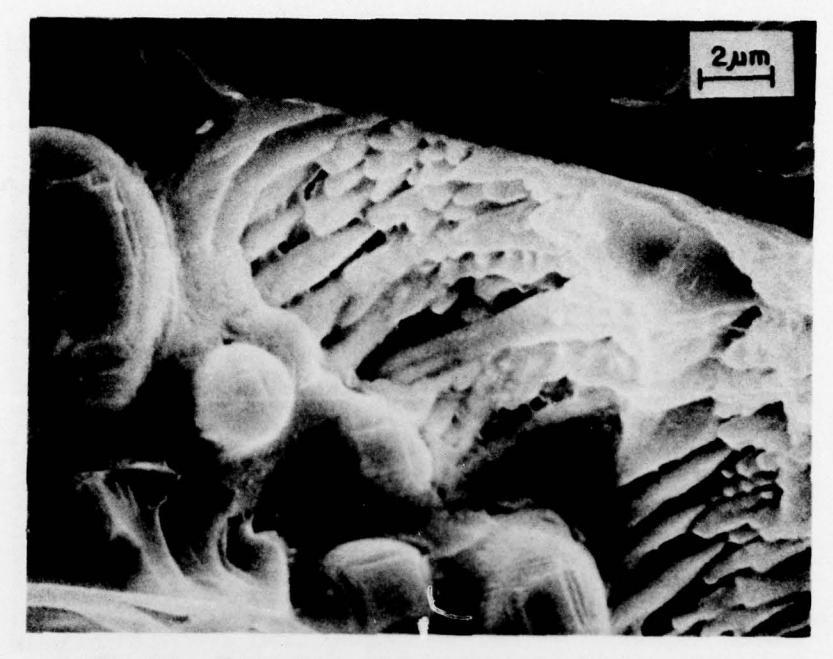
Fig. 12 – Faceted growth structures in siliceous void. Specimen 0404B.

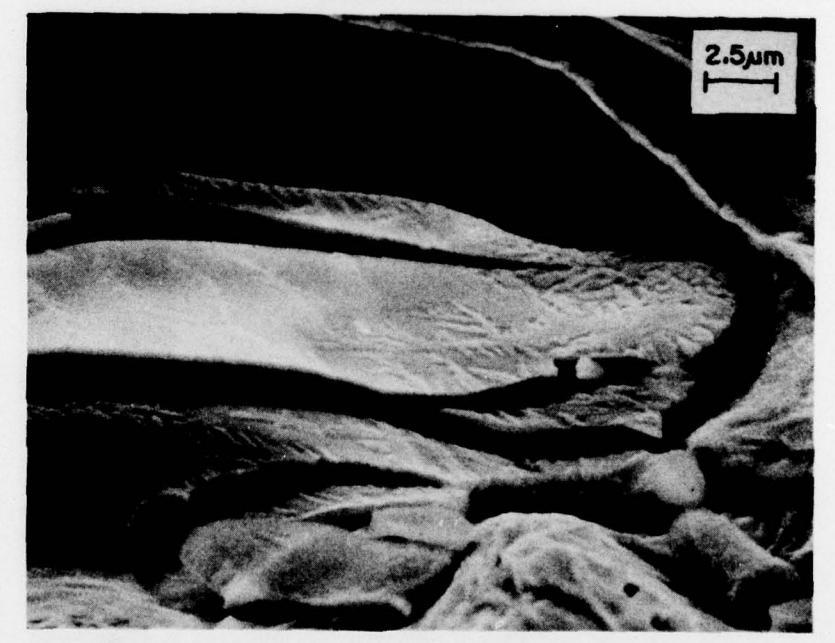
Fig. 13 – Dendritic second phase in silicate platelet. Specimen 0405A.

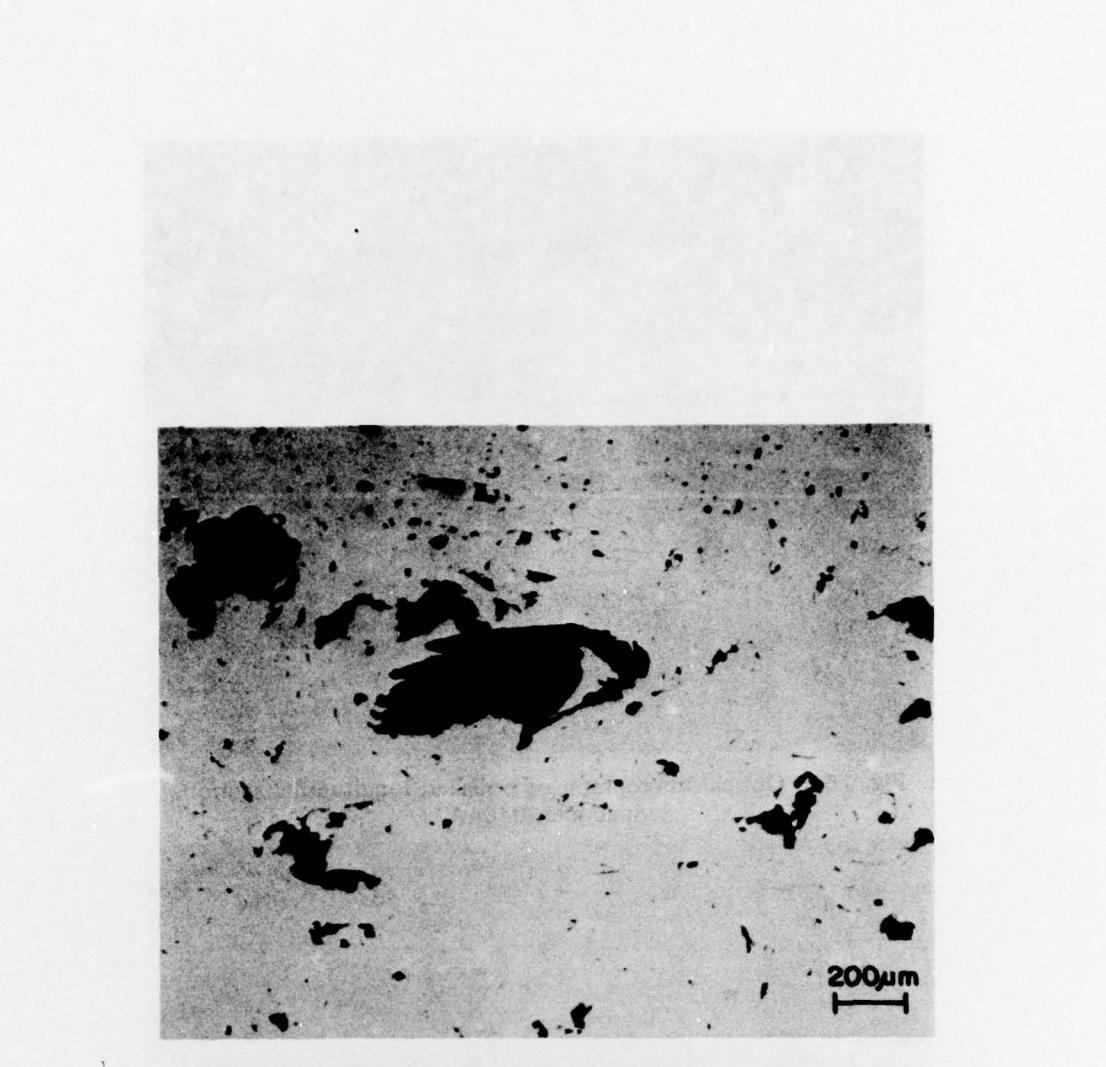
A typical magnified image from the face section obtained by an optical metallograph is shown in Figure 14. The inclusions have two types of composition as indicated by electron/x-ray spectrometry of this polished surface. Some smaller inclusions are composed of iron and silicon with small amounts of phosphorous and titanium. Some larger inclusions have a dendritic or spherical phase surrounded by another phase. This surrounding phase is composed of iron, silicon, calcium, phosphorous, sulfur, titanium, manganese, aluminum, and magnesium; while the inner phase is composed of the same elements but has less calcium, slightly less manganese, more sulfur, and somewhat more titanium.

Fig. 14 – Optical micrograph of polished face section. Specimen 0404A.

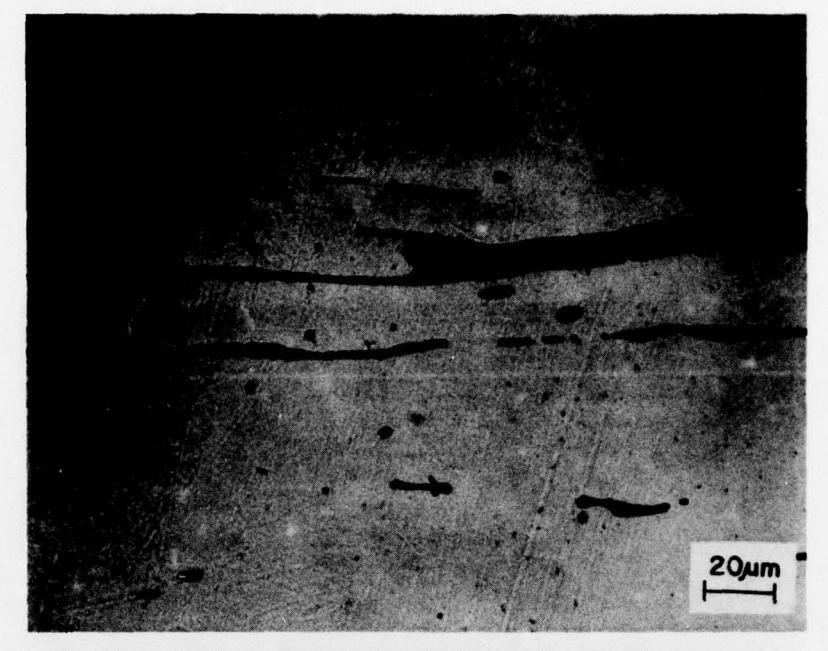
On the face section the inclusions have irregular shapes but they are roughly equiaxed. On the longitudinal and transverse sections, shown in Figures 15 and 16 respectively, the larger inclusions are long and thin and so they are platelets while the smaller inclusions are equiaxed and so they are roughly spherical. On both the transverse and longitudinal sections an occasional large inclusion will be equiaxed indicating a large particle.

Fig. 15 – Optical micrograph of polished longitudinal section. Specimen 0404A.

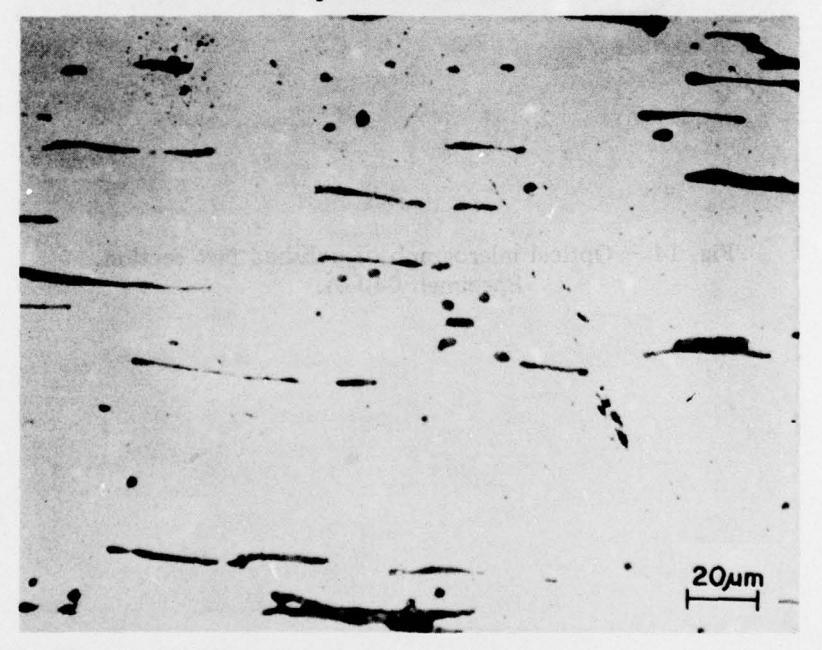
Fig. 16 – Optical micrograph of polished transverse section. Specimen 0404A.

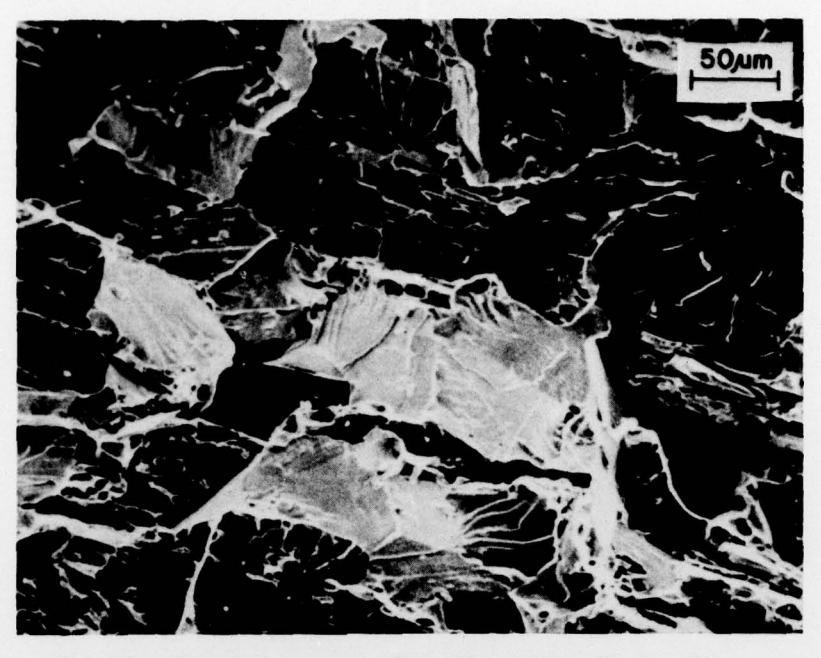
Fig. 17 — Brittle fracture surface of specimen fractured by impact at 77K (-321F). Specimen 0404C.

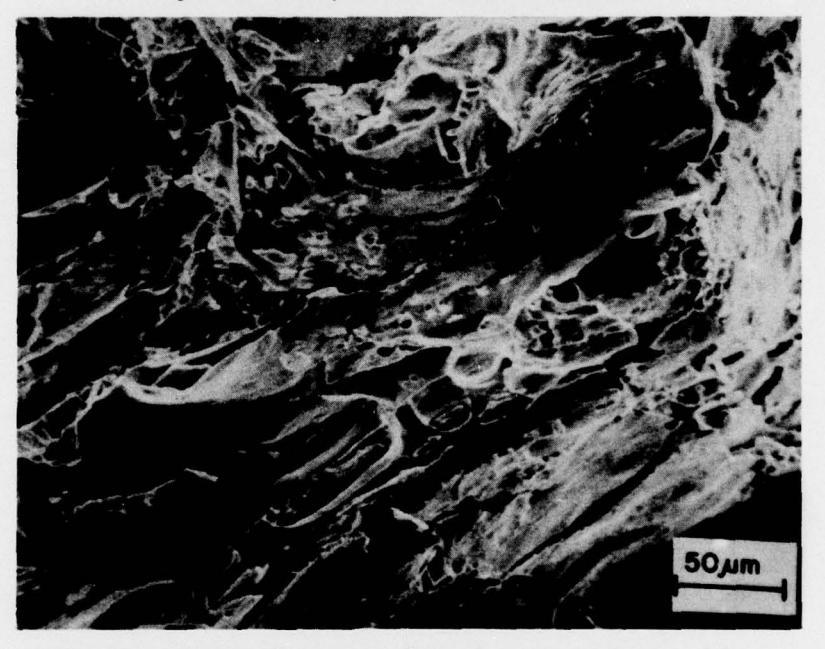
transition, if it occurred between the temperature of the wreck and the temperature at which the mechanical properties were determined, about 297K (75F), would cause the wreck to be much more fragile than the tensile tests indicated. To determine whether the wreck would remain ductile at the temperature of the seawater, two notch impact tests were performed at about 77K (-32IF) and 273K (32F). The specimen struck at 77K broke in a brittle manner and the fracture surface had large, shiny facets. Figure 17 is a scanning electron micrograph of this surface showing the facets and river markings characteristic of brittle cleavage. The specimen struck at 273K behaved in a ductile manner, requiring much more energy to cause fracture. The fracture surface appeared woody like those in the tensile tests. Figure 18 is a representative micrograph of this fracture surface.

Fig. 18 — Ductile fracture surface of specimen fractured by impact at 273 K (32F). Specimen 0404B.
