SCS PA 477 BERKS COUNTY, PENNSYLVANIA

NDS I.D. NO. PA 00720 DER I.D. NO. 6-457 DACW31-80-C-0018 Yew

PHASE I INSPECTION REPORT NATIONAL DAM INSPECTION PROGRAM

JANUARY 1980

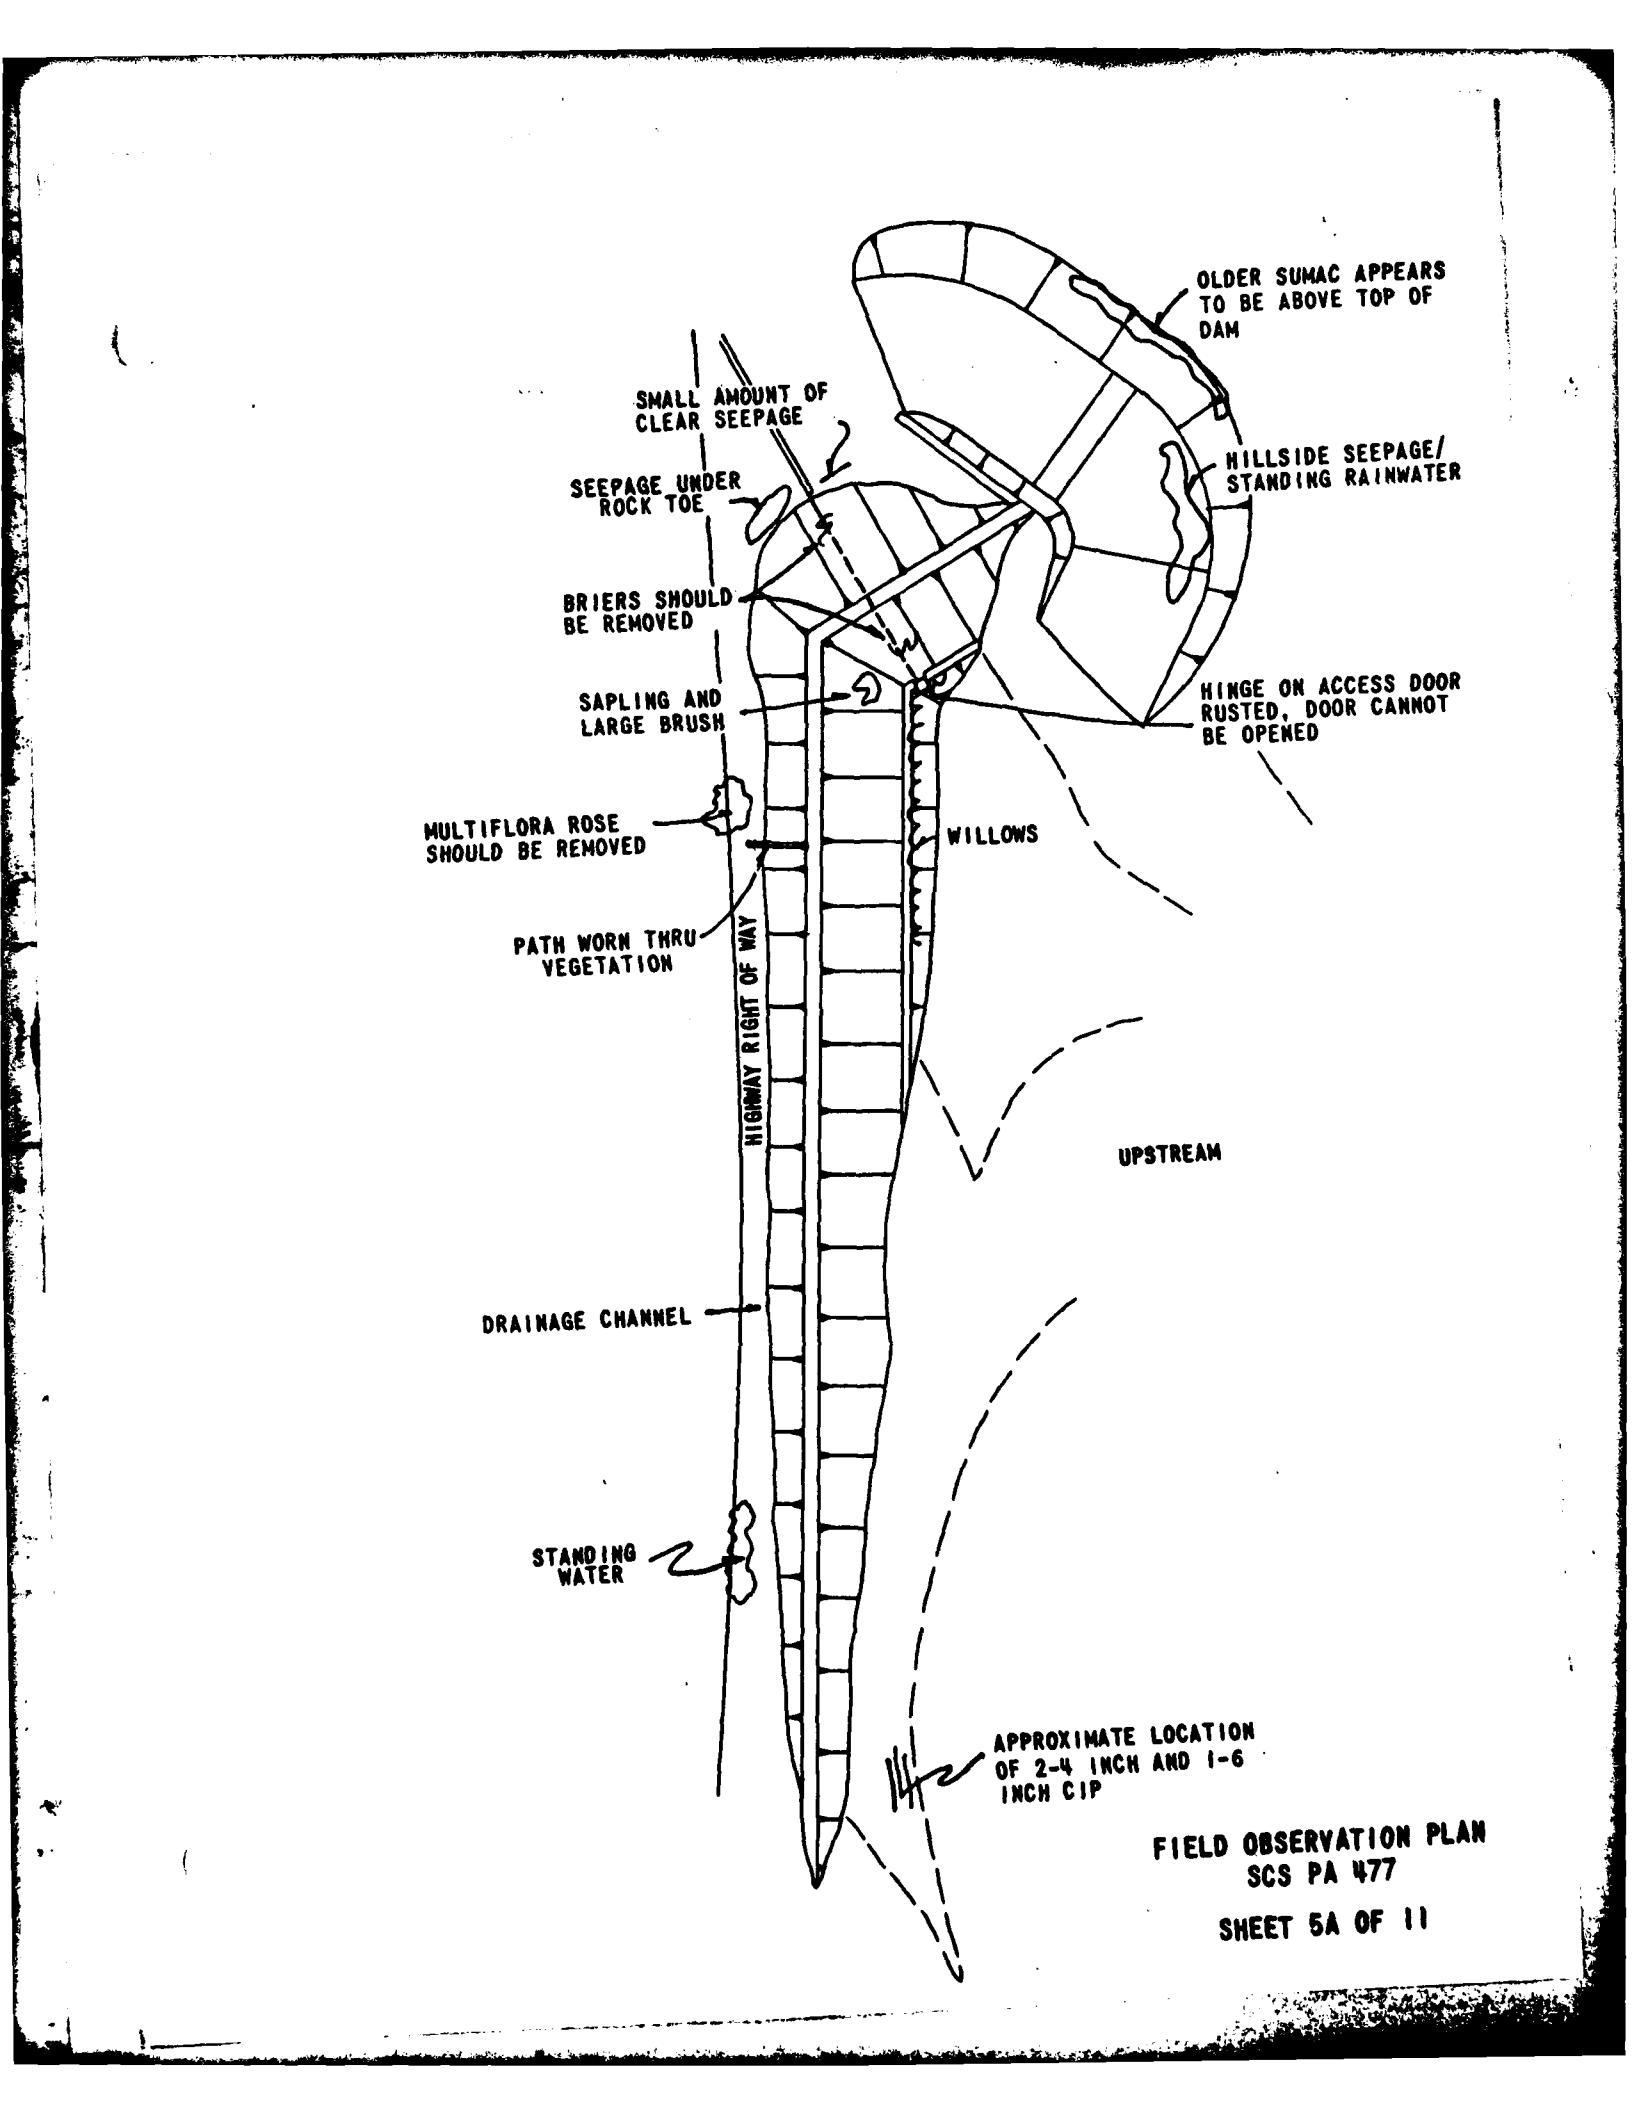
SHEET 58 OF 11

entering below water level from the right of the impact basin. No water was flowing from the embankment drains outletting through the impact basin walls, but slight seepage was noted within the rock to the left of the impact basin. Standing water was noted at the upper end of the drainage swale between the embankment and the highway. Three cast iron pipes were observed draining into the reservoir at the upper end. See sheet 5a of Appendix A.

FIELD OBSERVATION PROFILE SCS PA 477

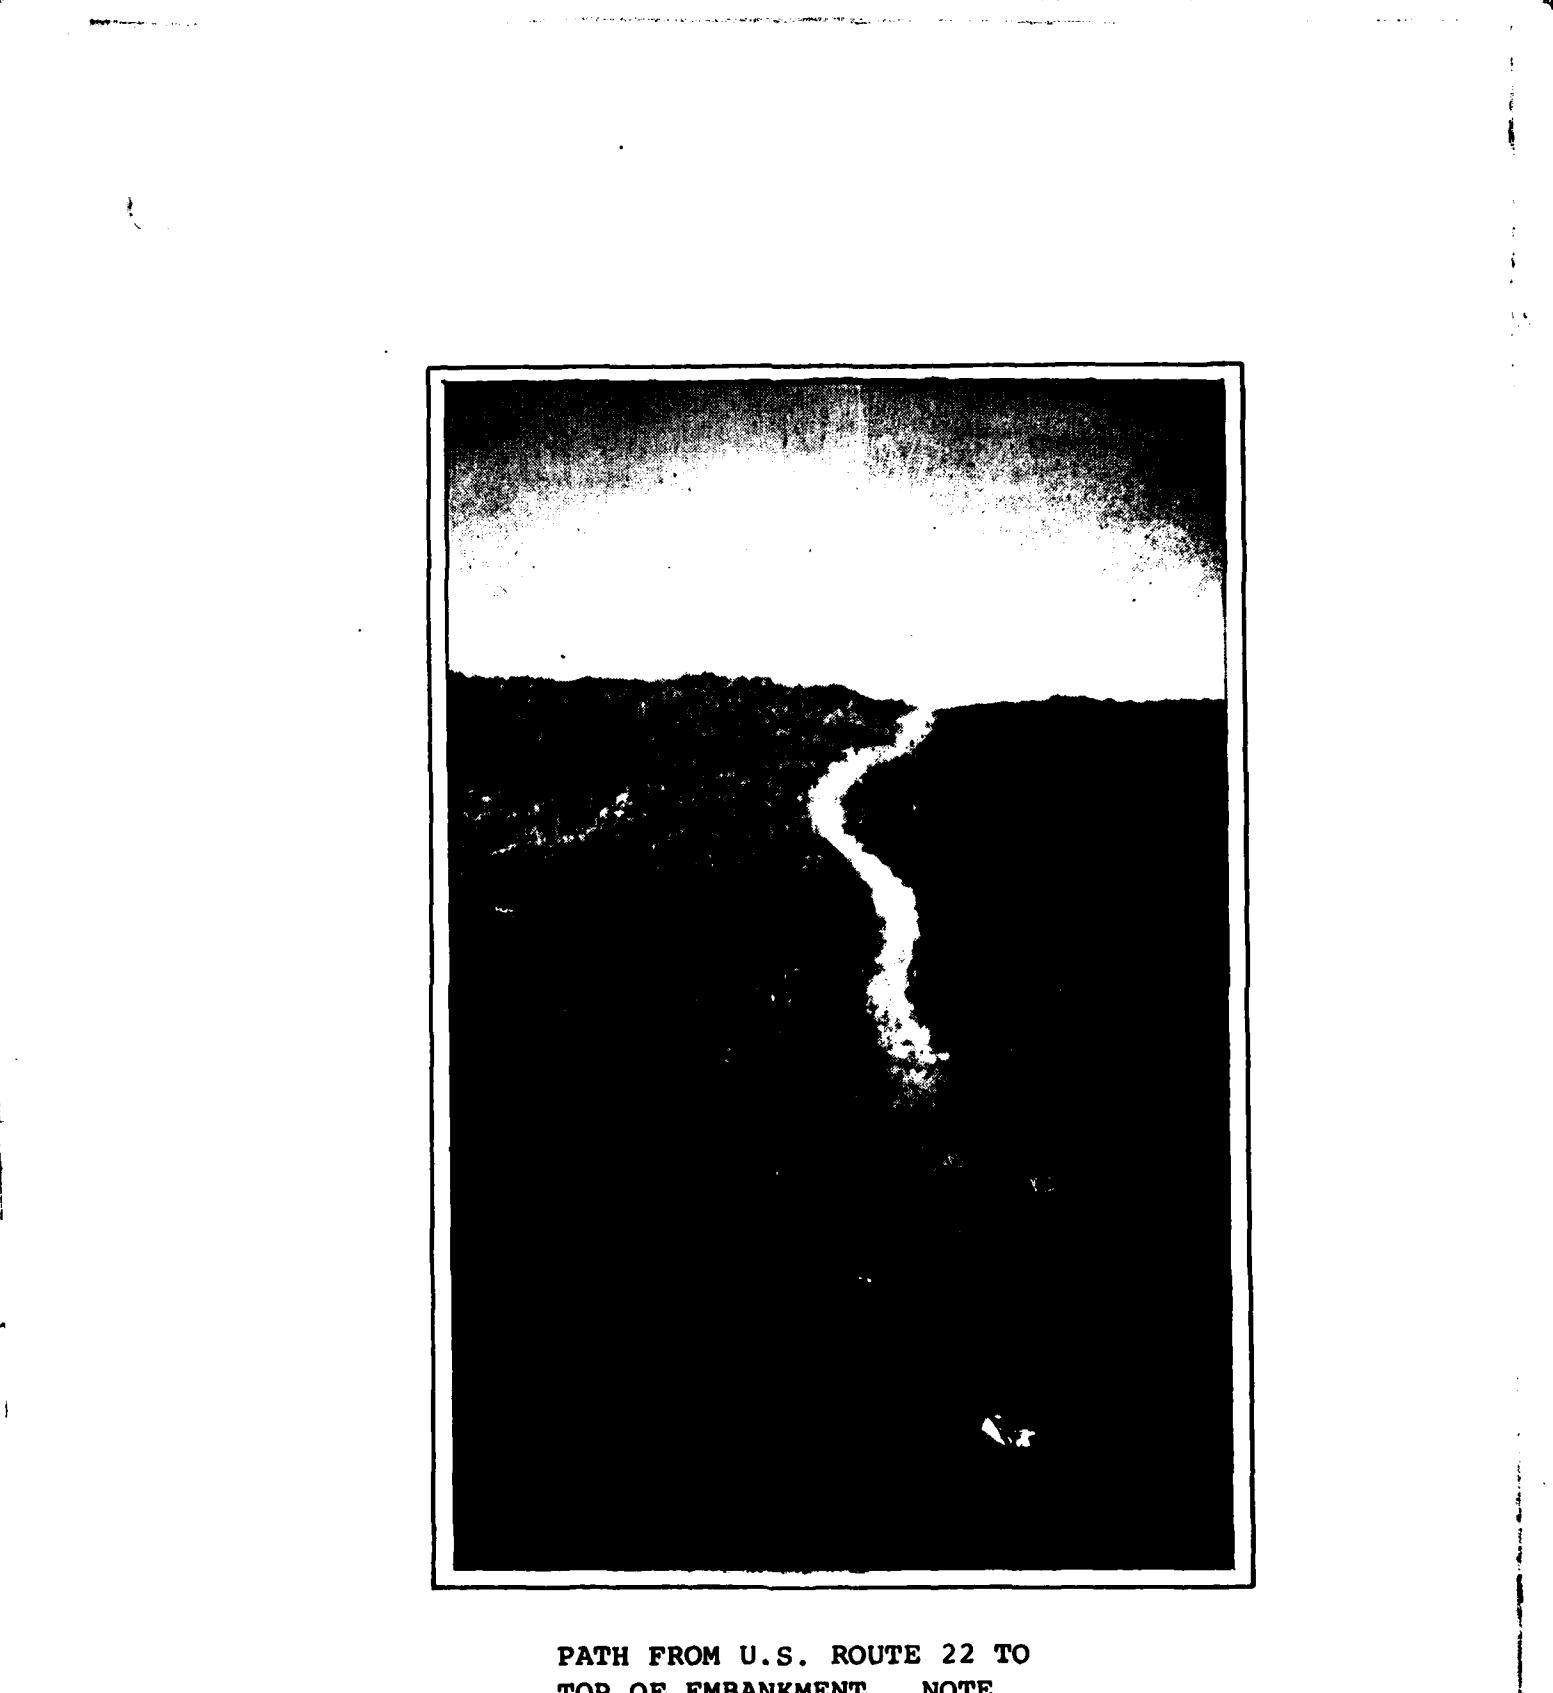
PHOTOGRAPH NO. 8

TOP OF EMBANKMENT. NOTE MULTIFLORA ROSE TO THE RIGHT OF THE PATH.

1. The multiflora rose should be removed from the drainage swale between the embankment and the highway to prevent the spread of the multiflora rose to the embankment.
