REPORT DOCUMENTATION PAGE	READ INSTRUCTIONS BEFORE COMPLETING FORM
1. REPORT NUMBER 2. GOVT ACCESSION	NO. 3. RECIPIENT'S CATALOG NUMBER
NRL Memorandum Report 4202 AD-AD&44	989

F. R. Stonesifer, H. L. Smith, and D. A. Meyn	
S. PERFORMING ORGANIZATION NAME AND ADDRESS	10. PROGRAM ELEMENT, PROJECT, TASK
Naval Research Laboratory	AREA & WORK UNIT NUMBERS
Washington, D.C. 20375	NDI Problem 84 M001 X-0
······································	NRL HODelli 84-MOOT-X-0

11. CONTROLLING OFFICE NAME AND ADDRESS	12. REPORT DATE
Department of the Navy Nevel See Systems Command DMS 205-A11	April 4, 1980
Washington, D.C. 20362	26

FAILURE ANALYSIS OF ROLLER CHAIN DRIVES

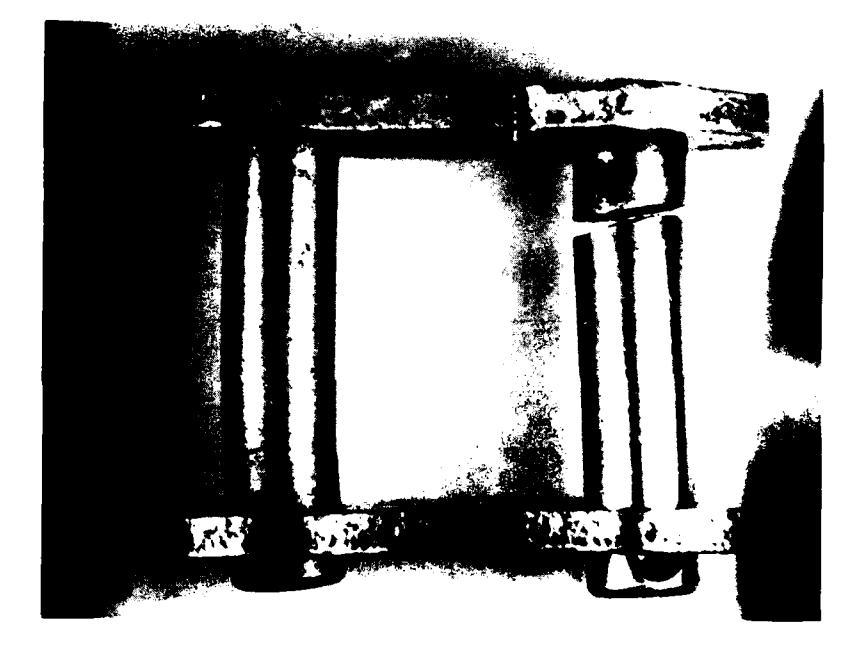
A pin of the connecting link fixing the chain to the support block was broken approximately 0.110" from the link plate near the peened end, Fig. 1. Apparently a crack initiated on the tension side, assuming tensile loading of the chain and the associated bending in the pin. No significant pitting or fretting was evident. The pin was noticeably bent at the fractured end. The fracture surface is shown in Fig. 2 with the origin visible at the top of the figure. The pin is martensite with case hardening to a depth of 20 to 25 mils and a surface hardness of 62 to 63 R_c, Figs. 2 and 3. Although post-fracture corrosion obscured fracture surface details at the origin, the case fracture was predominately transgranular, with some small areas of intergranular failure, Fig. 4. The core fracture was completely transgranular. A longitudinal hairline crack was found in the pin extending in from the surface to the interface between the hardened case and softer core, but it was not near the fracture origin. The probable cause of failure is overloading. There is no indication that the pin was substandard in strength or hardness. Surface hardness of the pin was approximately 60 on the Rockwell C scale.

Supporting the overload hypothesis, the other pin in the connecting link was found to be bent and cracked in two places at the cotter pin end but did not separate, Figs. 1 and 5. The two cracks correspond to locations just inside and just outside the end of the roller bushing on the tension side of the pin. The cotter pin, which constrains the link plate, had sheared off allowing the plate to move out and impose high bending stresses on the end of the pin.

Fig. 1 — The double cotter type connecting pin link which failed in June 1979. Note the bending in the fractured pin. Note the indentation and cracks near the end of the other pin. This was an in-service failure photographed at 3.5X.

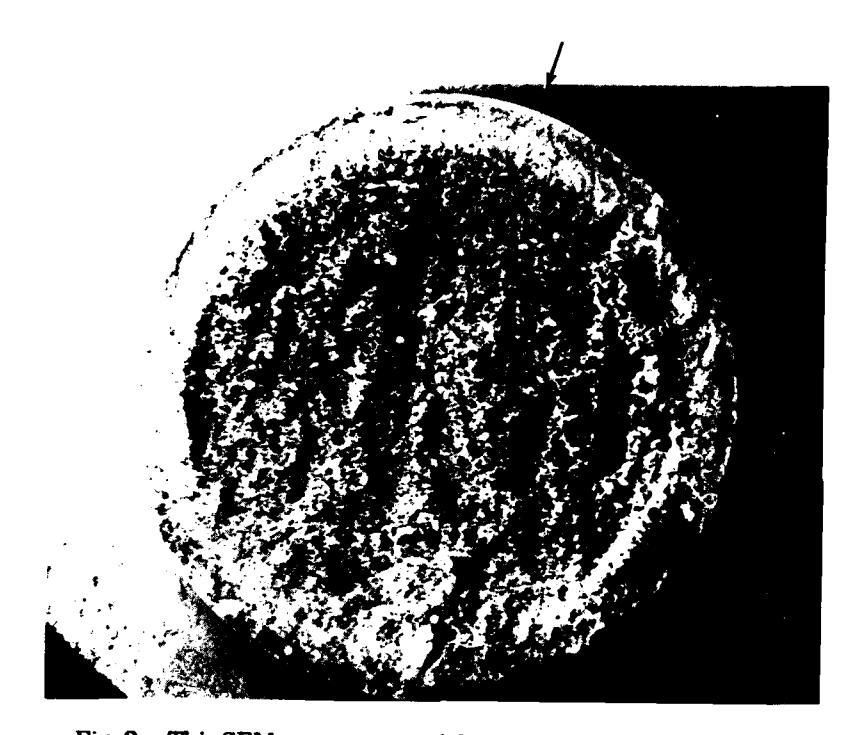
Fig. 2 — This SEM macrograph of the fracture surface from the June failure shows the fracture origin (see arrow). Depth of the core hardening can be inferred to be 0.020 in. to 0.025 in. from the fracture appearance. (16X).

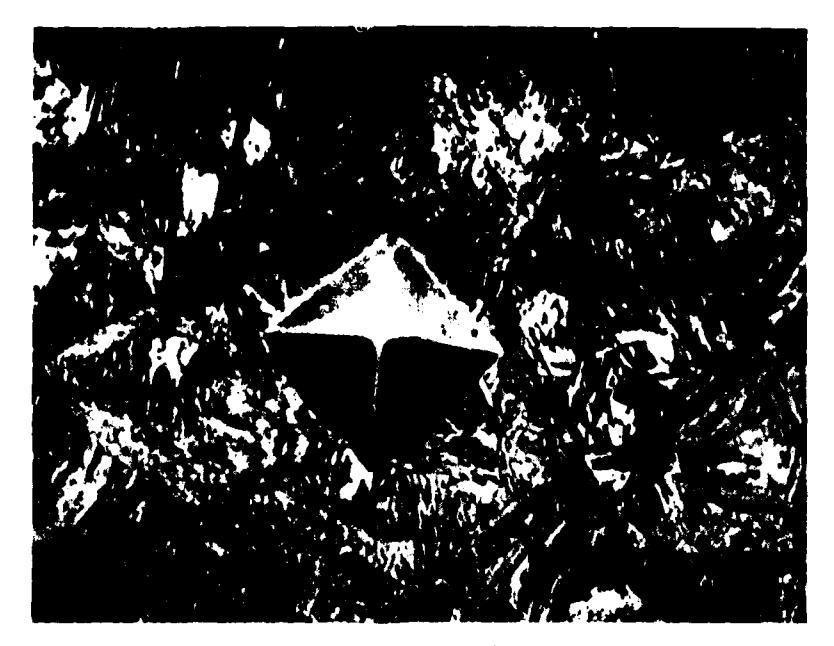
Fig. 3 — Polished and etched cross-section of the June failed pin shows structure and microhardness indents. (1000X).

(a) Fine martensite in hardened area 0.006 in. from the pin surface. Small indent connotes high hardness.

(b) Coarser martensite in core of pin. Larger indent connotes lower hardness.

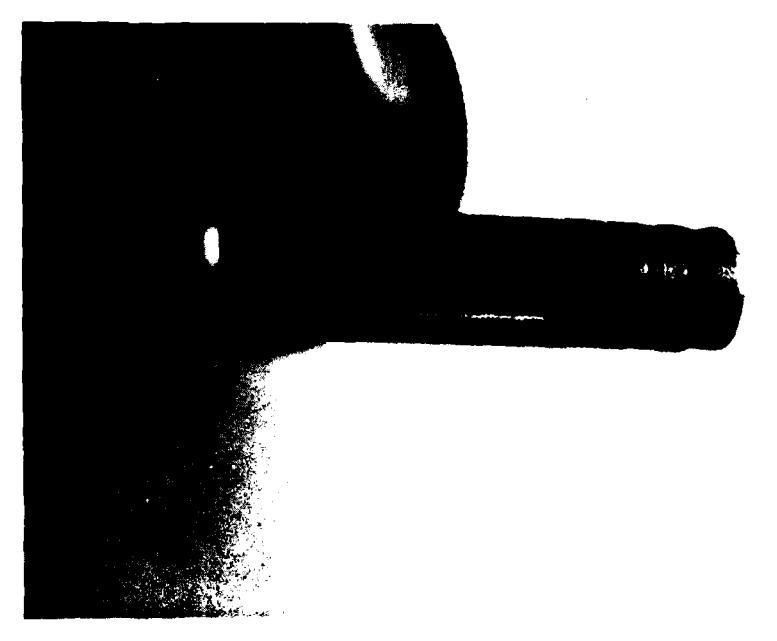
Fig. 5 — The non-fractured, bent and cracked pin from the June failure. Fretting corrosion is evident around the cotter pin and two cracks are visible on the side of the pin subjected to tensile bending stresses. (4X).

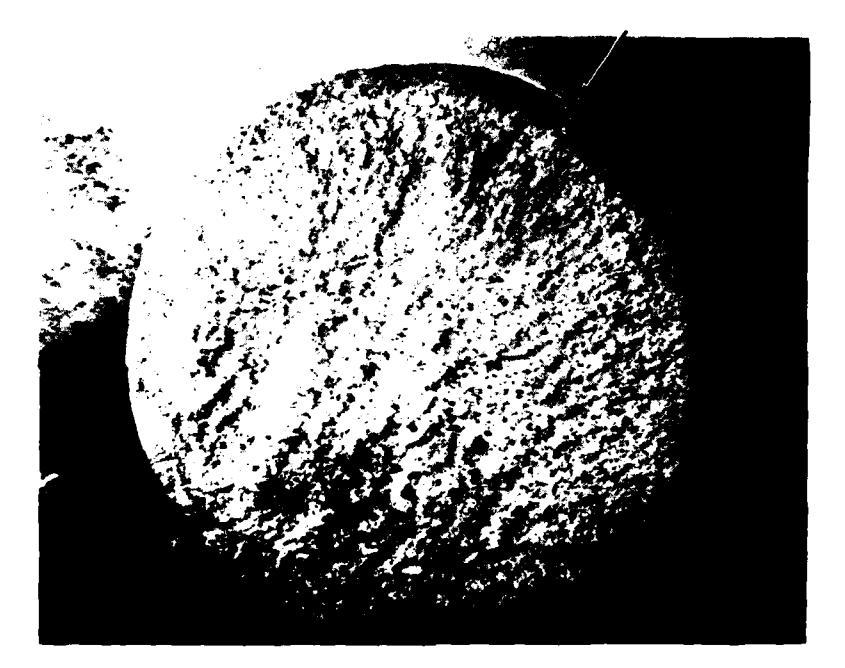
The pin of the support block end of the connecting link broke near its peened end, about 0.130" inside the link plate. Origin is at a corrosion pit, about 0.0016" deep, on the side of the pin subjected to tensile bending stress when the chain is loaded in simple tension, Figs. 6, 7 and 8. In this case, no permanent bend deformation was evident. The case fracture is intergranular to within a few mils of the origin pit where the surface becomes too corroded to determine the cracking mode. The case hardening depth is 0.020" to 0.025". Probable cause of failure is stress corrosion cracking, with some corrosion fatigue.

Fig. 6 — Macrophotograph of fracture surface of pin from the July failure. The fracture origin is indicated by the arrow and is associated with a pit existing before the crack initiated. (16X).

a) Replace the case hardened 1021 pins with pins of greater resistance to stress corrosion cracking, such as MP35N stainless steel.

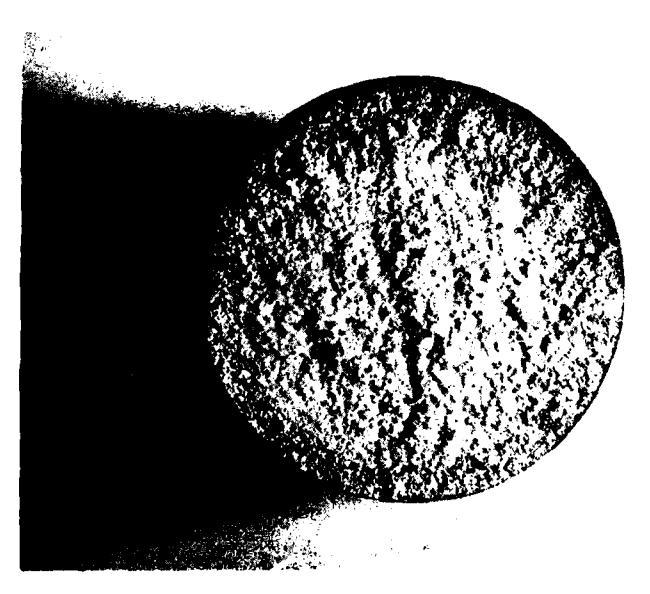
The fracture surface was intergranular in the hardened case and in the adjacent core where the stress corrosion crack had penetrated, Fig. 13 and 14. No corrosion pit was evident at the origin. General corrosion was obvious from the thick black oxide scale on the pin and a redorange precipitate in the solution.

Fig. 13 — Macrograph of stress corrosion cracked pin tested in 3 point bending. The fracture origin area is near the top of the figure. Intergranular cracking goes well into the core in some spots. (12X).
