MISCELLANEOUS PAPER SL-80-8

# CONCRETE AND ROCK TESTS MAJOR REHABILITATION, DRESDEN ISLAND LOCK AND DAM, ILLINOIS WATERWAY CHICAGO DISTRICT, PHASE I REHABILITATION

September 1980

Final Report

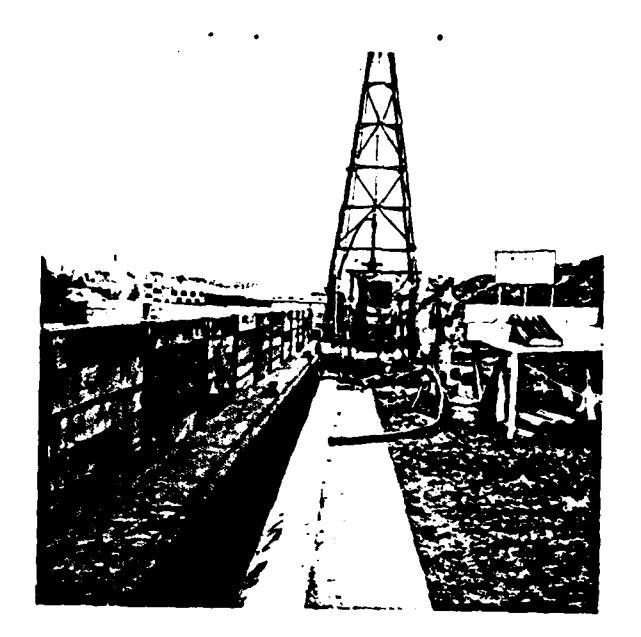
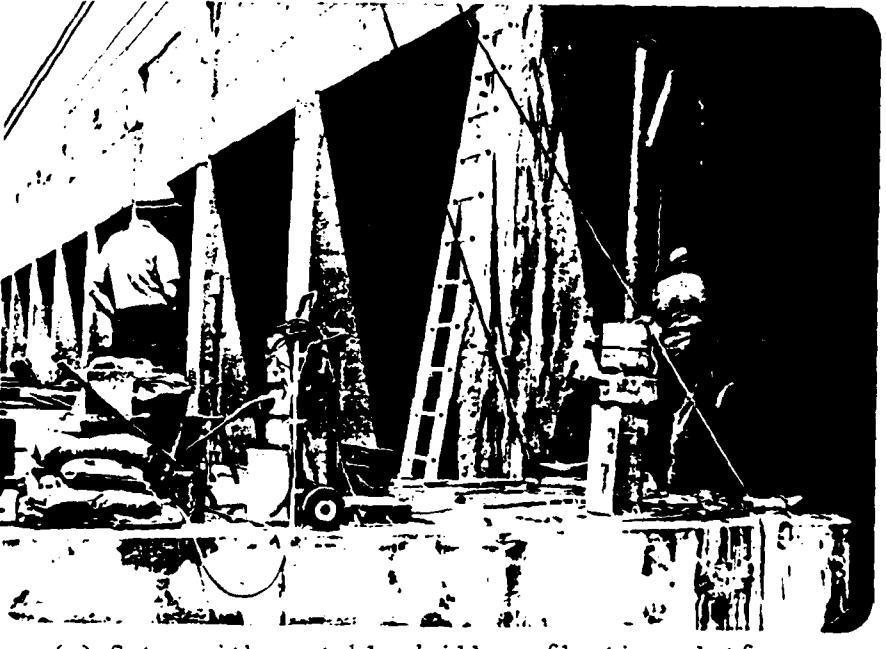
Figure 2. Typical drill rig setups, Dresden Island.

(b) Set up of skid-rig on top of approach wall.

(a) Setup with portable drill on floating platform

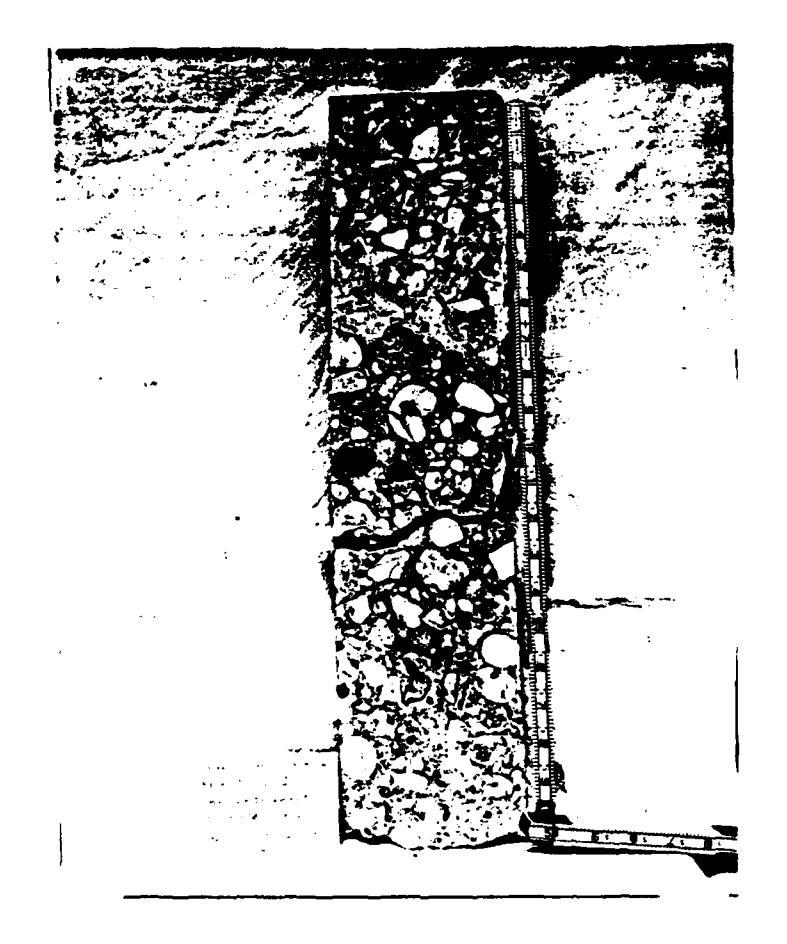
Figure 3. New and Old Concrete

60. The concrete varied in physical condition. The new concrete was intact and in good condition but as shown in Figure 3 the old concrete in boring D-1 is fractured to a depth of 1.5 ft. This depth is about 0.7 ft below the contact of the new and old concrete. In boring D-6, as illustrated in Figure 4, and in boring GW-5 a crack exists about 0.1 ft deeper than the contact of the old and new concrete. In boring GW-2 an old crack exists at the contact of the old and new concrete. Borings GW-1 and GW-8 were the only other borings with new concrete overlying the old concrete. The concrete was intact and in good condition throughout the entire length of core.

New concrete ends at about 0.8 foot depth and old concrete is below it. Parallel to subparallel fractures are to a depth of about 1.5 feet.

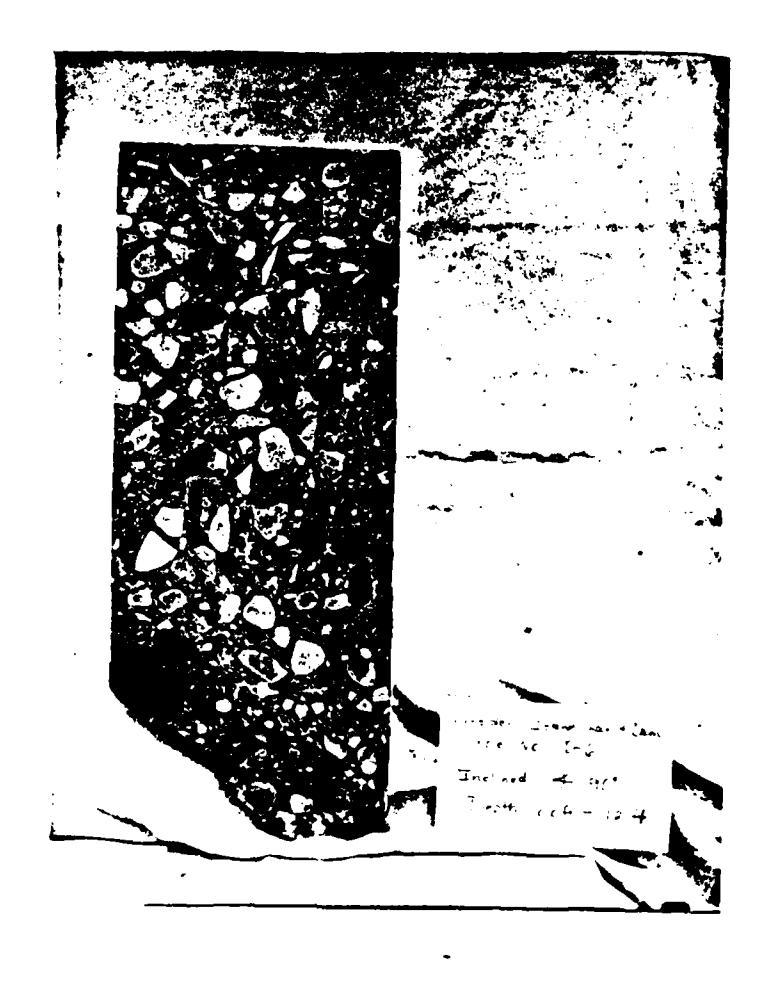
Figure 4.

New concrete is to a depth about 1 foot. The break parallel to the contact of the old and new concrete was considered to be old.

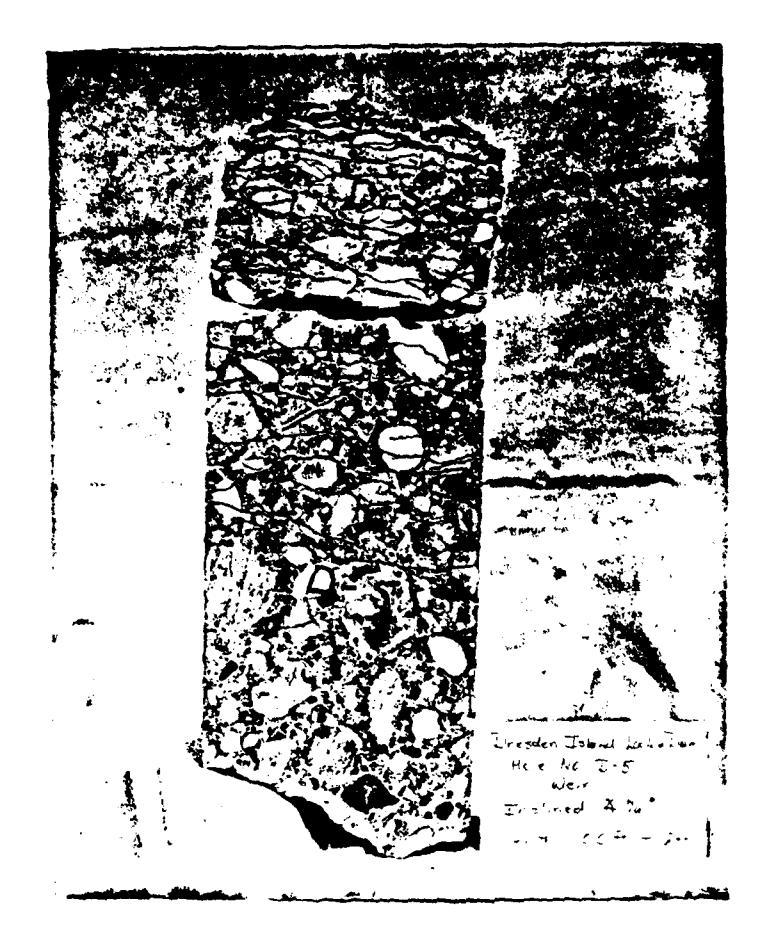
Figure 5. Effects of frost action

61. The near surface old concrete in some areas was intact and did not show any signs of deterioration. Other areas were highly fractured but remained relatively intact as illustrated in Figures 5 and 6. In other areas the surface had scaled off and the concrete near the surface was not intact as shown in Figure 7.

62. The depths of deterioration shown in Plates 10-15 are caused by frost action. This deterioration of the concrete was characterized by cracking parallel and subparallel to the surface of the concrete. The cracks propagate through aggregate as well as the paste. The depth of frost damage of the concrete was indicated at the deepest point when cracking was through the aggregate and paste.

The parallel and subparallel fractures decrease in frequency as the depth increases. The near surface fractures have been wedged apart by frost action and is easily removed.

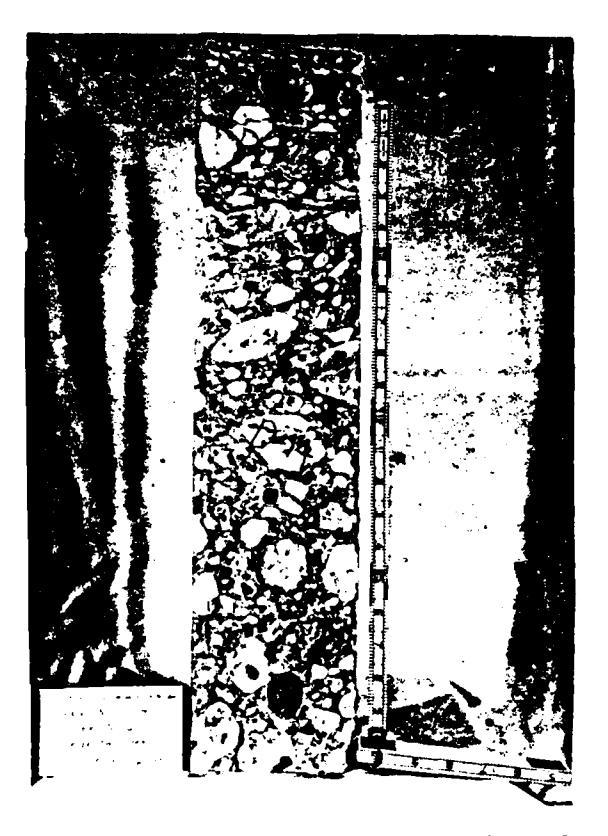
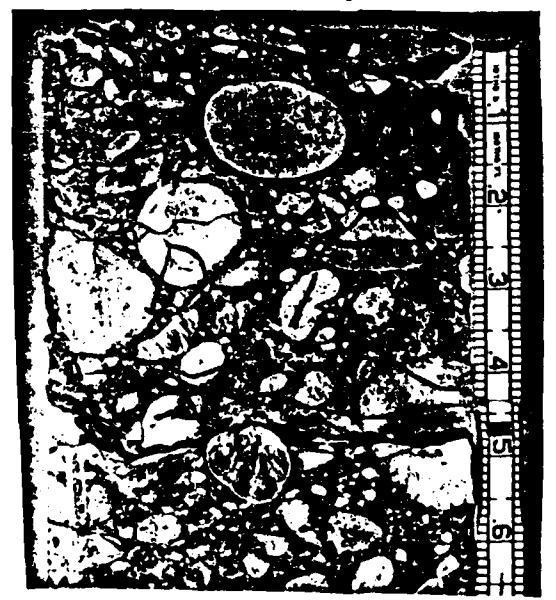
Figure 6. Effects of frost action.

Dresden Island Lock and Dam Hole No. D-14 Pier No. 6 Horizontal Core Depth 0.0 ft - 23 ft

Not all of the fractures were caused by frost action. Some of the fractures were caused by poor consolidation as shown by vertical crack near the bottom of this piece of core.

A close up of D-14 shows fractures going through paste and extending into aggregates. The near surface pieces were easily removed.

The lower velocity of the near surface concrete reflects the subparallel cracking in the concrete (see Figure 6 for example). However, the strength of the same core does not indicate the damaged concrete. The reason is that often times cracks in cores that are perpendicular to the axis of applied load have little effect on compressive strength.

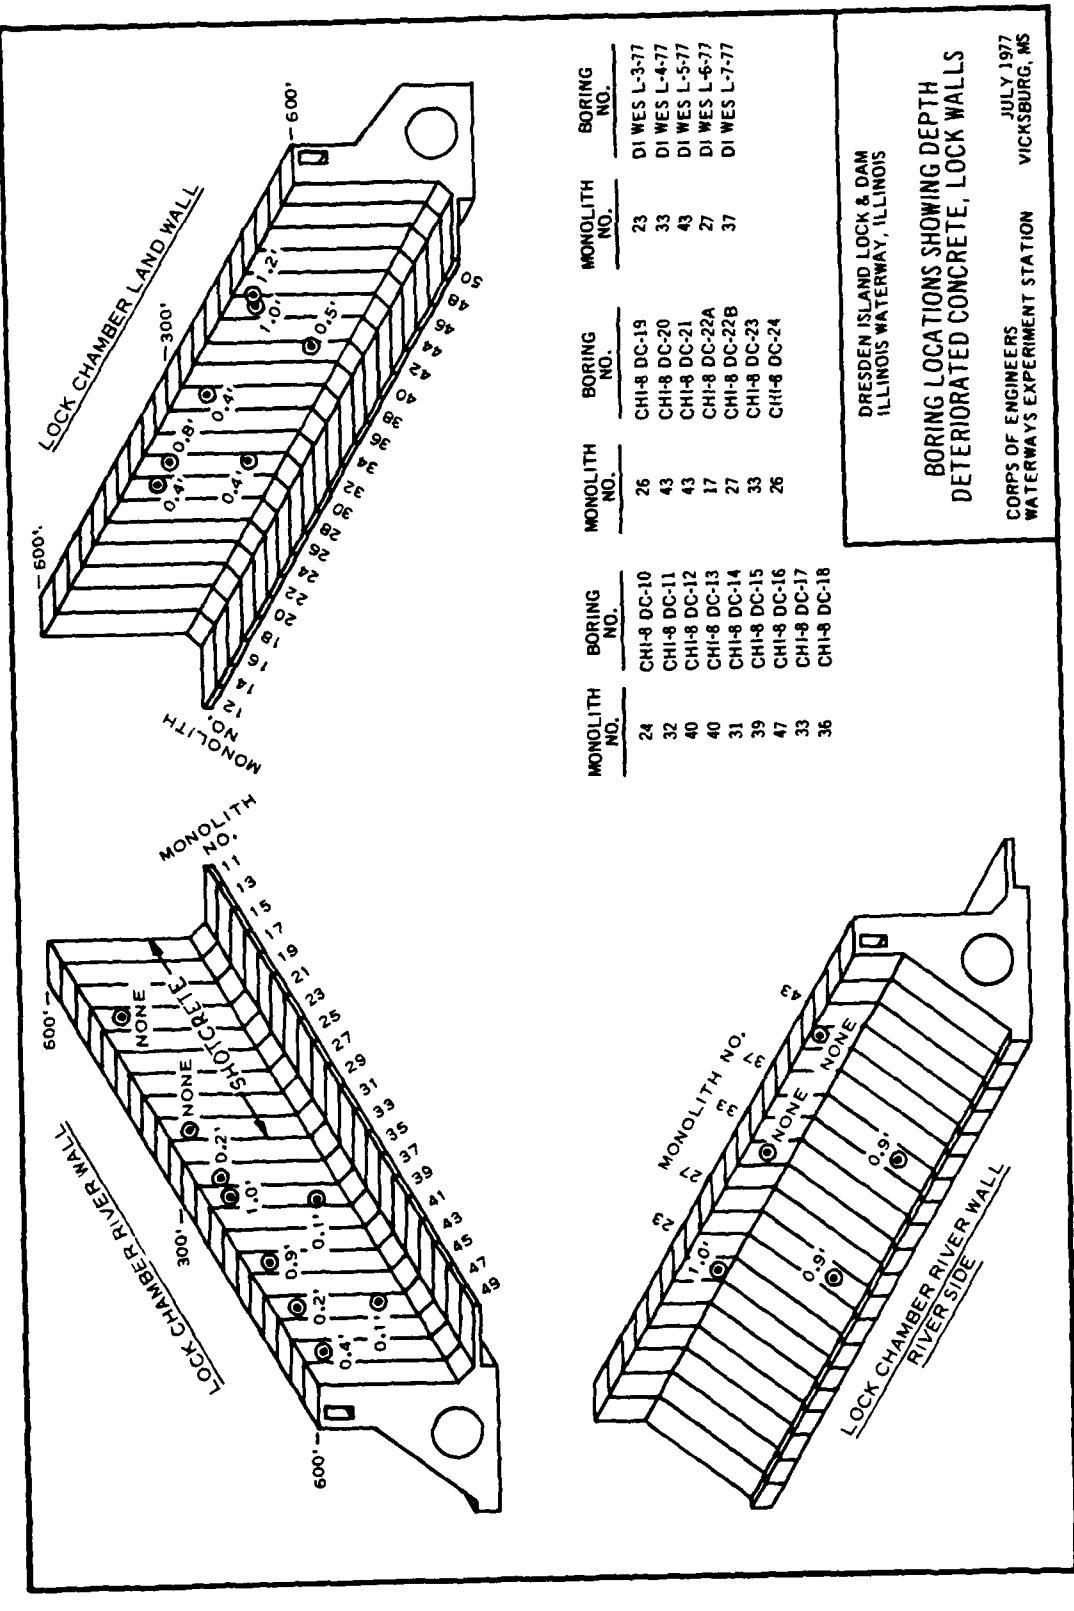
64. Depth of deterioration. The average depth of concrete deterioration through the eroded portion of the wall is 0.7 ft; the maximum depth is 1.2 ft (see Figure 8 for depth of deteriorated concrete for each hole). Figure 8 is a duplicate of Plate 1 which shows both boring locations and depth of deterioration; it is presented here for continuity. The total depth of deterioration as measured from the original face of the lock wall is the sum of the eroded depth and of the present frost damaged concrete. The deepest damaged concrete is near the top of the wall.

66. Depth of deterioration. The average depth of deteriorated concrete throughout this side of the wall is 0.7 ft; the maximum depth is 1.0 ft (see Figure 8 for depth of deteriorated concrete for each hole). The deepest frost damaged concrete is near the top of the wall. All of the cores exhibit frost damage near the veritcal lock wall surface.

68. Depth of deterioration. The average depth of concrete deterioration in borings L-3, L-6, and L-7 is 0.9 ft; the maximum depth is 1.0 ft. Frost damage was not evident in borings L-4 and L-5 (see Figure 8 for location). It is possible that the areas where no frost damage showed up in the cores, the concrete was well consolidated and the surface not cracked so that water could penetrate the concrete. Severe erosion and scabbing of the concrete is occurring in many locations along the wall.

97. It is recommended that 9 to 12 in. of concrete on exposed vertical and sloped surfaces be removed and replaced with new concrete. Localized areas may require deeper removal.

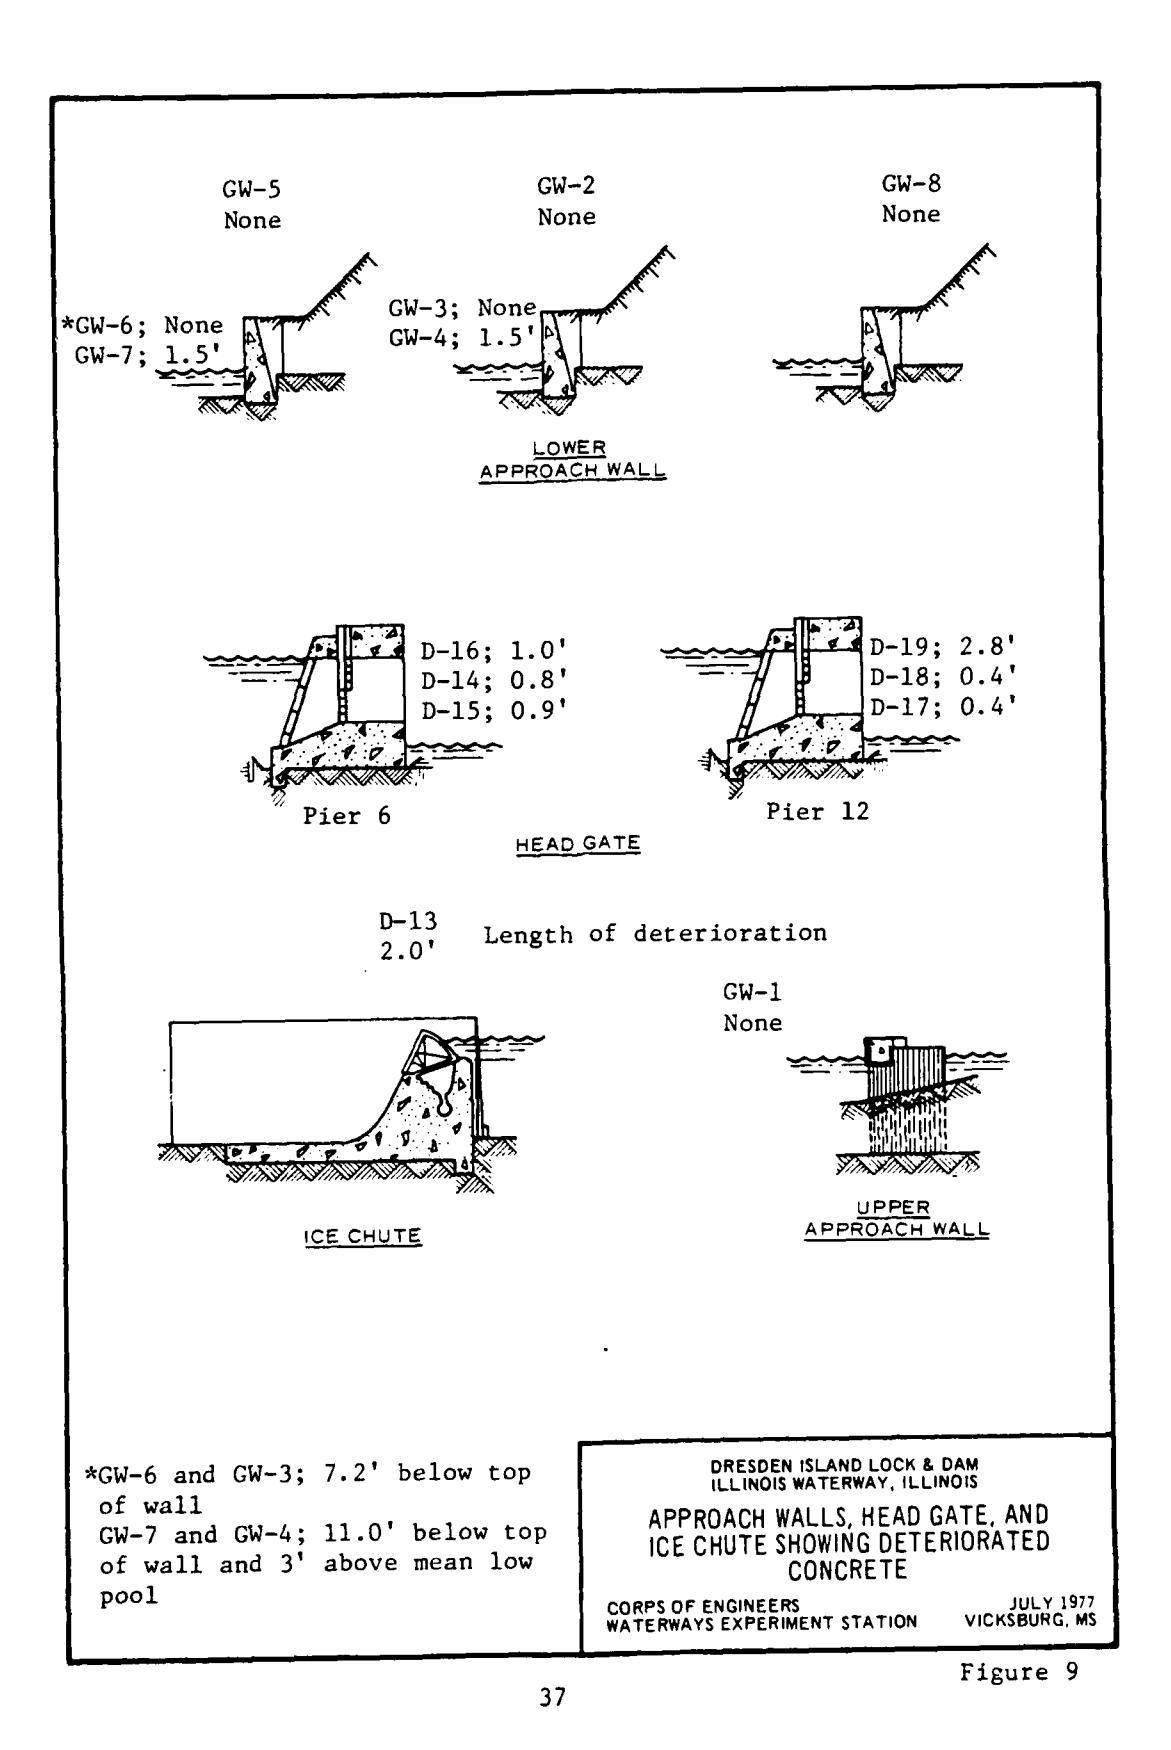
76. The average depth of damaged concrete in the lowest horizontally drilled holes (11 ft below top of wall) is 1.5 ft; this corresponds to the maximum depth of bad concrete. Figure 9 presents details of the damamged concrete in the lower approach wall. The vertical borings were 3.0 ft back from the face of the wall and did not encounter the damaged concrete observed in the core from the lowest borings. It is assumed that the damaged concrete is present in a zone from 7.2 ft below top of wall to a foot or so below mean lower pool and 1.5 ft into the wall. Severe erosion was noted at the monolith joints and at the water line.

86. <u>Depth of deterioration</u>. The average depth of deteriorated concrete in the head gate piers and sills is 1.0 ft; the maximum depth is 2.8 ft. See Figure 9 for damaged concrete at each of the boring locations. The greatest frost action has occurred on the downstream face of the piers just under the overhead slab.

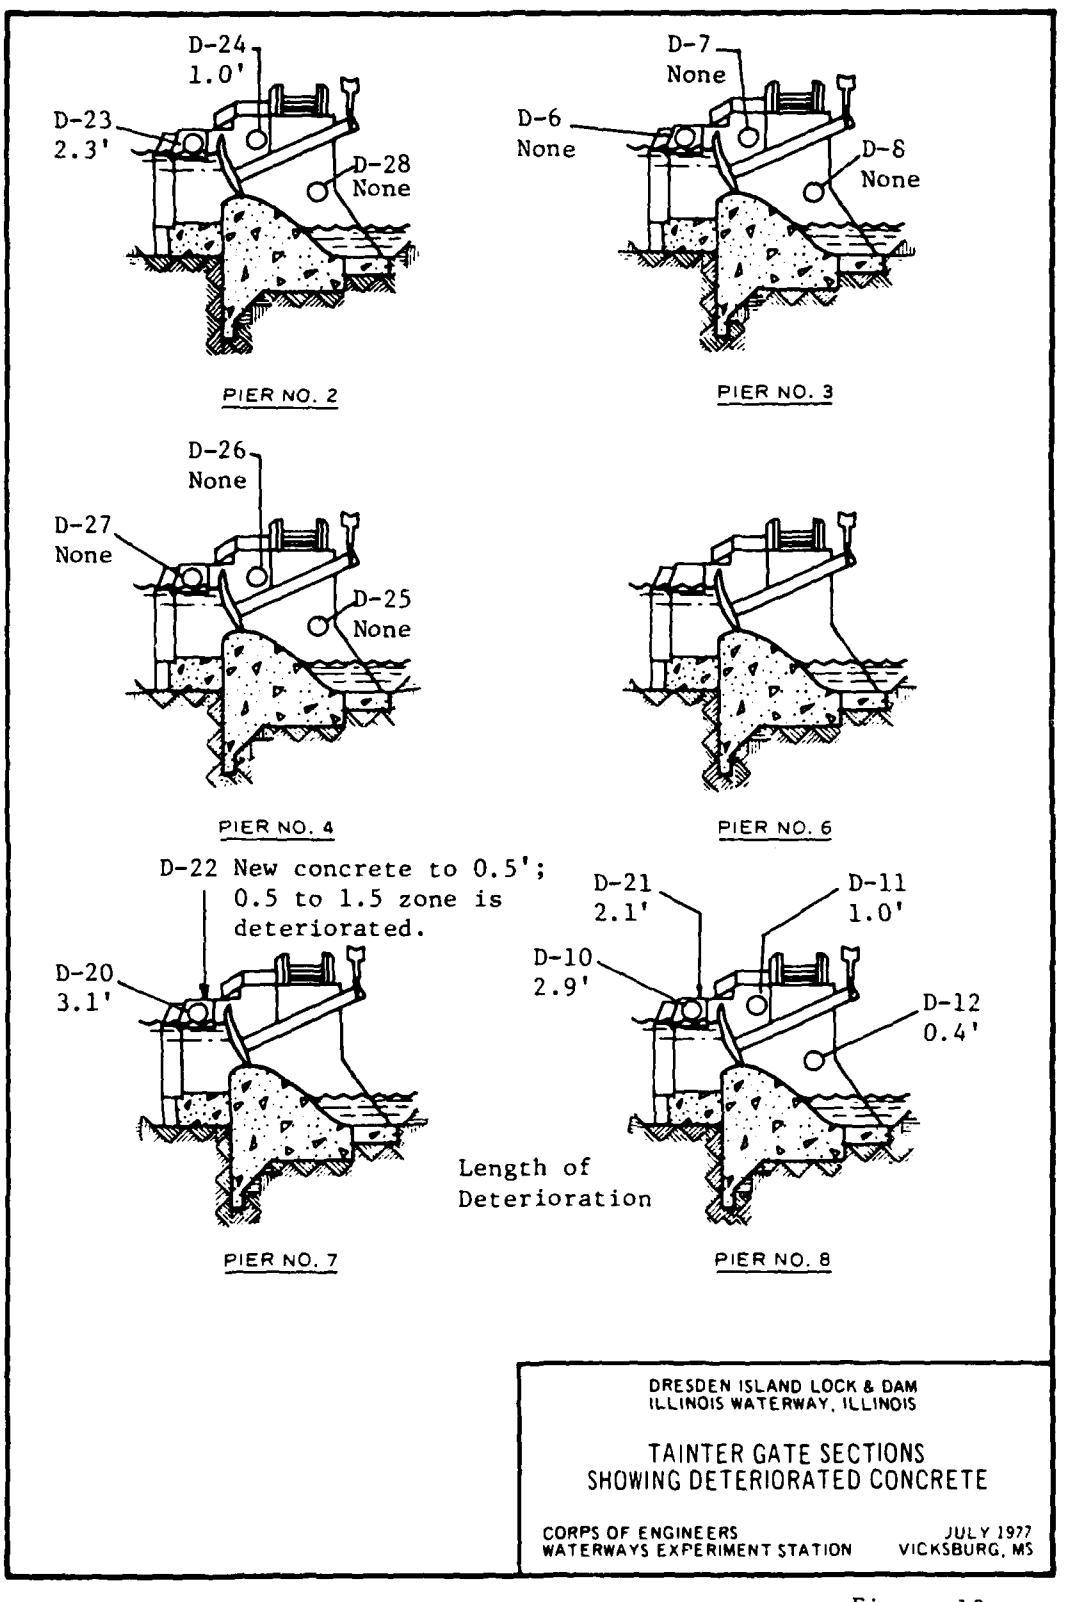
Figure 10

81. <u>Depth of deterioration</u>. No damaged concrete caused by frost action was detected in the three borings drilled into pier No. 3; see Figure 10. However, there were signs of erosion on the sides of the pier

as reported in Reference 2. Additional borings were drilled in tainter gate piers 2, 4, 7, and 8 to more fully determine the extent of bad concrete in this section of the dam. Extensive deterioration was found in the core from the upstream one-half portion of piers 2, 7, and 8. No evidence of frost damage was found in pier 4.

82. The average depth of deterioration in the upstream one-half portion of pier 2 is 1.7 ft; the maximum depth is 2.3 ft. The average depth of deterioration in that portion of piers 7 and 8 from about 10 ft in front of the tainter gate and upstream to the nose of the pier is 2.3 ft; the maximum depth is 3.1 ft in pier No. 7, boring D-20. It appears that the greatest amount of frost damaged concrete in the tainter gate piers occurs in the upstream one-half portion and above mean upper pool elevation. Severe erosion has occurred at the upstream water line around the nose of the piers. Up to 0.4 ft of damaged concrete was found in boring D-12 located near the downstream edge of pier No. 8 (see Figure 10); no damaged concrete was detected near the downstream edge of piers 2 and 4.
