COKEBURG WATER SUPPLY DAM

NDI ID NO. PA-1094 DER ID NO. 63-30

PHASE 1 INSPECTION REPORT NATIONAL DAM INSPECTION PROGRAM

APRIL, 1981

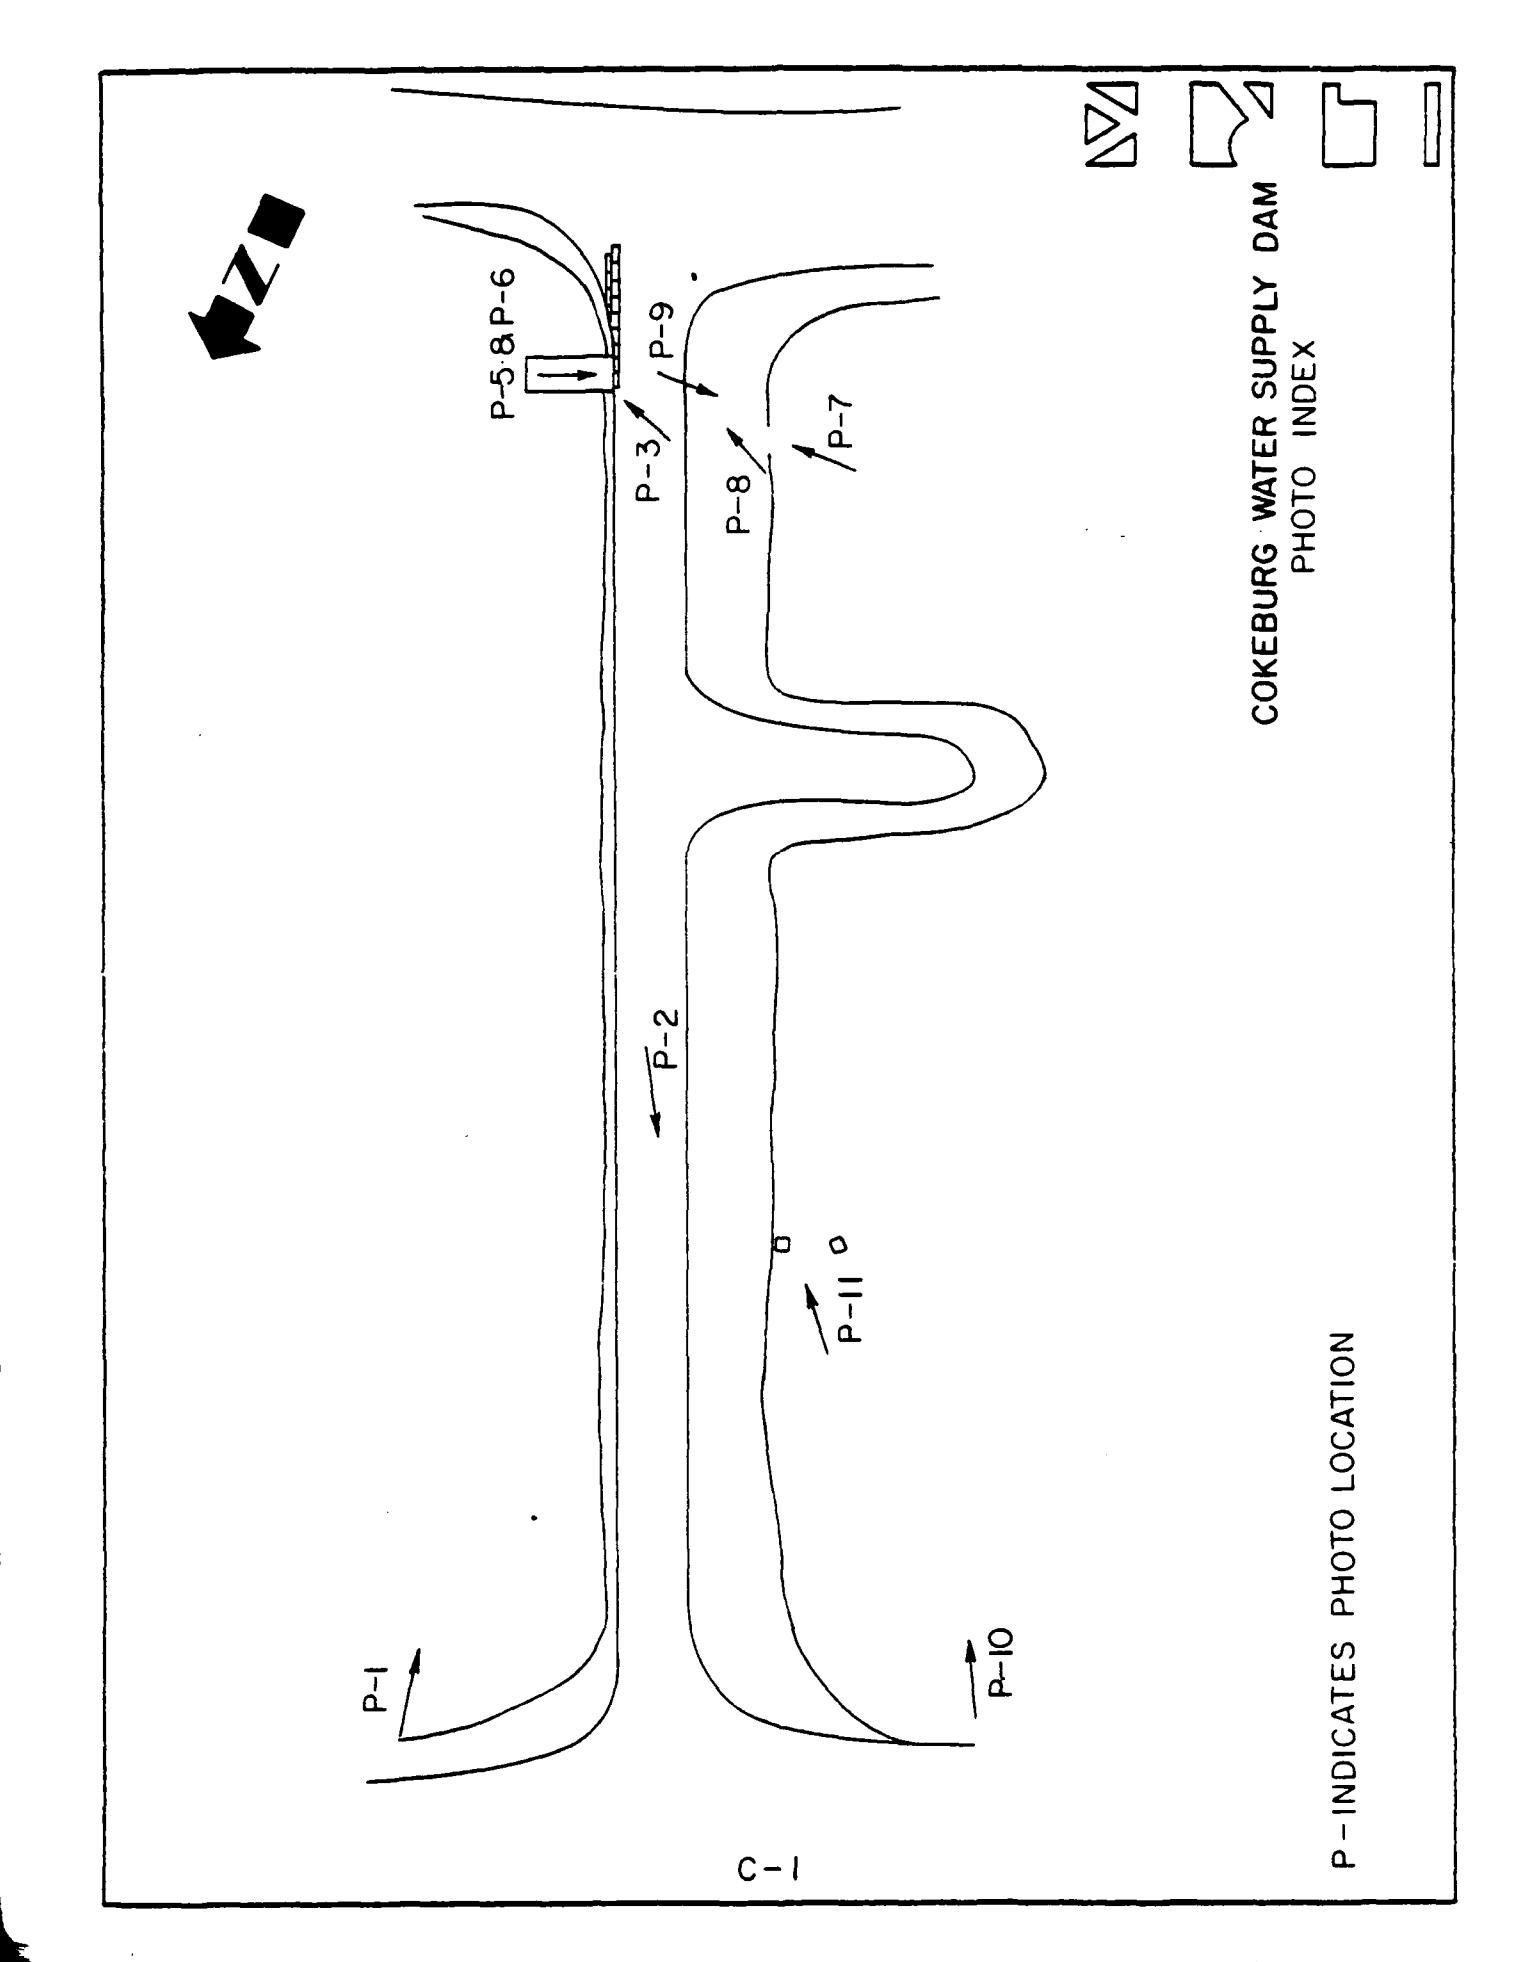
Sheet 1

(1)	Upper	left	-	View of upstream slope and left abutment.
(2)	Upper	right	-	View of upstream slope, embankment crest
				and right abutment.
(3)	Lower	left	-	View of the spillway intake structure.
(4)	Lower	right	-	View of seepage along the culvert wall
				directly inside the entrance to the
				culvert.
Back				
(5)	Upper	left	-	View of the approach to the spillwav
				culvert.
(6)	Upper	right	-	View of drop inlet section of spillway.
(7)	Lower	left	-	View of the outlet for the discharge
				culvert. Note the deterioration and
				collapse of the walls near the outlet.
(8)	Lower	right	-	Partial view of the downstream slope
				directly above the spillway discharge
				culvert. Note the deterioration of the
				coke oven structure and the obvious void
