# MISSISSIPPI - KASKASKIA - ST. LOUIS BASIN

SAYERSBROOK LAKE DAM WASHINGTON COUNTY, MISSOURI MO 30112

# PHASE 1 INSPECTION REPORT NATIONAL DAM SAFETY PROGRAM

DECEMBER 1978

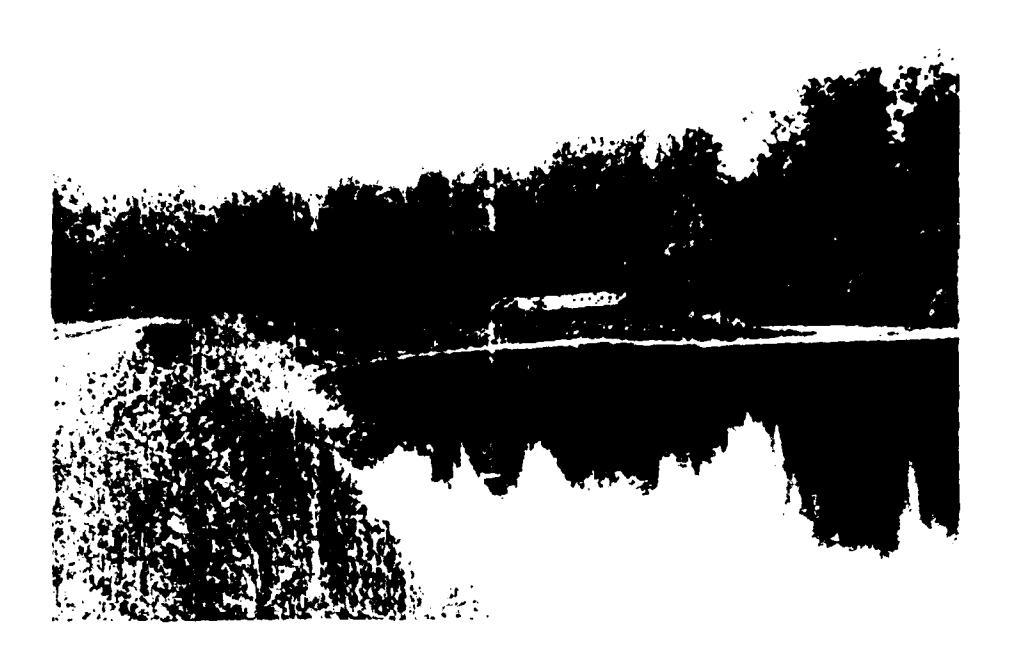
b. Dam. The visible portions of the upstream and downstream faces of the dam (see Photos 1, 2, and 3) appeared to be in sound condition although several small and medium-size trees and patches of brush exist on the downstream face. Riprap, consisting of limestone rock that varies in size from about 2-inches to about 12-inches, serves to protect the upstream slope from erosion. The riprap extends to a level approximately 3 feet above the normal waterline. The downstream slope at the junction with the left abutment is eroded, apparently by storm drainage runoff, to a maximum depth of about 3 feet. No lake seepage was noticed at the downstream toe of slope or at the junction of the embankment and abutments.

NO. 1: UPSTREAM FACE OF DAM AT RIGHT ABUTMENT

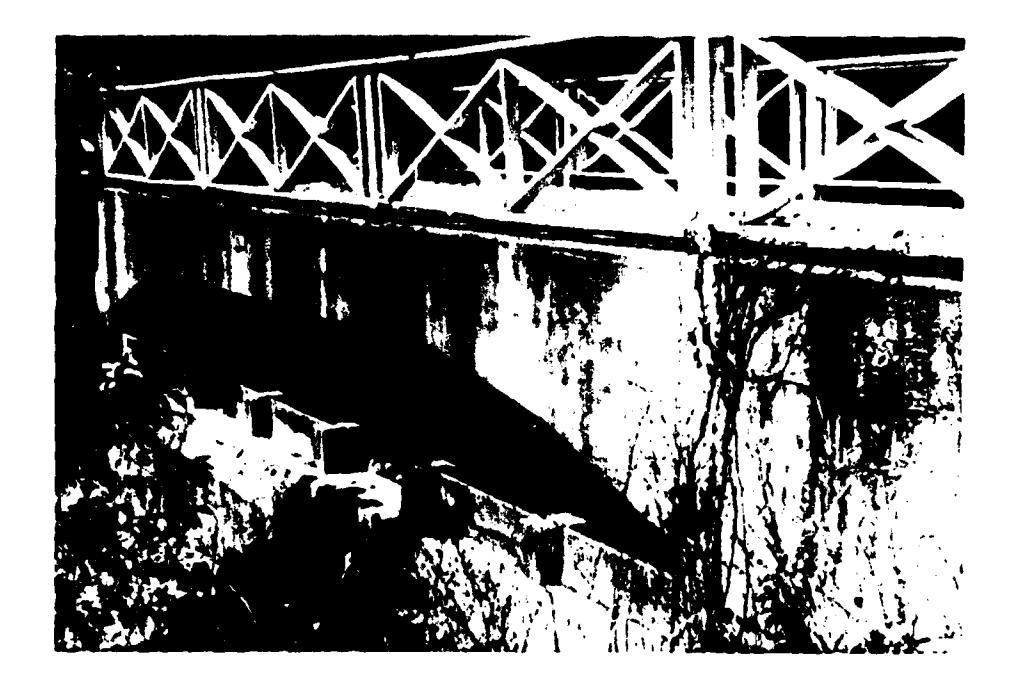
c. <u>Principal Spillway</u>. The concrete weir at the principal spillway, including the 12-inch high piers for support of the wood planks and the concrete bridge crossing the spillway approach channel (see Photo 5), appeared to be in sound condition. The clear distance between the concrete weir and the underside of the bridge was measured to be approximately 3.5 feet. Water, believed to be from the lake, was emerging in the bottom of the spillway channel at a point approximately 10 feet downstream of the concrete weir. A heavy growth of small willows and brush was noticed in the exit channel (see Photo 6) between the spillway crest and the downstream channel.

NO. 5: SPILLWAY WEIR AND BRIDGE
