LAKE PAHO DAM MERCER COUNTY, MISSOURI MO 10108

PHASE 1 INSPECTION REPORT NATIONAL DAM SAFETY PROGRAM

JULY, 1978

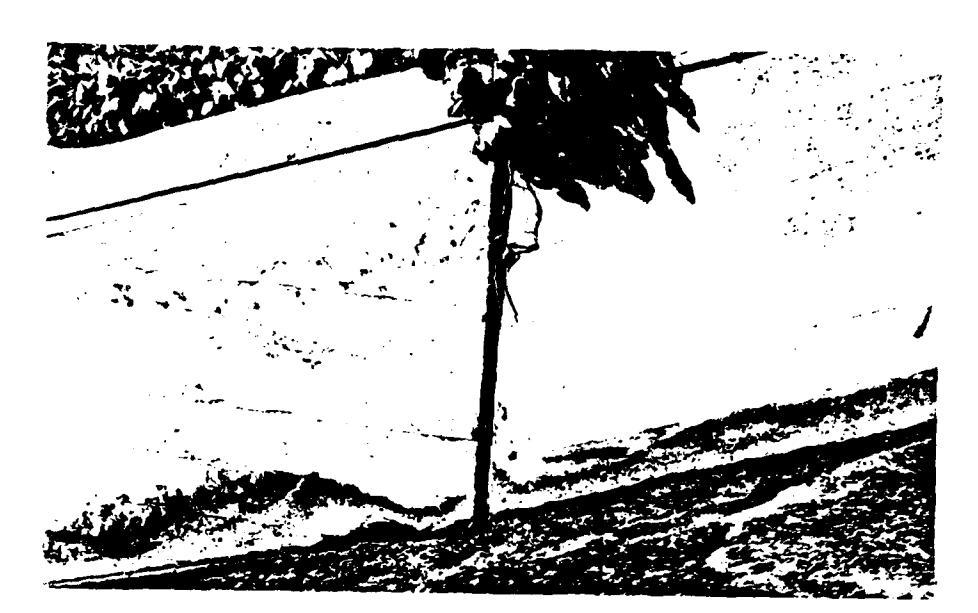
PHOTO NO. 5 EXPANSION JOINT J-4 (LOWEST JOINT) JOINT OPEN APPROX. 1/2 INCH

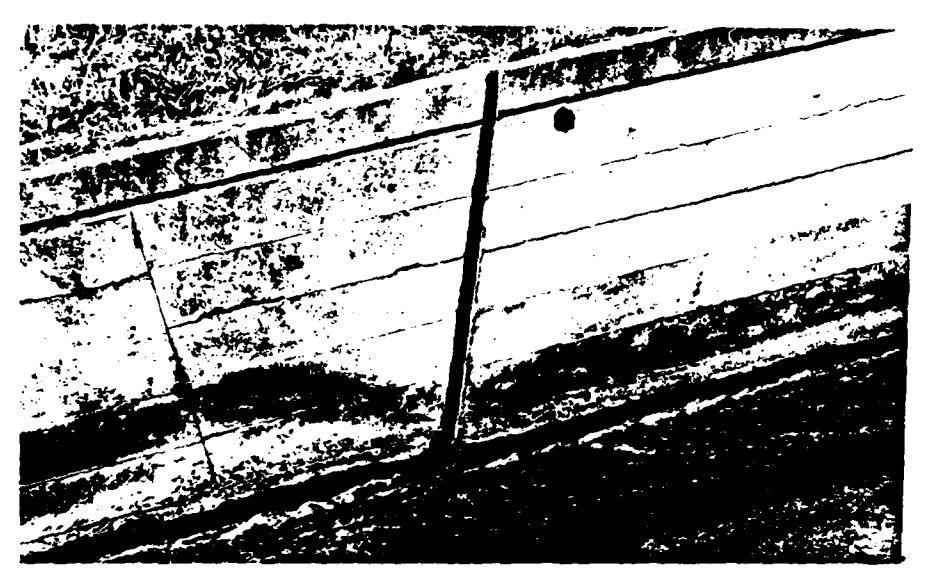
PHOTO NO. 6 EXPANSION JOINT J-3 (RIGHT SIDE) JOINT OPEN APPROX. 1/2 INCH. 3" X 3" HOLE AT BOTTOM OF JOINT

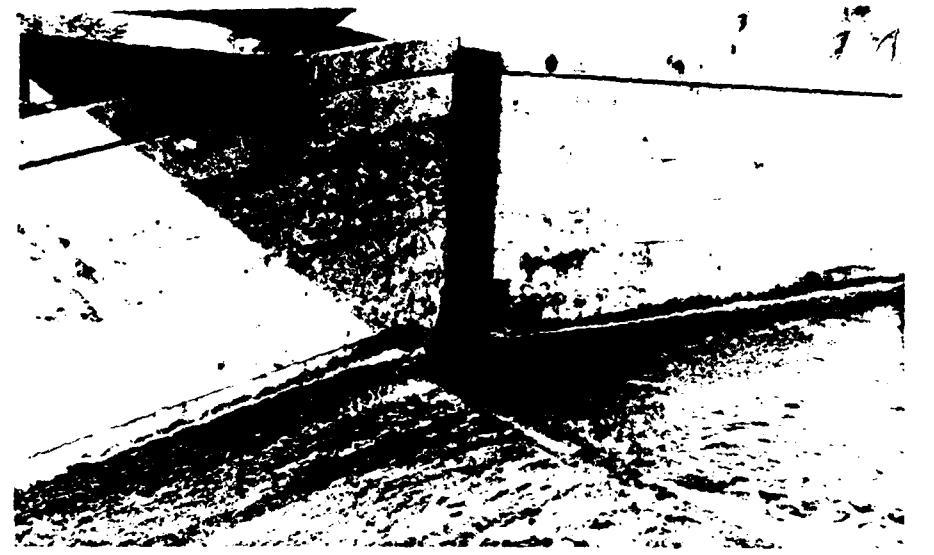
PHOTO NO. 9 EXPANSION JOINT J-1 (RIGHT SIDE) NOTE APPROX. 6" X 6" HOLE AT BOTTOM OF JOINT

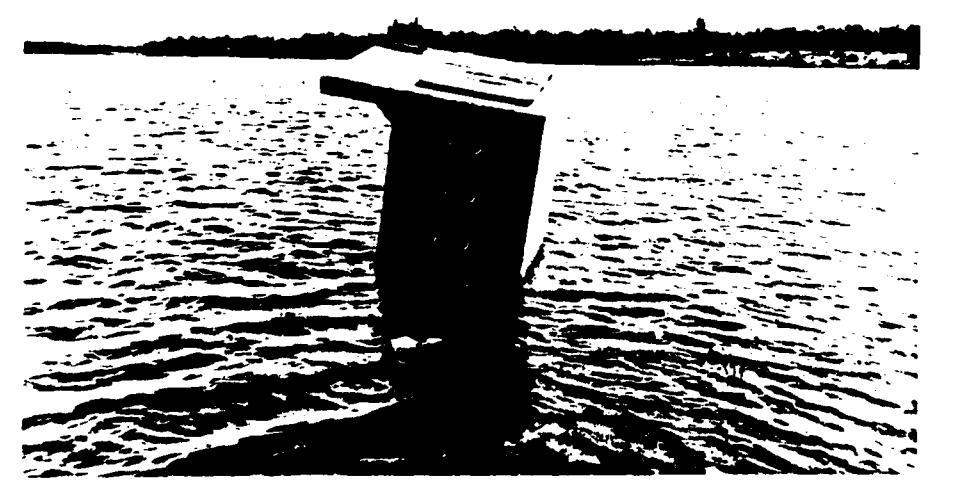
The control or inlet tower for this system is tilted about 10 degrees off of vertical towards the left (east) and downstream (south) as shown in photo No. 13. It was reported that this vertical deformation was caused by ice the first year after installation. A plan view and cross section of this system is shown in Appendix C.

PHOTO NO. 13 OUTLET TOWER FROM SOUTH

It was reported that this system is to be replaced in the near future. Asbestos/concrete pipe was on-site for the new system at the time of the inspection.

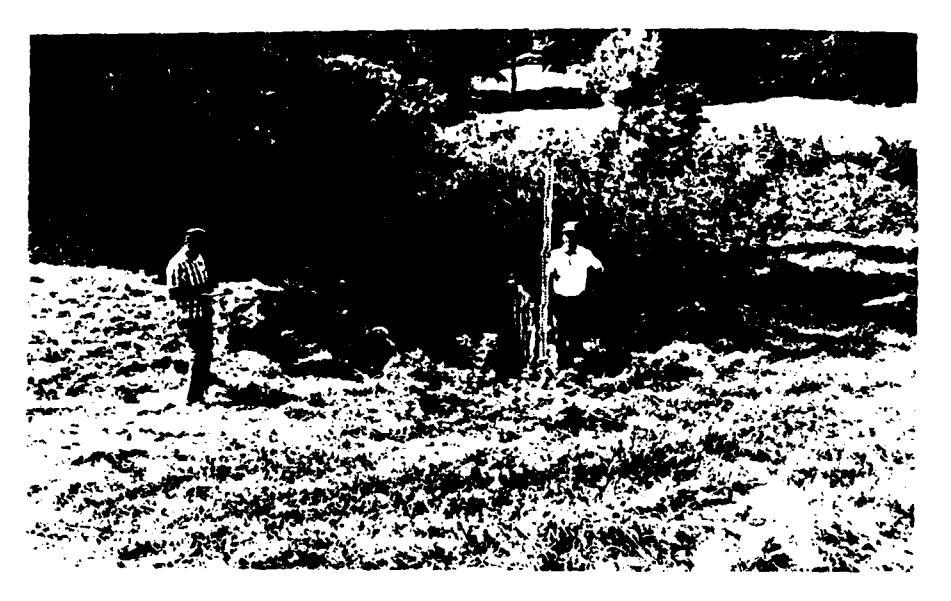
PHOTO NO. 18 ORIGINAL SPILLWAY THAT HAS BEEN PLUGGED

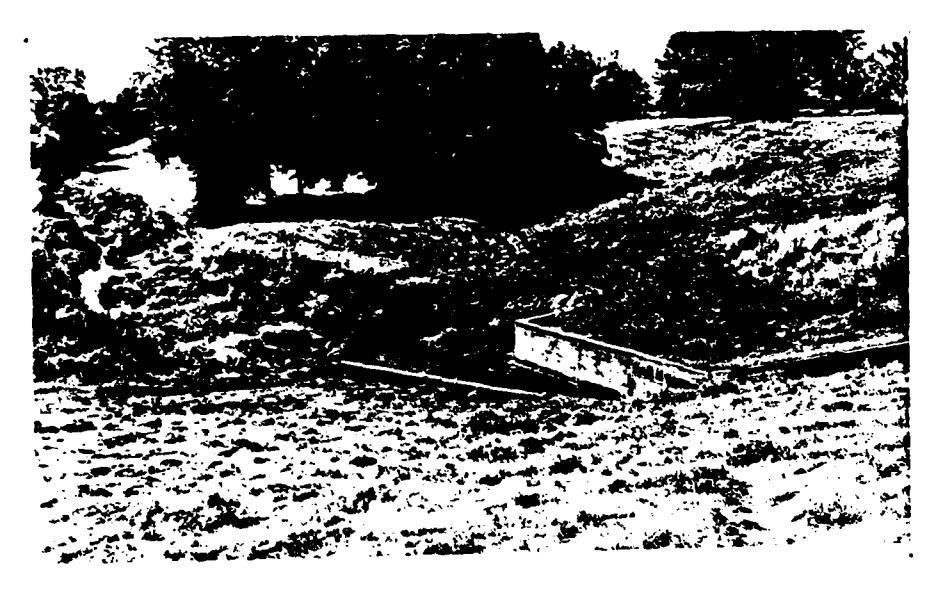
PHOTO NO. 21 EROSION AT RIGHT SIDE OF SPILLWAY STILL-ING BASIN
