PHASE 1 INSPECTION REPORT NATIONAL DAM SAFETY PROGRAM

PREPARED BY: U.S. ARMY ENGINEER DISTRICT, ST. LOUIS

FOR: STATE OF MISSOURI

PHASE 1 INSPECTION REPORT NATIONAL DAM SAFETY PROGRAM CRANE STRUCTURE NO. 1 MISSOURI INVENTORY NO. 20509

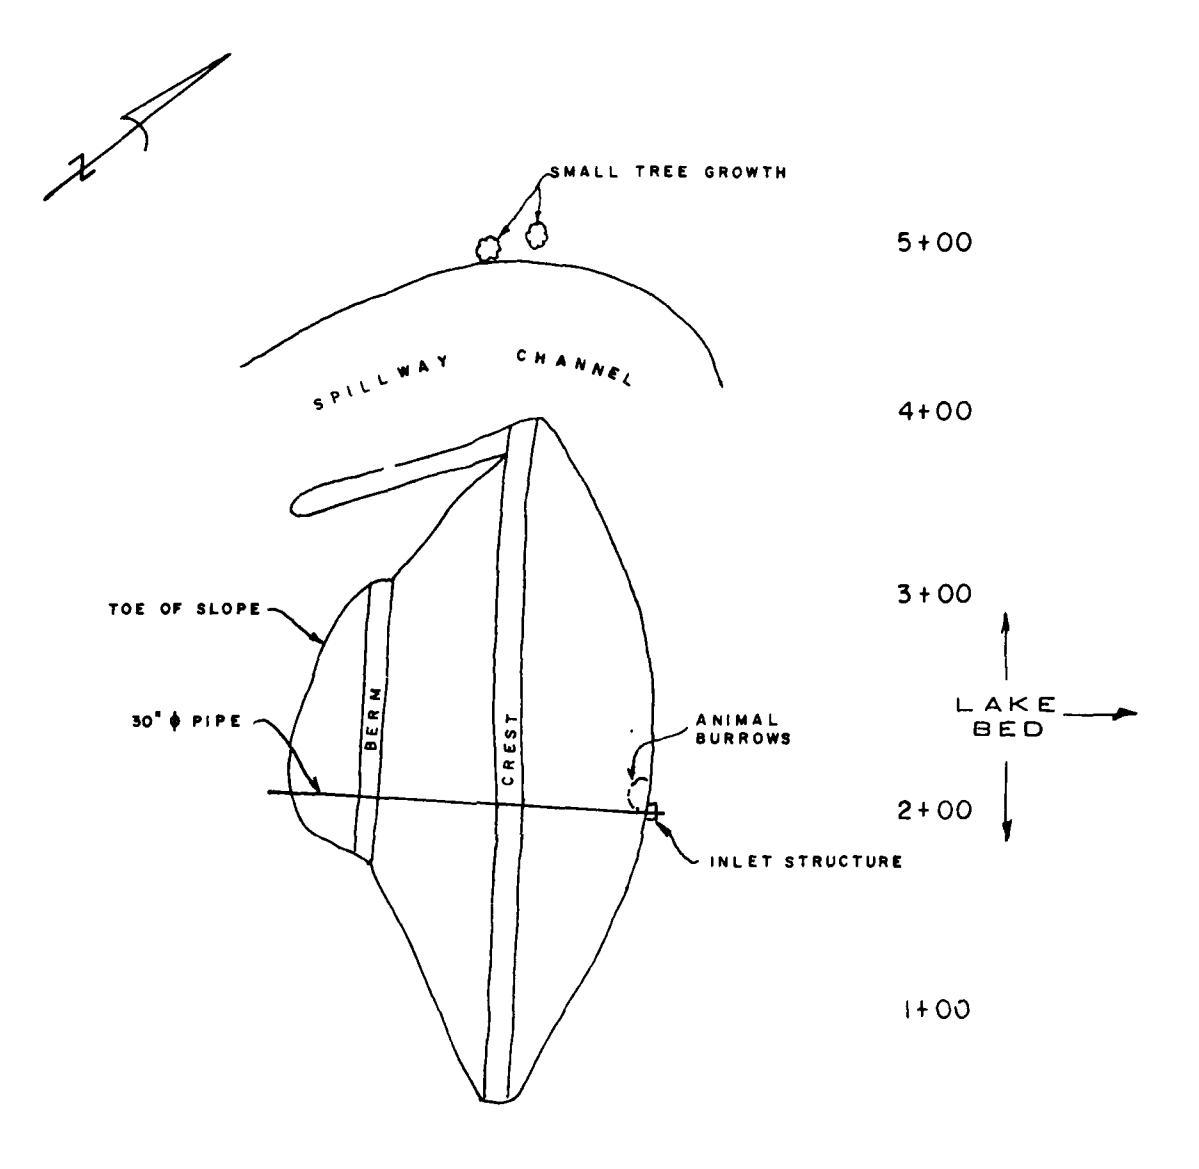
Sheet <u>4</u> of Appendix <u>A</u>

PLAN SKETCH OF DAM
