### LOW COST SHORE PROTECTION

A Report on the Shoreline Erosion Control Demonstration Program (Section 54 Program)

Office, Chief of Engineers U.S. Army Corps of Engineers Washington, D.C. 20314

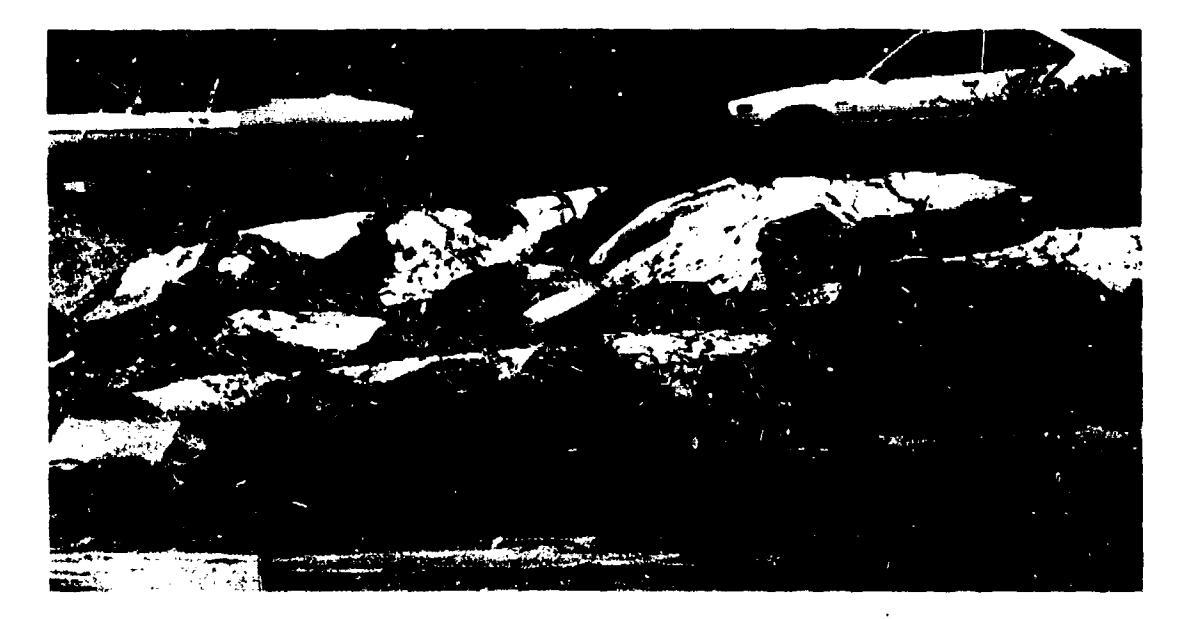
Figure 2-274. Structural damage to device 6, Alameda, California, 20 February 1980.

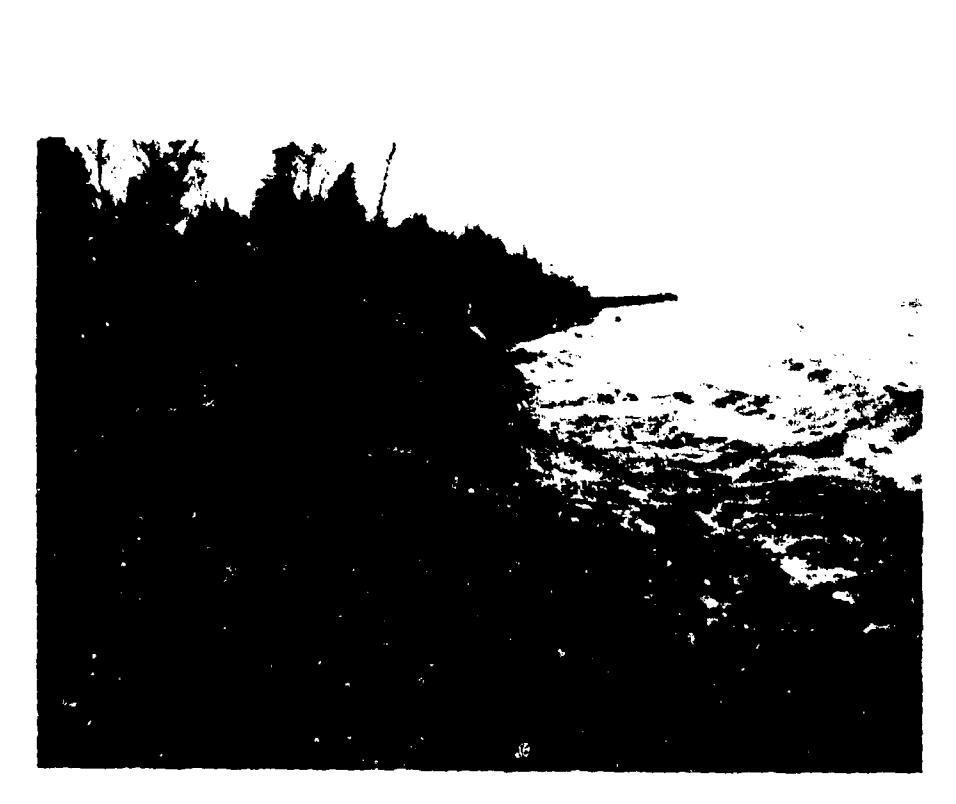
Figure 2-402. Debris scattered on the damaged Turfblock revetment, Port Wing, Wisconsin, 10 November 1978.

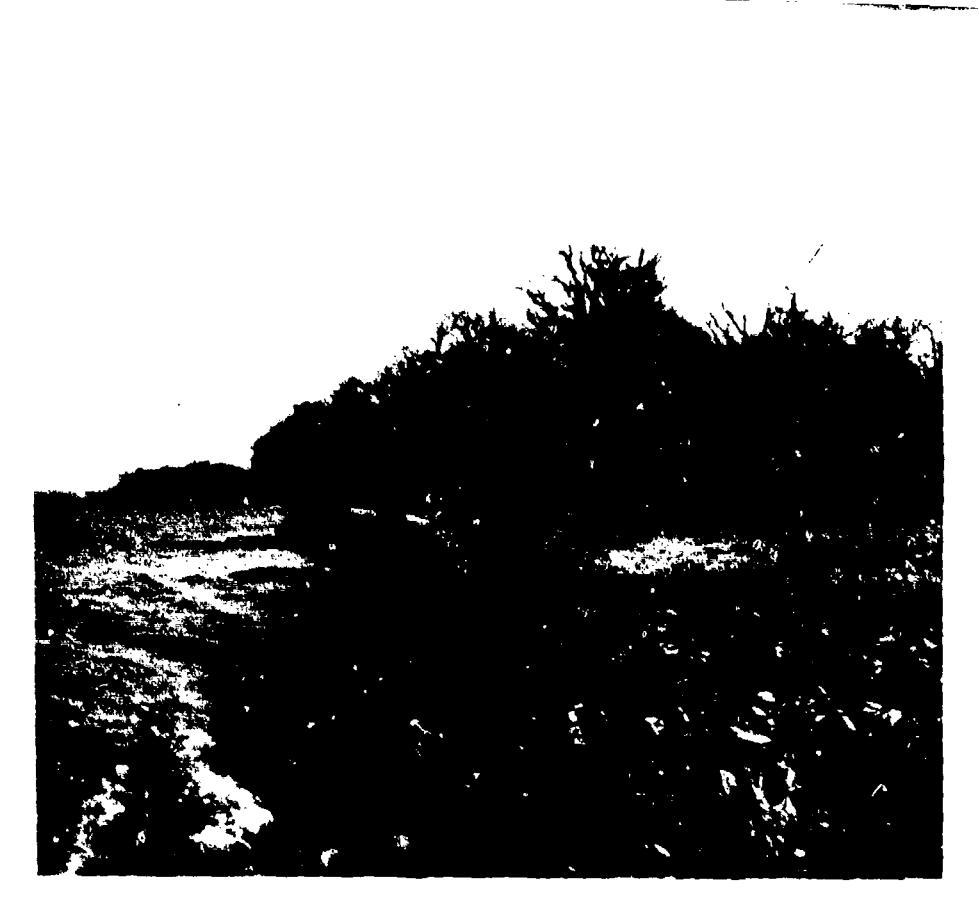
Figure 2-433. Deterioration of the lakeside gabions, Geneva State Park, Ohio, 11 December 1979.

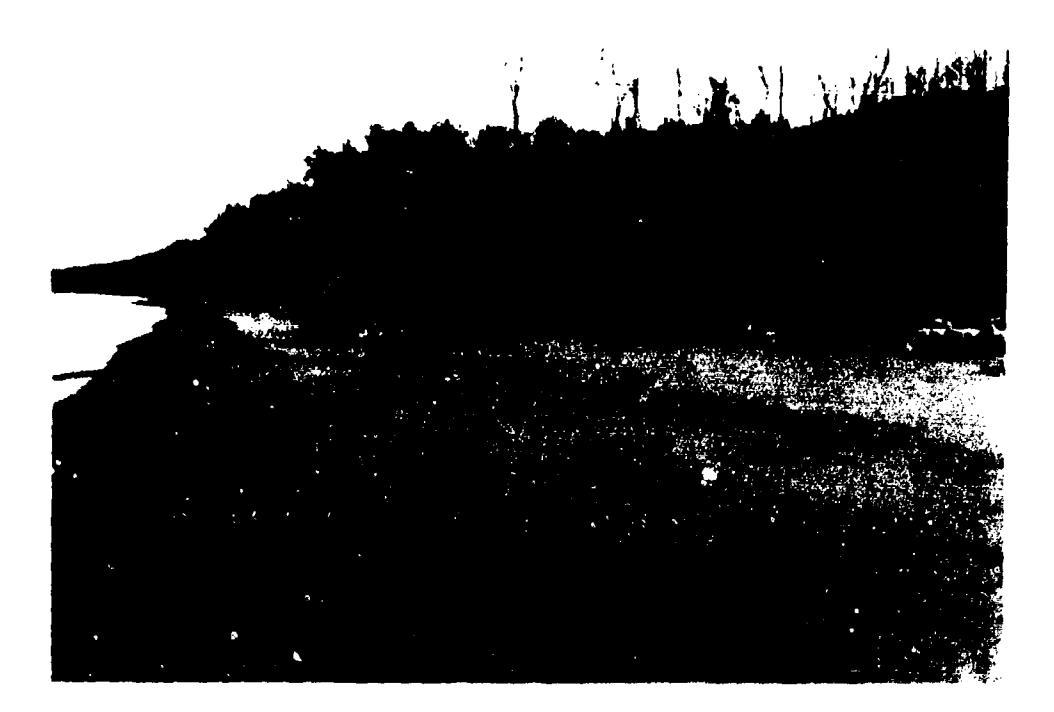
Figure 2-460. Groin 5 damaged as of 14 May 1980, Ashland, Wisconsin.

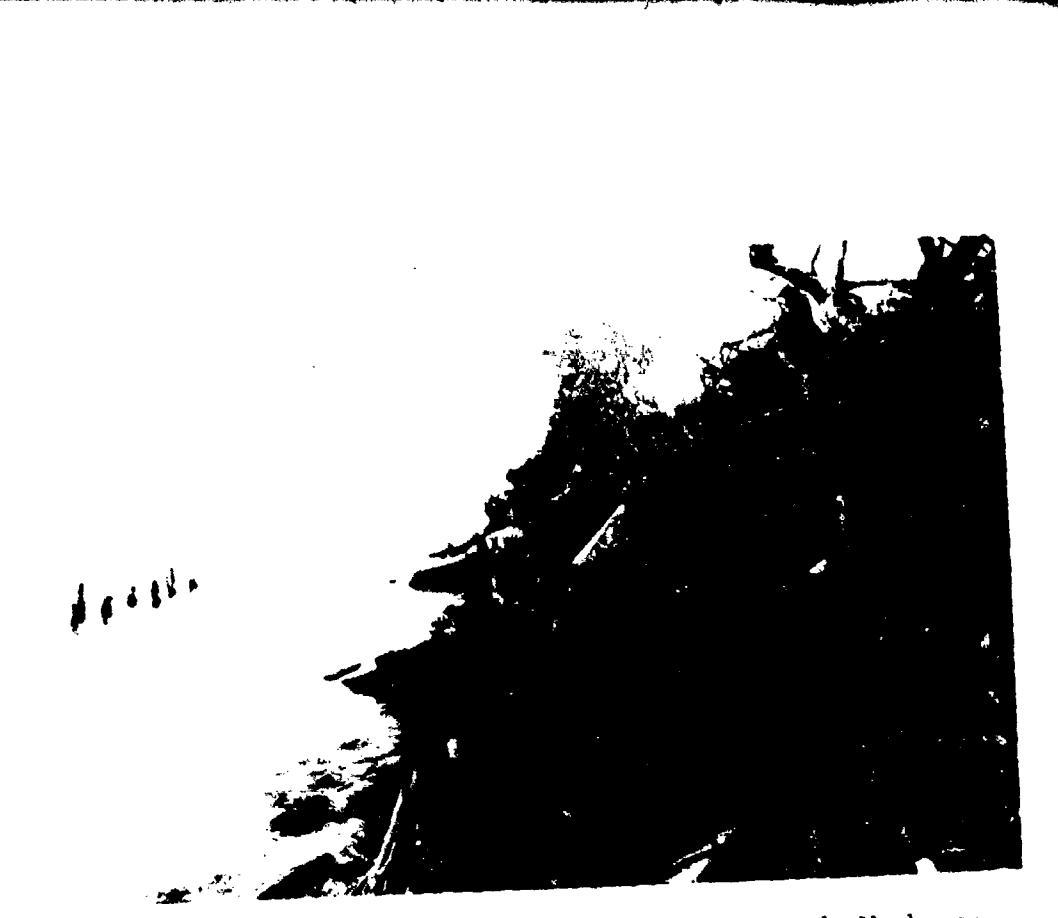
Figure 2-500. Tree stumps on slope at north end, Muskegon State Park, Michigan, August 1979.

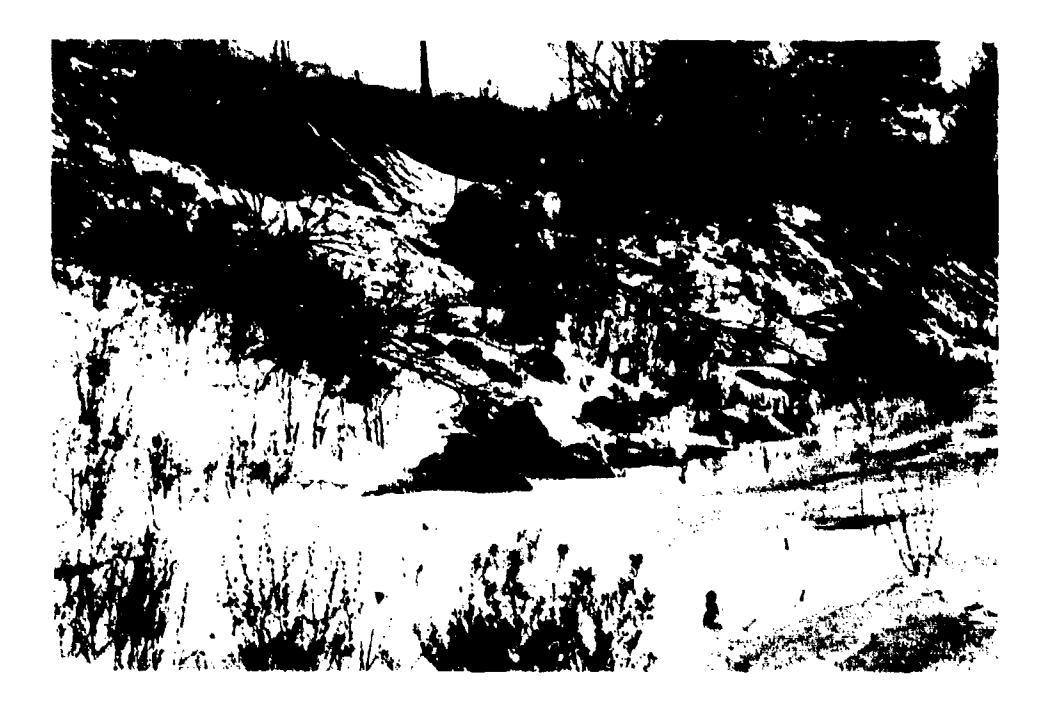
Figure 2-517. Fallen trees indicating additional slumping, Sanilac Section 11, Michigan, 10 January 1980.

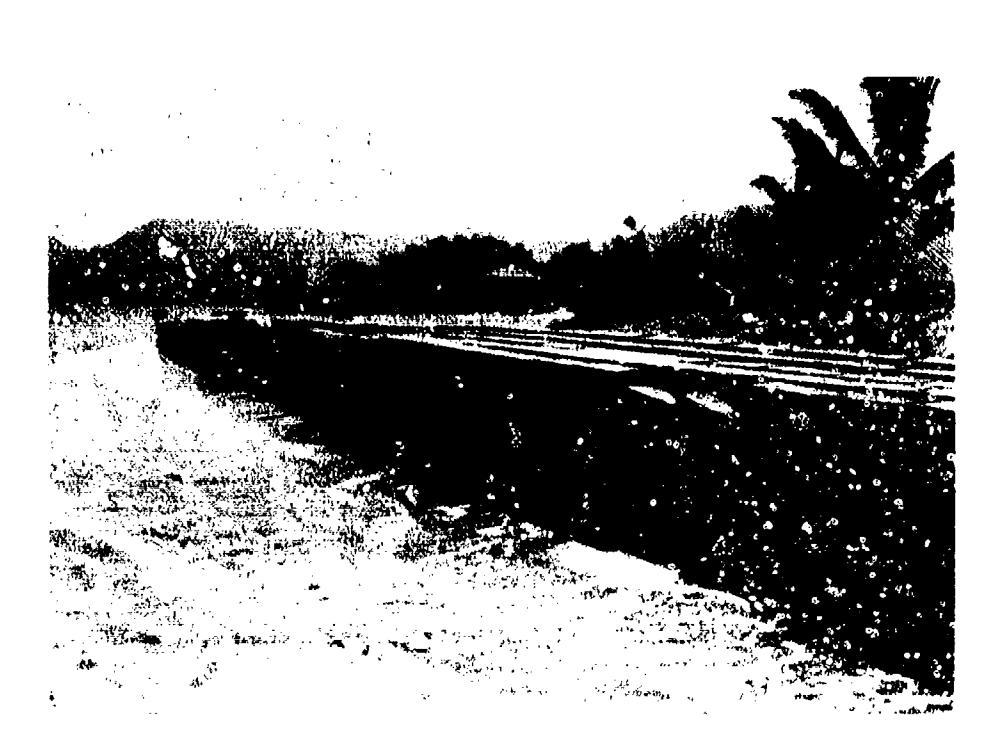
Figure 2-605. Broken blocks viewed from midsection of structure, Kualoa, Hawaii, 8 November 1979.

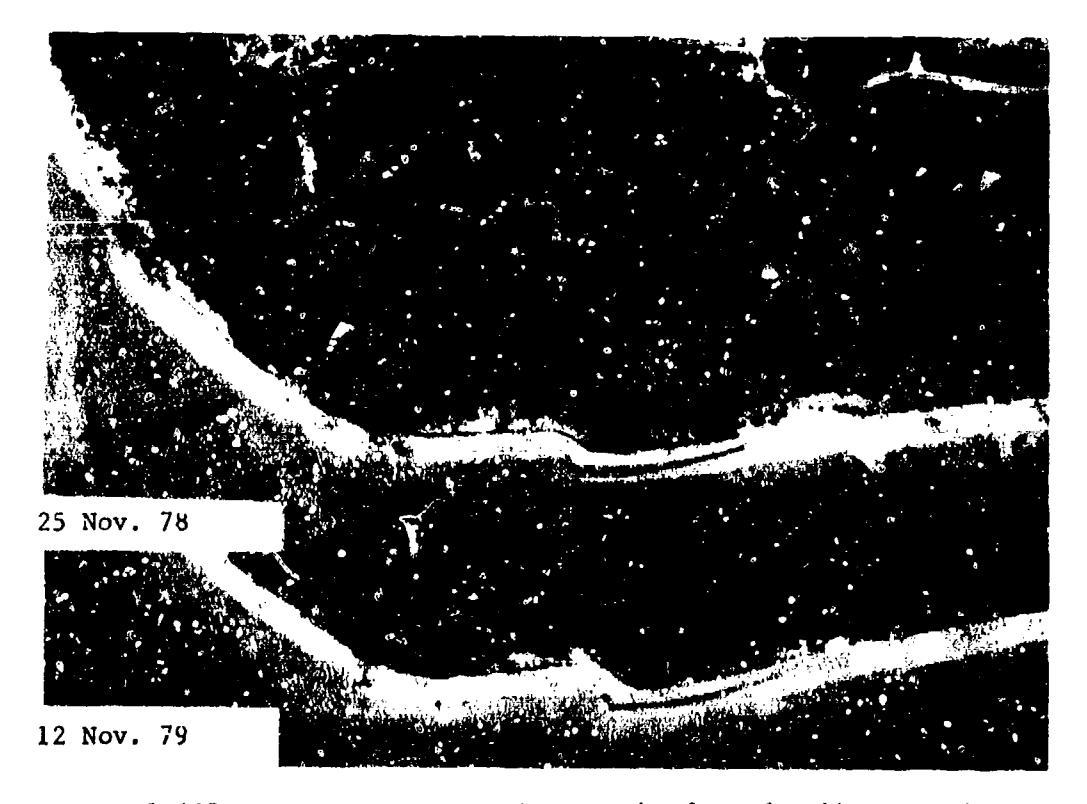
Figure 2-608. Progressive erosion south of Sandgrahher, Kualca, Hawaii, 25 November 1978 and 12 November 1979.

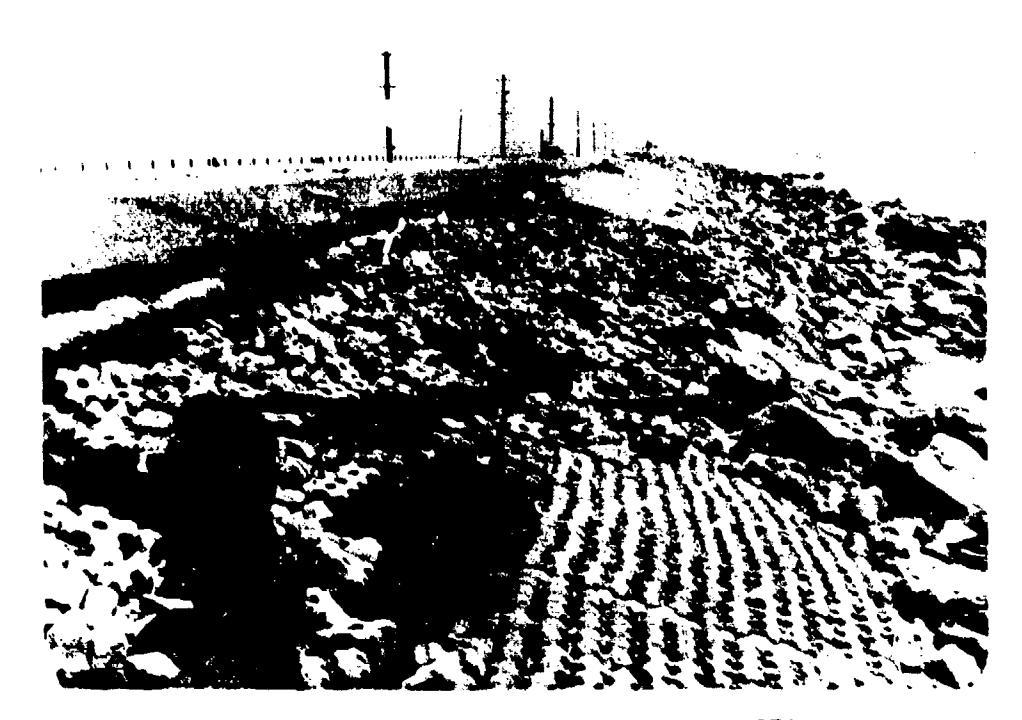
Figure 3-22. Gobi blocks displaced during a 1979 storm at Holly Beach, Louisiana, 16 April 1980.

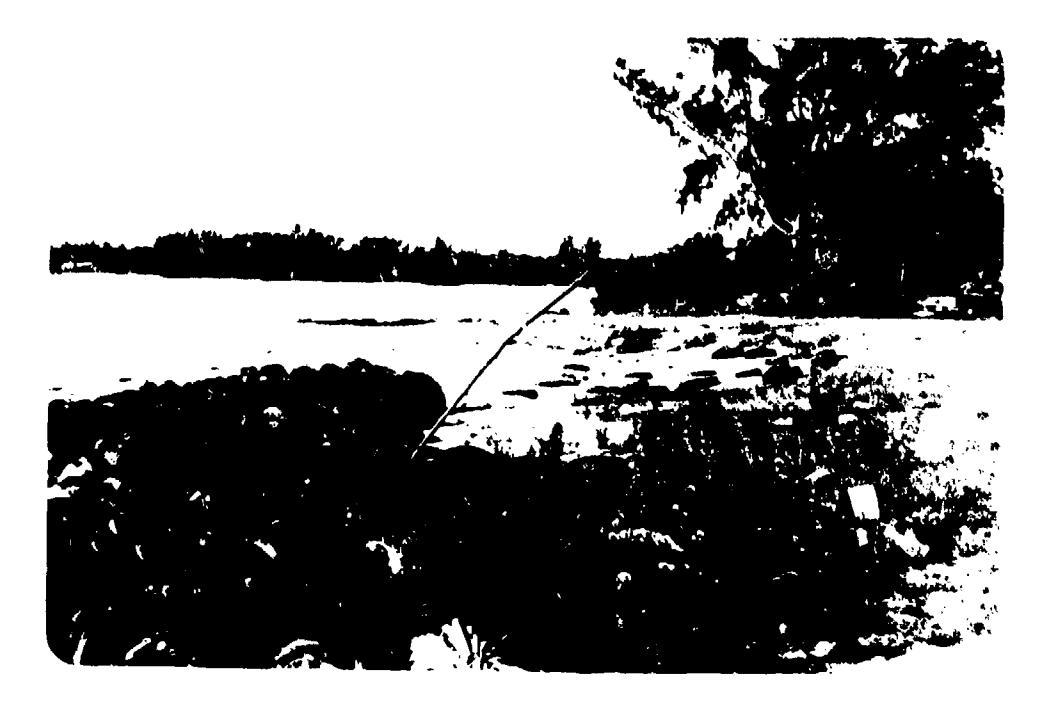
Figure 3-47. Floating tire breakwater at Stuart and Jensen Beach Causeways, Florida, washed ashore with tire bundles scattered along beach, 7 December 1979.
