HOUSATONIC RIVER BASIN DANBURY, CONNECTICUT

EAST LAKE RESERVOIR DAM

CT. 00066

PHASE I INSPECTION REPORT NATIONAL DAM INSPECTION PROGRAM

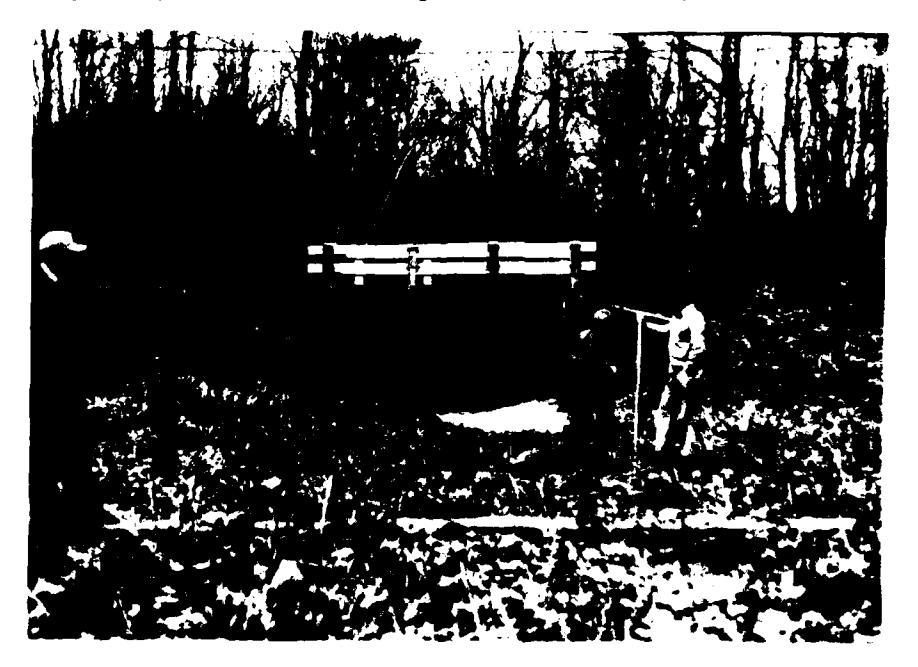
The highway bridge over the spillway channel appears of more recent construction and probably replaces an original bridge which had a much wider waterway. Although the shorter spanned bridge has reduced spillway capacity, it has no direct effect on dam stability.

4. Spillway sill and discharge channel looking downstream, device bridge

- 1. Determine whether additional spillway capacity is required, and whether the bridge across the outlet channel should be lengthened or the outlet channel deepened.
- Determine the source of apparent leakages at and downstream of the toe of the embankment in the vicinities of the 16 in. dia. main outlet and the 12 in. dia. left abutment outlet pipes.
- 3. Examine the configuration of the roadway on the crest of the dam and provide for its adequate support by the dam embankment.
