MERRIMACK RIVER BASIN
34	BRISTOL, NEW HAMPSHIRE
N N	INTERNATIONAL PACKINGS
115	CORPORATION
	LOWER DAM
AI	NH-00480
	PHASE I INSPECTION REPORT
	NATIONAL DAM INSPECTION PROGRAM
ad	
8	
	S. G.
3110	DEPARTMENT OF THE ARMY NEW ENGLAND DIVISION CORPS OF ENGINEERS
-	WALTHAM, MASS. 02154
@	APRIL 1979 DISTRIBUTION STATEMENT A APRIL 1979 Approved for public released Distribution Unlimited
	06 26 050 Distribution duminet

PHASE I INSPECTION REPORT

INTERNATIONAL PACKINGS CORPORATION

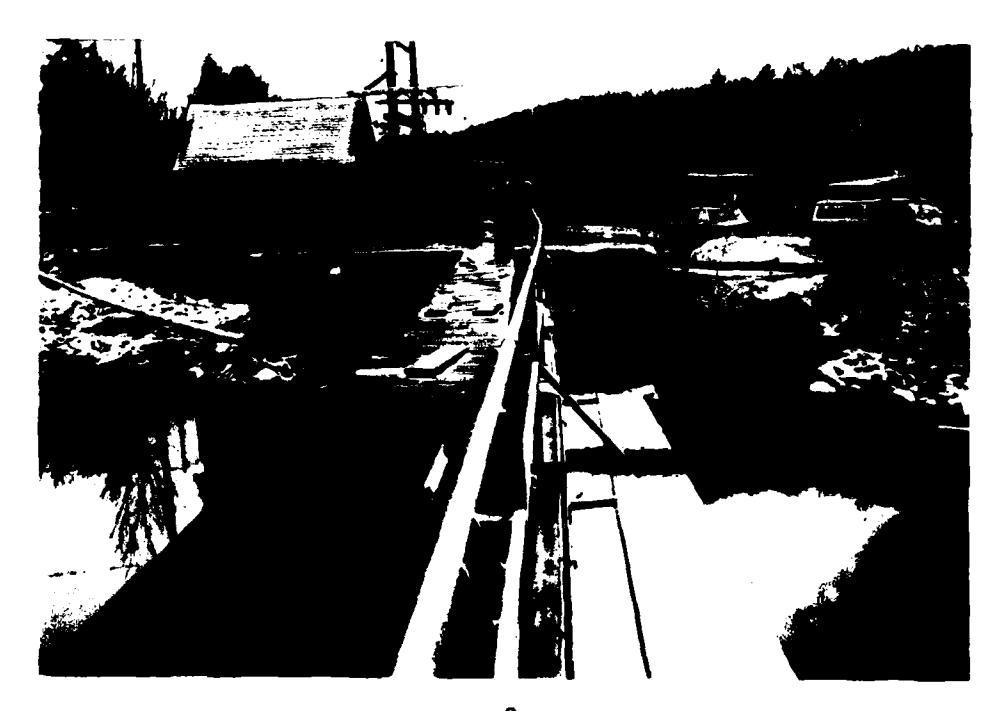
- (a) The spillway section and downstream apron of the dam show evidence of settlement and deflection downstream. Settlement of the apron of at least 4 inches has occurred (see overview photograph). Downstream deflection of the stop log section of the spillway of 5 to 7 inches at its' center is evident. (see Appendix C, photograph 2)
- (b) Significant scour has occurred downstream of the apron below the spillway. (see photograph 9) Some undermining of the timber cribs is evident.
- (c) Direct leakage from the upstream face of the dam to the downstream toe is occurring. This was evidenced by eroded depressions and flow

- (4) A pronounced settlement and downstream deflection of the spillway structure have occurred.
 - (5) Deterioration of some of the concrete is evident, particularly at the north abutment of the spillway which is pitted in places to a depth of 12 inches and at the east wingwall of the canal entrance which is very seriously eroded.

2 VIEW OF SPILLWAY STRUCTURE FROM NORTH END; NOTE DEFLECTION OF STRUCTURE TOWARD DOWNSTREAM

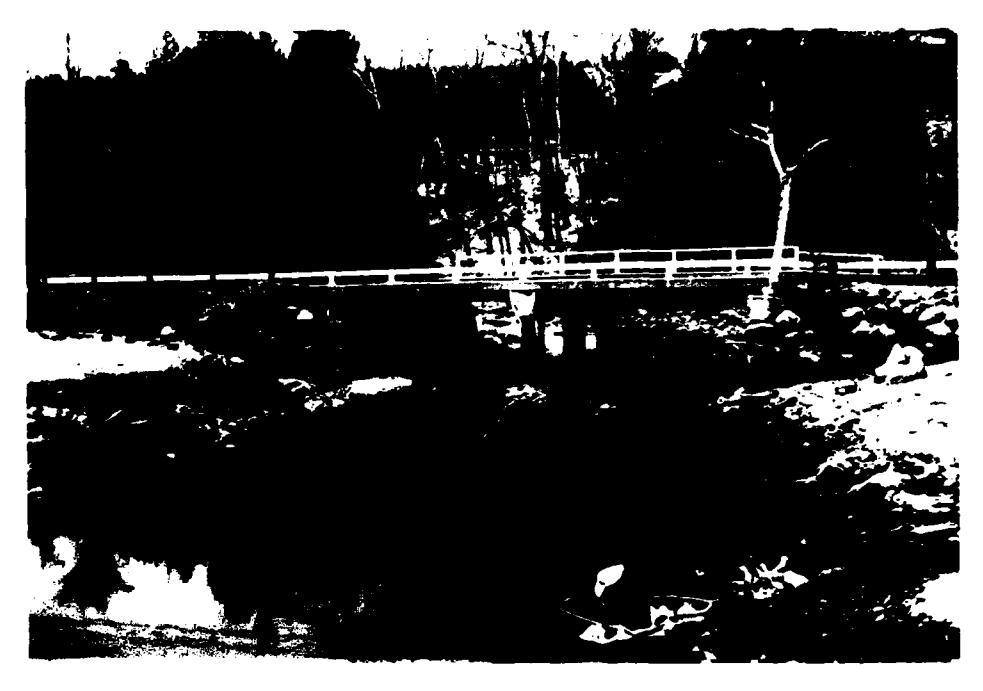
The Route 3A highway bridge located approximately 150 feet above the dam causes a restriction in the approach channel to the dam.

8 BRIDGE IMMEDIATELY UPSTREAM FROM DAM

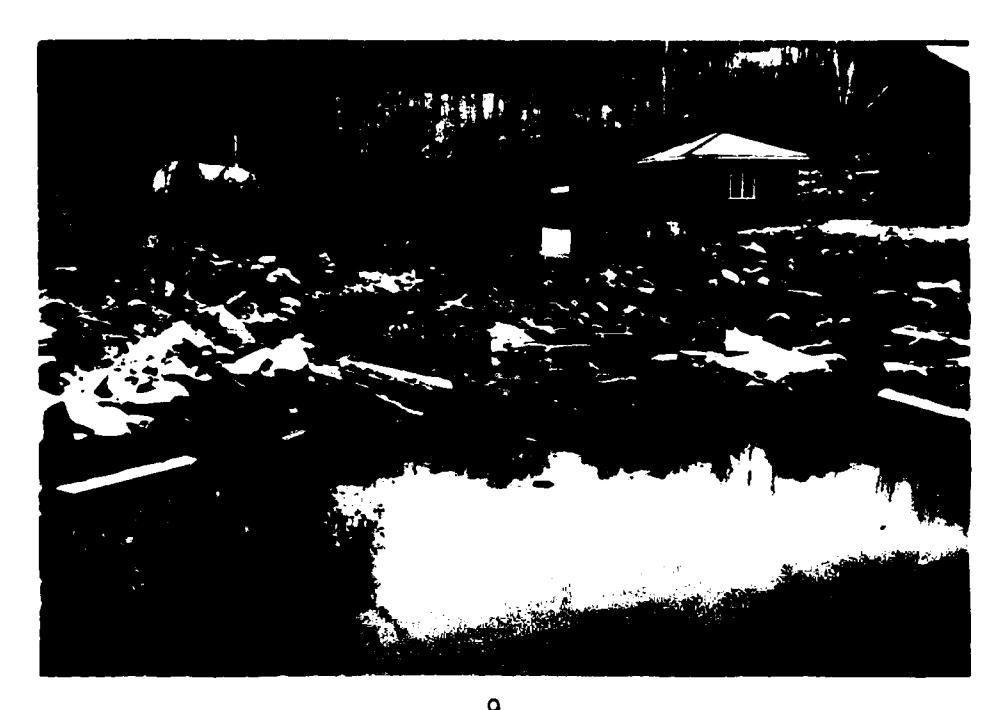
9 DOWNSTREAM VIEW; DEEPER WATER IN FOREGROUND IS RESULT OF SCOUR IMMEDIATELY BELOW DAM

The dam should remain stable during overtopping conditions if the underseepage from the upstream apron is properly repaired and the downstream scour is remedied. It is important that any further scour be prevented and the current effects of scour be repaired.
