MRL-R-956

WELD REPAIR OF CRACKED DEFA CANNON MOUNT FRAMES

J.C. Ritter, R.H. Phillips and B.F. Dixon

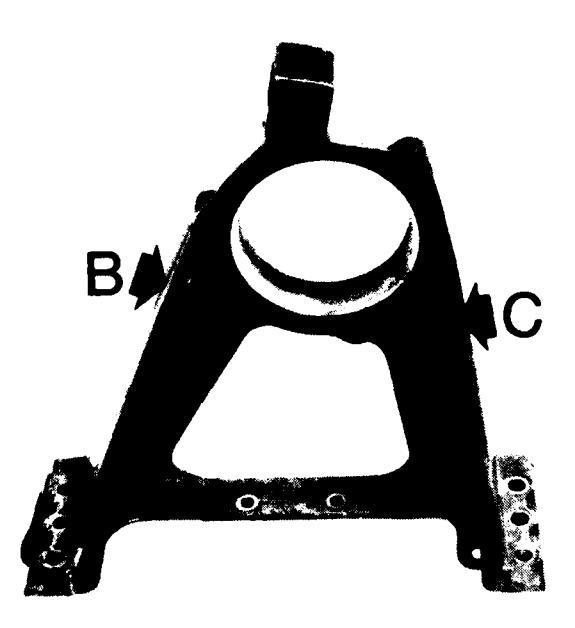
FIGURE 1

Previous inspection of cracked frames at MRL had shown that even the most severe cracks were repairable. All cracks in positions A,B and C (Fig. 1) were therefore weld repaired, regardless of size. Cracks were ground out using specially shaped tungsten carbide cutting burrs in a pneumatic rotary grinding tool. In this crack removal operation a 'U' shaped groove with tapering sides was required as the most suitable repair preparation. This geometry was chosen to minimize the possibility of lack of side wall fusion during subsequent welding.

- (i) Cracks were totally removed where they had not propagated through a complete section. This situation commonly arose at position A, Fig.
  1. During the process of crack removal it was frequently necessary to check for complete elimination of the crack using the fluorescent magnetic particle technique.
- (ii) Where crack had propagated through a section, as could occur in position B]Fig. 1), 0.5 mm of metal was left to help support the subsequent weld root run. The aim here was to completely fuse out the remaining crack in the first root pass. The weld preparation to achieve this is shown diagramatically in Figs 3. A grooved copper backing strip, especially manufactured for this operation, was used for additional support during welding (Fig. 4).

Location of cracks in Defa front mount frames. Cracking was most common in sites A and B.

In the case where cracking had occurred at only one or two of the identified recurrent sites, preventative action was taken to delay fatigue crack initiation at the remaining sites (Fig. 1), by coarse polishing over an area about 30 mm across using a pneumatic rotary polishing wheel, followed by fine hand polishing. A final fluorescent magnetic particle inspection was then applied.

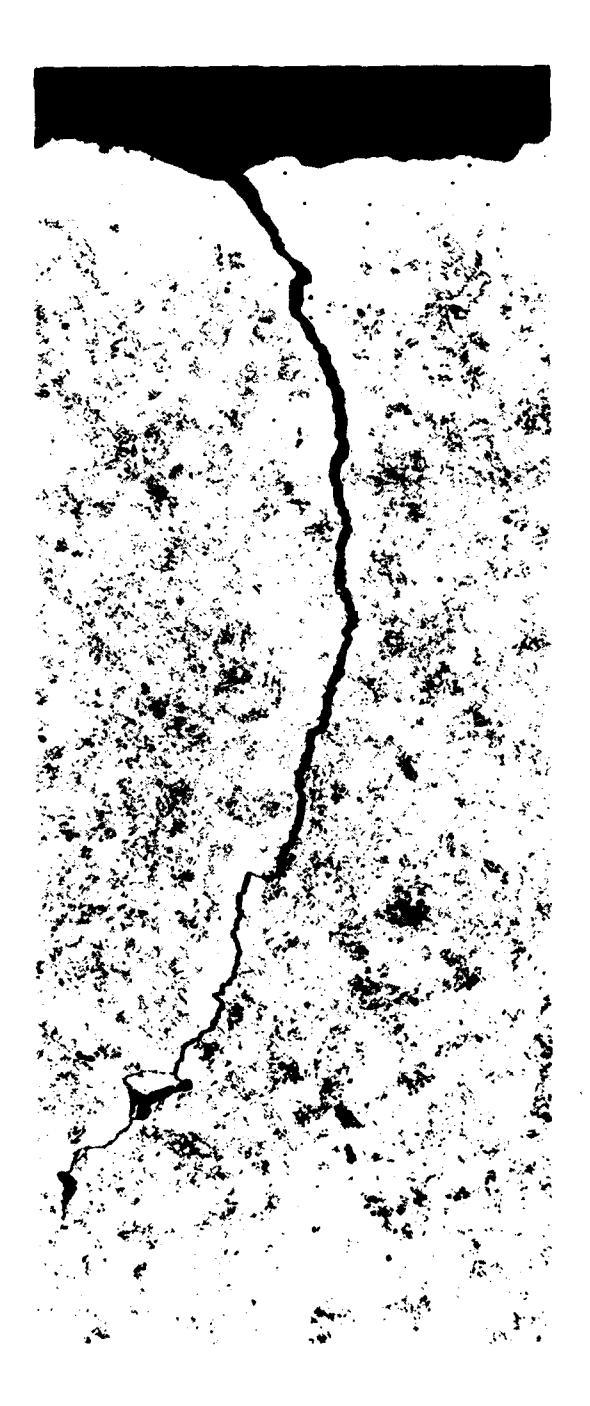
FIGURE 2

1. The upsurge in the incidence of cracking in these front mount frames has been identified as fatigue cracking caused by the harmful effect of a decarburized layer on the surface of the heat-treated steel castings.

Initiation of a fatigue crack in the decarburized surface layer of a frame.

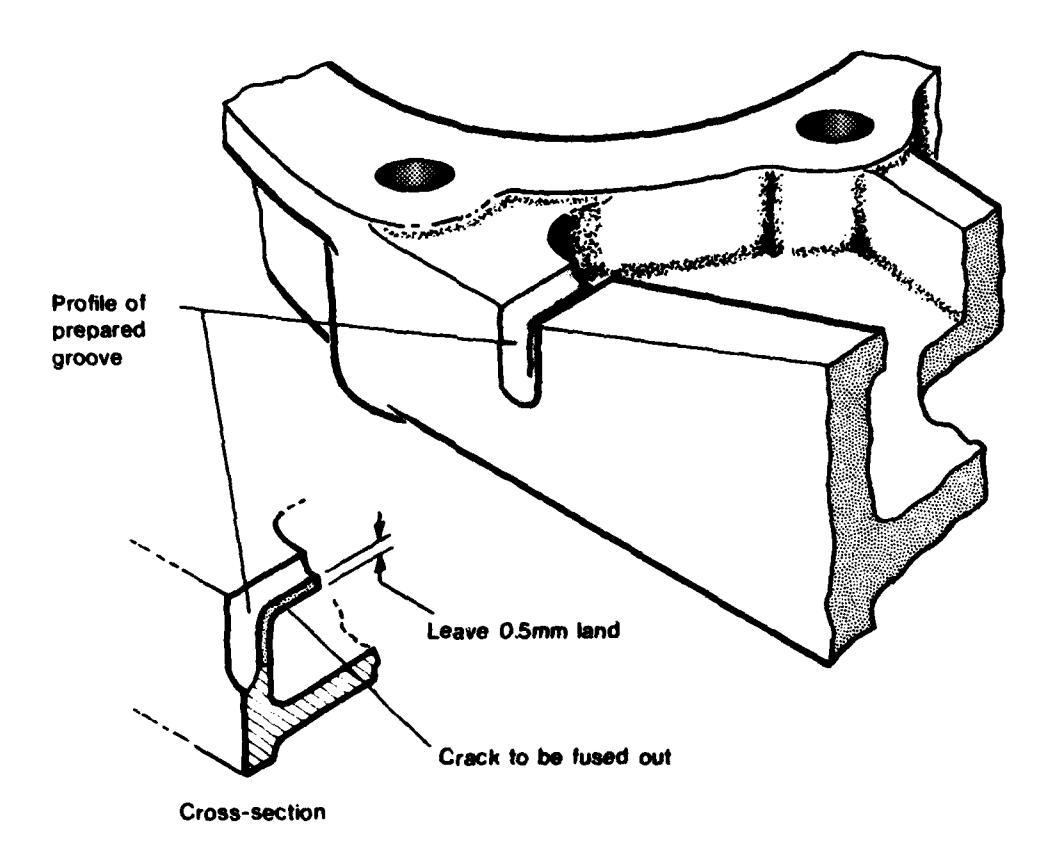
Recommended weld preparation for through-thickness cracks in position B, shown in Fig. 1. FIGURE 3

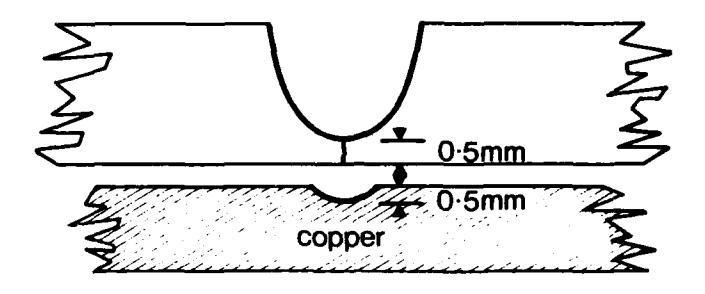
#### FIGURE 4 Schematic diagram of weld preparation and copper backing strip for through-section cracks.

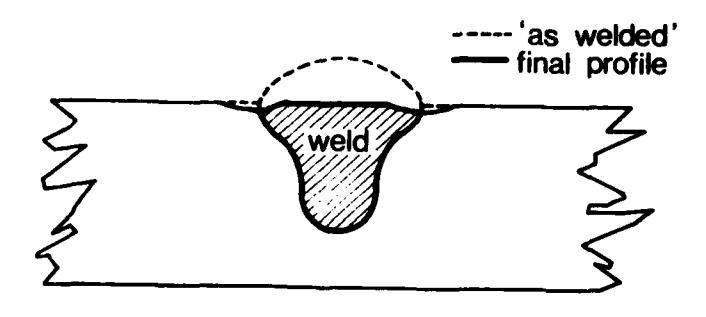
FIGURE 5

Schematic diagram showing blending out in weld toe areas.

The weld reinforcement was then ground off using tungsten carbide cutting burrs and the weld toe areas carefully blended out as shown in Fig. 5. A pneumatic rotary polishing wheel was used in the final blending-out operation. This polishing was done to minimize the propensity for crack initiation in the region of the weld toe, a common site for fatigue cracking, where the geometric notch effect of machining grooves and fusion boundary is compounded by the metallurgical notch effect of the weld.

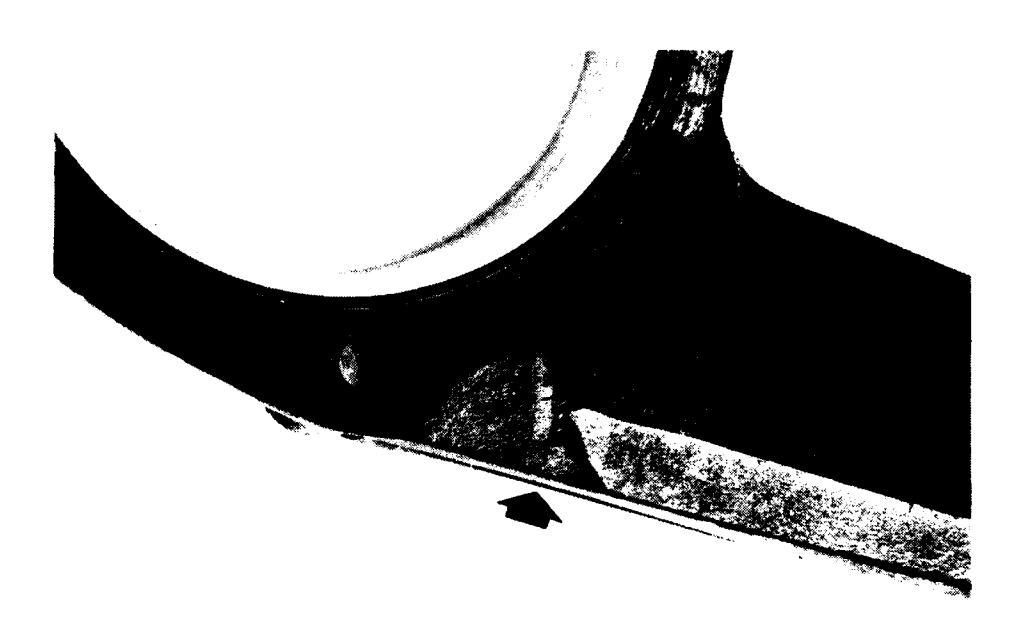
Analysis was undertaken on one crack, labelled B in Fig. 1, and shown more clearly in Fig. 6.

FIGURE 6 Detail of the crack shown at B in Fig. 1. The section shown had been subjected to bending stresses across the crack (arrowed), causing flexure convex to the plane of the page. The crack initiated at a machining groove, at the periphery of the machined surface.

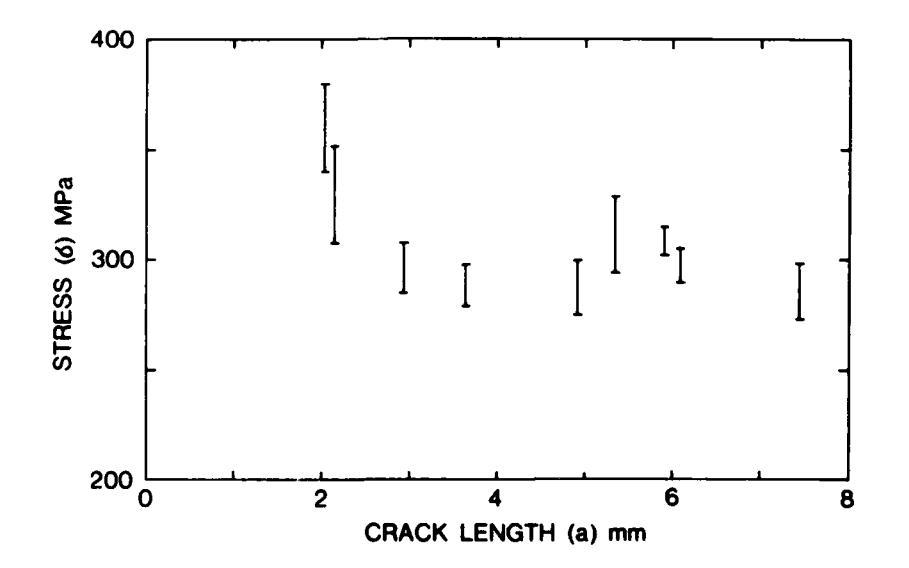
FIGURE 11

The results in Table 3 are presented graphically in Fig. 11. Despite considerable scatter in fractographic measurements, a reasonably confident estimate of  $300 \pm 30$  MPa for crack driving stress is obtained provided that two values from measurement at a = 2 mm (where measurement was more difficult) are given less weighting. The scatter bars in fact reflect

Estimates of the fatigue crack driving stress in the cast frame based on measurements of the crack shown in Figs. 7 and 8.
