TTIC FILE COPY TECHNICAL REPORT HL-87-8

NORTH DIVERSION STRUCTURE ALBUQUERQUE, NEW MEXICO

Hydraulic Model Investigation

May 1987 **Final Report**

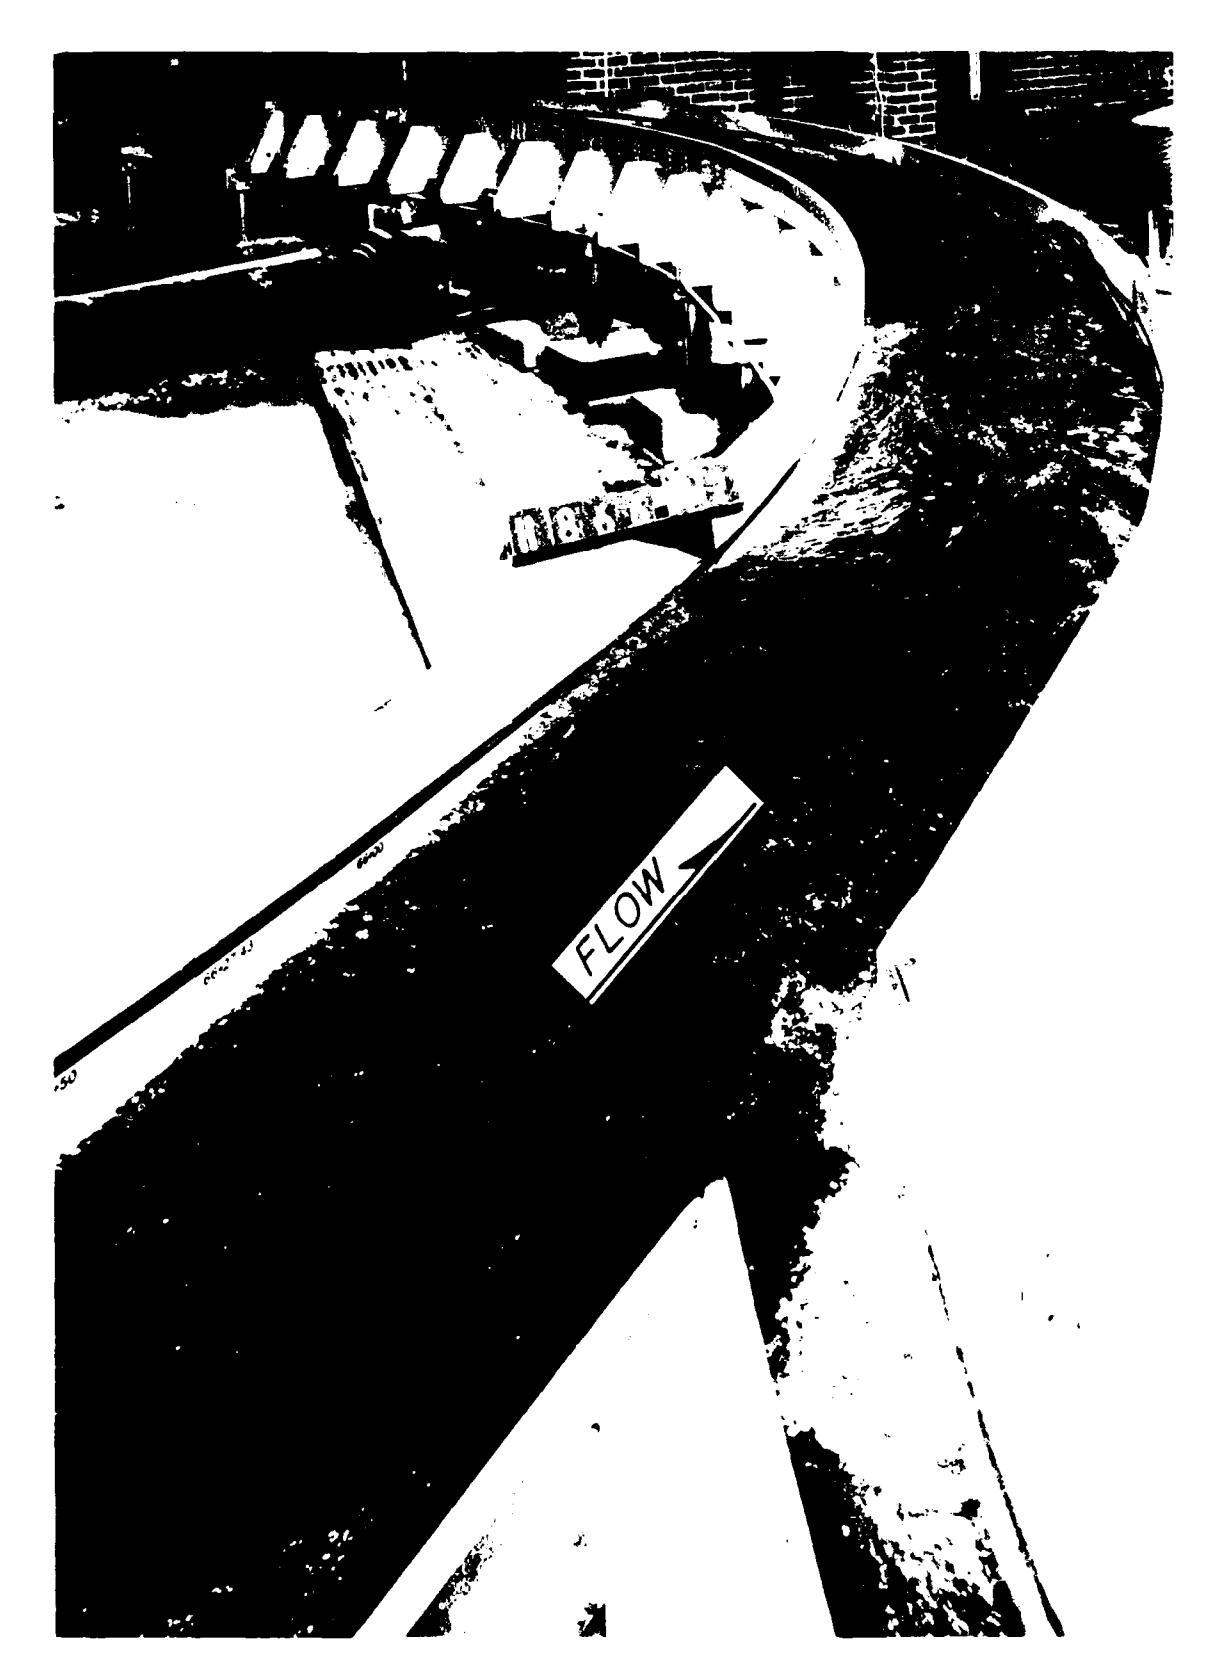
15. As shown in Plate 2, the flow at Camino Arroyo Inlet overtopped the channel walls at the junction with the downstream wall of Camino Arroyo Inlet. This overtopping was due to the standing wave caused by the vehicle access ramp and by the flow conditions resulting from flow falling into the gap in the main channel wall formed by Camino Arroyo Inlet. This flow impacted and ran up the downstream wall. The sudden expansion in the channel at the gap and the flow disturbance caused by the gap set up an additional standing wave that combined with the wave from the access ramp and contributed to the water-surface elevation at the Camino Arroyo Inlet. The combined effects caused the flow to overtop the channel walls by up to 10 ft.

Photo 5. Camino Arroyo Inlet and North Diversion Channel junction, design discharge

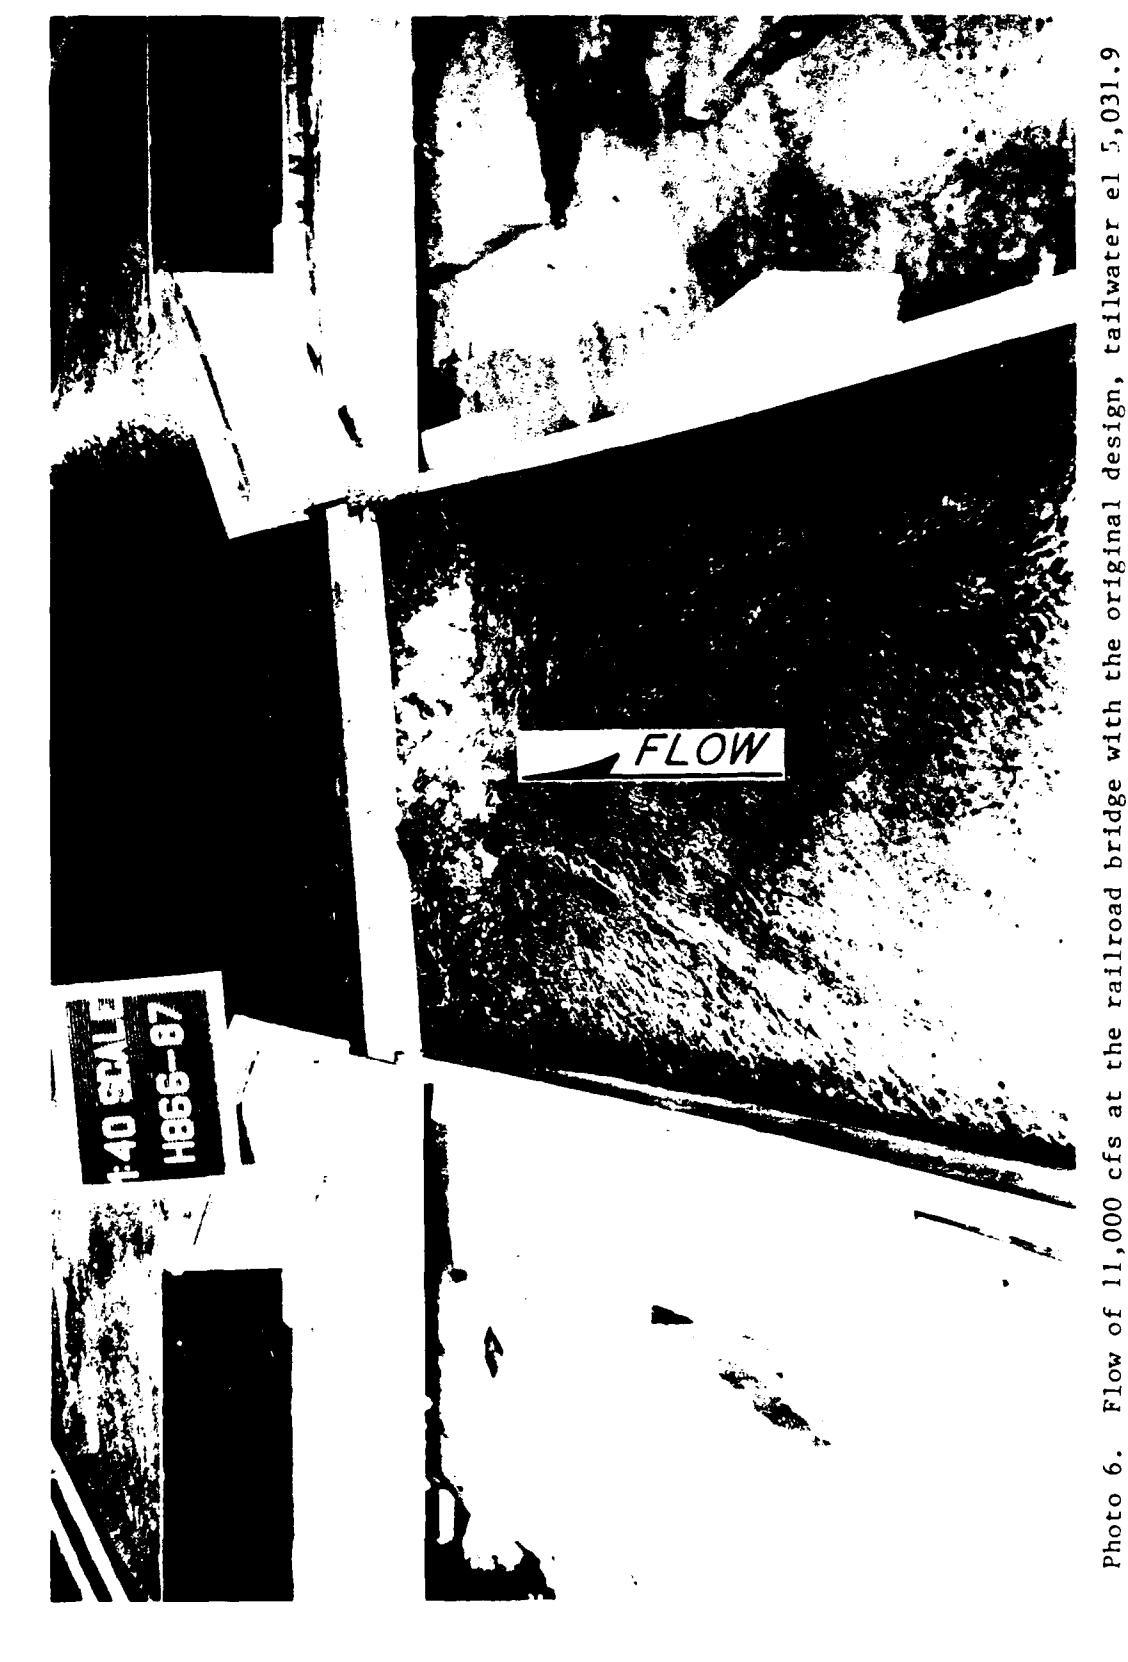
Flow of 11,000 cfs at the railroad bridge with the original design, tailwater el 5,031.9 Photo 6.

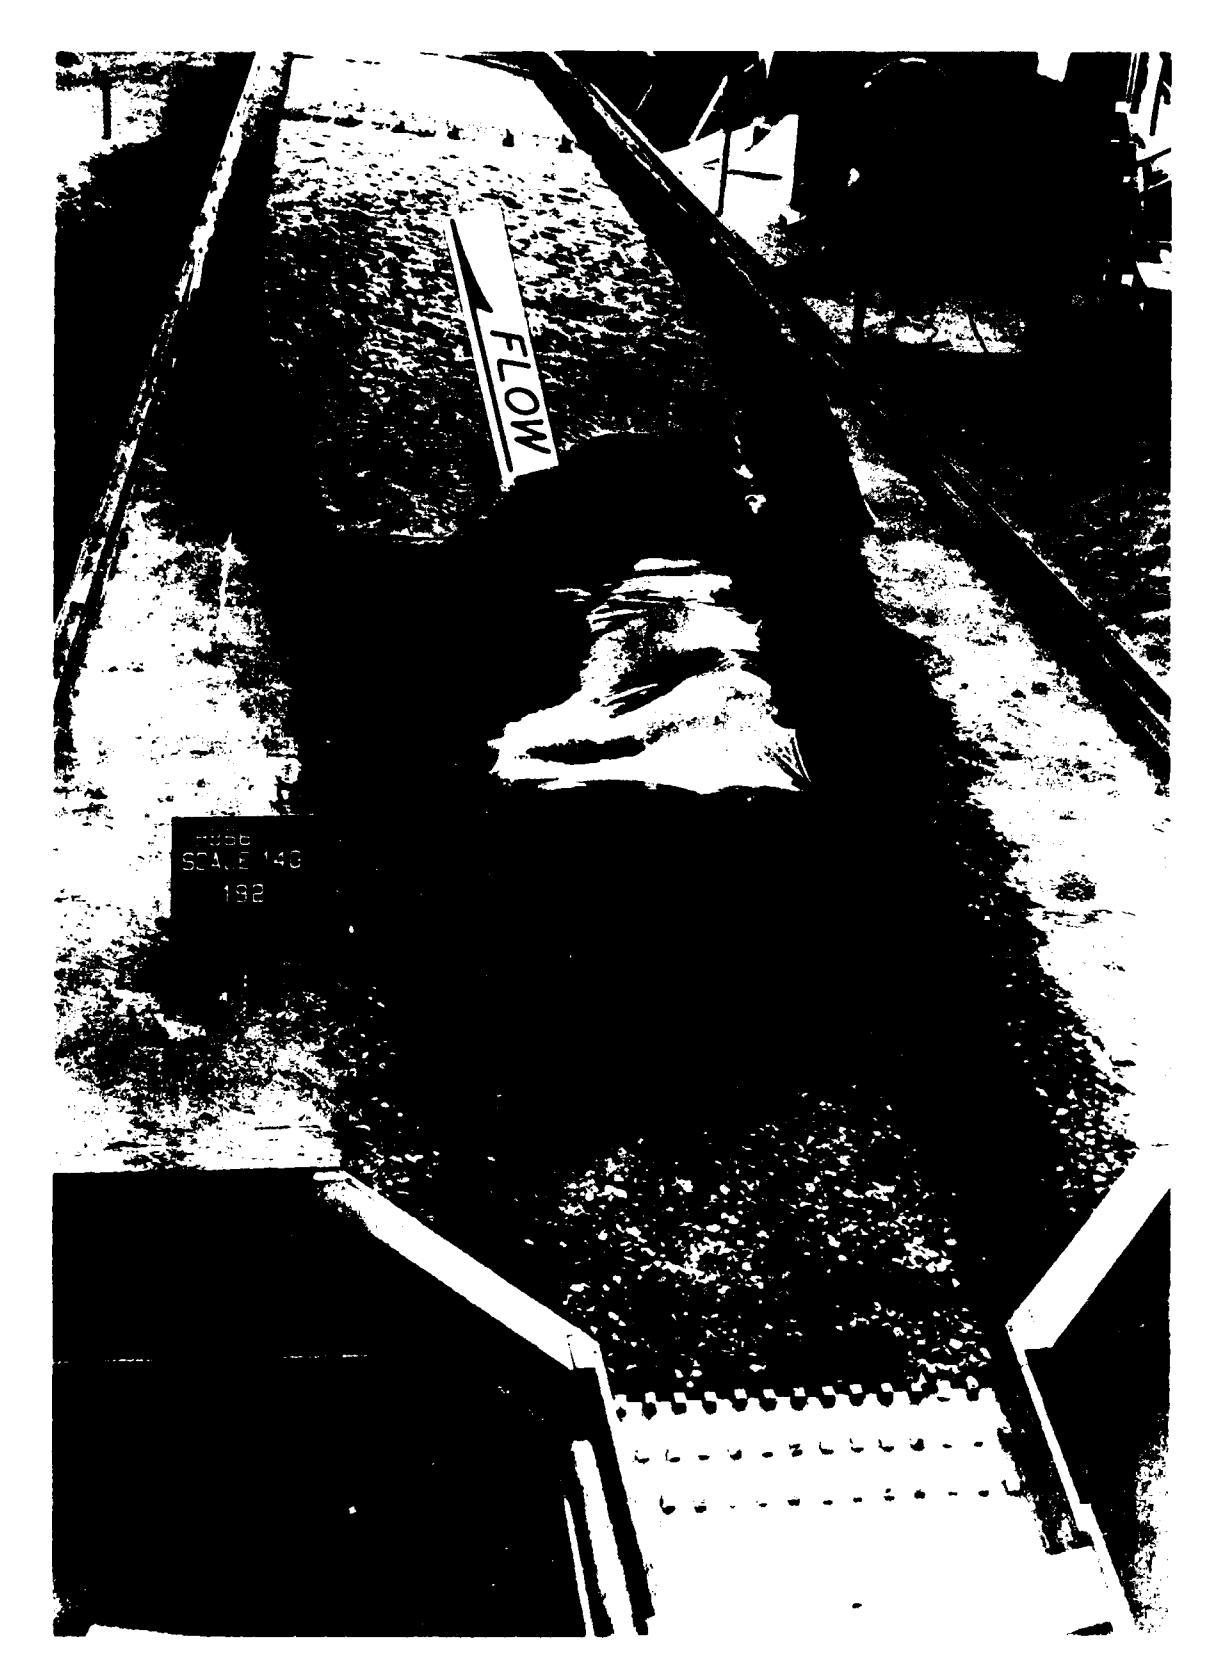
22. The as-built riprap protection is shown in Plate 11. The upstream portion of the riprap is grouted with concrete between sta 48+37.26 and 45+20.69. Riprap in the model was also grouted with a mortar mixture; however, the model does not simulate the strength of the grouted riprap. For flows up to 28,000 cfs, the riprap was stable in the model. Higher flows (Photo 17) resulted in the nongrouted riprap failing on the right side of the exit channel beginning at the downstream edge of the grouted riprap (Photo 7). Significant scour also occurred at the downstream edge of the riprap failure and

scour were more pronounced for the improved exit channel (Photo 18).

Photo 18. Outlet channel scour after design hydrograph, improved exit channel

26. The nongrouted as-built riprap failed in the model for flows above 28,000 cfs. AMAFCA personnel were willing to accept some damage to the channel invert for flows of that magnitude due to the infrequence of such flows and the costs associated with providing additional scour protection. Additionally, scour to the channel invert should not threaten the integrity of the structure. Some consideration should be given to providing additional scour protection to the toe of the right levee between sta 45+20.69 and 36+00 due to the scour potential exhibited in the model.
