TECHNICAL REPORT CERC-87-12

# HURRICANE KATE STORM SURGE DATA

**Report 5**

August 1987 Report 5 of a Series

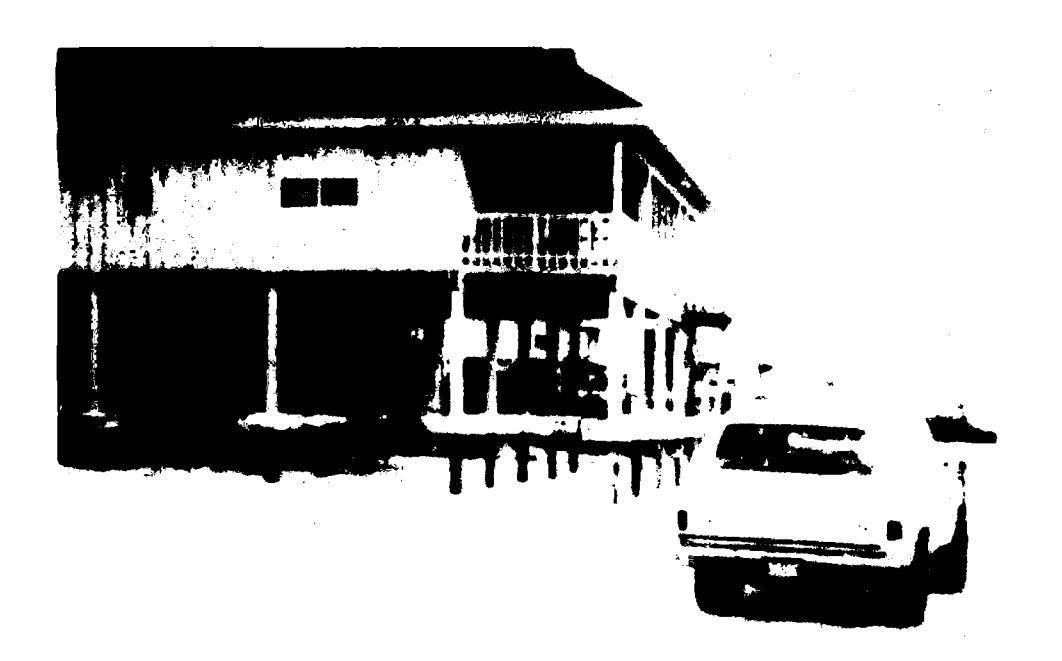
Photo 8. Beach erosion under house, Cape San Blas, Fla.

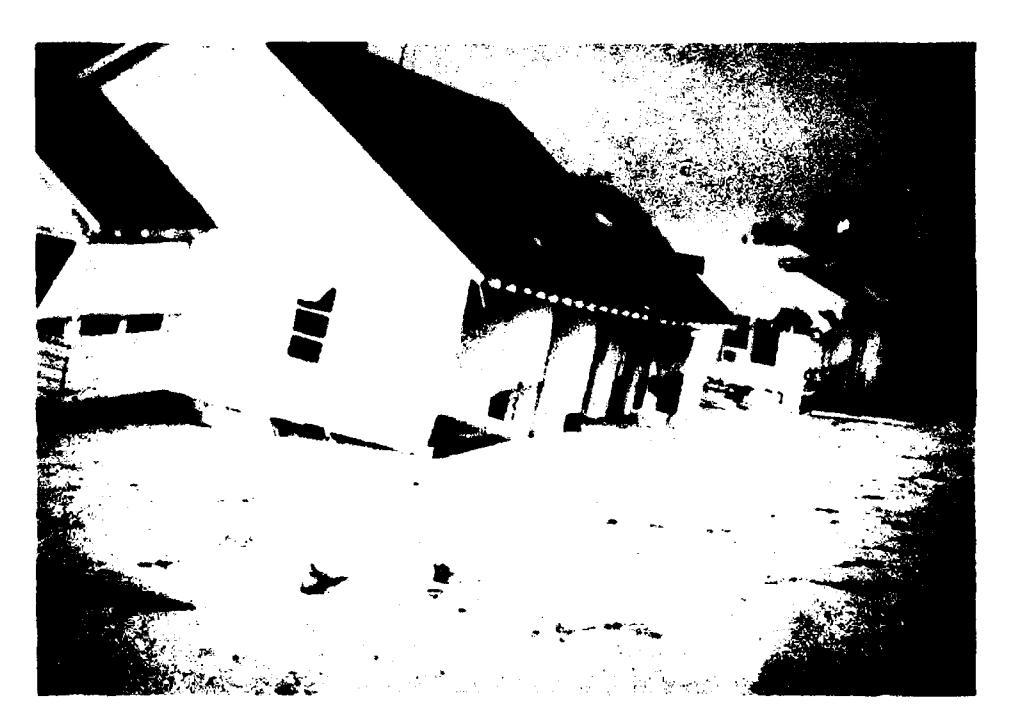
Photo 16. House destruction, Lighthouse Point, Fla.
