4. PERFORMI	NG ORGANIZATION	REPORT NUMBE	R(S)	5. MONITORING	ORGANIZATION	REPORT	UMBER(S)
Miscel:	laneous Paper	CERC-88-6	Ch. OFFICE CYMPOL		ONITOPING ORG	NUZATION	
USAEWE	S. Coastal Er	gineering	(If applicable)	78. NAME OF M	UNITOKING OKG	ANIZATION	•
Resear	ch_Center		L				
6c. ADDRESS	(City, State, and Zi	Code)		7b. ADDRESS (Ci	ty, State, and ZIP	Code)	
PO Box	631						
Vicksb	urg, MS 3918	0-0631			T INCTO IN	CALTICIC 41	
Sa. NAME OF ORGANIZ	+ FUNDING / SPONSC ATION	KING	80. OFFICE SYMBOL (If applicable)	9. PROCUREMEN	I INSTRUMENT I	DENTIFICA	ION NUMBER
US Arm	y Corps of En	gineers	l				
8c. ADDRESS	(City, State, and ZIP	Code)		10. SOURCE OF	FUNDING NUMBE	RS	Liver.
Washin	gton, DC 203	14-1000		ELÉMENT NO.	NO.	NO.	ACCESS
	lude Security Classi	ication)		L	L	1	
Monito	ring Complete	d Coastal	Projects: Oper	ational Asse	ssment of F	loating	g Breakwate
Puget	Sound, Washin	igton					
Nelson	. Eric E.: H	mslev. J.	Michael

This report was prepared by Messrs. Eric E. Nelson, US Army Engineer District, Seattle, and J. Michael Hemsley, Prototype Measurement and Analysis Branch, Engineering Development Division (CD), CERC, under direct supervision of Mr. Thomas W. Richardson, Chief, CD; and

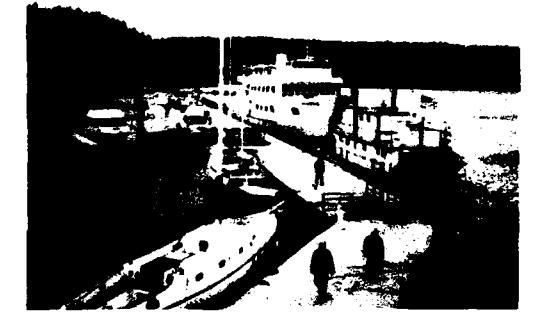
29. After project completion, the Port of Friday Harbor found that there was a considerable demand for moorage on the seaward side, particularly for large (75-ft) vessels (Photo 10). The Port requested that the Corps evaluate a proposal to moor large vessels on the seaward side of the breakwater. Additional loads that could be generated if large vessels were moored on the seaward side of the breakwater were calculated and found to be well within the allowable design criteria. However, safety concerns voiced by the Washington State Ferry System remain an unresolved issue. Finally, no adequate tie-up facilities are available on the seaward side of the breakwater, and if

Photo 10. Large vessels moored on seaward side of breakwater

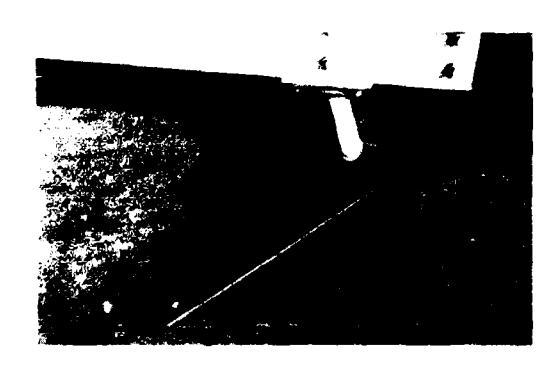
30. Lateral and longitudinal excursions of the breakwater were monitored by noting the extent of marks left on the breakwater by access ramp casters (Photo 11). Maximum longitudinal motion (north-south) was about \pm 2.5 ft, and maximum lateral motion (east-west) was \pm 6 in. North-south motion was probably increased by the sail effect of larger vessels temporarily moored to the B- and C-floats. Several minor storms from the south did not produce particularly large waves but did have winds in excess of 40 mph and may have been responsible for the maximum north-south excursions.

Photo 11. Caster marks indicating limits of motion

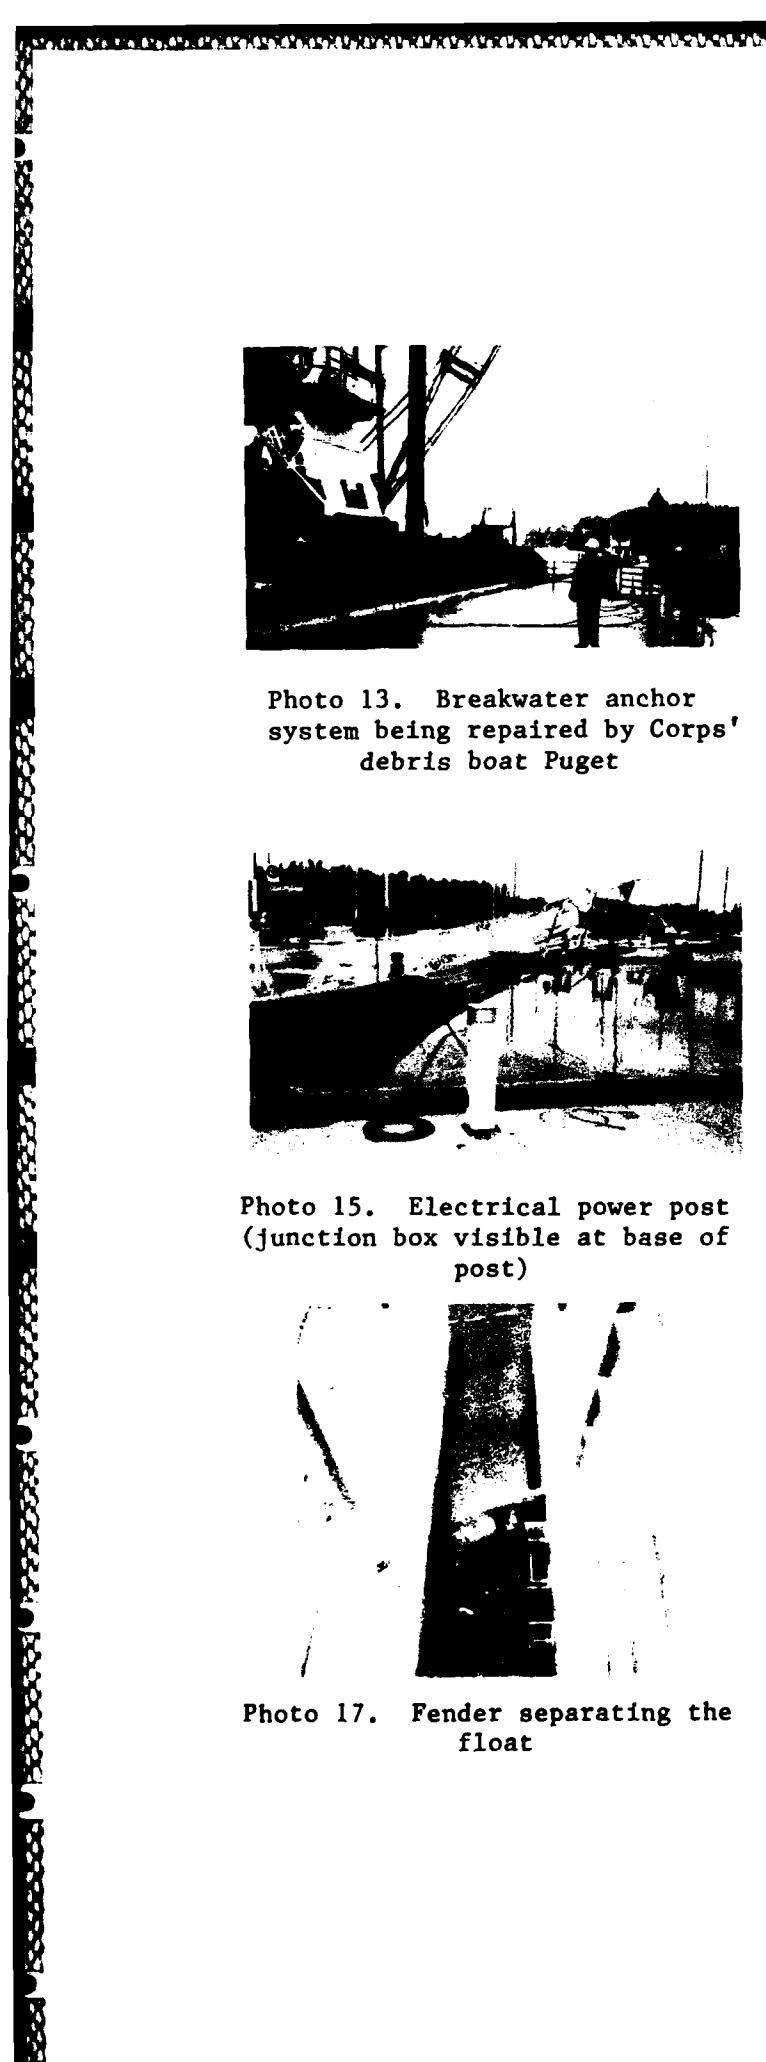
Photo 13. Breakwater anchor system being repaired by Corps' debris boat Puget

32. The repair involved releasing the seaward anchor line from the breakwater, lowering it under and around the landward anchor line, then reconnecting and retensioning it. Work was carried out with no difficulties, but the procedure did require the use of CENPS' debris boat <u>Puget</u> (105 ft long with a 20-ton capacity crane) and a four-man "hard-hat," or surface-supplied, air dive crew (Photo 13). Total cost for the repair was approximately \$10,000. Divers using surface-supplied air with communications linked to the surface were invaluable in adjusting final anchor line tensions to assure there was no contact between the anchor lines.

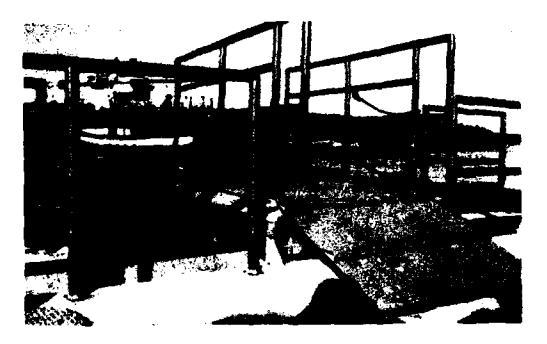
experienced several persistent maintenance problems. Access and interfloat ramps are only 4 ft wide (Photo 14). This width precludes access to the breakwater by electrically powered vehicles. The Port would like to use these vehicles to reduce travel time for the 1/2-mile round trip to the end of the breakwater. Stanchions, located on the breakwater to supply electrical service to transient boats, are relatively tall. Their height, combined with their placement near the edge of the breakwater, make them vulnerable to being knocked over by bowsprits of docking boats (Photo 15). This particular stanchion design is also prone to being pulled over by boaters who neglect to unlug their shore power lines before departing. Electrical junction boxes present another problem. The boxes are mounted flush with the deck, so they fill with water unless access plates are carefully sealed. Much of the hardware which provides mechanical support for the electrical wiring was not designed specifically for use in a marine environment; consequently this hardware is now badly corroded and eventually will have to be replaced.

Photo 14. Interfloat ramps

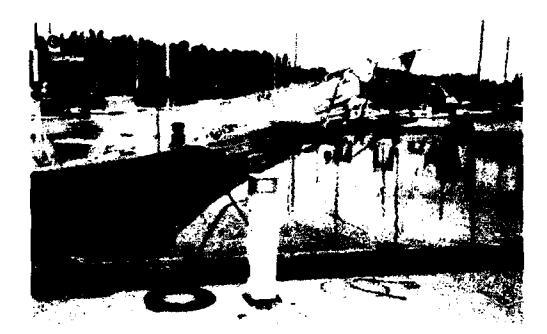
Photo 15. Electrical power post (junction box visible at base of post)

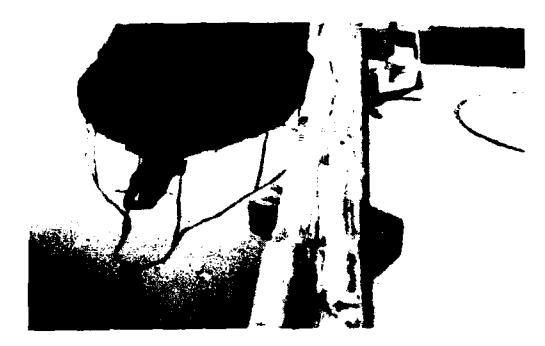
34. A relatively minor, but persistent, problem involves the bull rail. Blocks supporting the bull rail are held in place with only one bolt. Some of the blocks have rotated and present a hazard to boats tied up alongside (Photo 16). Finally, the Port is aware of at least one incident in which a person fell off the breakwater and had to swim to an adjacent dock because he was unable to pull himself up over the bull rail and onto the deck of the breakwater. Plans are underway to install life rings and possibly add safety ladders at various locations along the breakwater.

Photo 16. Spacer blocks on bull rail

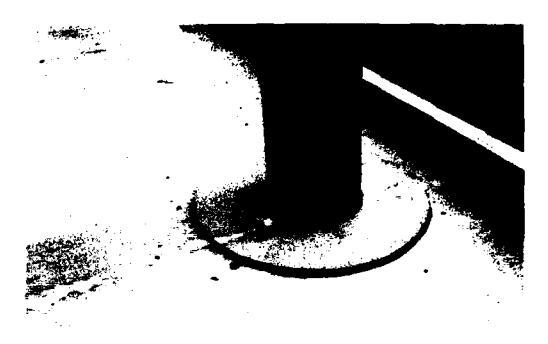
37. No northerly winds of any significance occurred at the East Bay site, and no damage has been noted on the breakwater after 3 years of operation. A potential problem, pointed out by the concessioner operating the marina for the Port of Olympia, was that the holes through which the pilings passed were large enough to allow a child to fall between the piling and the float (Photo 19). As a temporary solution, plywood rings were placed over the pilings (Photo 20). Another problem, which did not affect the breakwater but did affect all of the access floats within the marina, was that during one period of extreme cold, numerous waterlines ruptured because of either differential expansion between the floats and polyvinyl-chloride waterlines or the freezing of trapped water. Waterlines on the breakwater were enclosed within the float and were not damaged.

Photo 20. Temporary cover for the breakwater-piling gap
