WRDC-TR-89-4148

AIRCRAFT BATTLE DAMAGE REPAIR OF TRANSPARENCIES

April 1990

Interim Report for Period October 1986-December 1988

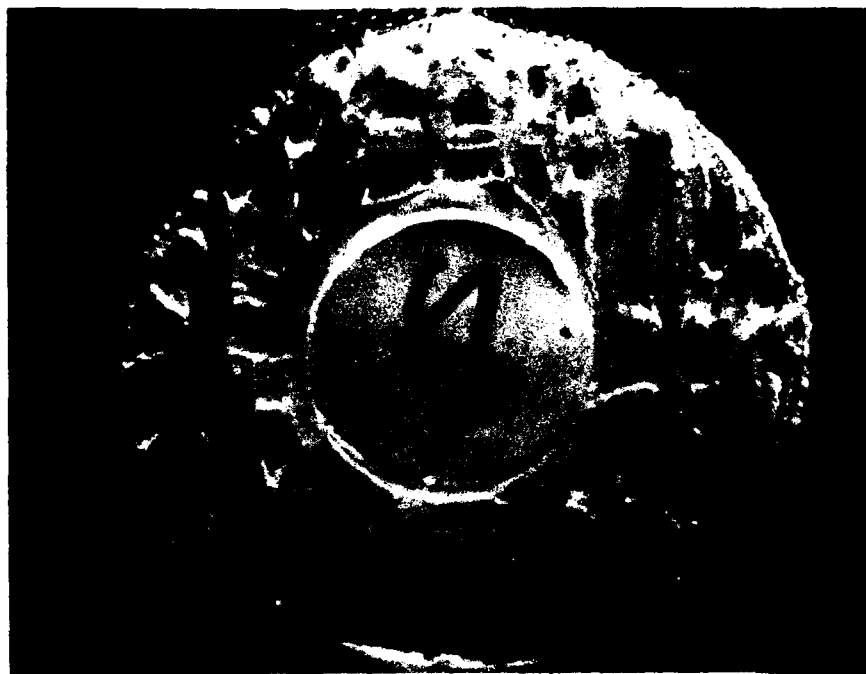
fusion bonding could be used successfully to apply a patch to both polycarbonate and cast acrylic samples. In addition, it was determined that the TOROBONDER could not be used to apply a patch to any type of stretched acrylic material because the temperatures necessary to effect melting of the stretched acrylic surface caused significant shrinkage and cavitation of the stretched acrylic substrate. Based on these results, actual canopy surfaces were then utilized as substrates for additional bonding studies. As in the case of the flat samples, we determined that the TOROBONDER alone could not be used to apply a patch to any type of stretched acrylic canopy surface. Figure 3 illustrates a typical cavitated stretched acrylic surface. The cavitated areas in the bond line between the patch and the stretched acrylic canopy leaked, although the patch adhered to the canopy at certain points in the bond line. The application of an RTV sealant to the cavitated areas of the patch resulted in a leak-proof patch.

Figure 3. Stretched Acrylic Surface Showing Cavitation Which Occurs as a Result of Induction Heating the Surface to its Melting Temperature.

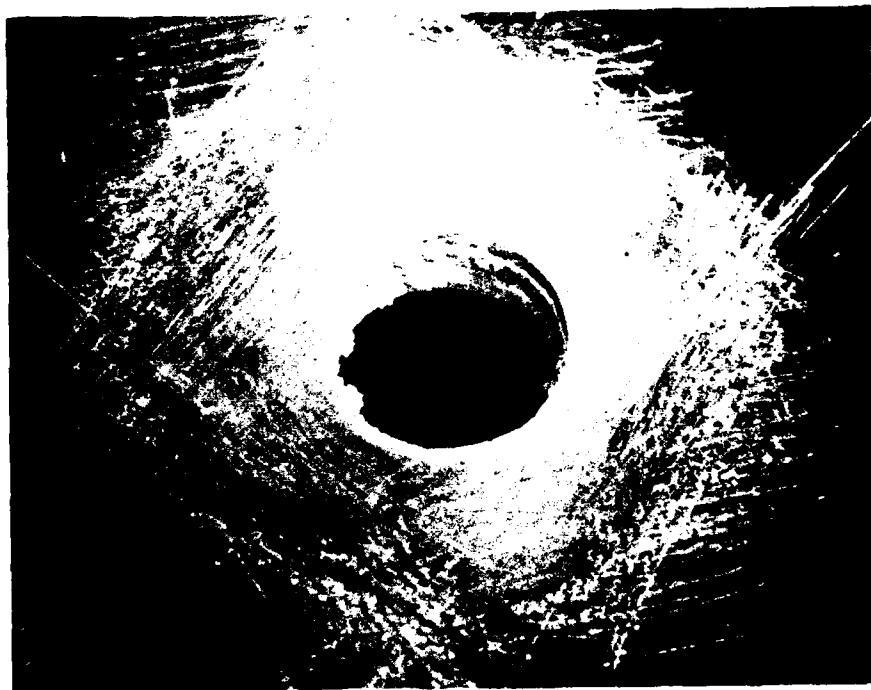
Figure A.9. The Bonding Area Around the Hole is Sanded Prior to the Application of Adhesive.

1. Remove the damage area using a drill. Make sure to remove all cracks in the potential bonding area.
2. Remove any surface film on the patch side of the canopy using either sand paper or a sanding drill.

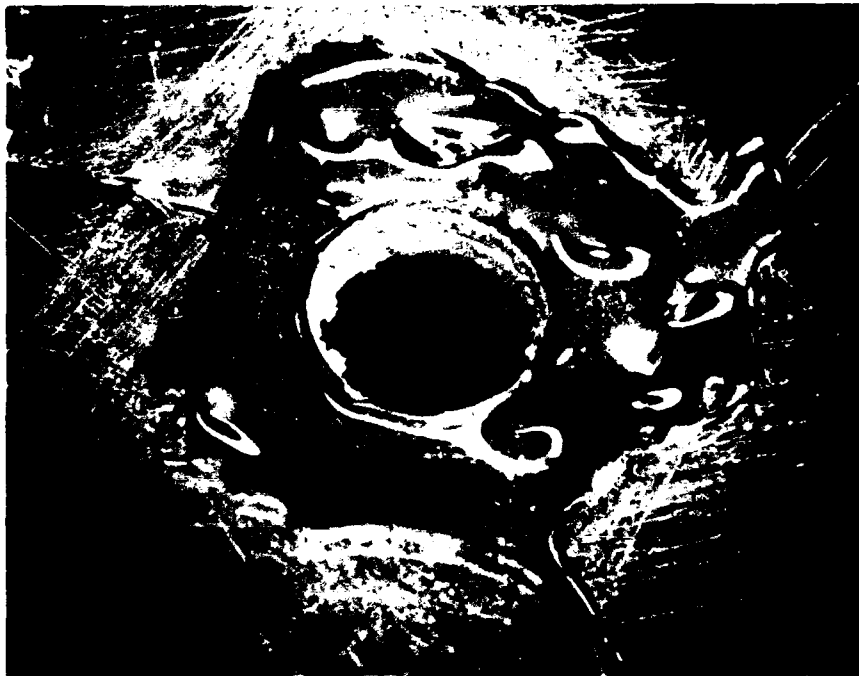
Figure A.10. Adhesive is Applied and a Thermocouple Placed in the Bond Line.

(1) For stretched acrylic canopies, a thermocouple should be placed in the bond line and the TOROBONDER temperature controller set at 160°F. The thermocouple bead will be permanently bonded into the bond line when the repair is completed so the wire will have to be snipped off and a new bead prepared for subsequent use.

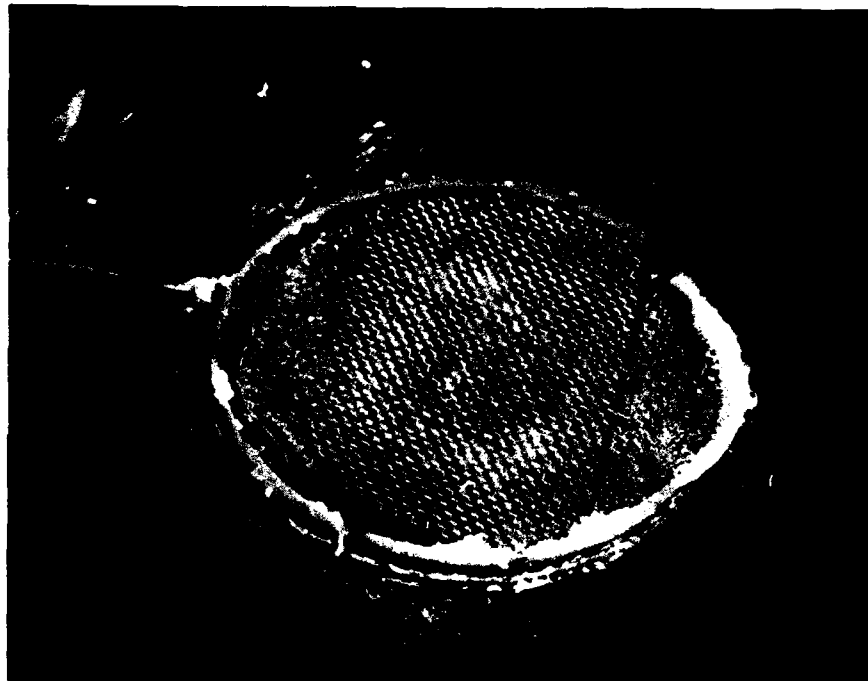
Figure A.12. The Cast Acrylic Patch is Placed over the Screen and the TOROBONDER is used to Cure the Adhesive.
