DOT/FAA/CT-94/56

Transportation Development Centre Montreal, Quebec, Canada Characterization of Corrosion and Development of a Breadboard Model of a D Sight Aircraft Inspection System: Phase I

August 1994

Final Report

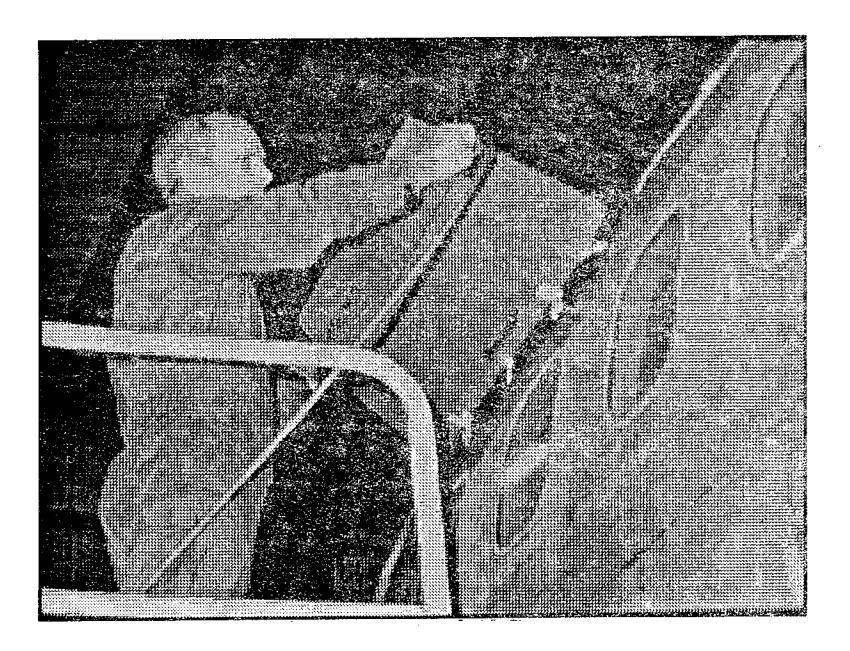
Validation Center (AANC), operated by Sandia National Laboratories in Albuquerque, New Mexico. An older B-737 is available at the facility for testing equipment and the human factors associated with hangar inspections. At present, this aircraft is not yet characterized for corrosion so that a comparison of inspection results could not be made on site. When this characterization is completed, a comparison could be made with the stored inspection results obtained during this field trip. The report "DAIS-250C Field Trial AANC - Albuquerque, NM" (attached as appendix E) details this field testing effort.

FIGURE 2.- FIELD TRIAL OF DAIS-250C AT AANC, ALBUQUERQUE, NEW MEXICO

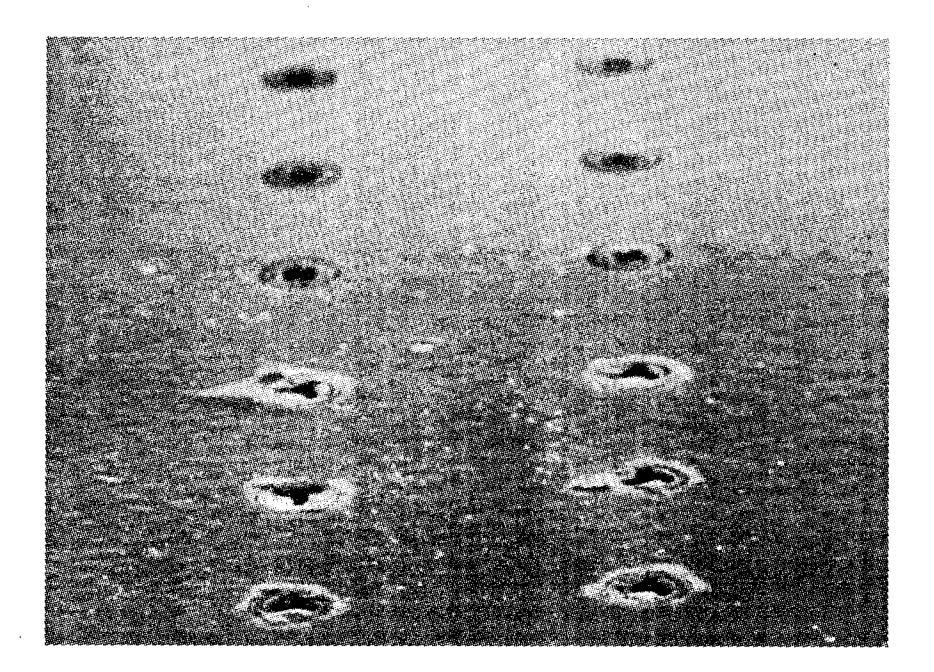
Figure 19 is a good illustration of galvanic corrosion around steel fastener in aluminium alloy. D Sight isolated corroded areas and the findings were later confirmed by ultrasonic inspection.

Figure 19. D Sight image of an aluminium alloy skin with two sets of fasteners. The six lower fasteners precipitated galvanic corrosion which is quite visible under D Sight.

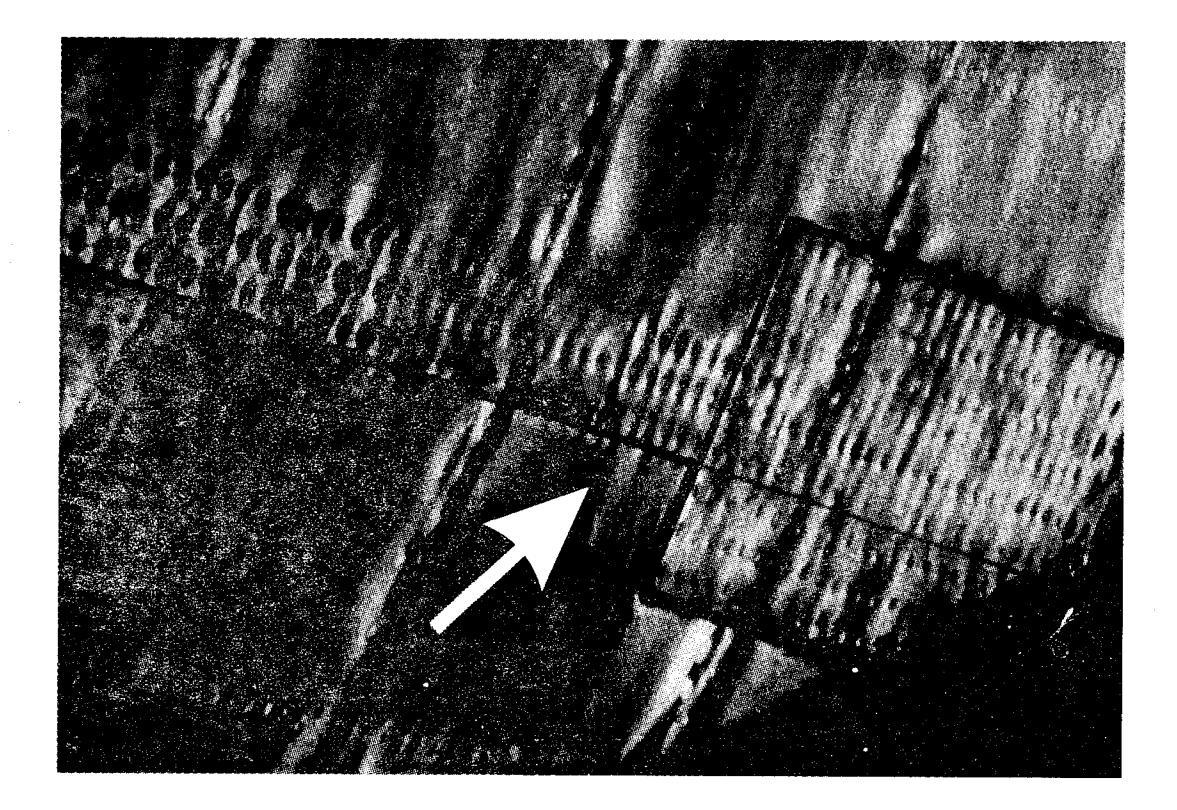
Corrosion in lap joints leads to pillowing (bulging) of skins held together by fasteners or spot welds. This is a very good application of D Sight which has been demonstrated on actual aircraft (B727) as shown in Figure 20.

Figure 20. D Sight image of B727 lap splice showing pillowing in 8 rivet rows outside the patch. Subsequent teardown revealed extensive corrosion.

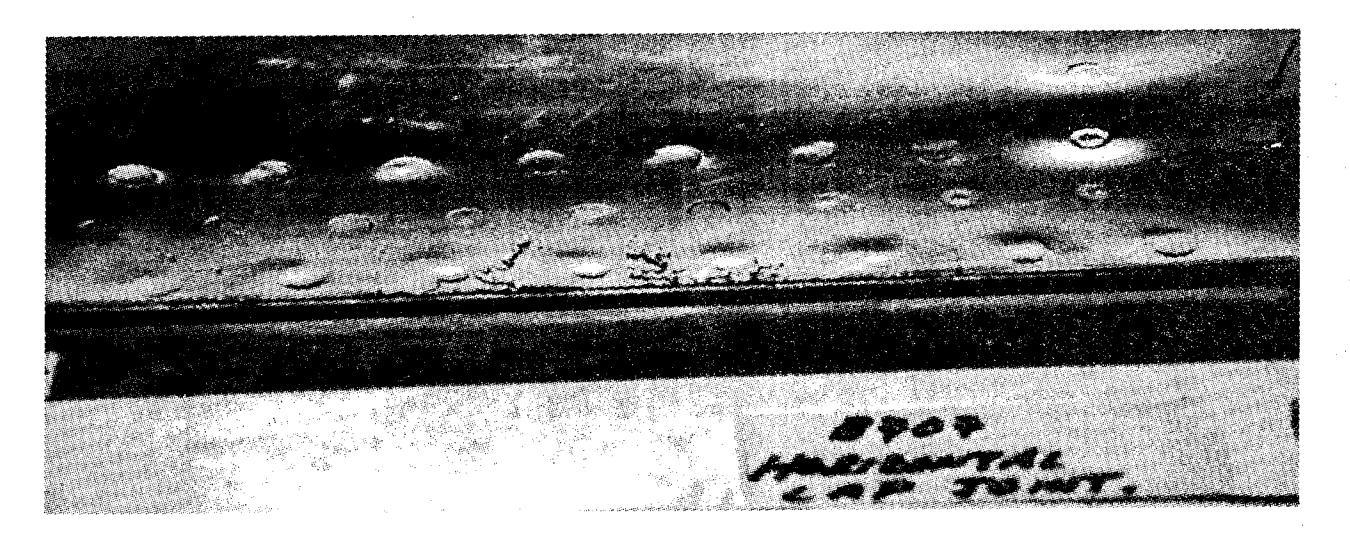
This is a good candidate form of corrosion for D Sight inspection as can be seen in Figure 21.

Figure 21. D Sight image. Filiform corrosion in a lap splice area.

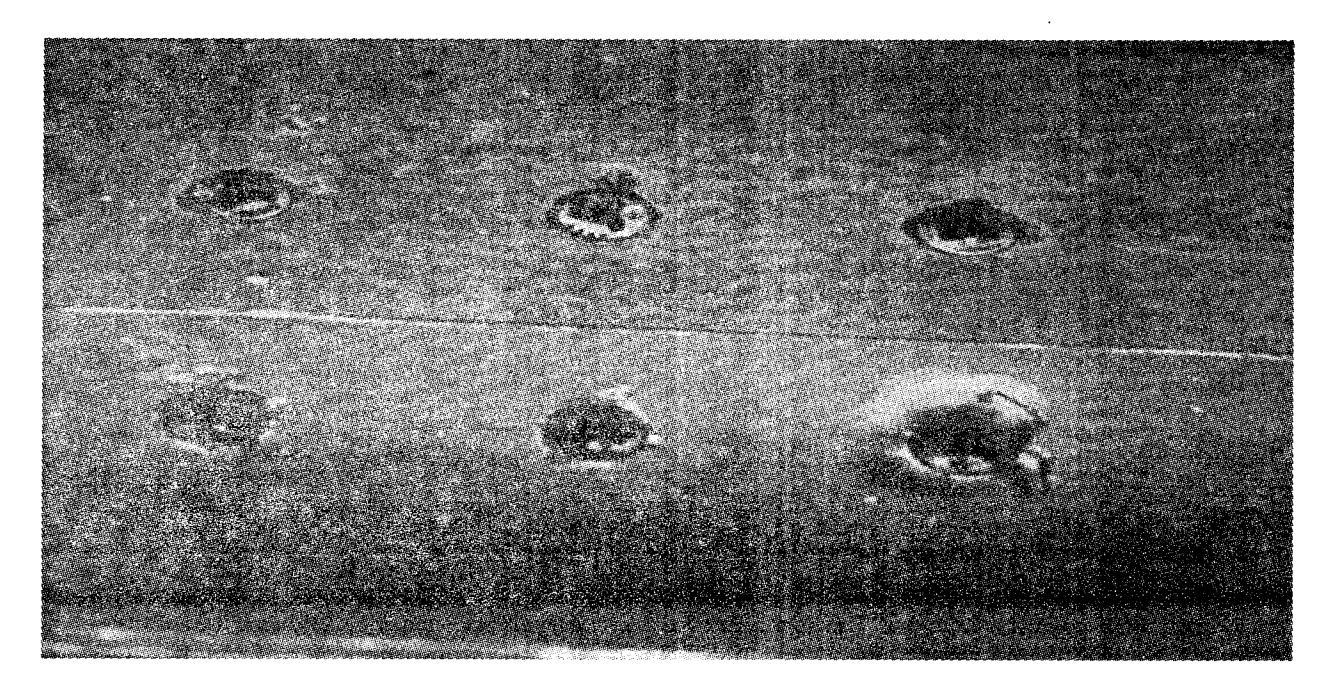
Figure 22 shows D Sight image of heavy exfoliation around fastener caused by galvanic corrosion. Exfoliation by definition will result in surface perturbation and is therefore well suited for D Sight inspection.

Figure 22. D Sight image showing exfoliation around a rivet head.

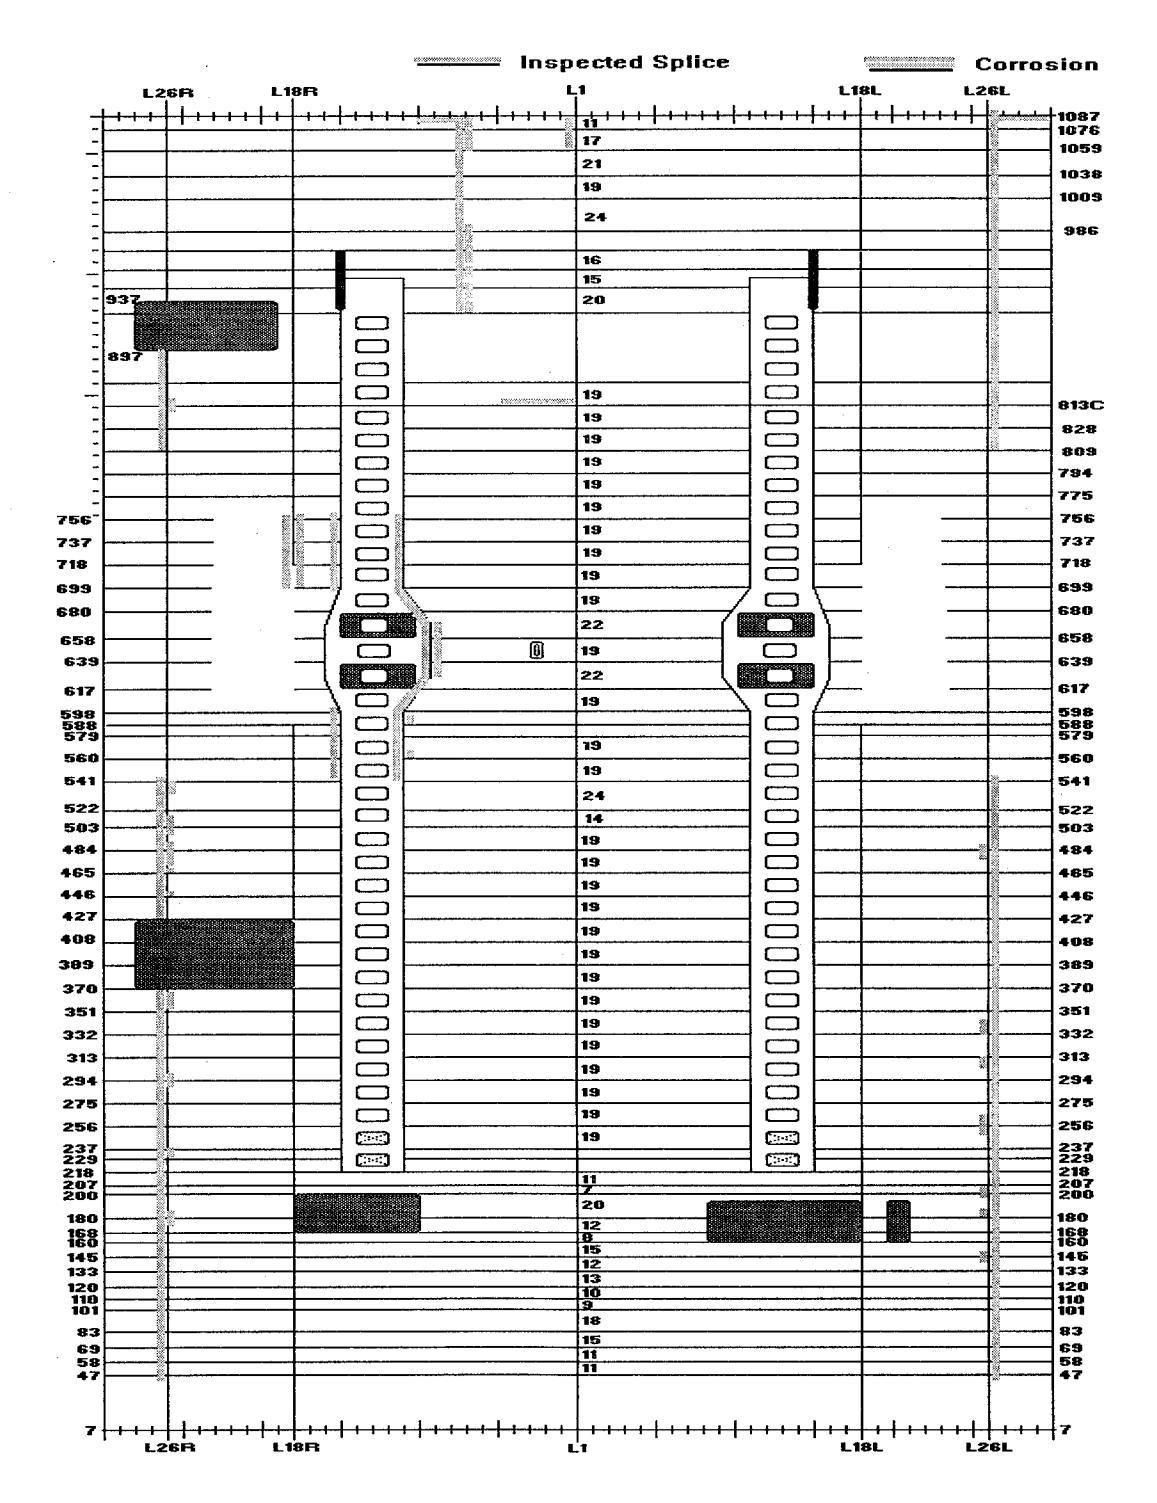
Figure 1: Results of D SIGHT inspection of DC-9-32 for corrosion

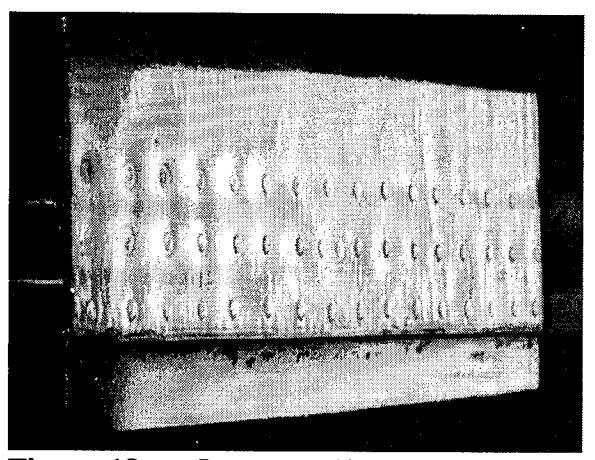
The presence of corrosion in lap splices around rivets causes a physical pillowing or bulging of the surrounding surface while the clamping force of the rivet prevents the surface from bulging to the same extent in the vicinity of the rivet. As a result, the rivet area forms a local depression in the surface. The key *D SIGHT* signature that indicates the presence of this depression at a moderate to high corrosion level is the occurrence of a dark-to-bright gray scale variation to the immediate right of the rivet with a bright zone immediately to the left of the rivet. Figure 18 shows these signatures for the specimen that was physically profiled in Figure 2. The dark and bright area to the right

Figure 18: Lap splice corrosion signatures

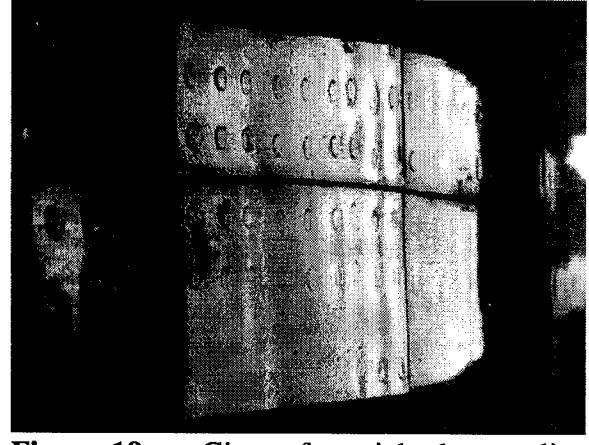
Figure 19: Circumferential lap splice corrosion

center row rivets even though there is a prominent wave signature pattern. This condition also may result from the rivet head not being reflective, causing a disruption in the formation of the depression's signature.

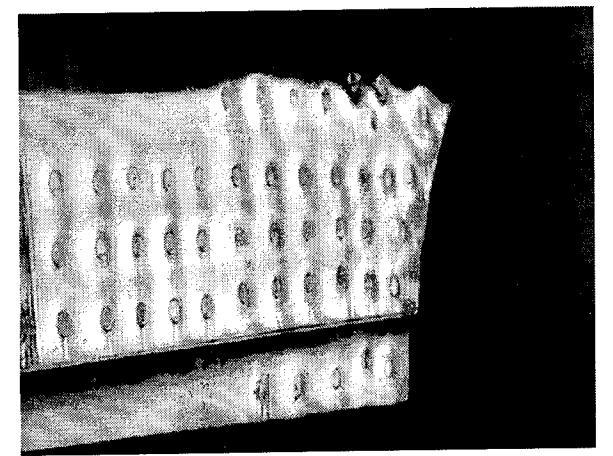
Figure 20: Weak signatures of corrosion

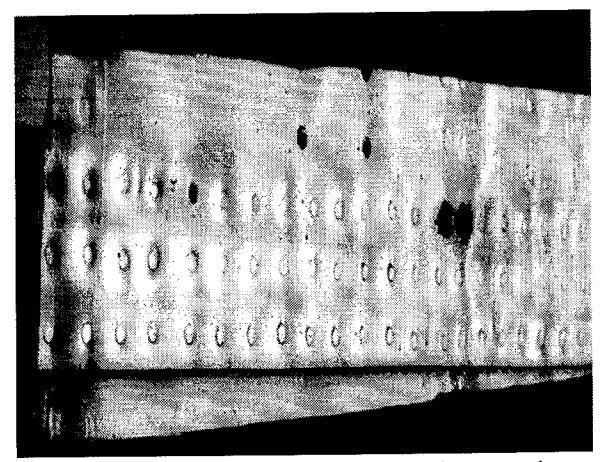
Figure 21: Lap splice corrosion on bare aluminum

Figure 21 is an example of a bare aluminum lap splice with corrosion predominately on the left side. The center row of rivets exhibit strong signature indications of corrosion. The edges of some rivets appear recessed to a point that they are no longer visible in the image. Such a condition is another key signature feature of corrosion. The fourth rivet from the left hand side of the middle row is recessed so deeply that the dark part of the signature is in fact in line with the rivet. Note that the fifth rivet from the left hand side in the top row is missing altogether.

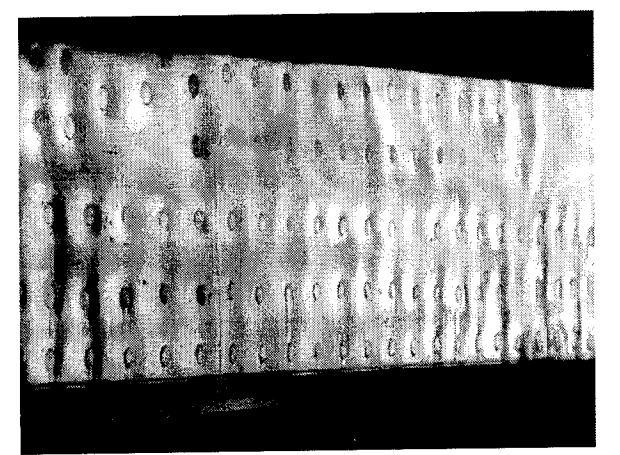
Figure 22: Two types of corrosion signatures

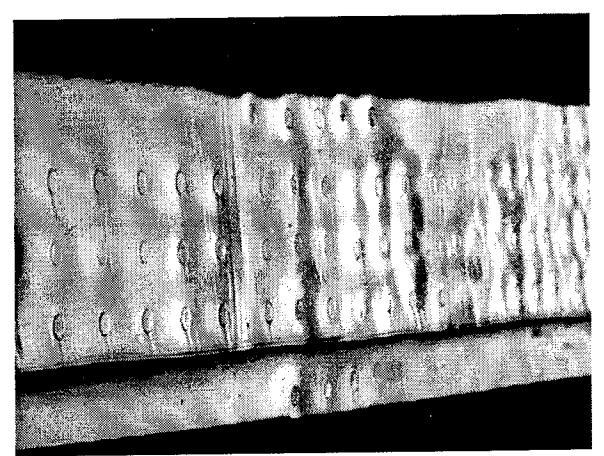
Figure 23: Severe corrosion signatures and uncorroded area

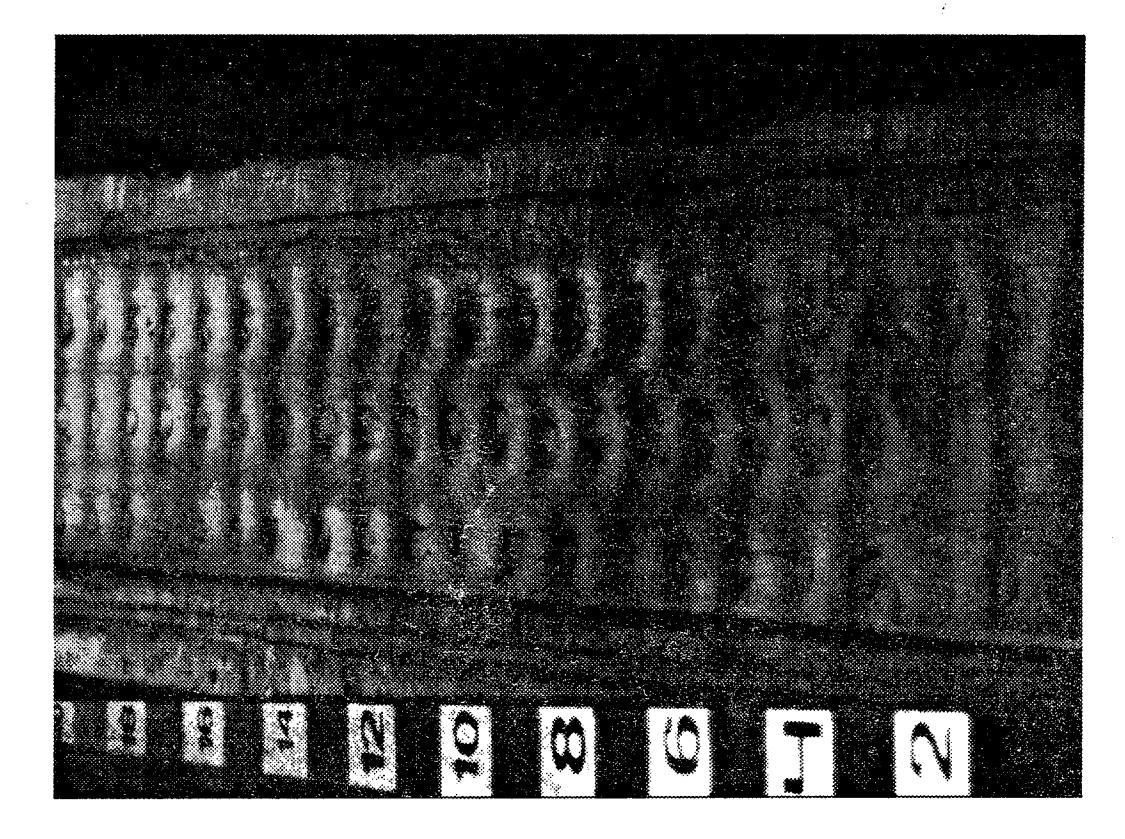
B727-N4747 SPECIMEN 12 IMAGE 5 - showing extensive corrosion

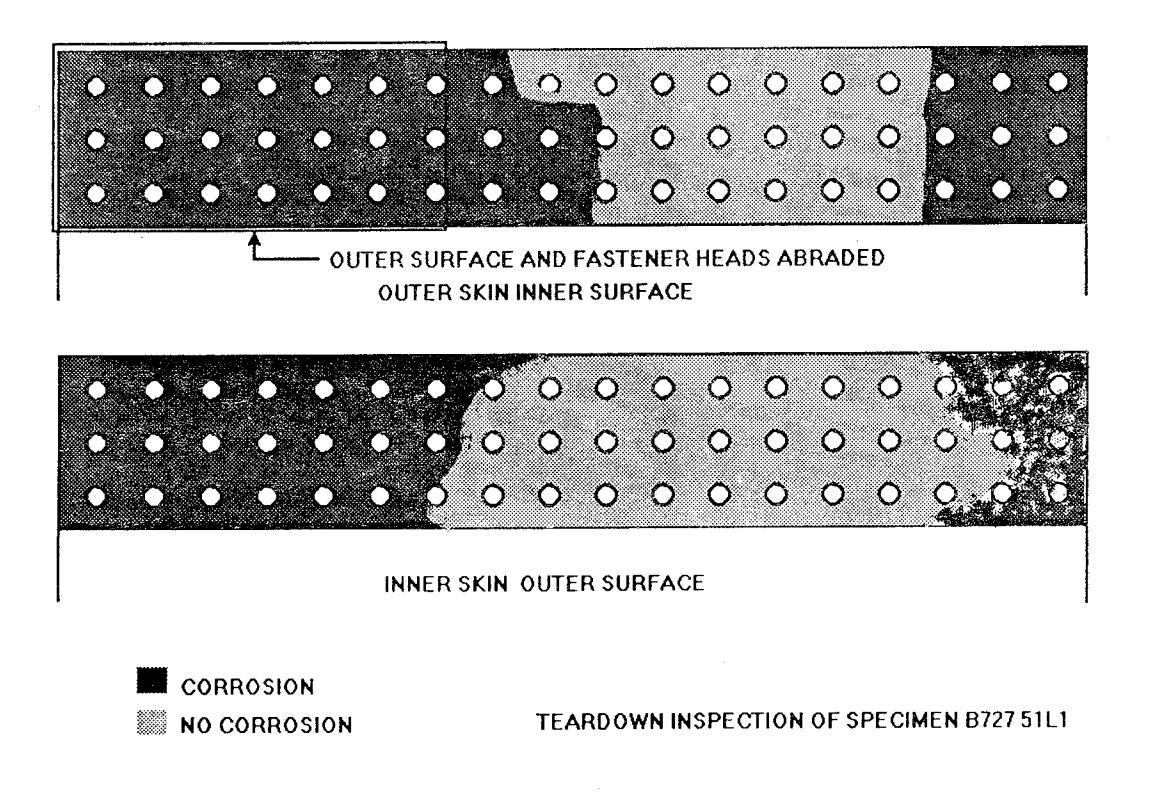
Only two specimens were subjected to tear down subsequent to D Sight inspections and these are shown in Figures 7.10 and 7.11. In both specimens the correlation is excellent.

Figure 7.10 Specimen 51L1 D Sight and teardown maps of corrosion.
