REPORT NO. NADC-77073-30

REAL-TIME X-RAY INSPECTION OF COMPOSITE AIRCRAFT STRUCTURES

F. PATRICELLI, J. BALTGALVIS, R. POLICHR and V. J. ORPHAN

December 1978

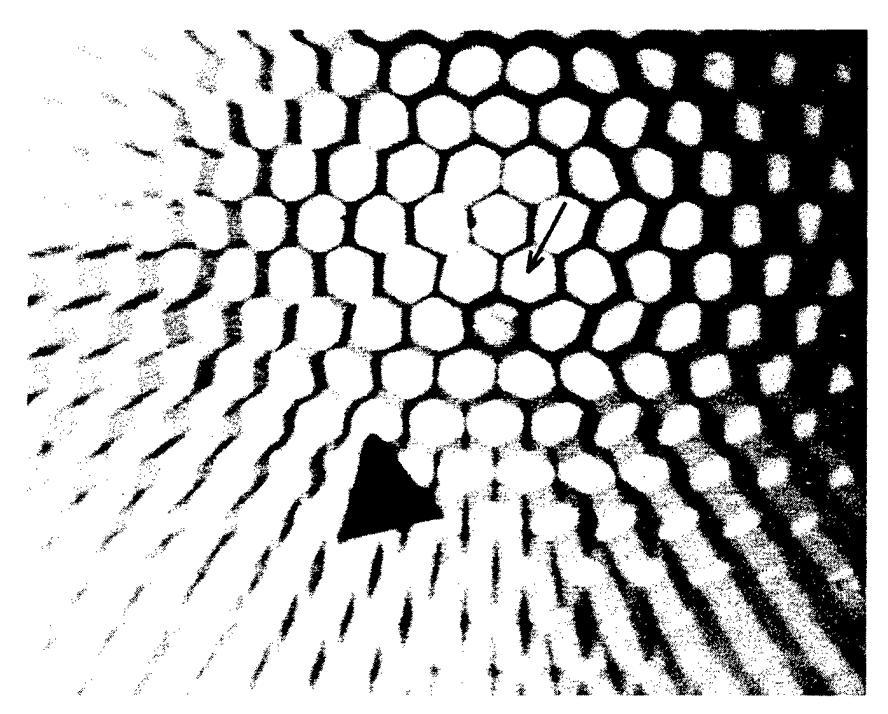
Figure 13. RTR of a Graphite/Epoxy sample with aluminum honeycomb illustrating damage in a singular core (70kV, 5mA)

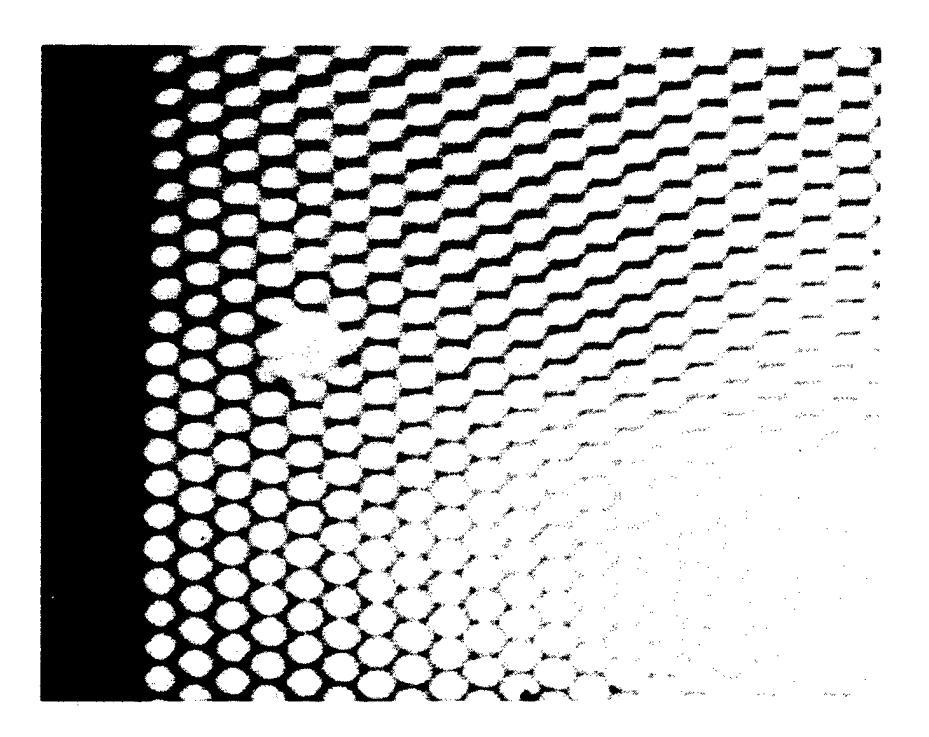
Figure 14. RTR of a Graphite /Epoxy Sample with Aluminum Honeycomb illustrating core damage (70kV, 5mA)

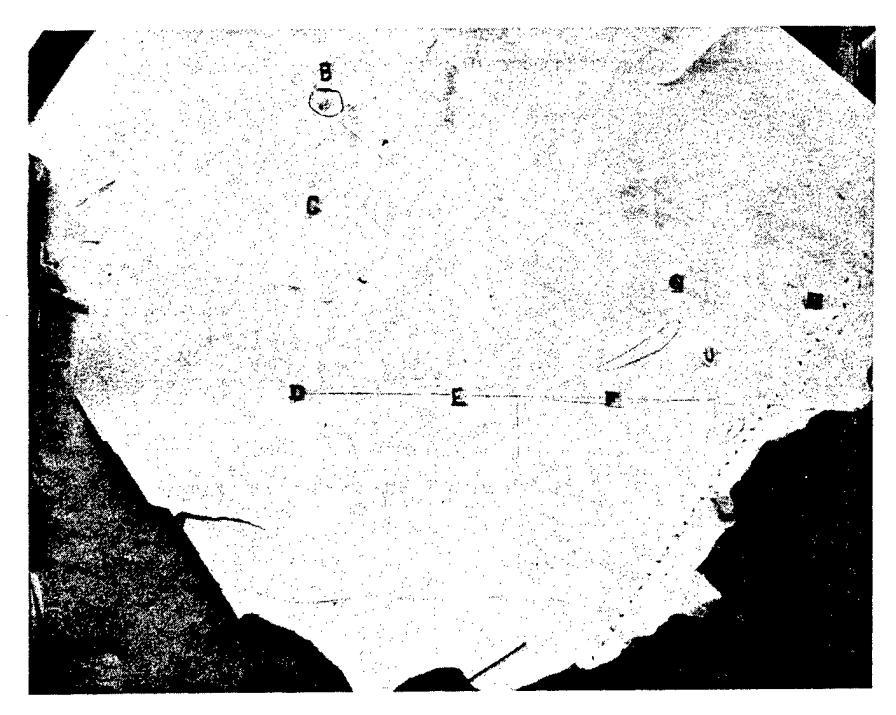
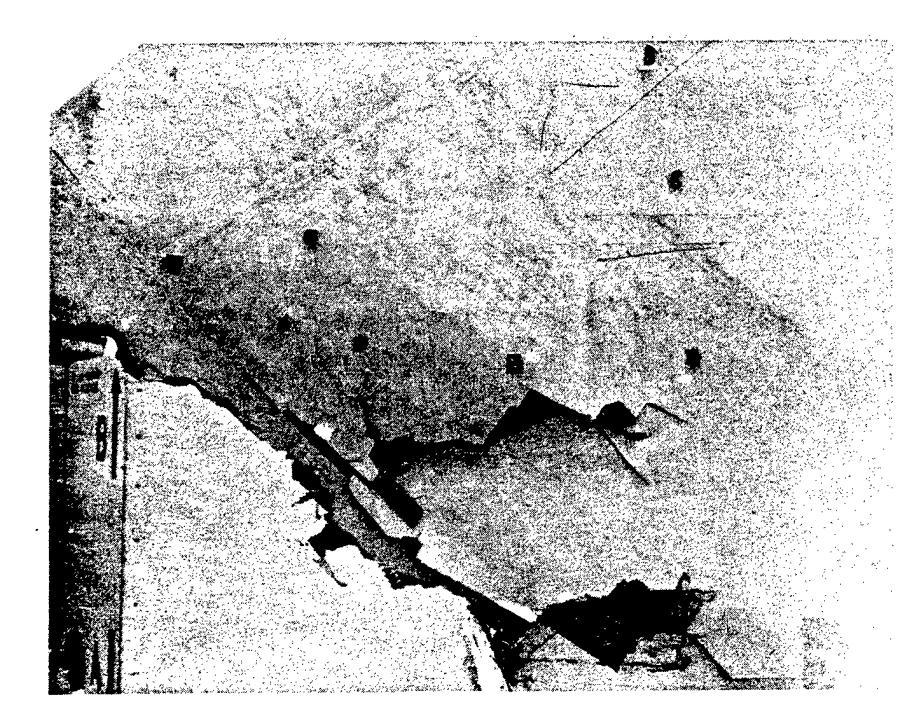
Figures 17 and 18 show the front (x-ray source side) and back (next to RTR screen) of a damaged F-14 stabilizer labelled with lead letters at different areas to identify the area during inspection. The photographs illustrate extensive damage at D, E and F, with no visible damage at C, H and U. Areas B and G contain small nicks that are visible on the surface.

Figure 17. Front Side of a damaged F-14 Boron/Epoxy horizontal stabilizer

Figure 18. Back side of the F-14 horizontal stabilizer

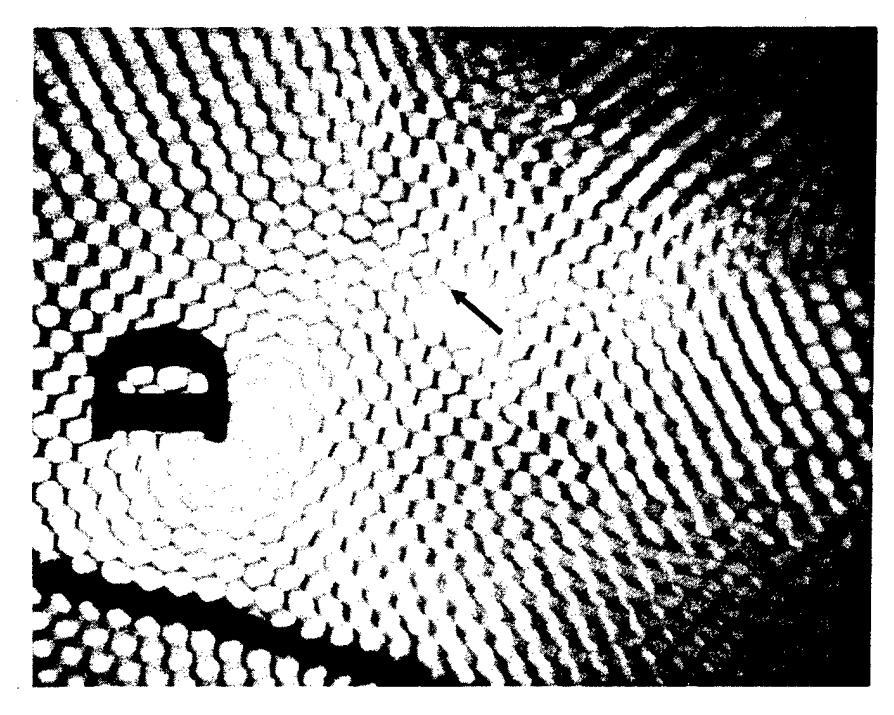
Figure 21. RTR of area D illustrating a large area of crushed honeycomb in the right corner. In addition a singular core indicates core damage similar to the type in Figure 13. (65kV, 4mA)

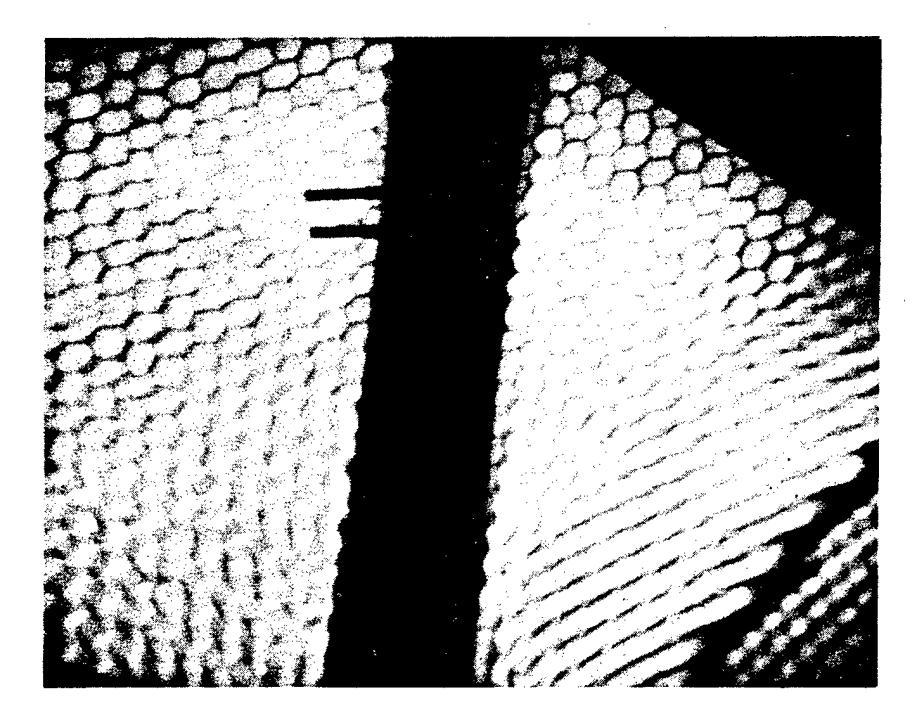
Figure 22. RTR of area U illustratint damage that is not visible on the surface (64kV, 4mA)

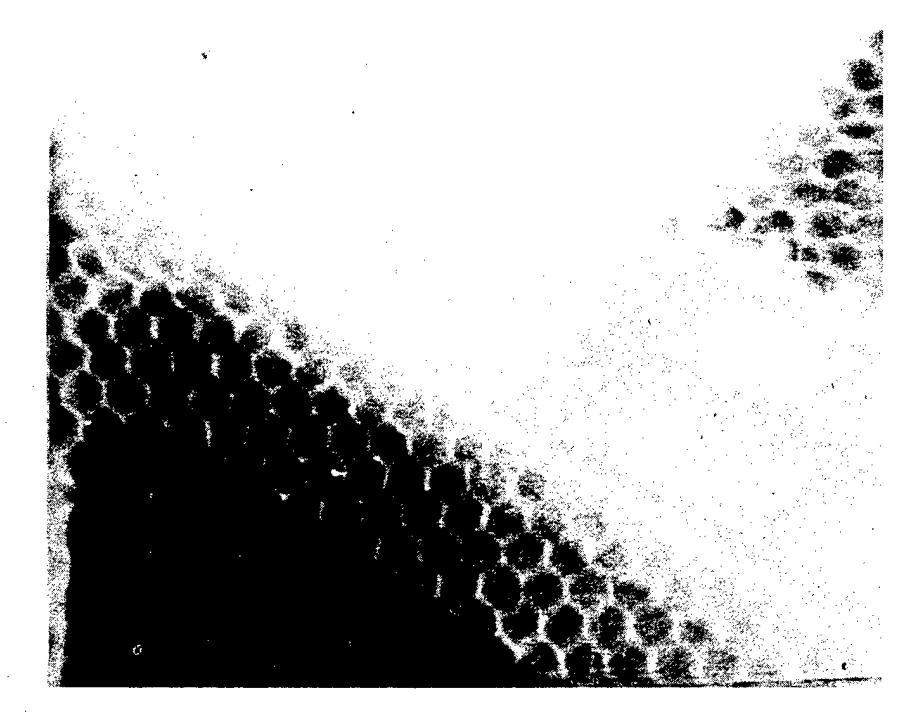
Figure 23. RTR of area H illustrating where the honeycomb is bonded to the aluminum honeycomb. The white areas indicate excessive adhesive (80kV, 4mA)

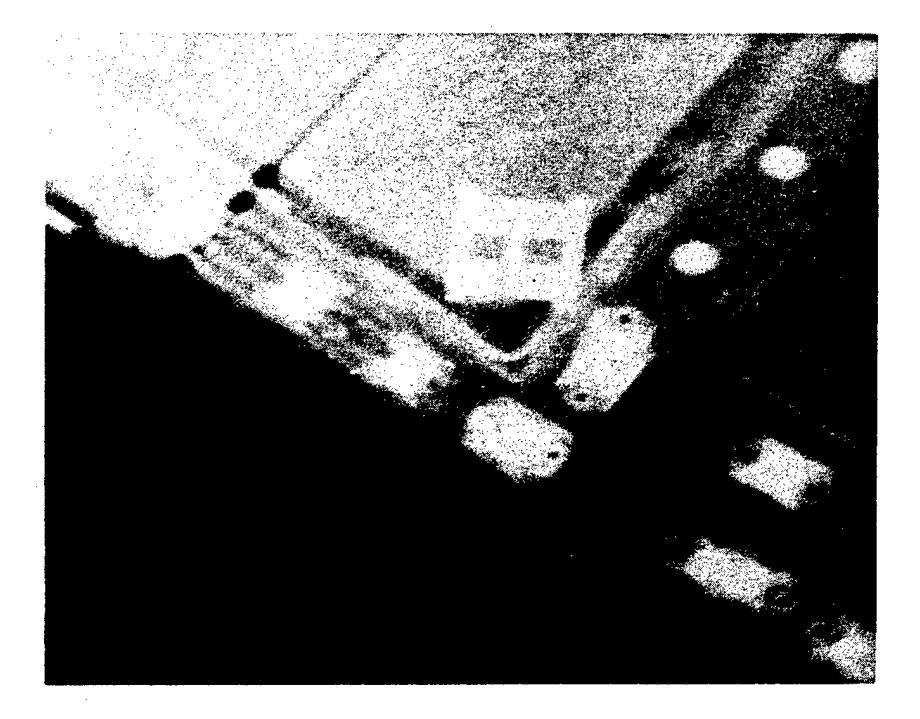
Figure 24. RTR of area H at a higher X-ray energy and current to highlight the metallic area (95kV, 5mA)

in Fig. 23. This illustrates an inherent feature of real-time radiography that allows continuous exposures at increasing x-ray energies to highlight differing materials. This would require multiple film exposures to accomplish the same singular real time inspection.

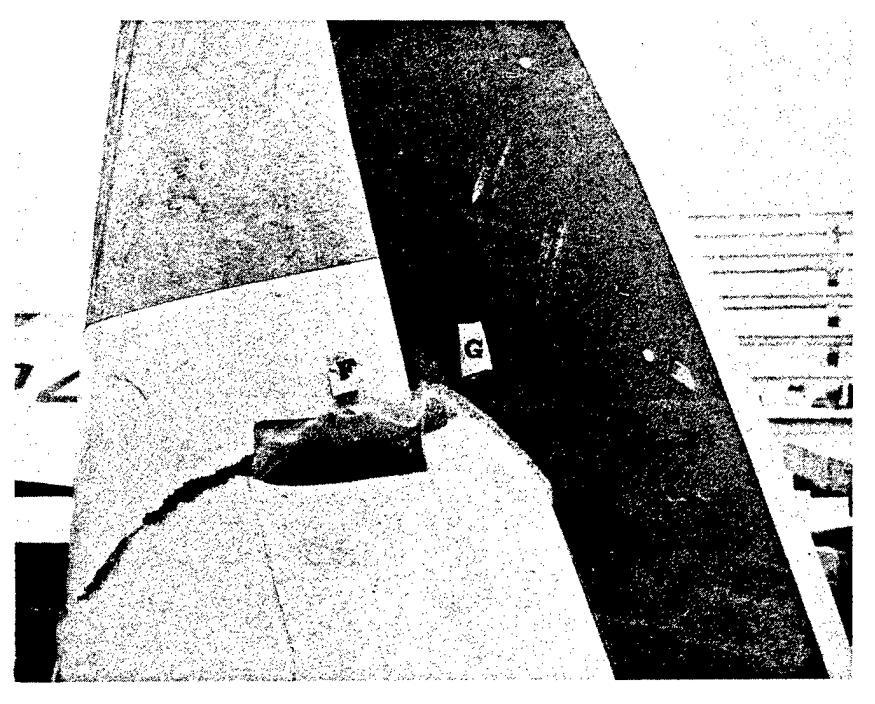
Figure 25. Damaged Fiberglass/Epoxy F-14 Radome containing a fiberglass honeycomb core

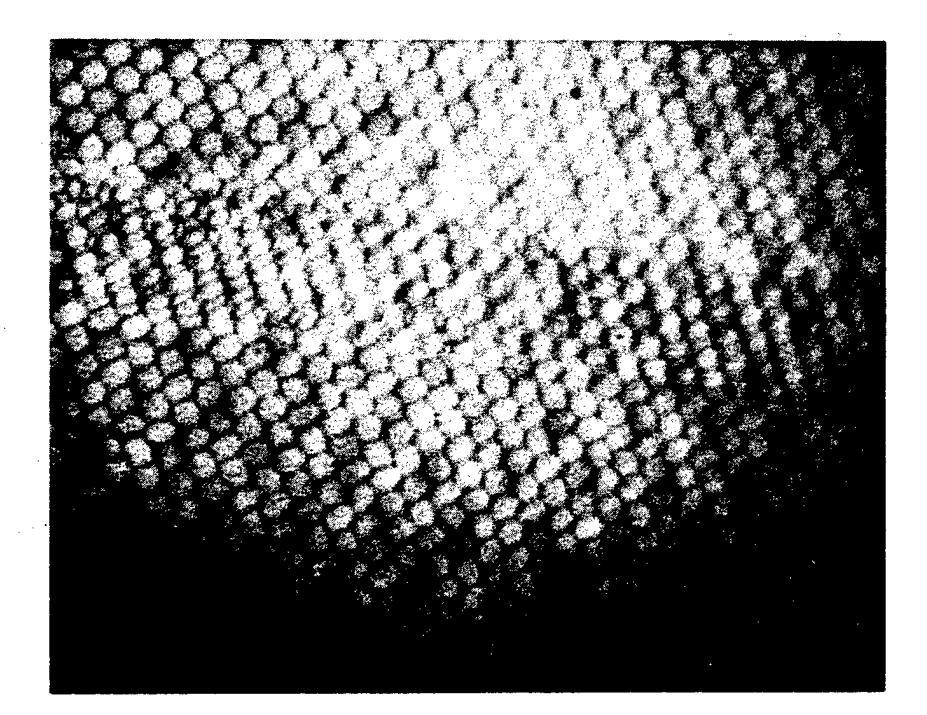
Figure 26. RTR of area F of the F-14 radome illustrating the cracks (white areas) and damaged honeycomb. The variations in the RTR indicate the porosity in the honeycomb. (60kV, 3.6mA)

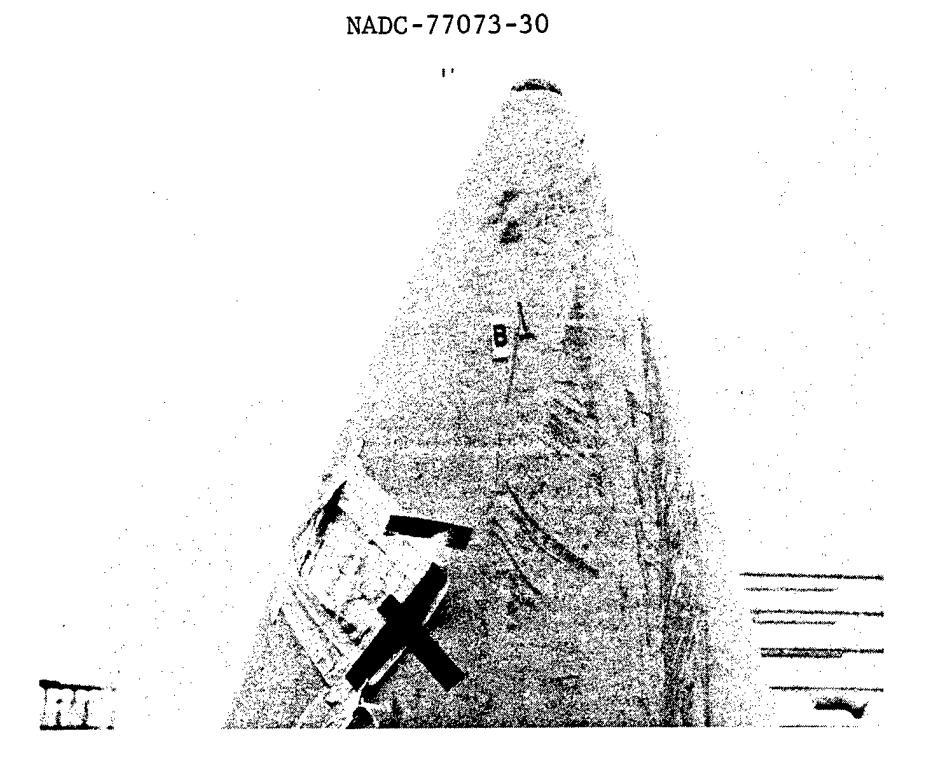
Figure 27. Damaged F-14 radome with a nick visible at area B

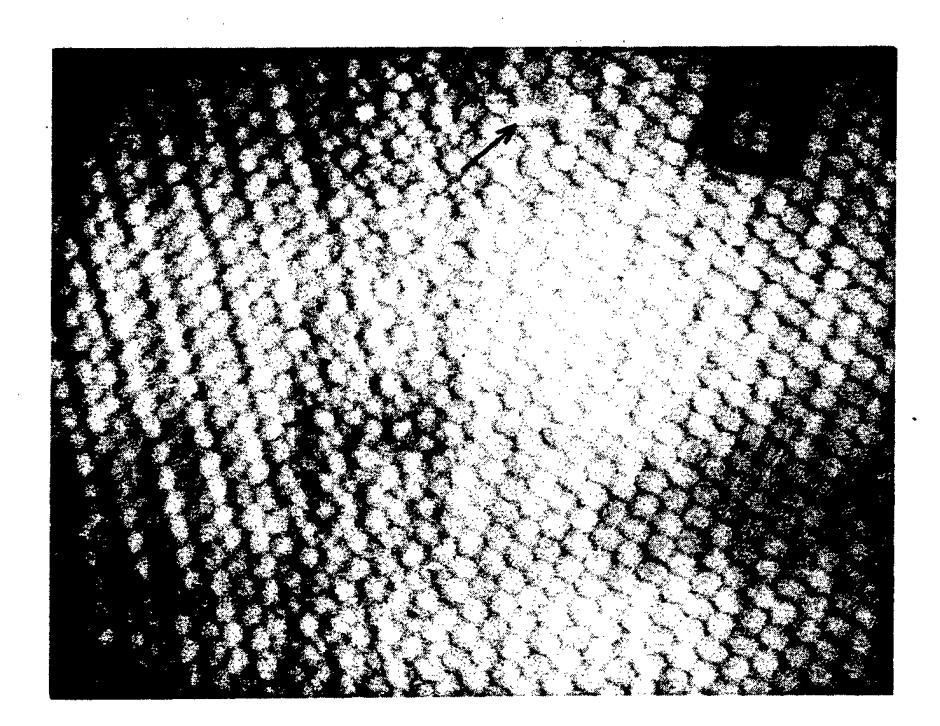
Figure 28. RTR of area B of F-14 radome illustrating the nick (60kV, 3.6mA)

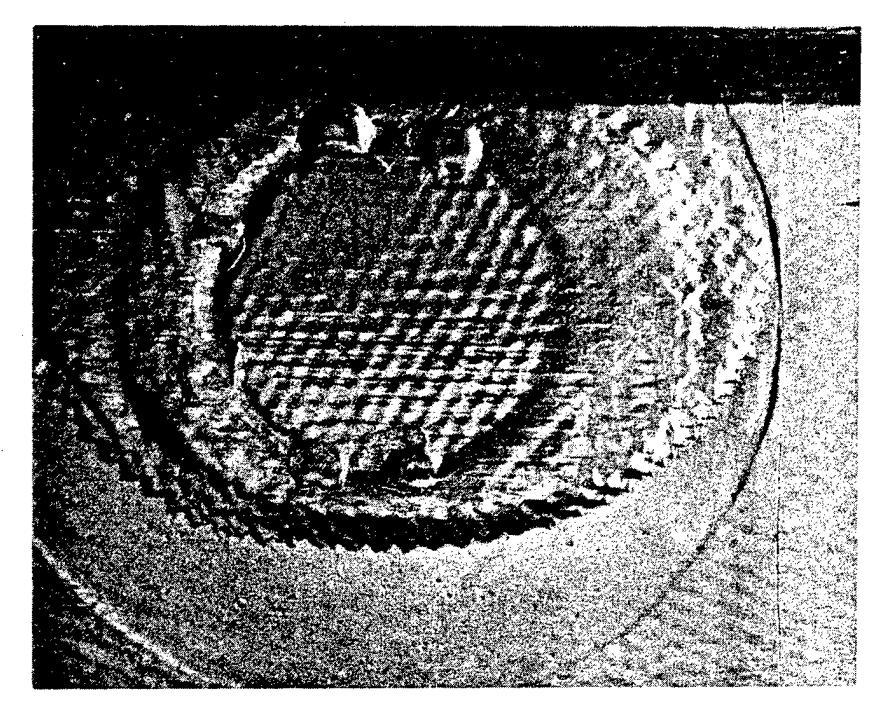
The last example inspected by direct RTR imaging was not for defects or damage, but repair verification. An S-3A spoiler recently repaired by the NARF, Alameda and NADC, Warminster was inspected at SAI to illustrate the feasibility of real-time radiography to image the repaired area and to inspect the splice of the core plug and also the core filter. Fig. 29 shows the repaired area of the graphite/epoxy S-3A spoiler. The RTR, Fig. 30, clearly illustrates the splice, plug, and filler This radiograph illustrates another feature of the RTR system; the ability to electronically enlarge the image on the videomoni-This was very advantageous when inspecting the splice tor. and was shown to be superior to film radiographs, because of the ease of viewing the area. Therefore, utilization of RTR for this application would allow inspection to immediately verify the condition of the repair.

Figure 29. Repaired area of an S-3A graphite/epoxy spoiler

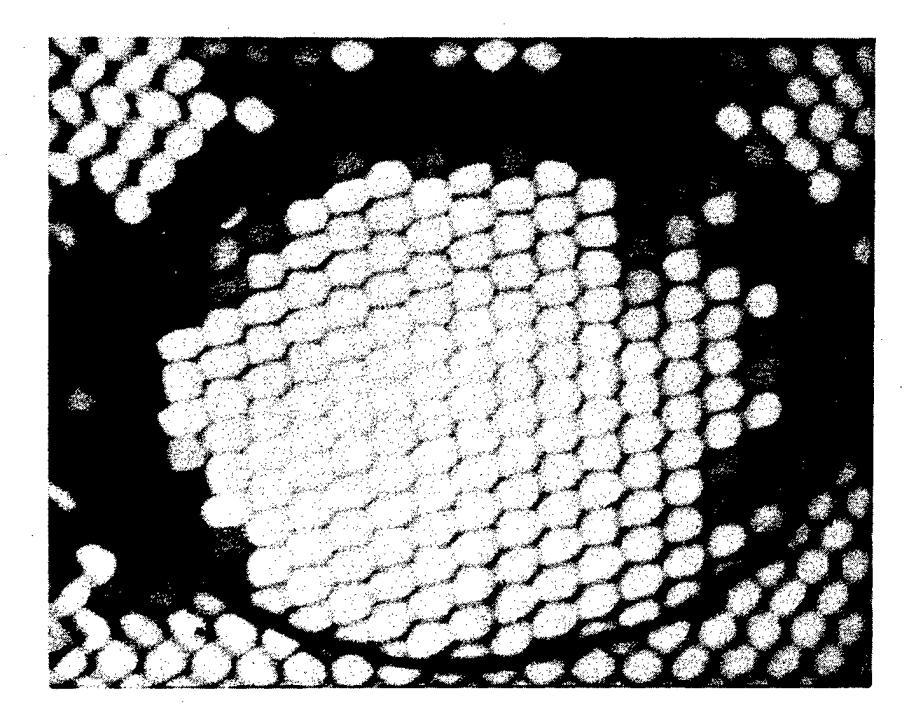
Figure 30. RTR of repaired area illustrating splice and filled core (70kV, 5mA)

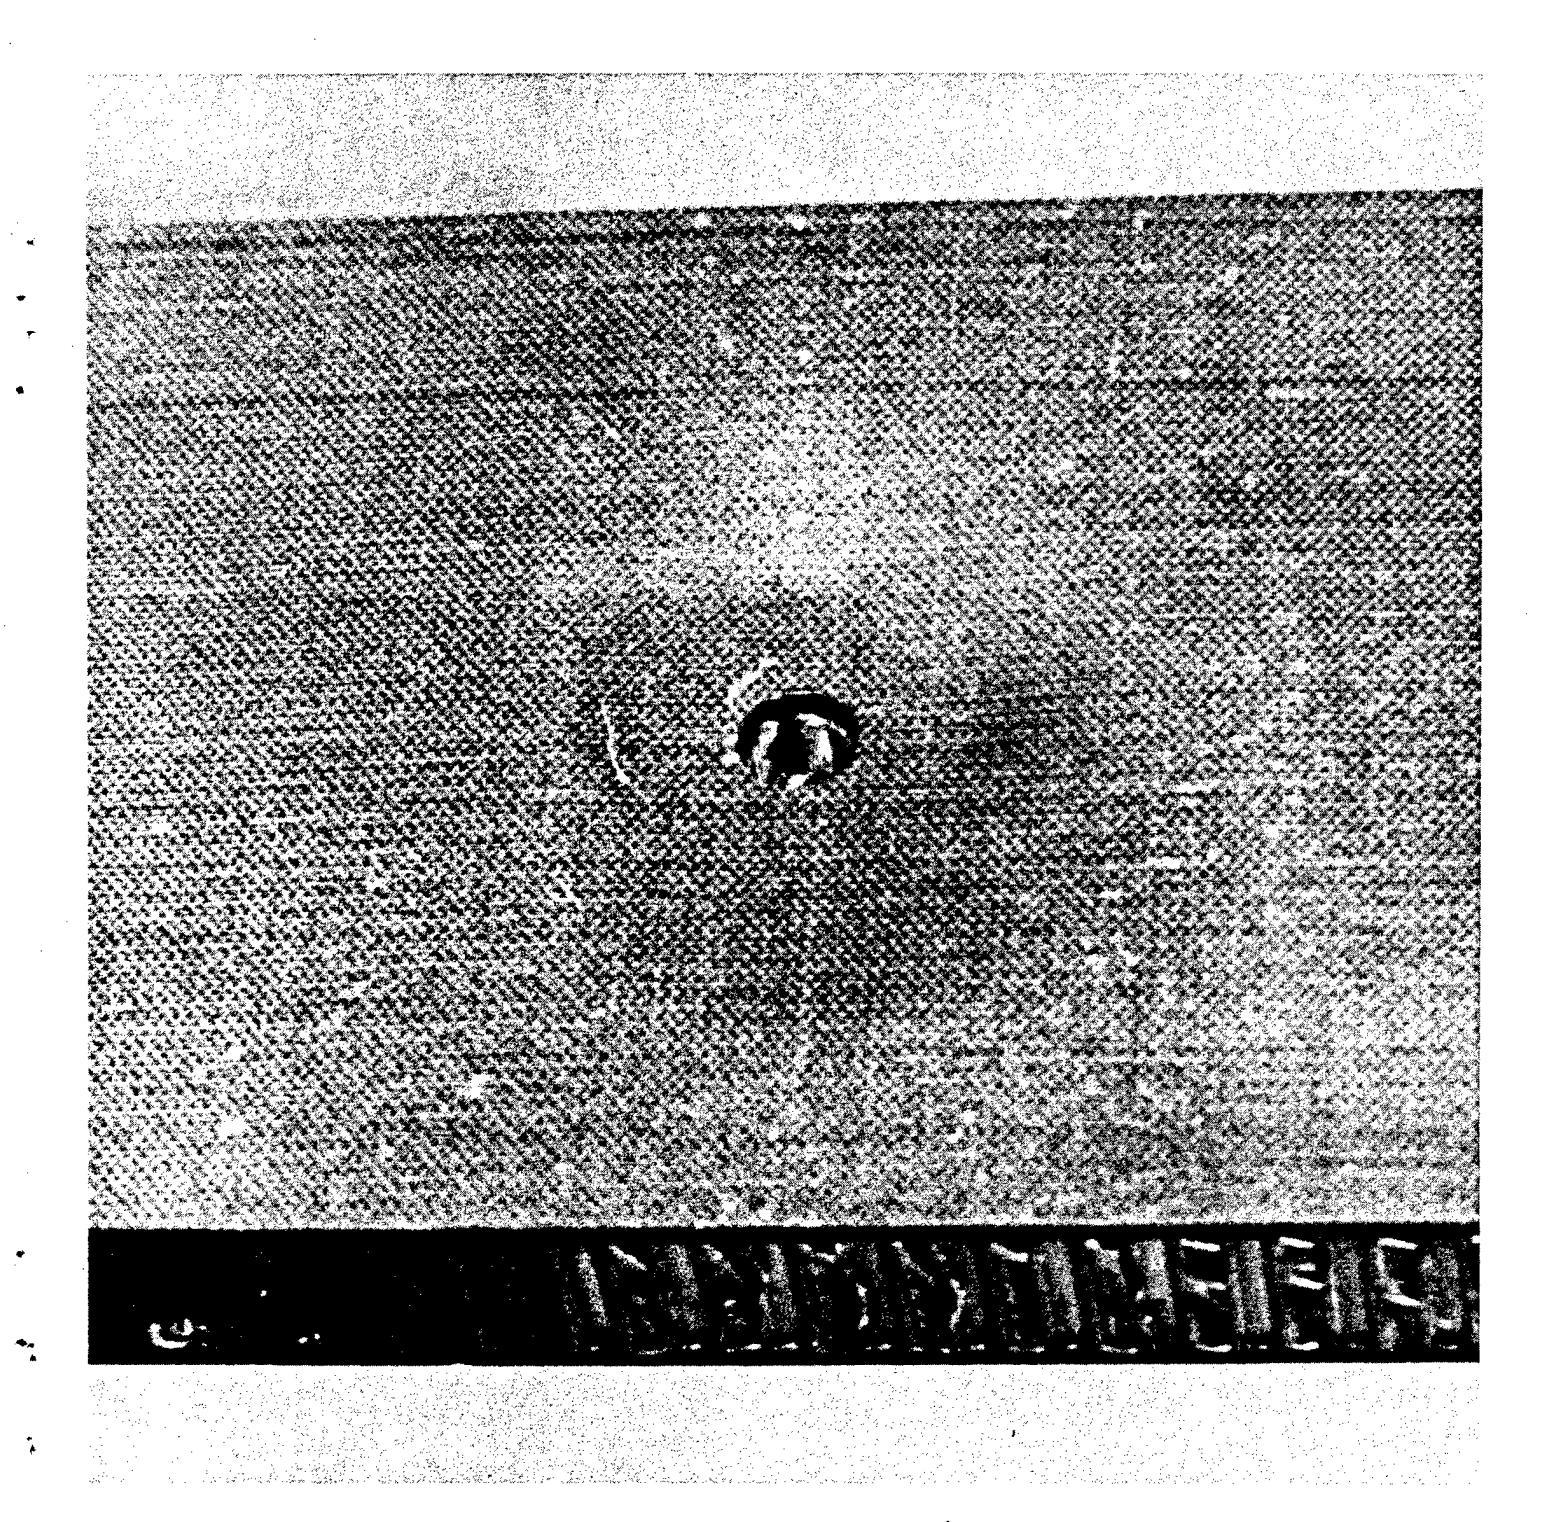
The first sample tested with the system is shown in Fig. 37. This is a graphite/epoxy sample with aluminum honeycomb that was hit with a hammer to produce debonds and delaminations. A 1/4 inch hole was then drilled and the penetrant was forced into the area. Figure 38, the RTR, shows where the liquid has flowed throughout the area illustrating debonds or delaminations. The next RTR, Fig. 39, shows an electronic video enlargement of the same area, showing areas where the liquid is not in the honeycomb, thus indicating that the liquid has flowed in between the graphite/epoxy layers.

Figure 37. Photograph of a section of a Graphite/Epoxy sample with aluminum honeycomb. It has been damaged by hitting the area with a hammer. A ½ inch hole has been drilled for the injector tip.

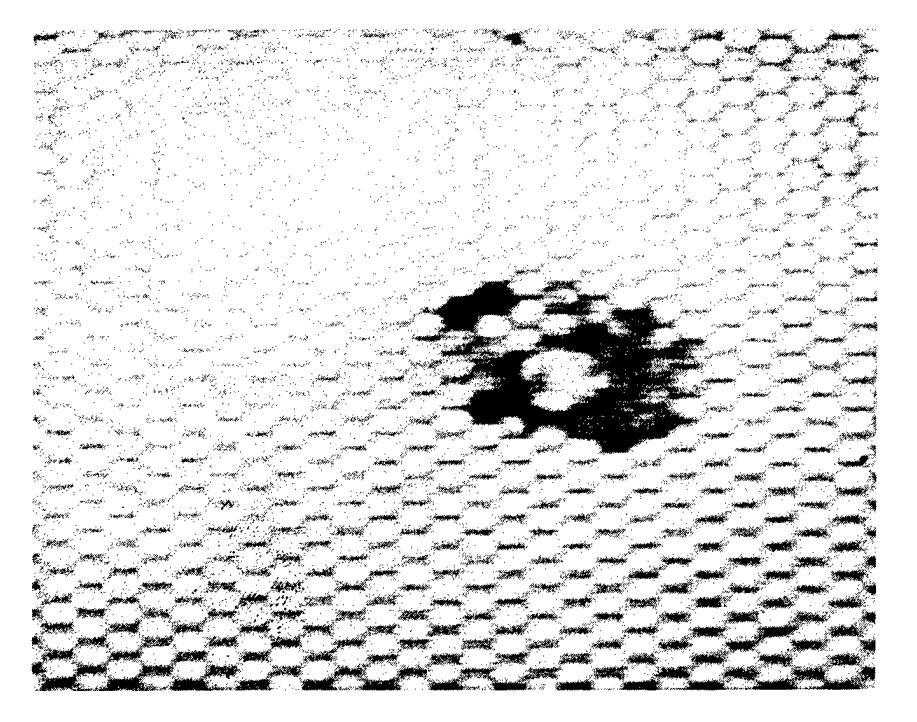
Figure 38. RTR of the damaged area illustrating where the penetrant has flowed into the honeycomb and possibly between the laminations indicating debonds and delaminations (65kV, 5mA)

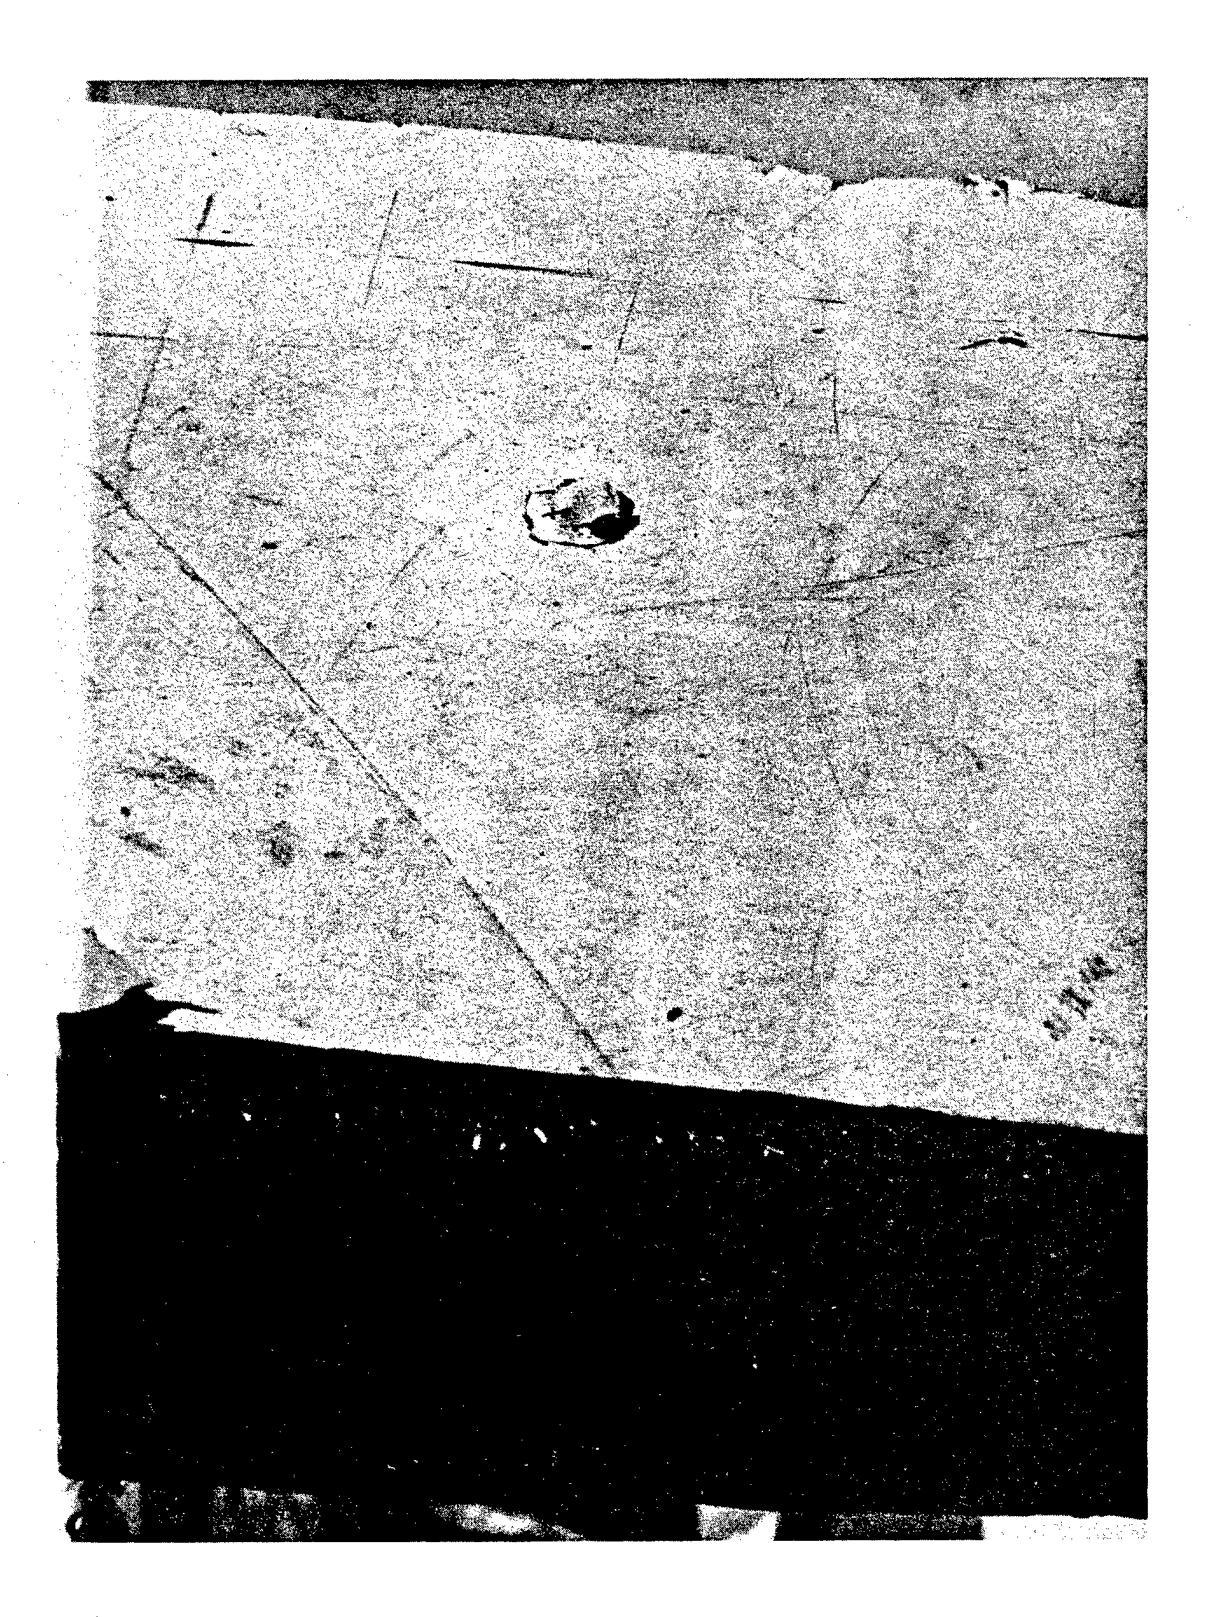
Another sample, a piece of an F-14 boron/epoxy horizontal stabilizer, Fig. 40 was hit with a hammer and injected with the penetrant to determine the extent of the damage. Figure 41 is an RTR of the area showing that there is no apparent physical damage to the structure. The light area in the radiograph is the 1/4 inch drilled hole. Figure 42, the RTR of the area with the penetrant, illustrates that the liquid has flowed throughout a much larger area than indicated by

Figure 40. Photograph of a small damaged area with a  $\frac{1}{4}$  inch drilled hole for the injector tip. This is a F-14 Boron/Epoxy horizontal stabilizer section.

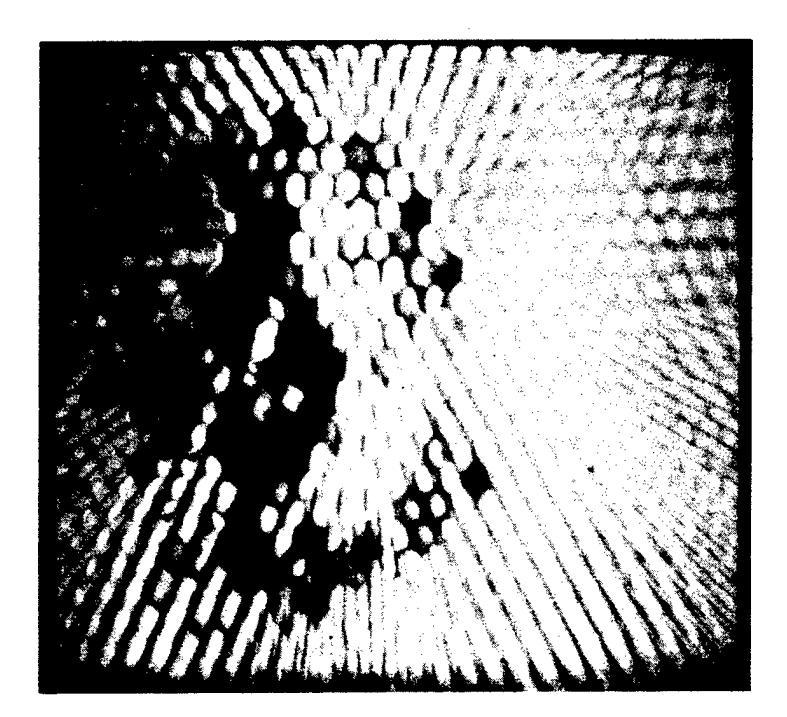
Figure 42. RTR of damaged area illustrating where the penetrant has flowed throughout the piece. This indicates fairly excessive damage for relatively small surface damage (65kV, 5mA)

the surface damage. The radiograph shows that the penetrant has filled many honeycomb cores, indicating debonds; but it is very difficult to determine if there are any delaminations between the boron/epoxy layers.
