Technical Report CHL-97-5 March 1997

Monitoring Completed Navigation Projects Program

# Burns Harbor, Indiana, Monitoring Study

## **Volume I: Overview of Approach and Results**

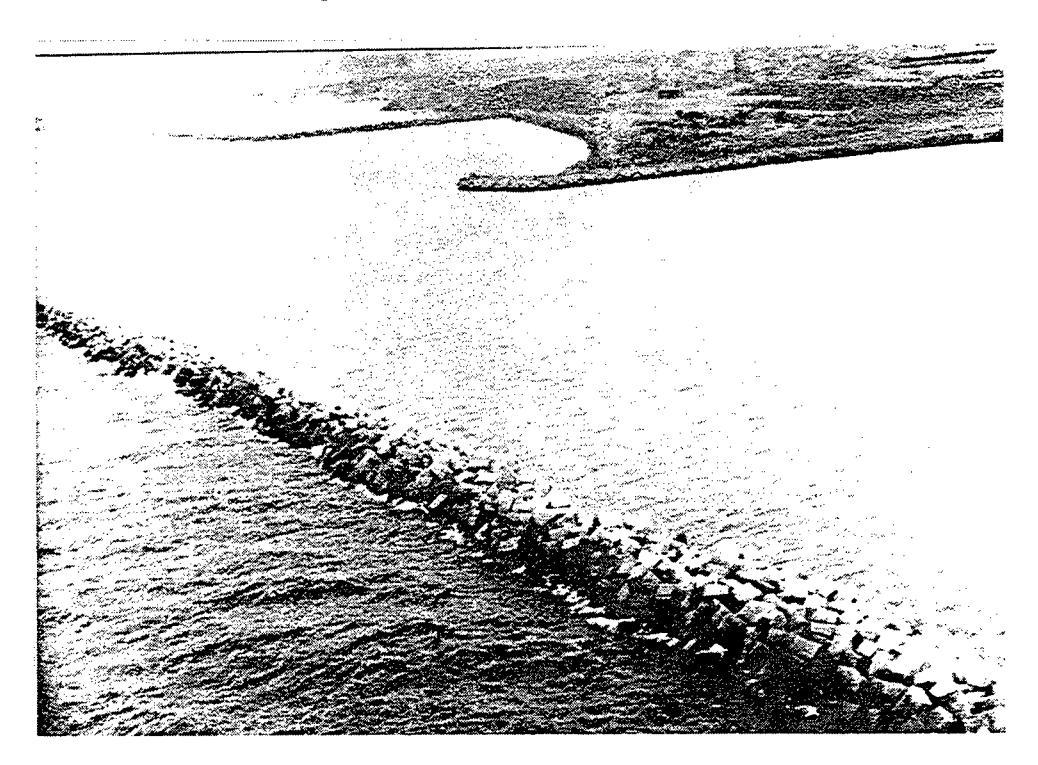
b. 1987 lakeside view

The parallelipiped, cut stone armor units, which range from 10 to 16 tons on the trunk and from 15 to 20 tons on the head, are typical for coastal structures in the Great Lakes, but the two-layer random placement was unusual at the time of its design. A high core design with laid-up placement of a single layer of armor is more typical. Burns Harbor was the first breakwater with this style of armor placement built in the Great Lakes (Figure 5).

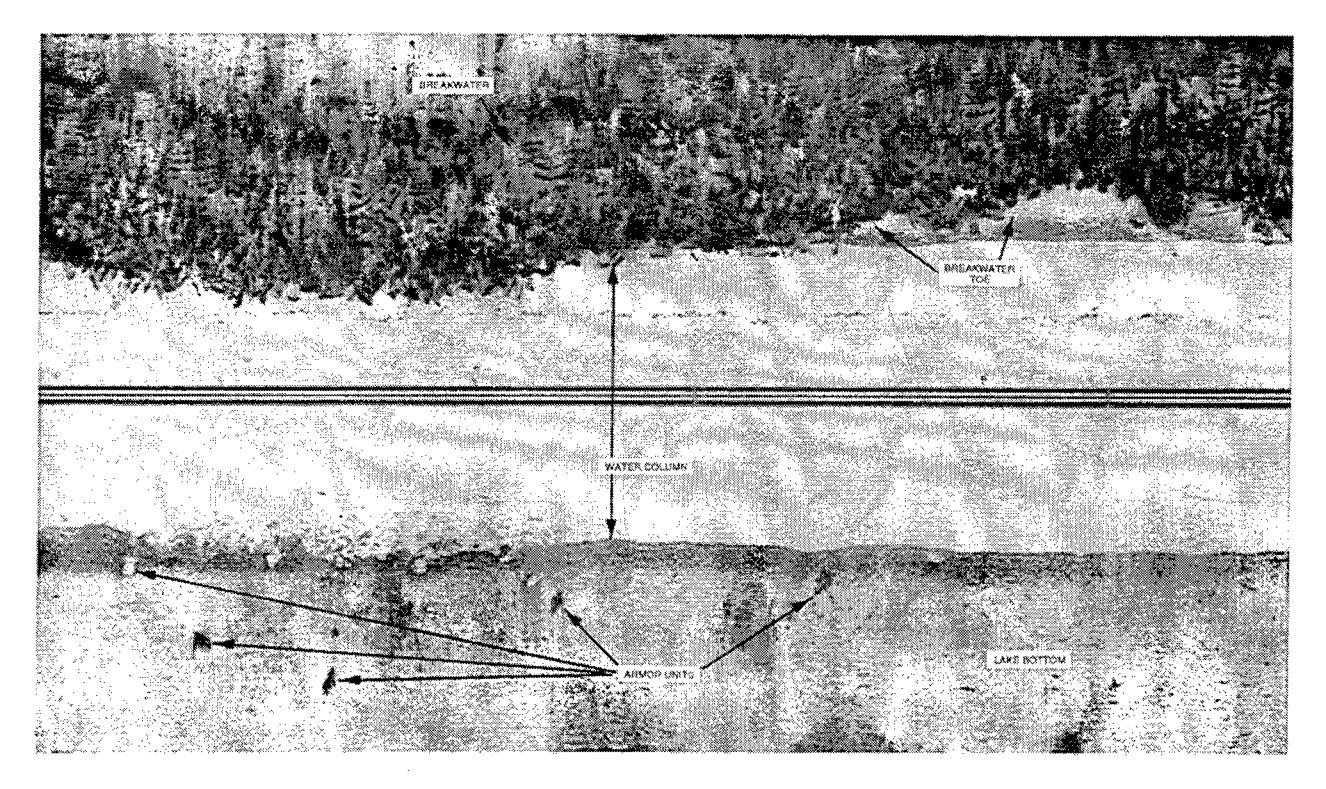
Figure 19. Lakeside SSS record showing individual armor units

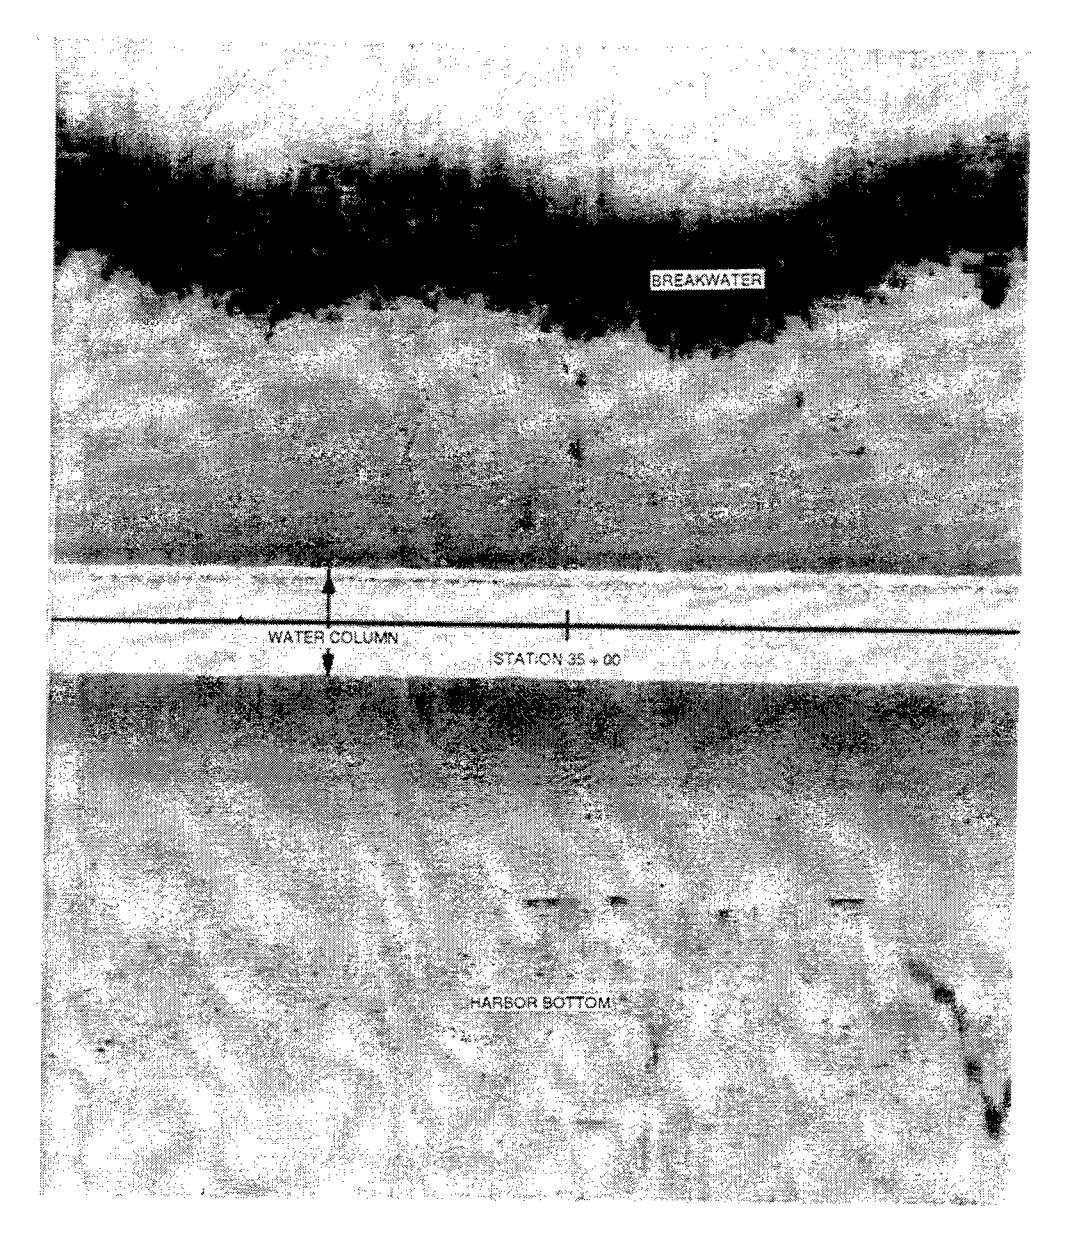
Figure 20. Typical portion of harborside area (SSS record, Station 30+00 to 40+00)

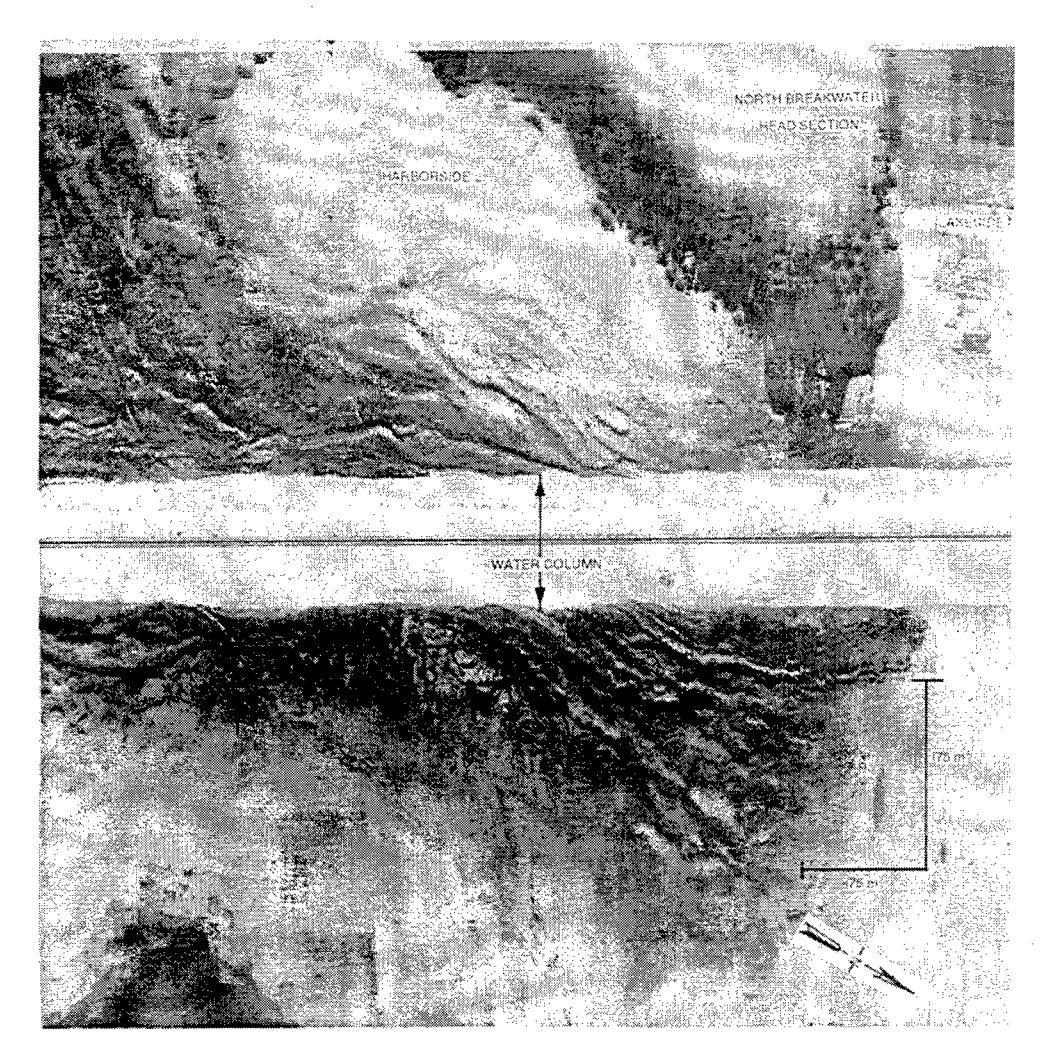
Figure 21. SSS record of scour features at harbor entrance

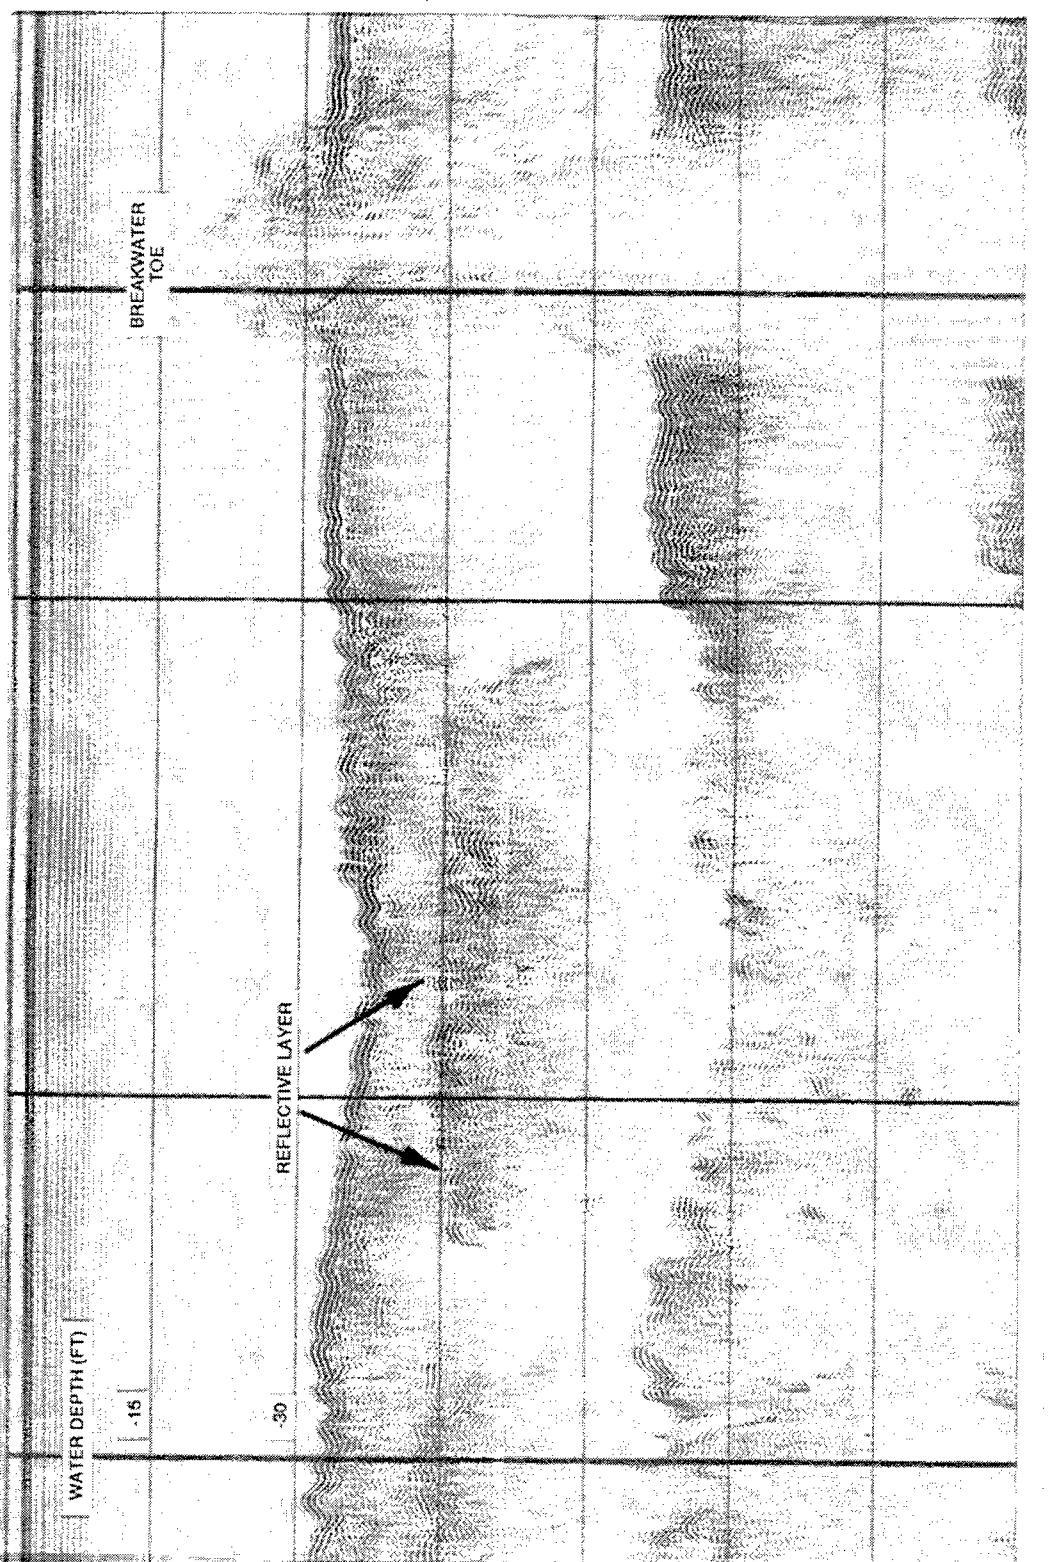
In contrast, line 6H (Figure 24), which traverses the entrance channel, indicates a harder layer 7-10 ft below the lake bottom, or at -45 ft. Approaching Eigure 18. SSS sonogram of breakwater (lakeside)

the structure slope, some reflectors are visible below the upper mud layer, indicating stone projects further out than the visible toe at -32 ft.

Figure 24. Subbottom sonar sonogram, line 6H

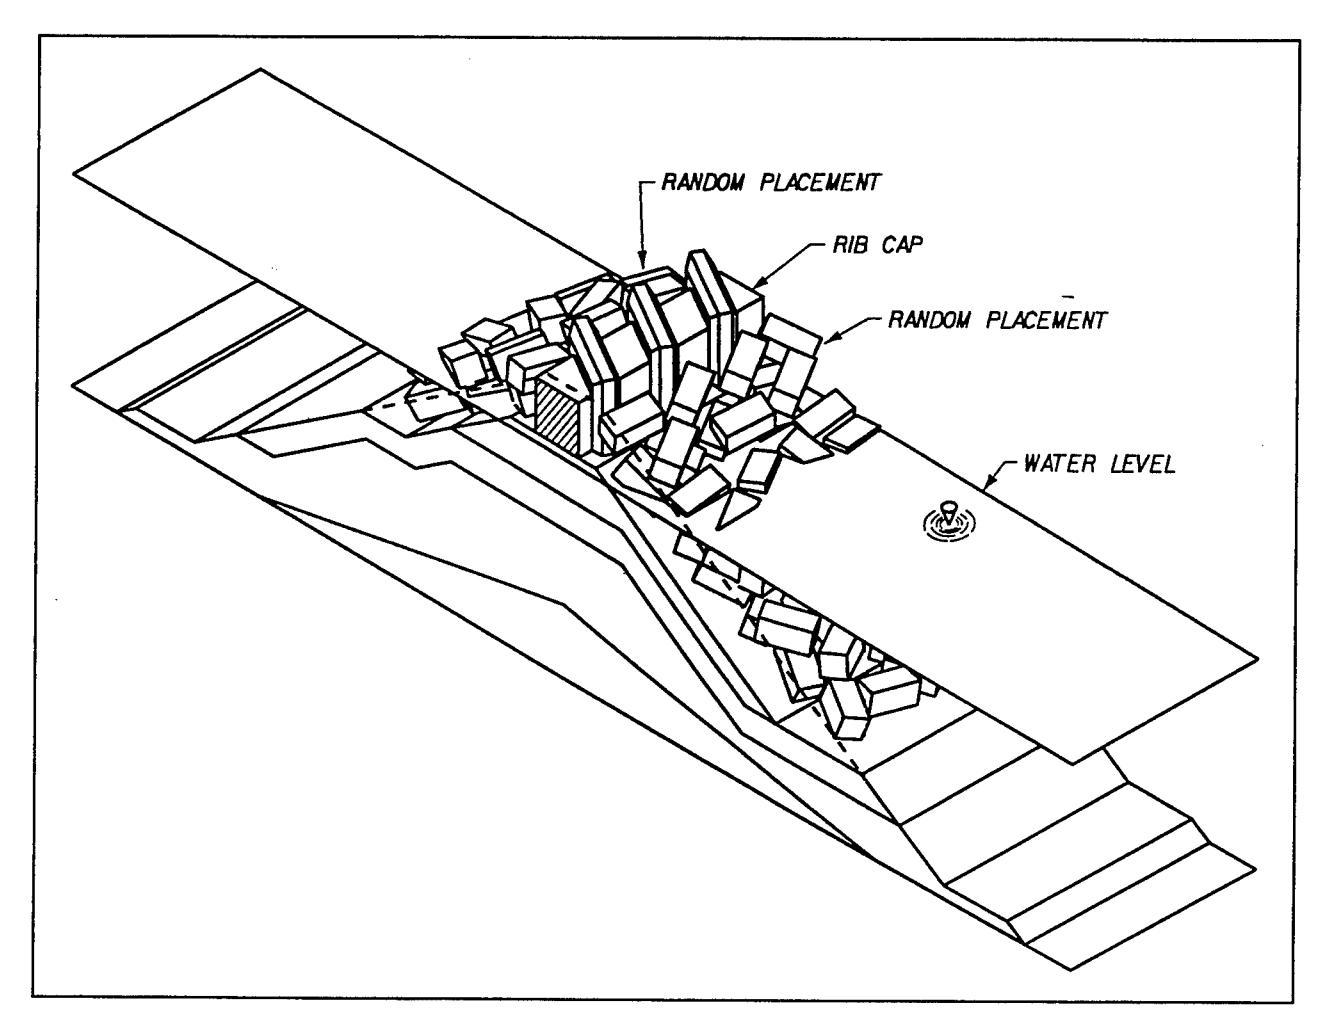
Figure 37. Illustration of rib cap

b. Seal the structure. Some options are available to tighten the structure by sealing voids with grout or asphalt. The long-term durability of these options is not well-known. It is possible that the existing armor

could be repositioned to achieve lower porosity, but those options are effectively restricted to the subaerial portion of the structure because they cannot be practically accomplished below the waterline.
