ESL-TR-91-13  
VOL II

**EXPEDIENT REPAIR OF STRUCTURAL  
FACILITIES (ERSF) - VOLUME II: ERSF  
SYSTEM REQUIREMENTS AND USERS  
GUIDE**

**JULY 1991**

**FINAL REPORT**

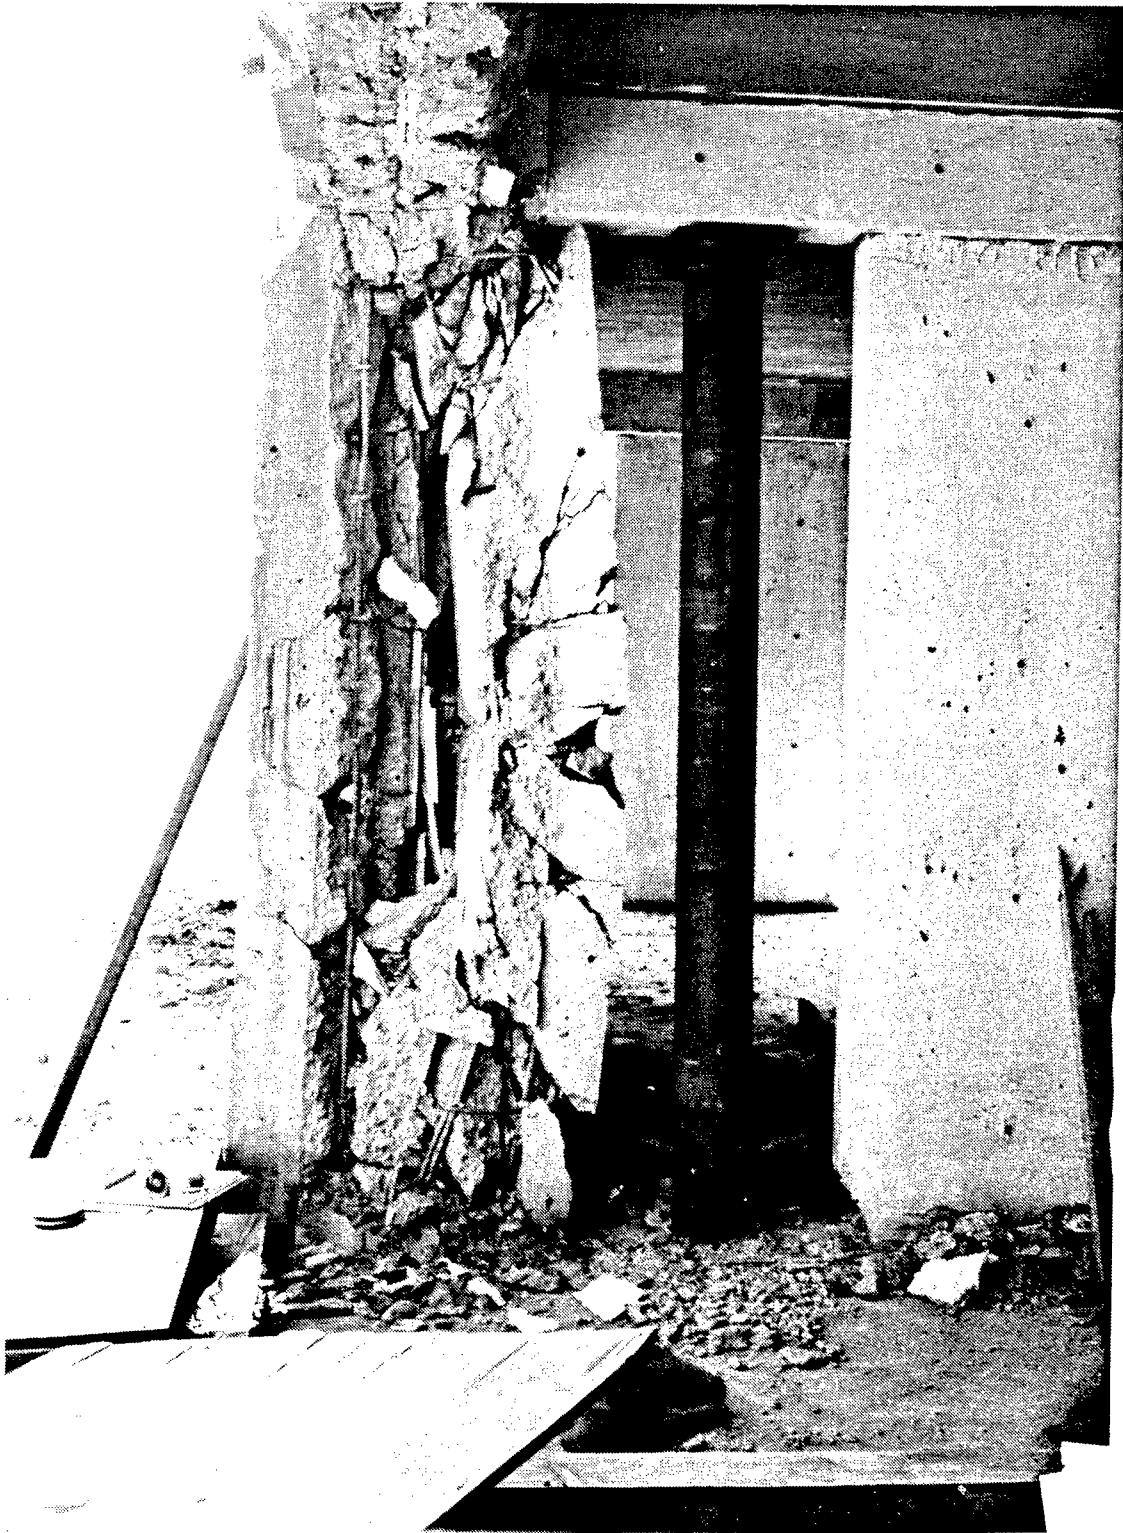
In this damage mode, a reinforced concrete column is damaged by blast and/or fragments, to the extent that it can no longer support its design load and must be replaced. An example of such a damaged column is shown in Figure 1. Candidate column replacement ERSF systems are described below.

Figure 1. Example of a Destroyed Column.

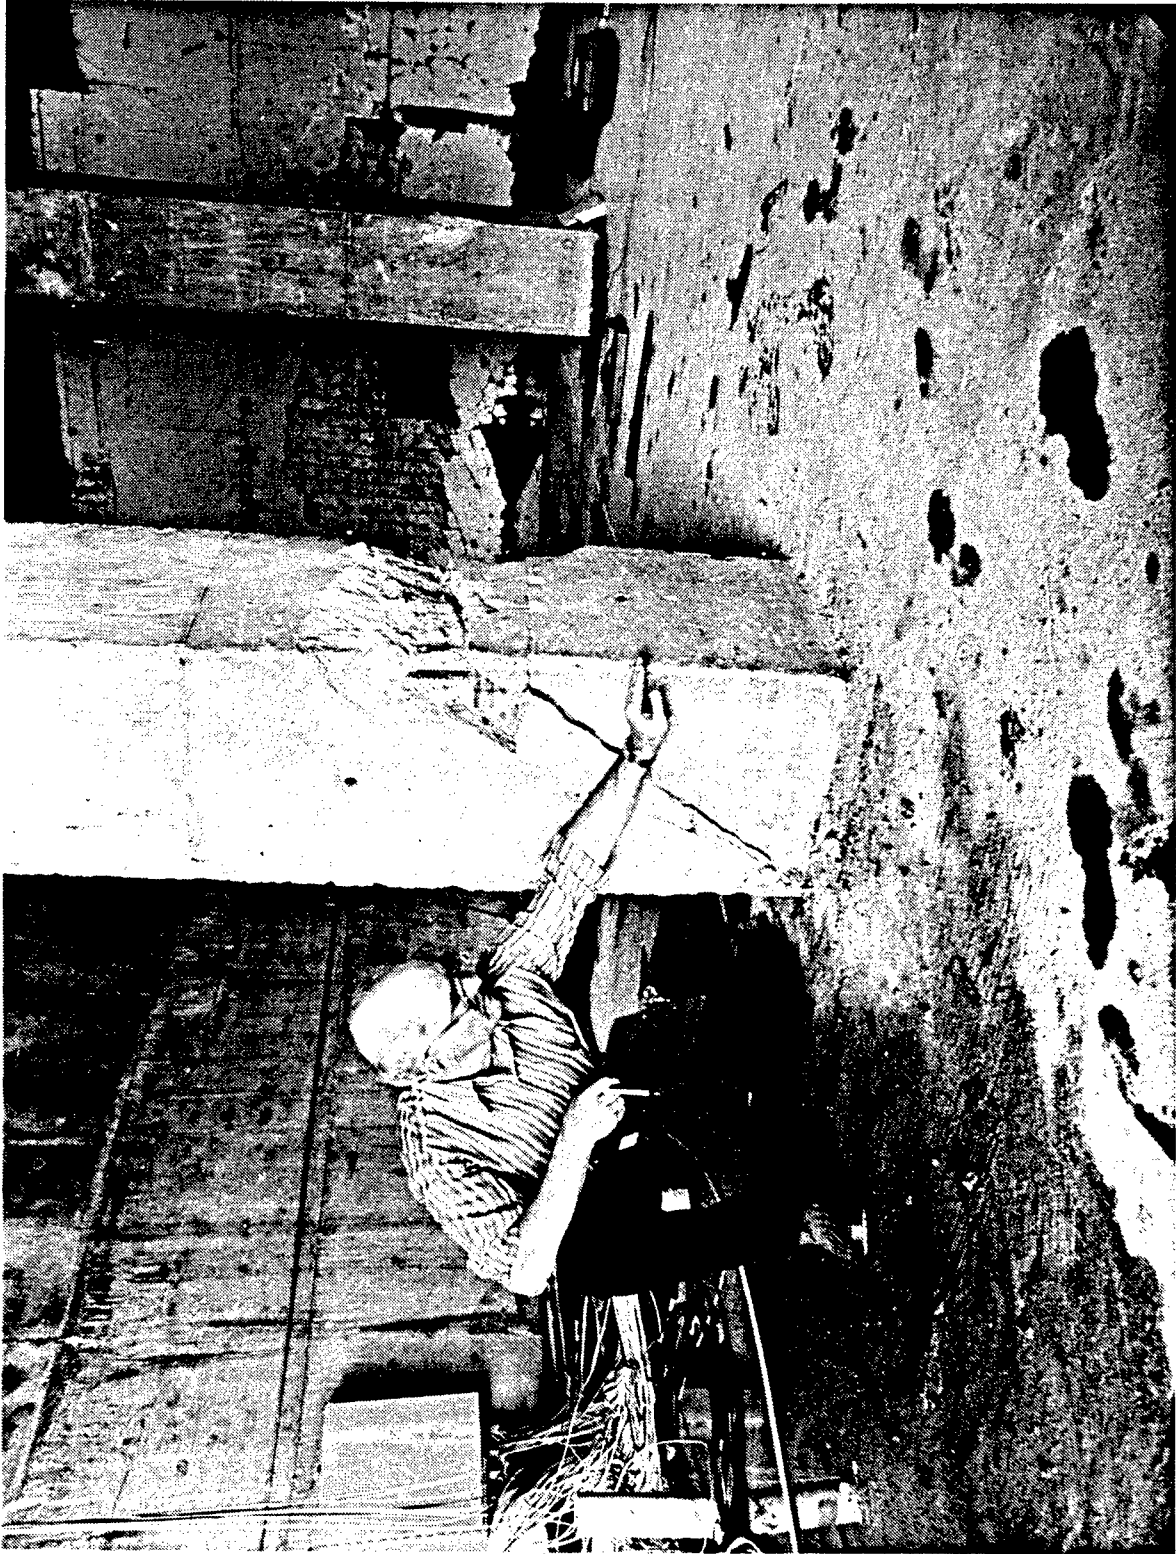
Figure 8. Cracked Concrete Column.

Figure 9. Splinting a Cracked Reinforced Concrete Column.

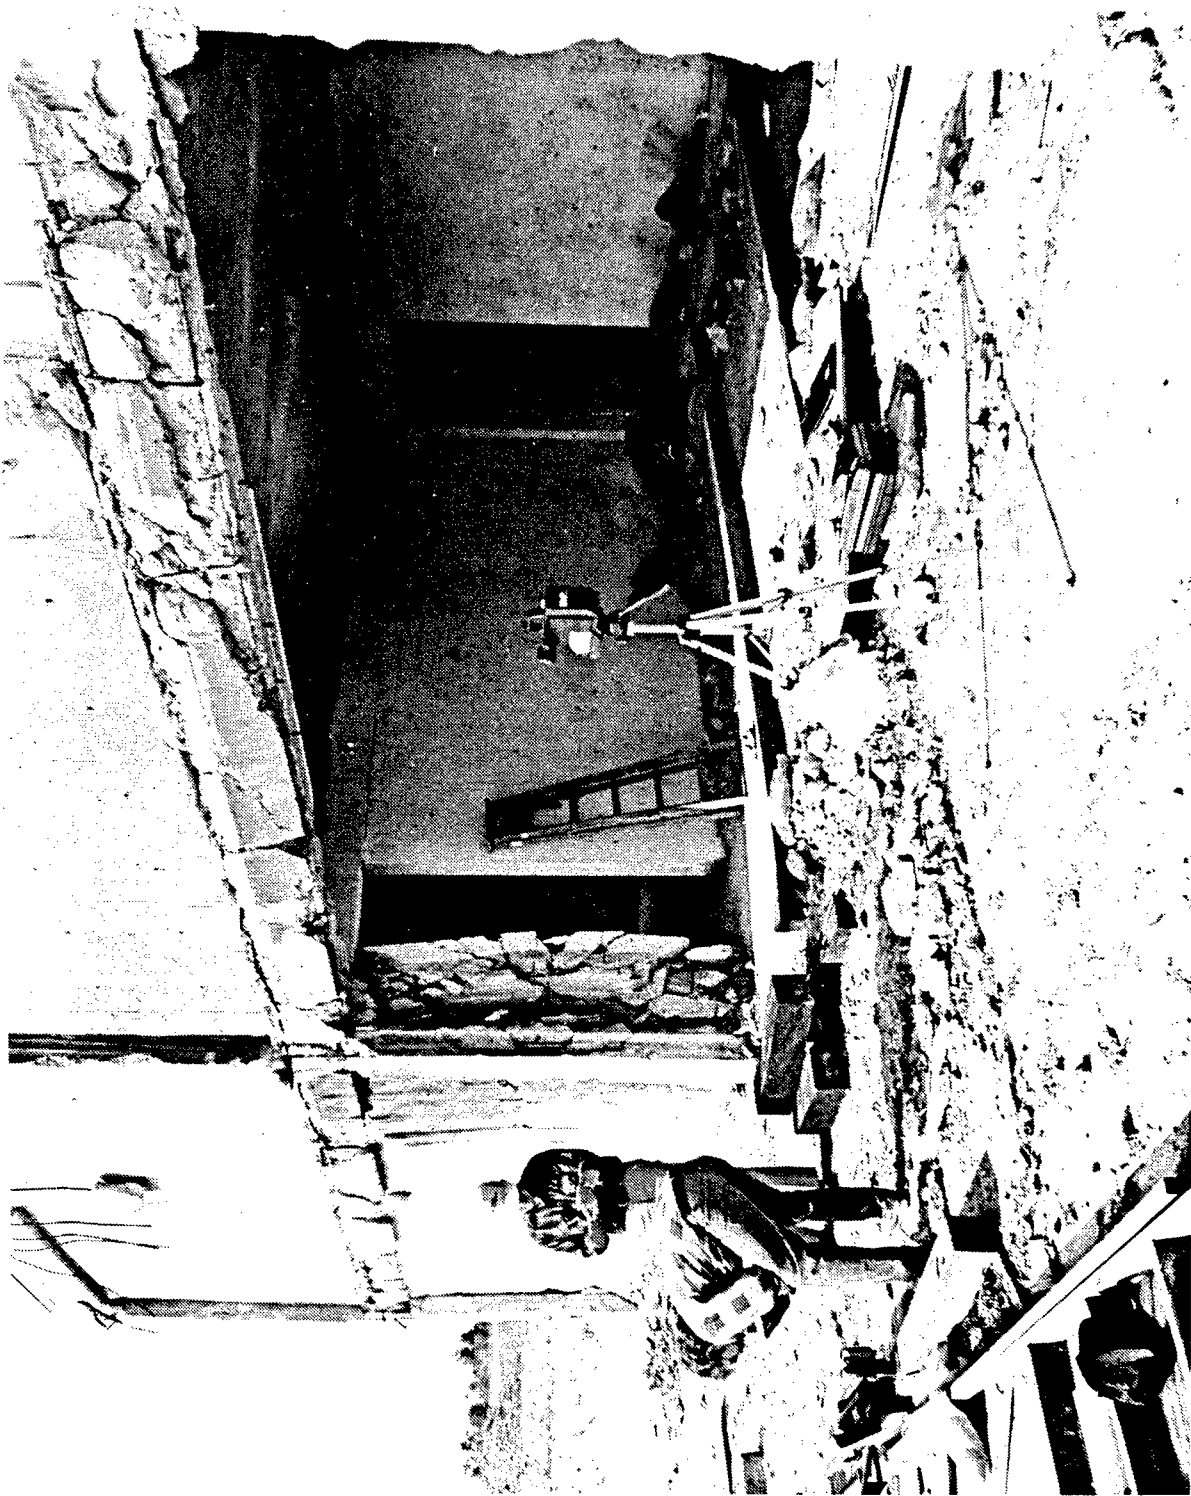
In this damage mode, a reinforced concrete girder/beam is fractured, but still capable of carrying a reduced load. An example of this damage mode is shown in Figure 11. The beam's load-carrying ability can be increased by using a vertical shore, similar to a column replacement repair, or by the king post device shown in Figure 12. The disadvantages of the king post are the high tensile forces in the rods (essentially the bottom chords of a simple truss), and the difficulty in securely anchoring the rods at both ends of the damaged beam. However, when other structural damage precludes using a vertical shore, a king post may be the only alternative.

Figure 11. Damaged Reinforced Concrete Beam/Girder.

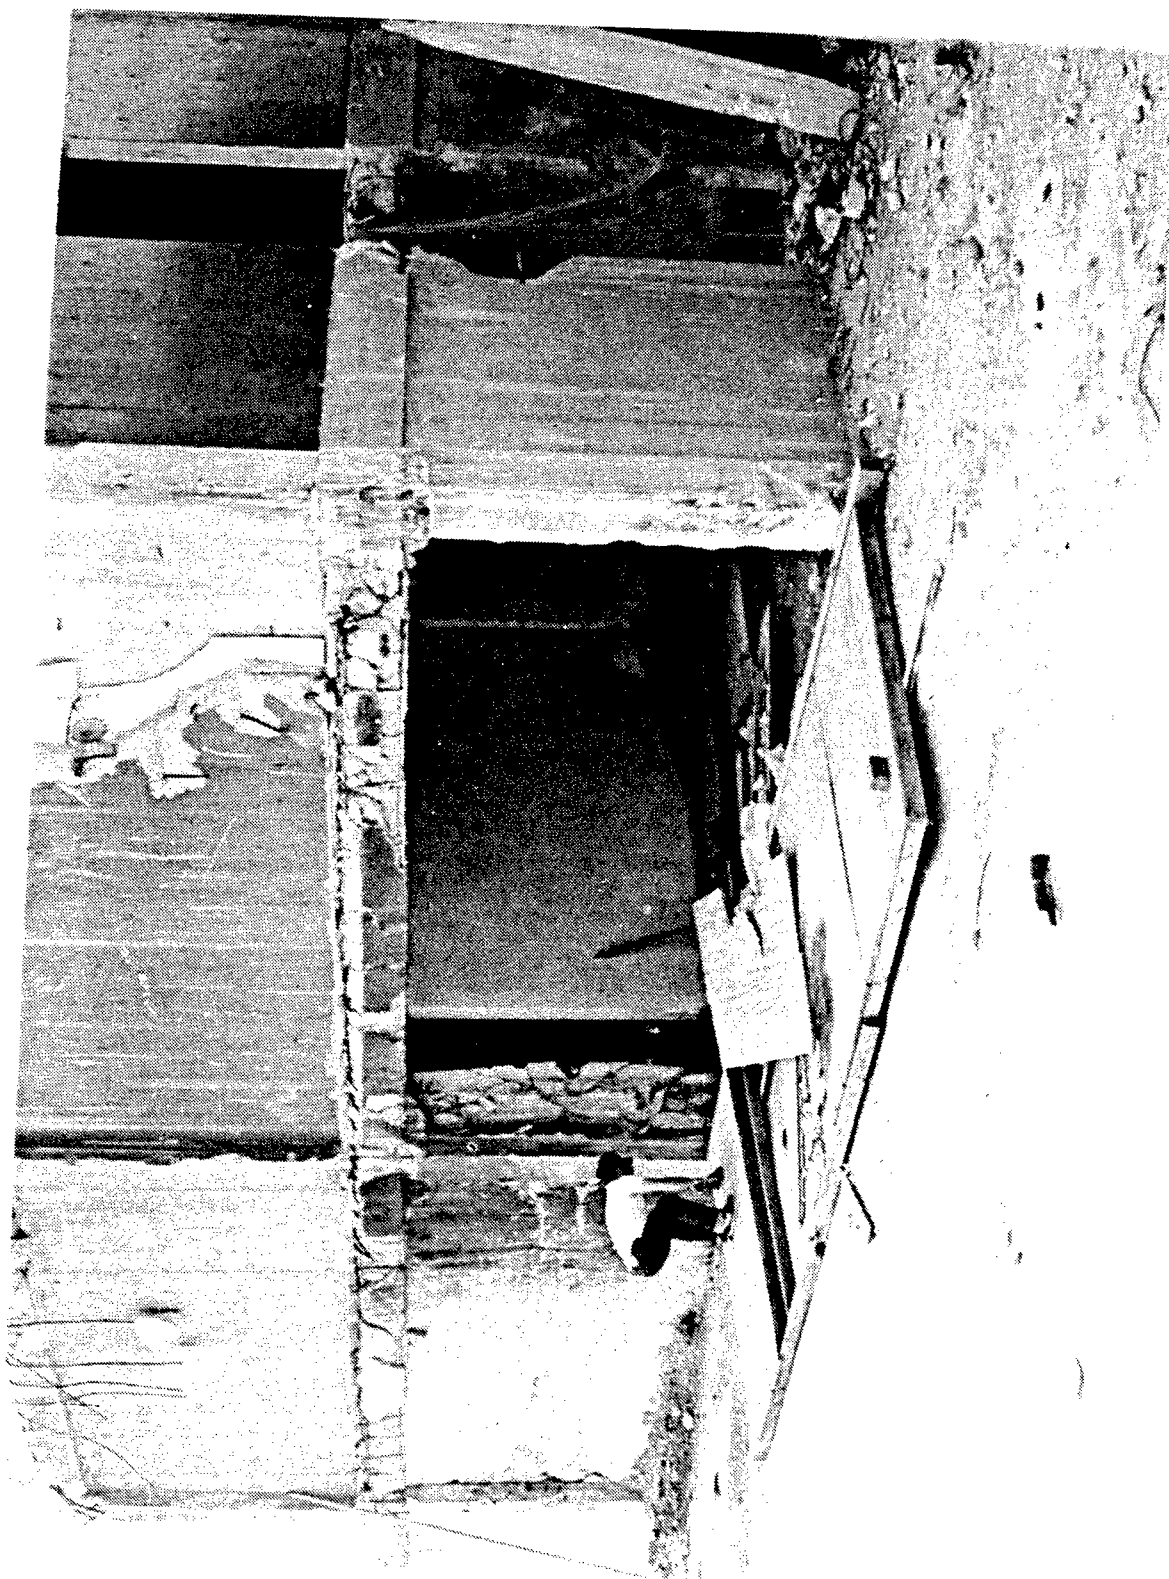
Figure 14. Destroyed Reinforced Concrete Wall.

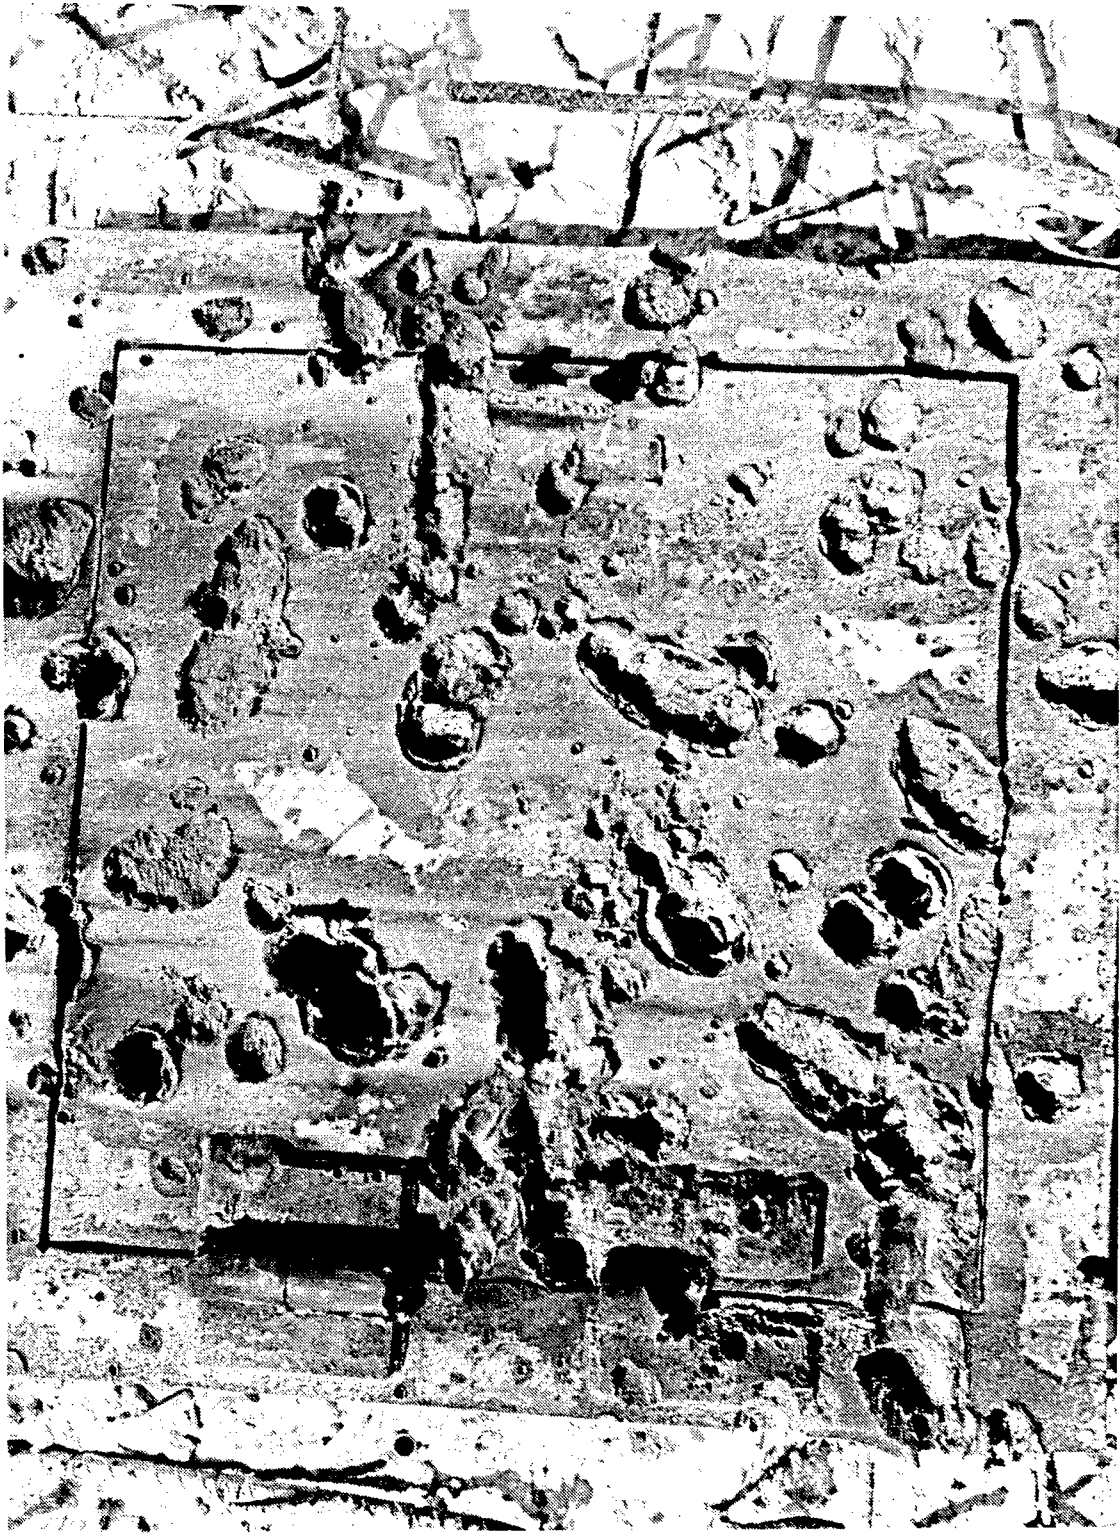
In this damage mode, a blast door has been stuck closed by fragment damage, which has damaged the door's hinges and/or welded the door to its frame. An example of this damage mode is shown in Figure 26. As with the aircraft shelter blast door, it is not the purpose of expedient repair to make the blast door functional again, but instead to force the door open to gain access to and egress from the building. Consequently, the repair will consist of cutting the door's hinges and/or weld points along the

Figure 26. Damaged Blast Door.

door/frame interface with an acetylene torch. Then a front-end-loader or other piece of heavy equipment is attached to the door with chains and shackles, and used to pull the door from its frame.

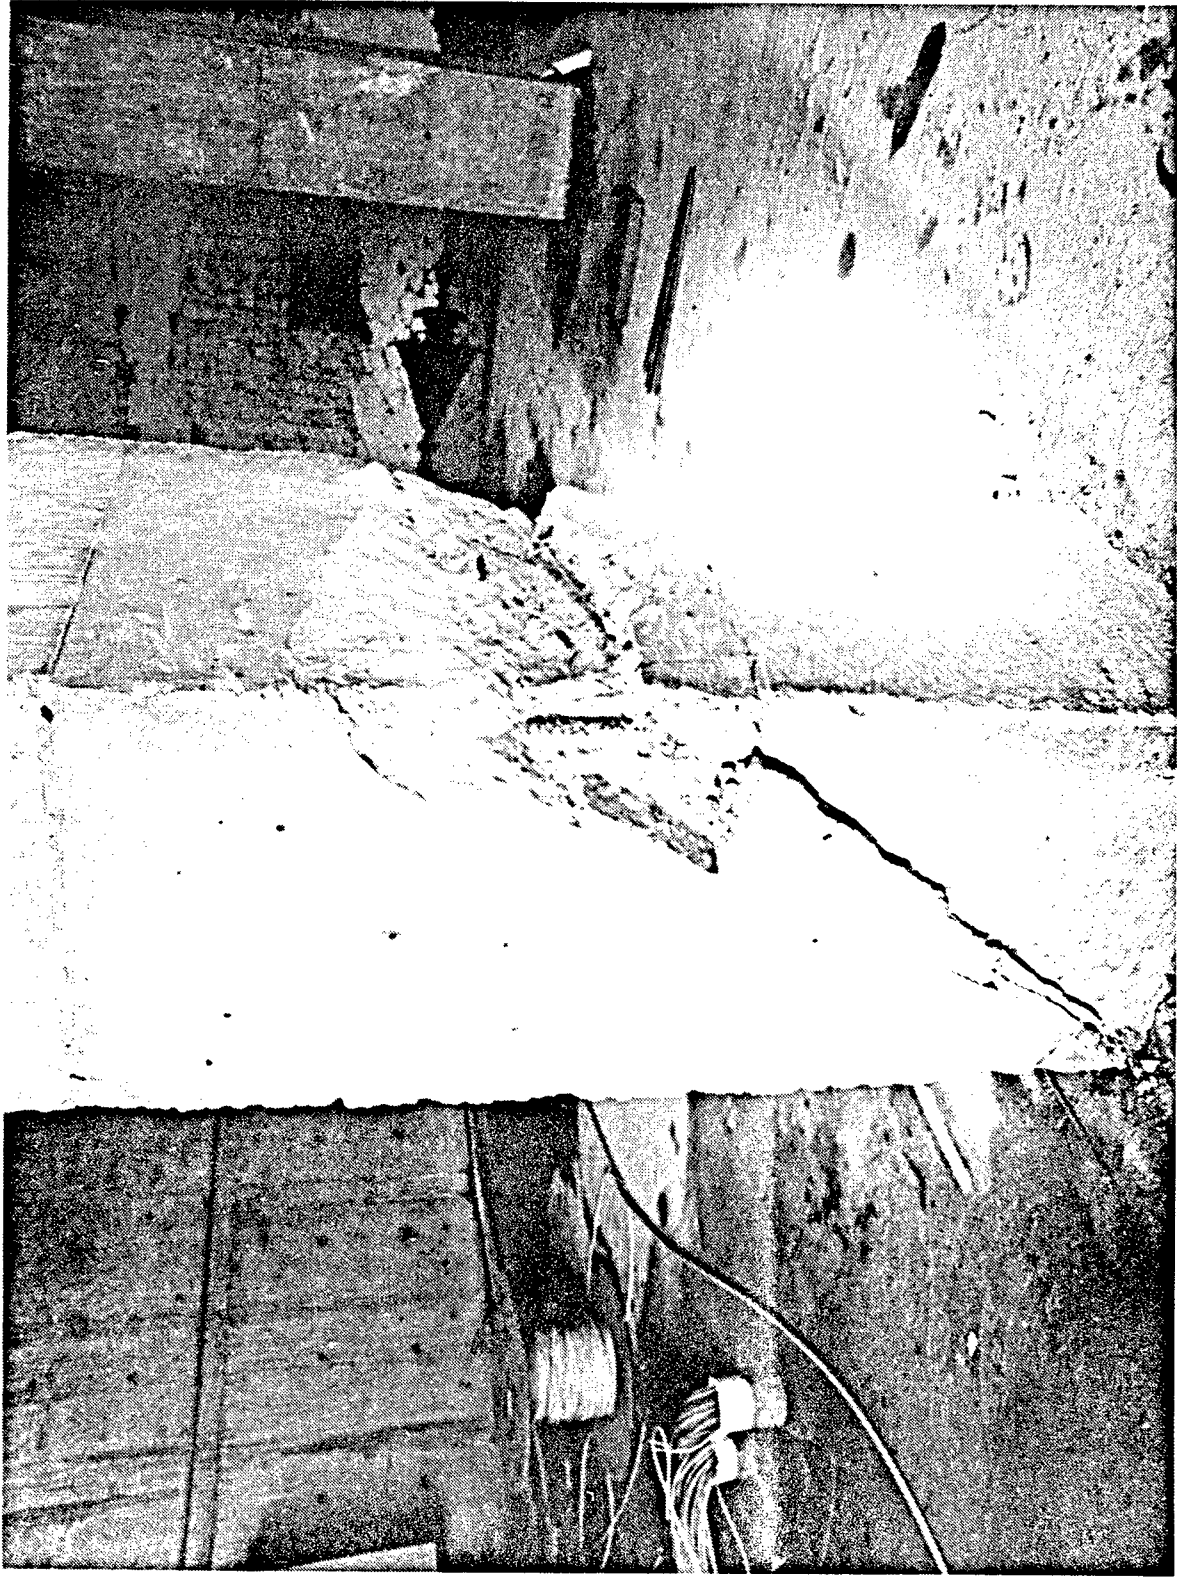
Figure 36. Cracked Concrete Column Used for the Column Splint  
Field Demonstration.

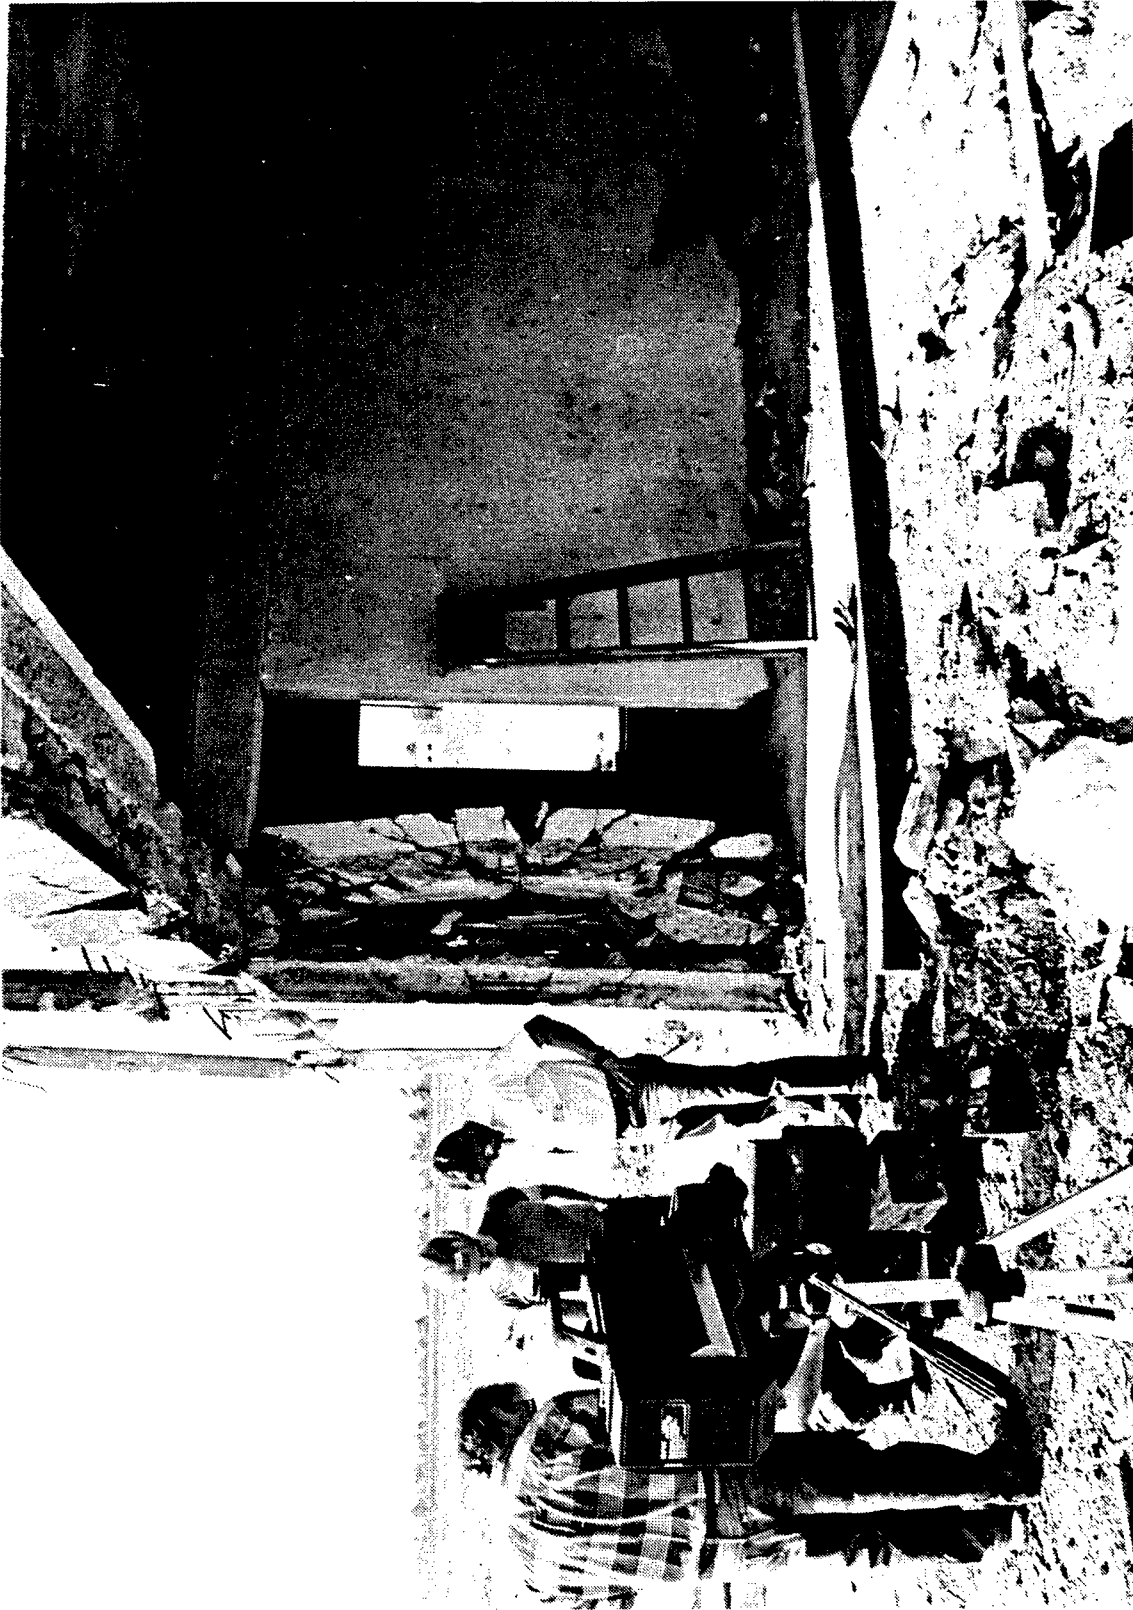
Figure 45. C 74 Structure's Destroyed Column Used for the Column Replacement Field Demonstration.

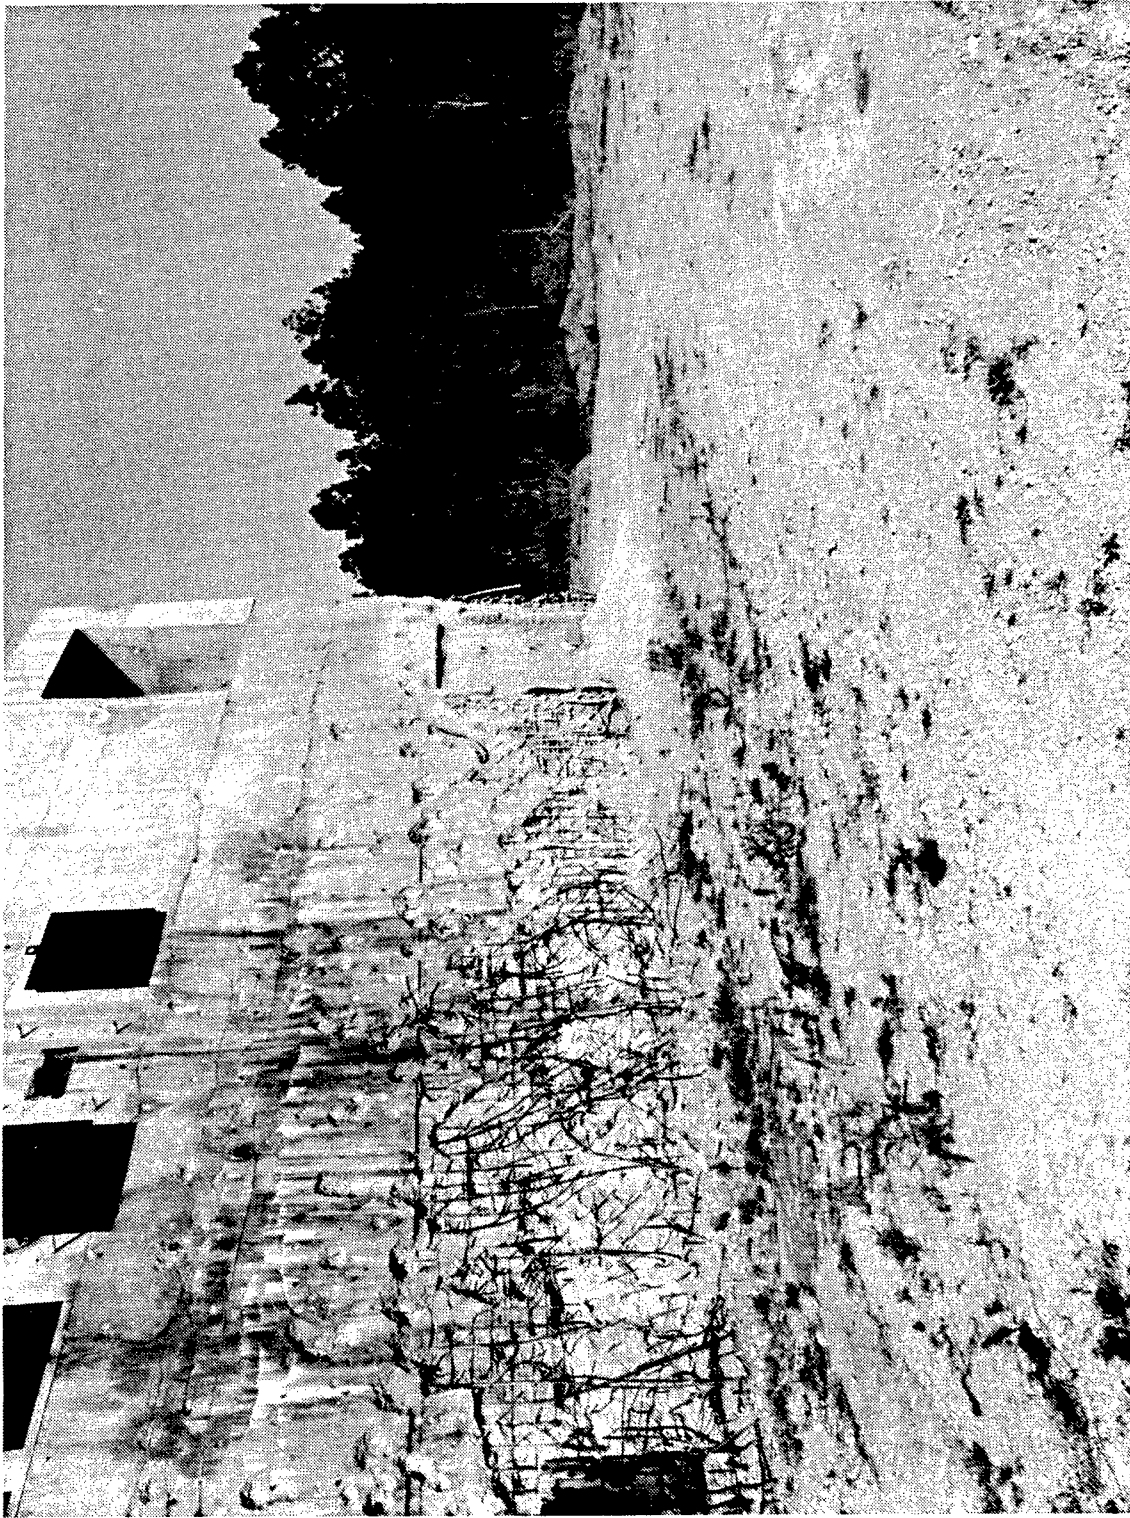
Figure 56. Spall Area of NATO Structure Used for the Wall Breach Repair Field Demonstration.

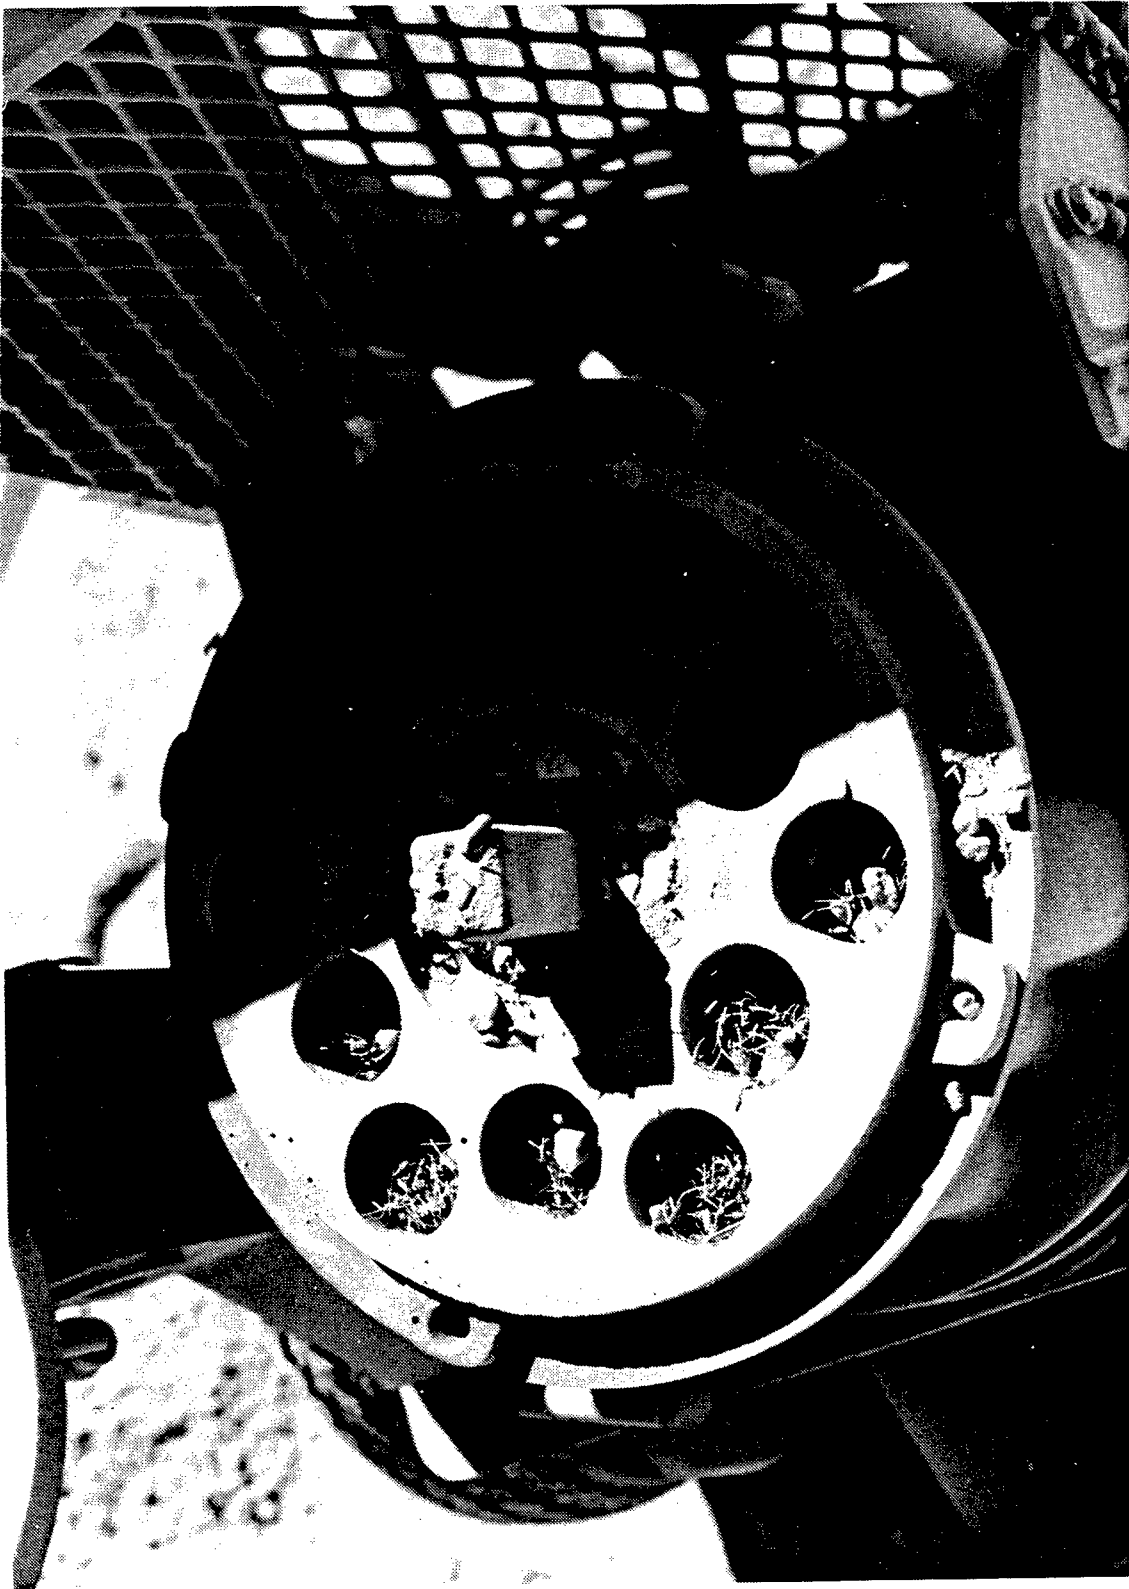
Figure 71. Clogged Shotcrete Gun Feed Cylinders.

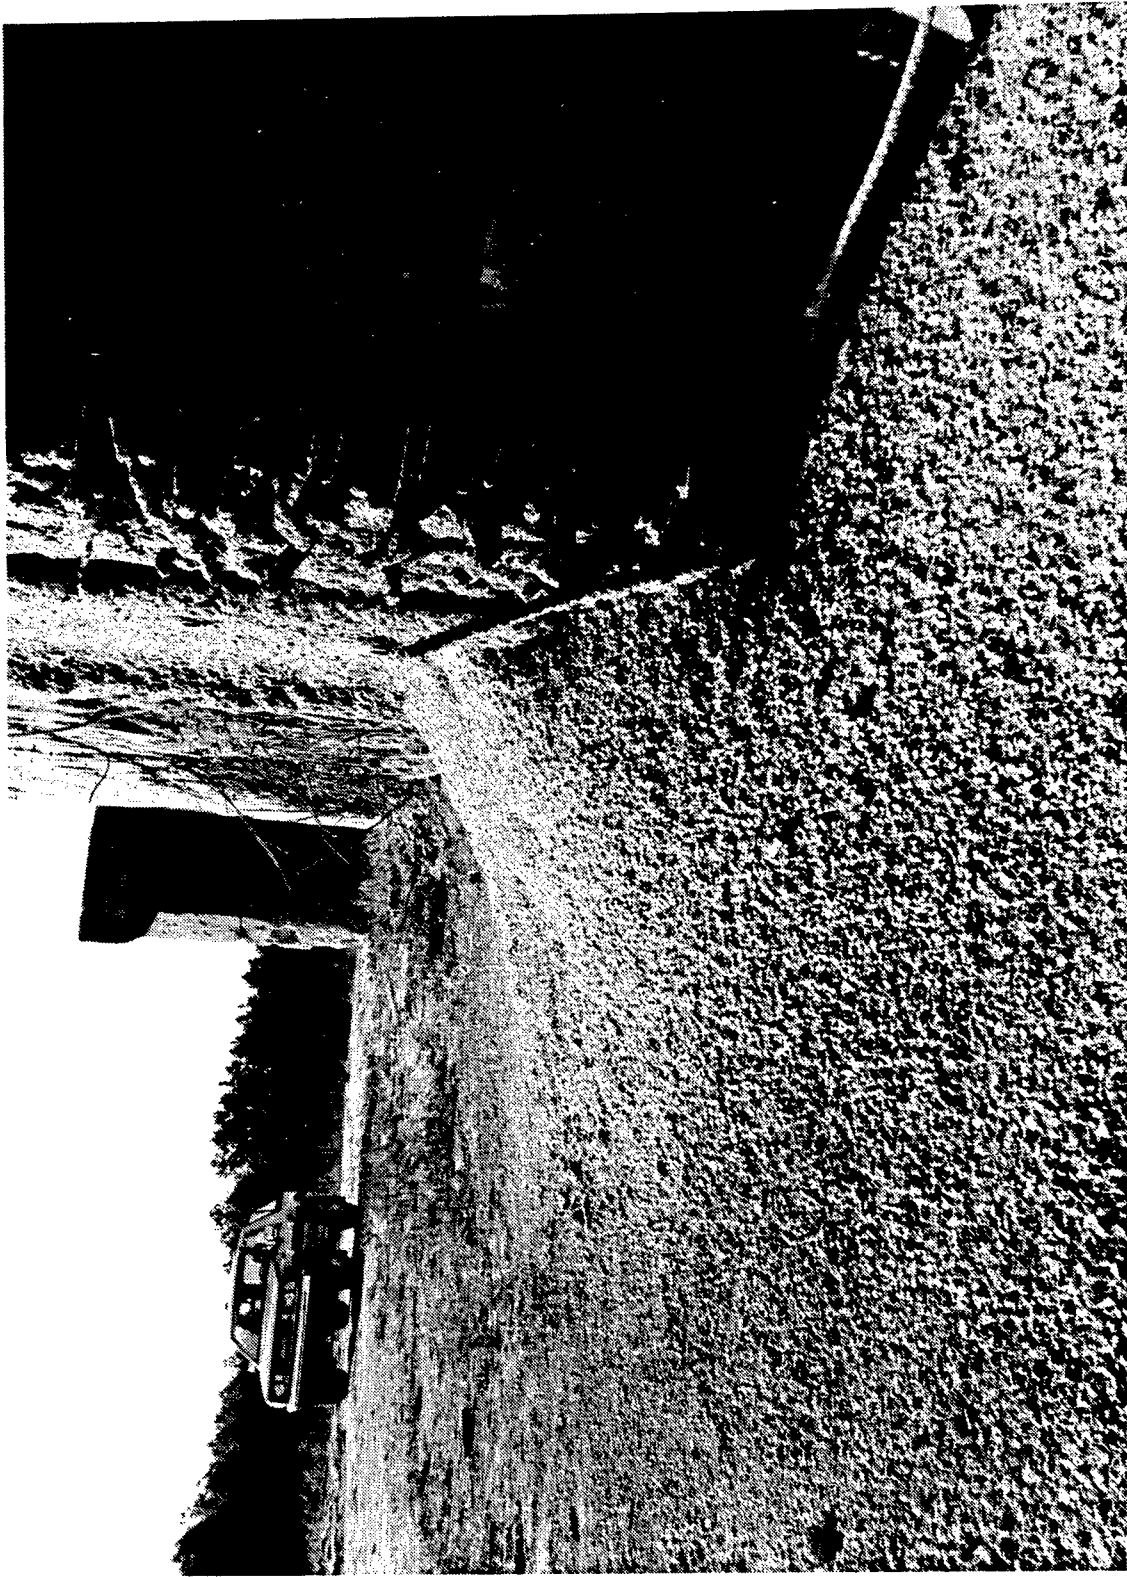
Figure 74. Ramp Caused by Material Rebound During Shotcrete Wall Replacement.

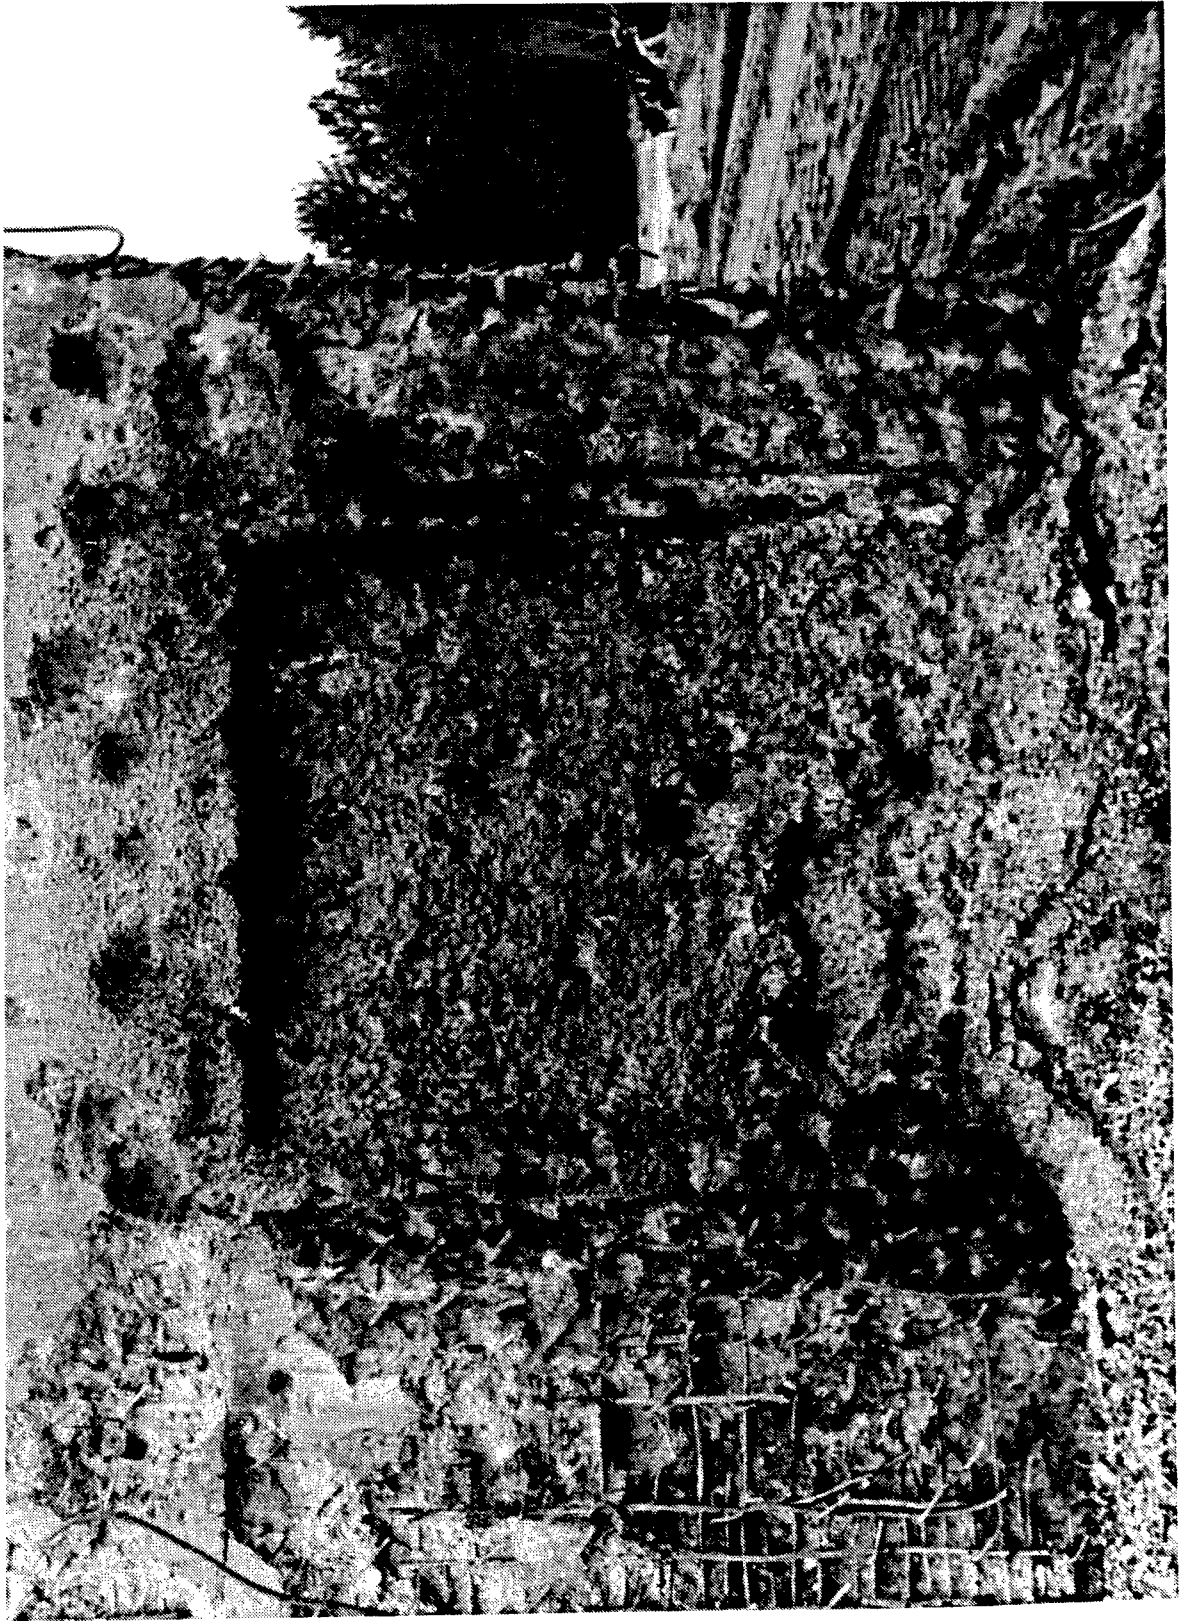
Figure 75. Repair Area After the Explosion of a Mark 83 Bomb at 50 Feet.

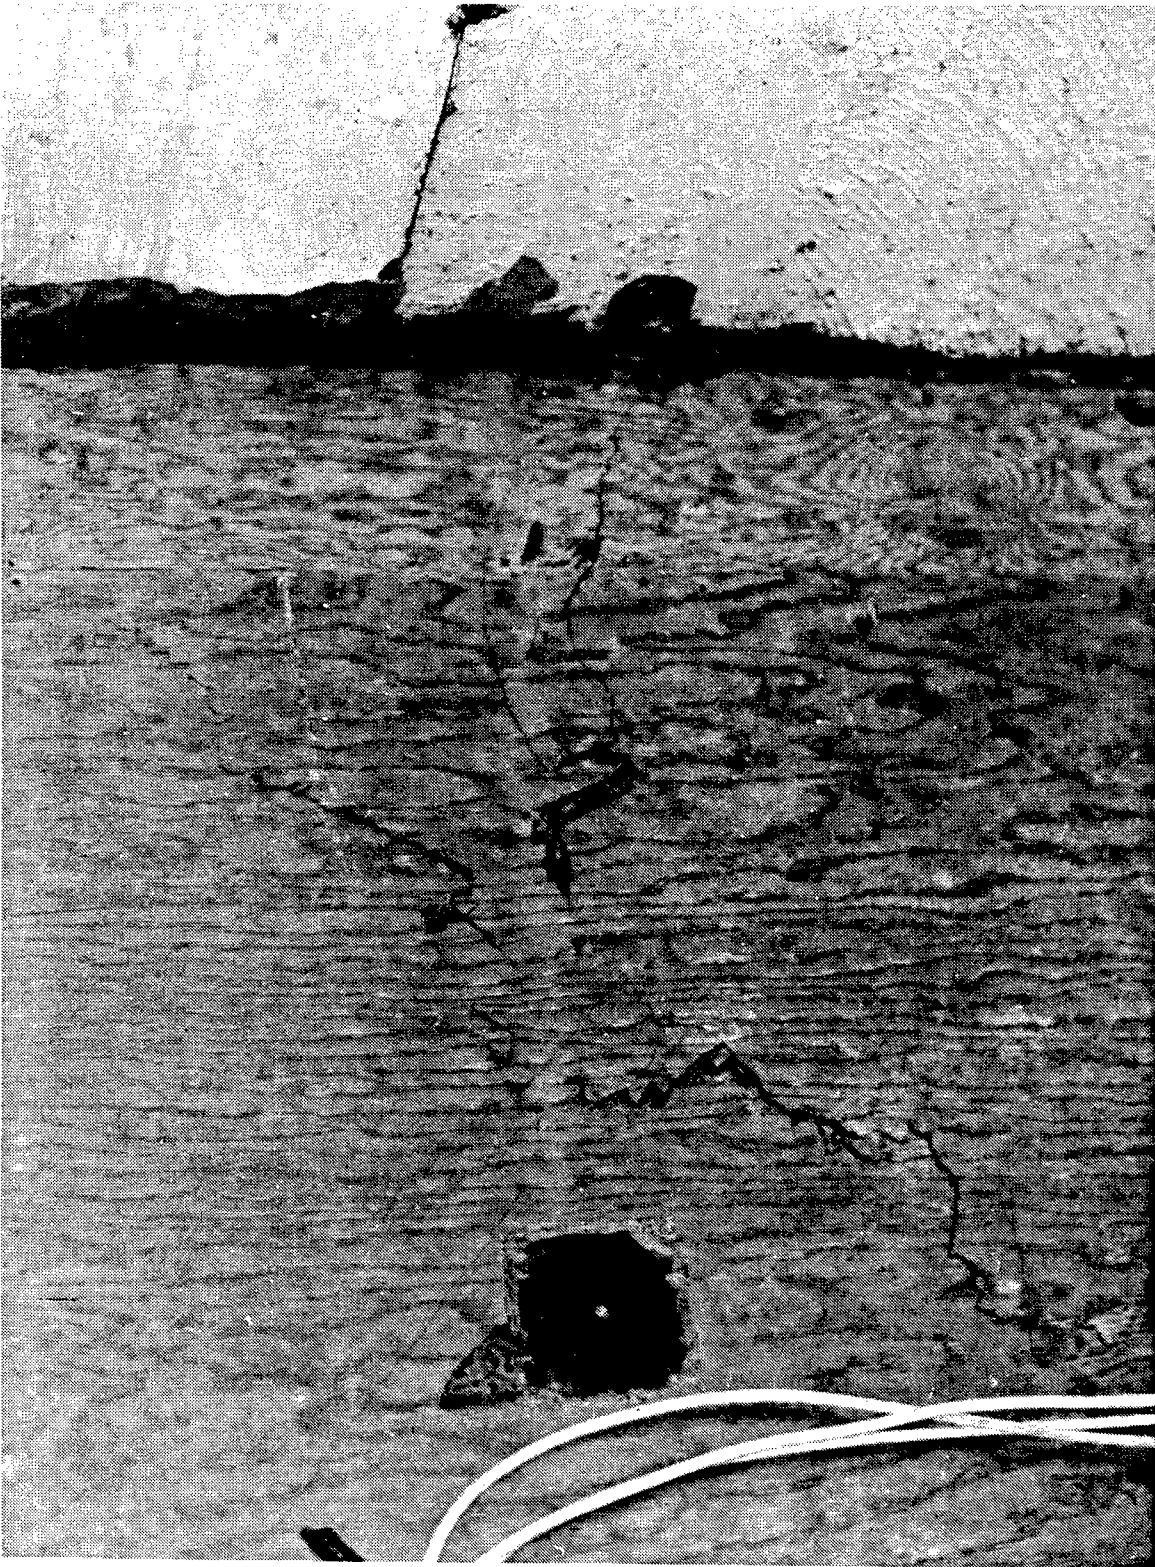
Figure 76. Damage to the Backside of the Repair from the Explosion of a Mark 83 Bomb at 50 Feet.
