ESL-TR-91-13  
VOL II

**EXPEDIENT REPAIR OF STRUCTURAL  
FACILITIES (ERSF) - VOLUME II: ERSF  
SYSTEM REQUIREMENTS AND USERS  
GUIDE**

**JULY 1991**

**FINAL REPORT**

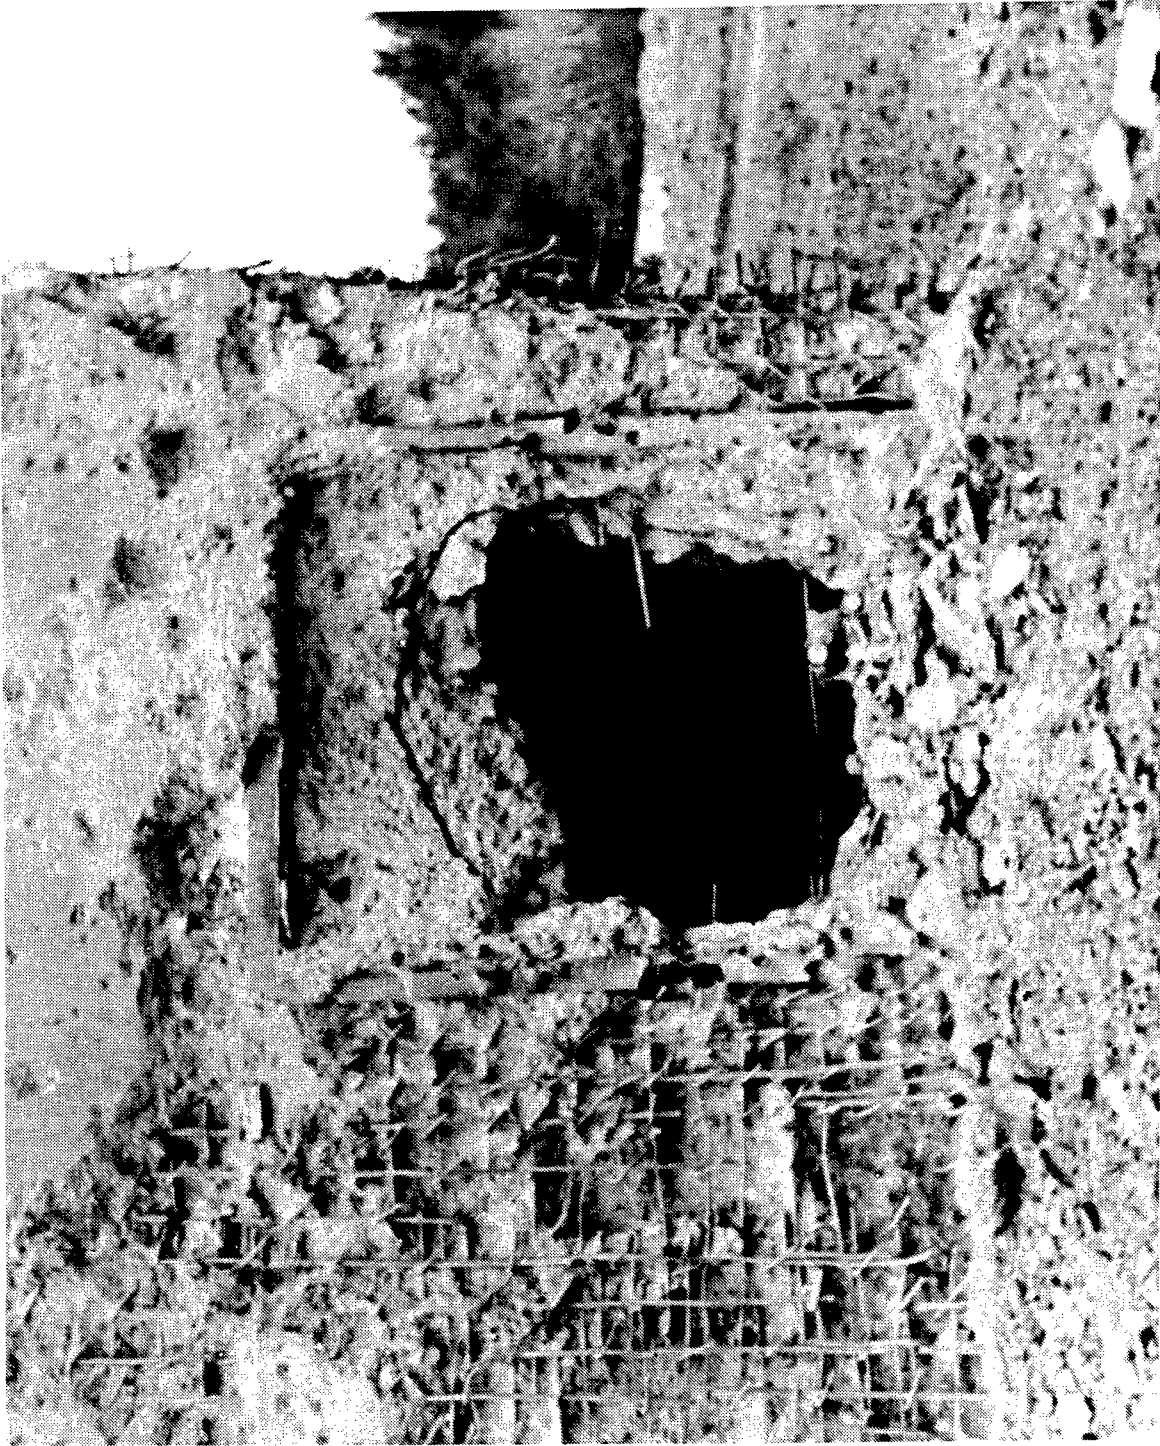
On 10 January, another Mark 83 bomb, in the same configuration as before, was exploded 25 feet from the repair. Severe damage to the repair occurred, as is shown in Figure 77. The center section of the repair was

Figure 77. Repair Area After the Explosion of a Mark 83 Bomb at 25 Feet.
