# AFRL-ML-WP-TR-1998-4191

# CUT PROGRESSION DURING DYNAMOMETER TESTING OF FOREIGN OBJECT DAMAGED TYPE VII EXTRA HIGH PRESSURE AIRCRAFT TIRES SAE PAPER 912155

# Cut Progression During Dynamometer Testing of Foreign Object Damaged Type VII Extra High Pressure Aircraft Tires

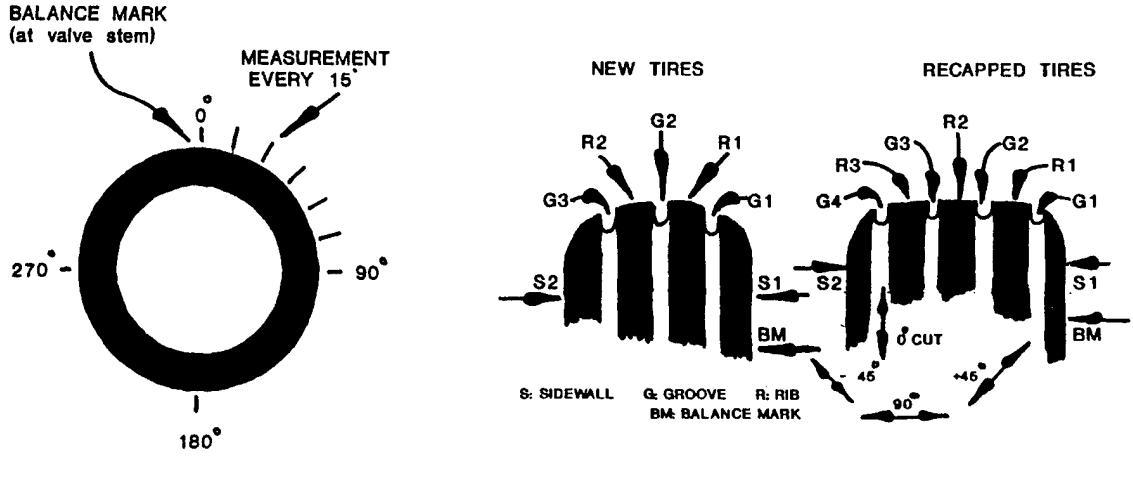
FIGURE 4: CUT MAP CONVENTIONS BIDE VIEW FIGURE 5: CUT MAP CONVENTIONS

GENERAL COMMENTS - Damage from running over the debris varied greatly, as did the performance of the tires on the dynamometer. Cut maps of the extremes of damage to the tread surface may be seen in Figures 6, 7, and 8:

LEAST PRIMARY DAMAGE - Tire X-2A (recap) sustained the fewest primary cuts of all dynamometer tires run on the track at NAEC, and is presented in Figure 6. There were four primary cuts (with one

past the Cut Limit) and four primary blemishes. As it ran on the dynamometer, the primary damage increased, and secondary cuts and blemishes appeared. After lab segment LT 1, there were six primary cuts (two past the Cut Limit) and one primary blemish; and 12 secondary cuts (with two past the Cut Limit) and three secondary blemishes.

Only 1.9% of the impacts at NAEC resulted in primary cuts and another 1.9% resulted in primary blemishes. After LT 1, the number of all cuts equalled 8.7% of the number of impacts. The 450% increase in the number of cuts, and 275% increase in total damage were the top percentage increase of damage for all tires tested. The tire stripped 100% of the tread during TTO 2.

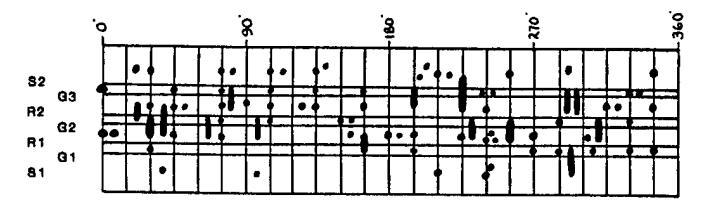
FIGURE 7: MOST PRIMARY DAMAGE 6202-0666/J-20 NEW TIRE

MOST PRIMARY DAMAGE - Tire J-20 (new) sustained the most primary cuts, and is presented in Figure 7. There were 81 primary cuts (ten past the Cut Limit) and six primary blemishes. After lab segment TTO 1, there were 86 primary cuts (11 past the Cut Limit) and no blemishes; and 27 secondary cuts (two past the Cut Limit) and three secondary blemishes.

Twenty three percent of the impacts resulted in primary cuts and 2% resulted in primary blemishes. After TTO 1, the number of all cuts equalled 33% of the impacts. This tire stripped 200 degrees of the inboard (R2) center rib during TTO 3.

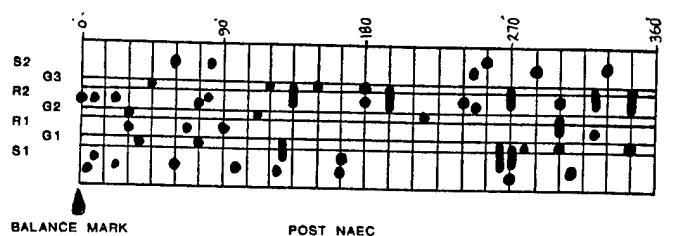
FIGURE 8: GREATEST SECONDARY DAMAGE

MOST SECONDARY DAMAGE - Tire H-8 (new) sustained more than the mean (40) number of cuts at NAEC, and is presented in Figure 8. There were 49 primary cuts (four past the Cut Limit) and one primary blemish. Growth of secondary damage after lab segment TTO 1 was dramatic. After TTO 1, there were 50 primary cuts (five past the Cut Limit) and no primary blemishes; and 43 secondary cuts (two past the Cut Limit) and one secondary blemish. The 43 secondary cuts after TTO 1 were the most noticed during this program.

Fourteen percent of the impacts resulted in primary cuts, and less than 1% resulted in primary blemishes. After TTO 1, the number of all cuts equalled 27% of the impacts. The tire completed 3 TTO and 3 LT segments without failure, and was removed from the test queue for the dynamometer.

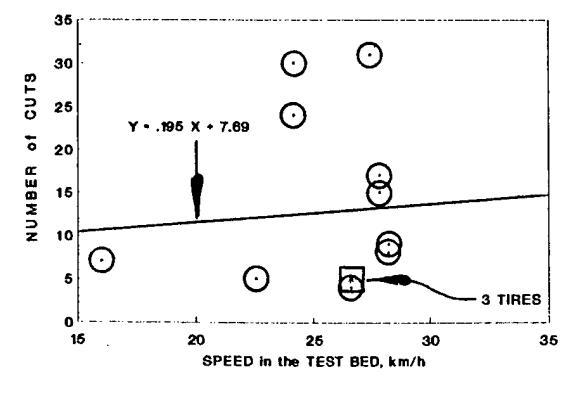
FIGURE 9: SPEED vs NUMBER OF CUTS Recapped Tires

The number of primary cuts produced is presented in Figure 9, as a function of speed in the test bed at NAEC. Individual tires had between four and 31 primary cuts, with 69% of the tires having 15 or fewer cuts. The positive slope indicates that more damage was done as the NAEC speed increased.
