# **DEMONSTRATION AND VALIDATION OF THERMAL SPRAY VITRIFICATION OF LEAD-CONTAINING PAINT ON STEEL STRUCTURES**

**CERL TR 99/61**

**July 1999**

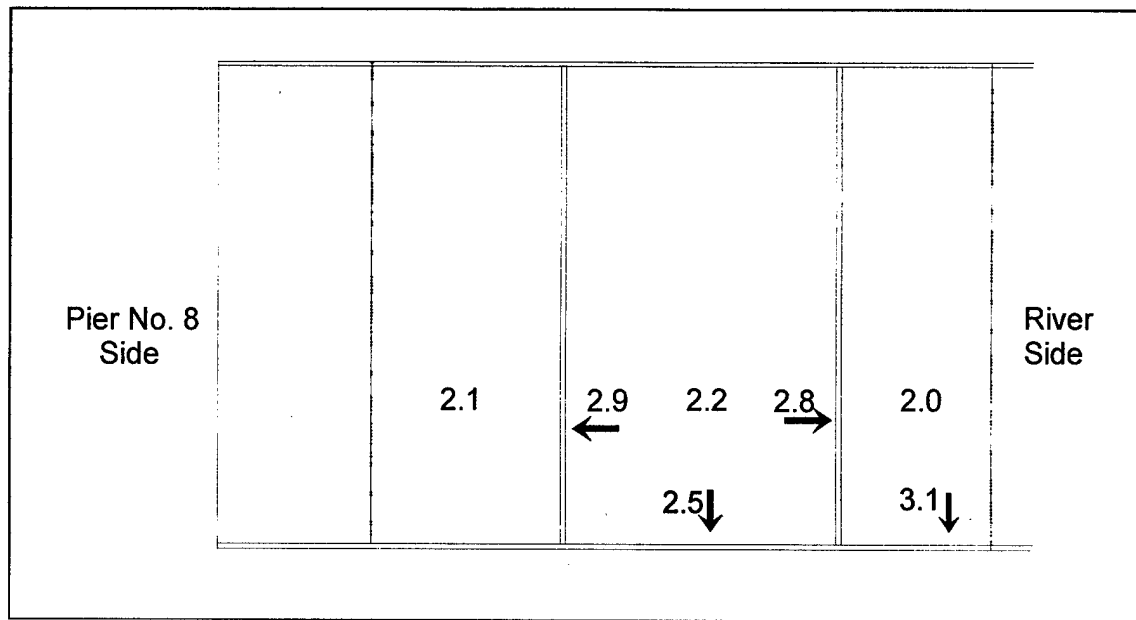
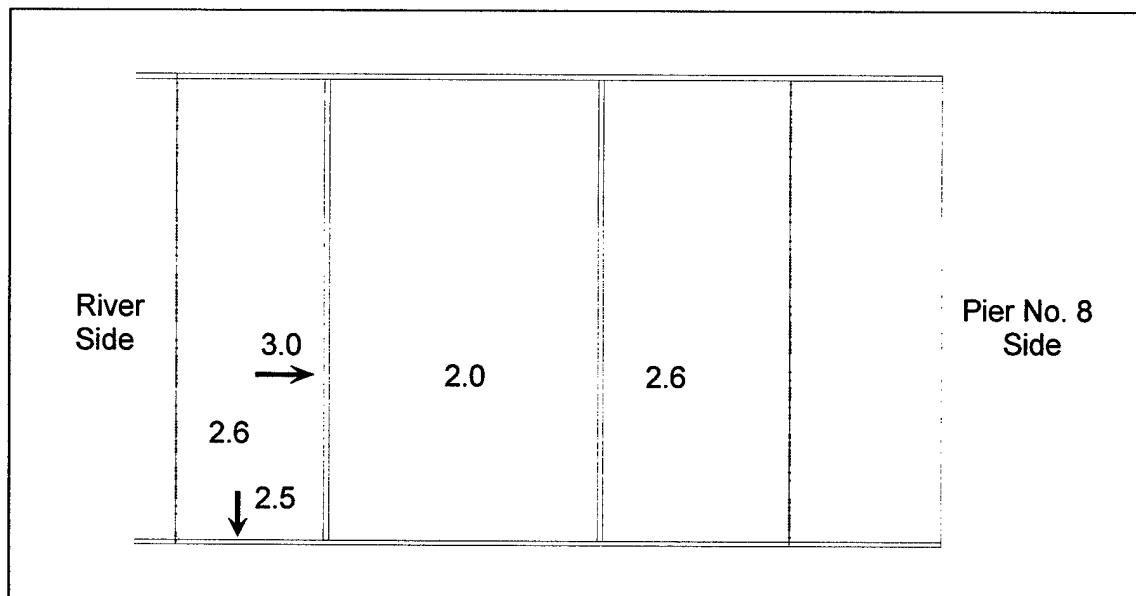
TSV met the principal performance criteria of providing surface preparation for repainting. Following application of TSV, the surface was inspected by personnel from the Paint Technology Center at U.S. Army Construction Engineering Research Laboratory and was found to meet the requirements of the Steel Structures Painting Council (SSPC) SP1 and SP3 required in the contract specification and was suitable for repainting with a surface tolerant coating system. The surface profile was measured using ASTM D 4417 and found to range from 2.0 to 3.0 mils, Figures C-5 and C-6.

Figure C- 5. Surface profile after TSV application (mils), east side.

Figure C- 6. Surface profile after TSV application (mils), west side.

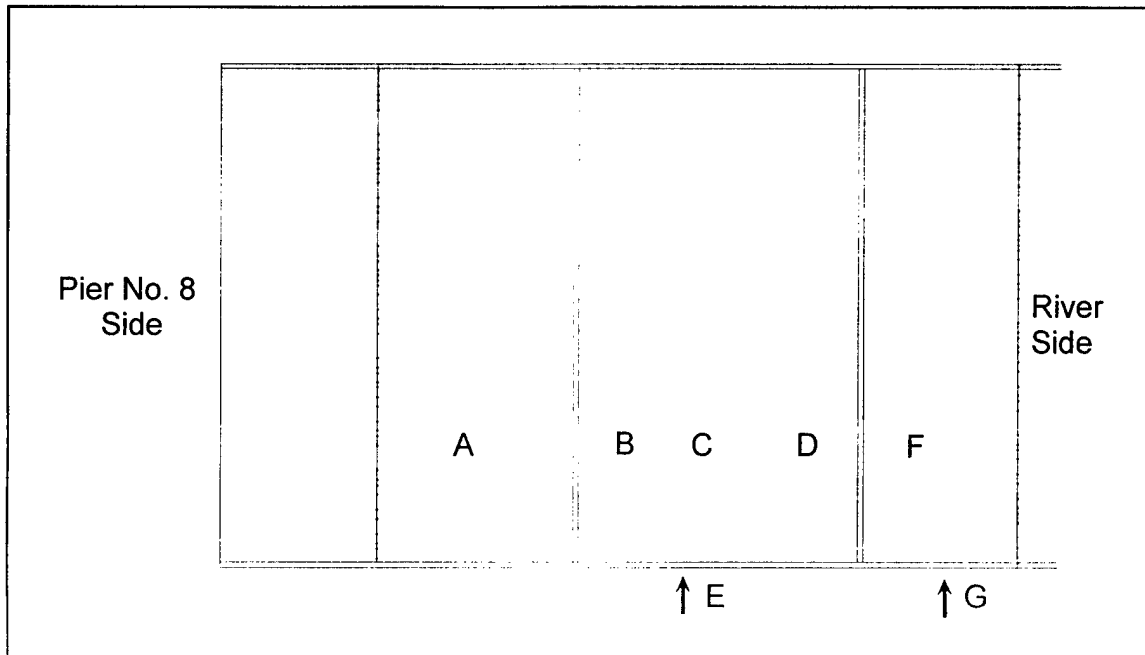
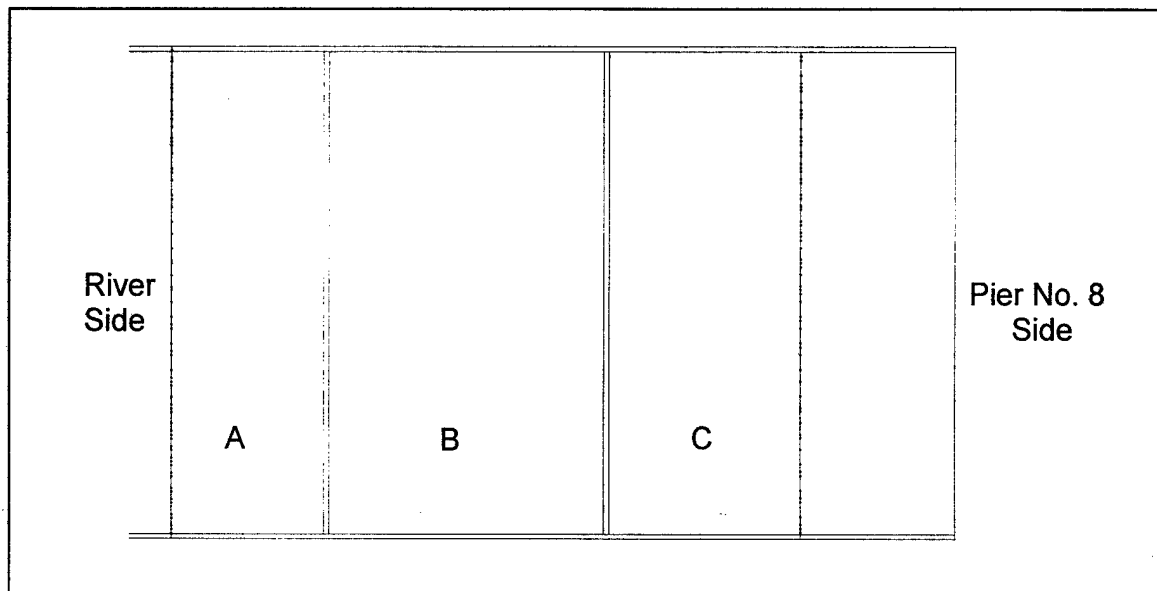
The first paint coat was a Sherwin Williams industrial coating SSPC 25 red primer. The top coat was a Sherwin Williams VOC complying industrial enamel No. 2.16. This is a medium oil, alkyd, all purpose enamel designed for new construction and maintenance work and provides performance comparable to products formulated to Federal Specification TT-E-489. Temperature and relative humidity were measured prior to painting. The temperature of the substrate was more than 5°F higher than the dew point and the relative humidity was below 80% before painting commenced. The contract specification required a spread rate of 500 sq ft per gallon. One gallon of the primer and one and half gallons of paint were used to apply the one coat of the primer and two top coats over the 180 sq ft area of the demonstration. The measured thickness of the dried primer ranged from 1.7 to 3.4 mils and was on average 3.0 mils, Figure C-7, Table C-3, Figure C-8, and Table C-4. The measured thickness of the completed coating system primer plus top coats ranged from 5.4 to 8.4 mils and was on average 6.9 mils, Figures C-9 and C-10, and Tables C-5 and C-6.

**Figure C- 9. Location of thickness measurement (primer plus topcoat) after TSV application, east side.**

**Figure C- 10. Location of thickness measurements (primer plus topcoat) after TSV application, west side.**

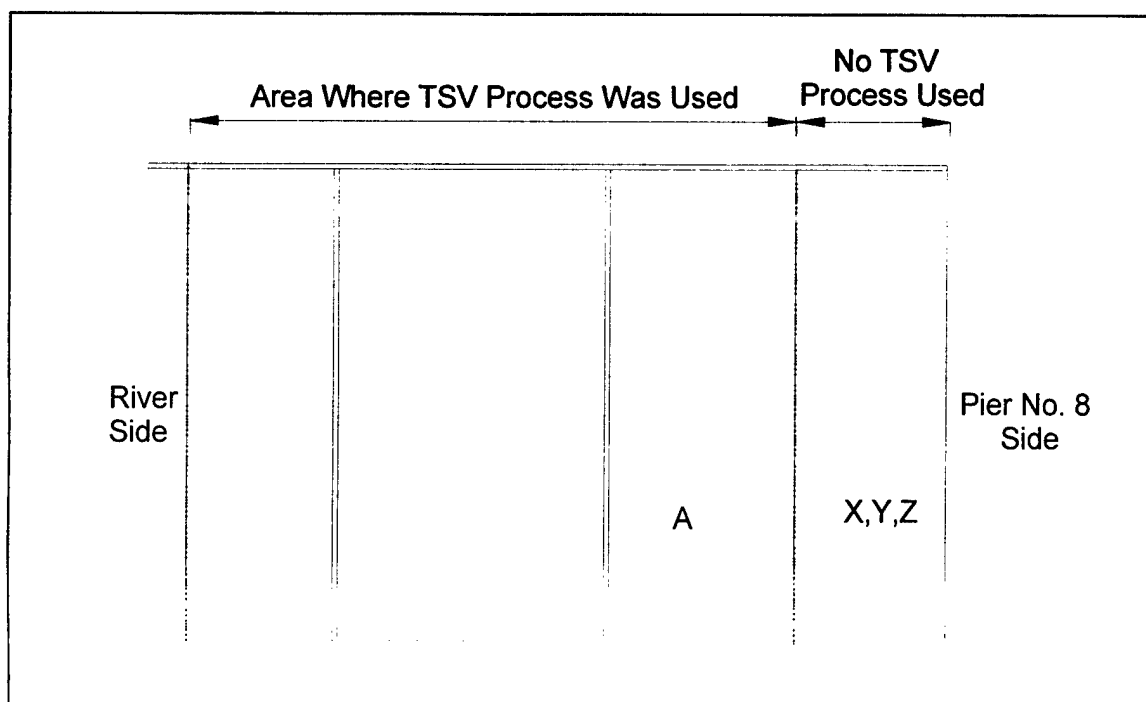
X-ray fluorescence analysis found the lead concentration in areas adjacent to the demonstration with intact original coating ranged from 4.7 to 5.8 mg/cm<sup>2</sup>, Figure C-11 and Table C-7. In areas on which the thermal spray vitrification was demonstrated, the measured lead concentration was found to range from 1.0 to 2.1 mg/cm<sup>2</sup>, Figures C-12 and Figure C-8. As with most other paint-removal processes, such as chemical removal, some residual lead was present on the surface. The aim of this demonstration was to reduce the concentration of lead on the surface to less than 1.0 mg/cm<sup>2</sup>. The retention of lead on the steel surface is a function of the experience of the applicator, the original amount of lead present, and the number of applications of TSV utilized. During the demonstration, two applications of TSV were used. One or two additional applications of the process would be expected to further reduce the residual concentration of lead on the substrate to below 1.0 mg/cm<sup>2</sup>. Experience with the technology also reduces the amount of lead remaining on the surface. The workers in this test had less than 2 days of experience by the end of the test. With a week of on-job experience, the amount of residual lead should also be reduced as the applicators become more proficient. The lead retention does not appear, with the data in hand, to be a function of the lead paint type or age. During any future paint removal from the

**Figure C- 11. Location of lead-concentration measurements using x-ray fluorescence spectroscopy with and without TSV application, west side.**

Location	Instrument Reading No.	TSV Process Used	Lead Conc. mg/cm <sup>2</sup>
A	107.6	Yes	2.12
X	107.7	No	4.70
Y	107.8	No	4.71
Z	107.9	No	5.84
