SACRAMENTO RIVER FLOOD CONTROL PROJECT, CALIFORNIA MID-VALLEY AREA, PHASE III

# DESIGN MEMORANDUM VOLUME I OF II

Sacramento District South Pacific Division

August 1995

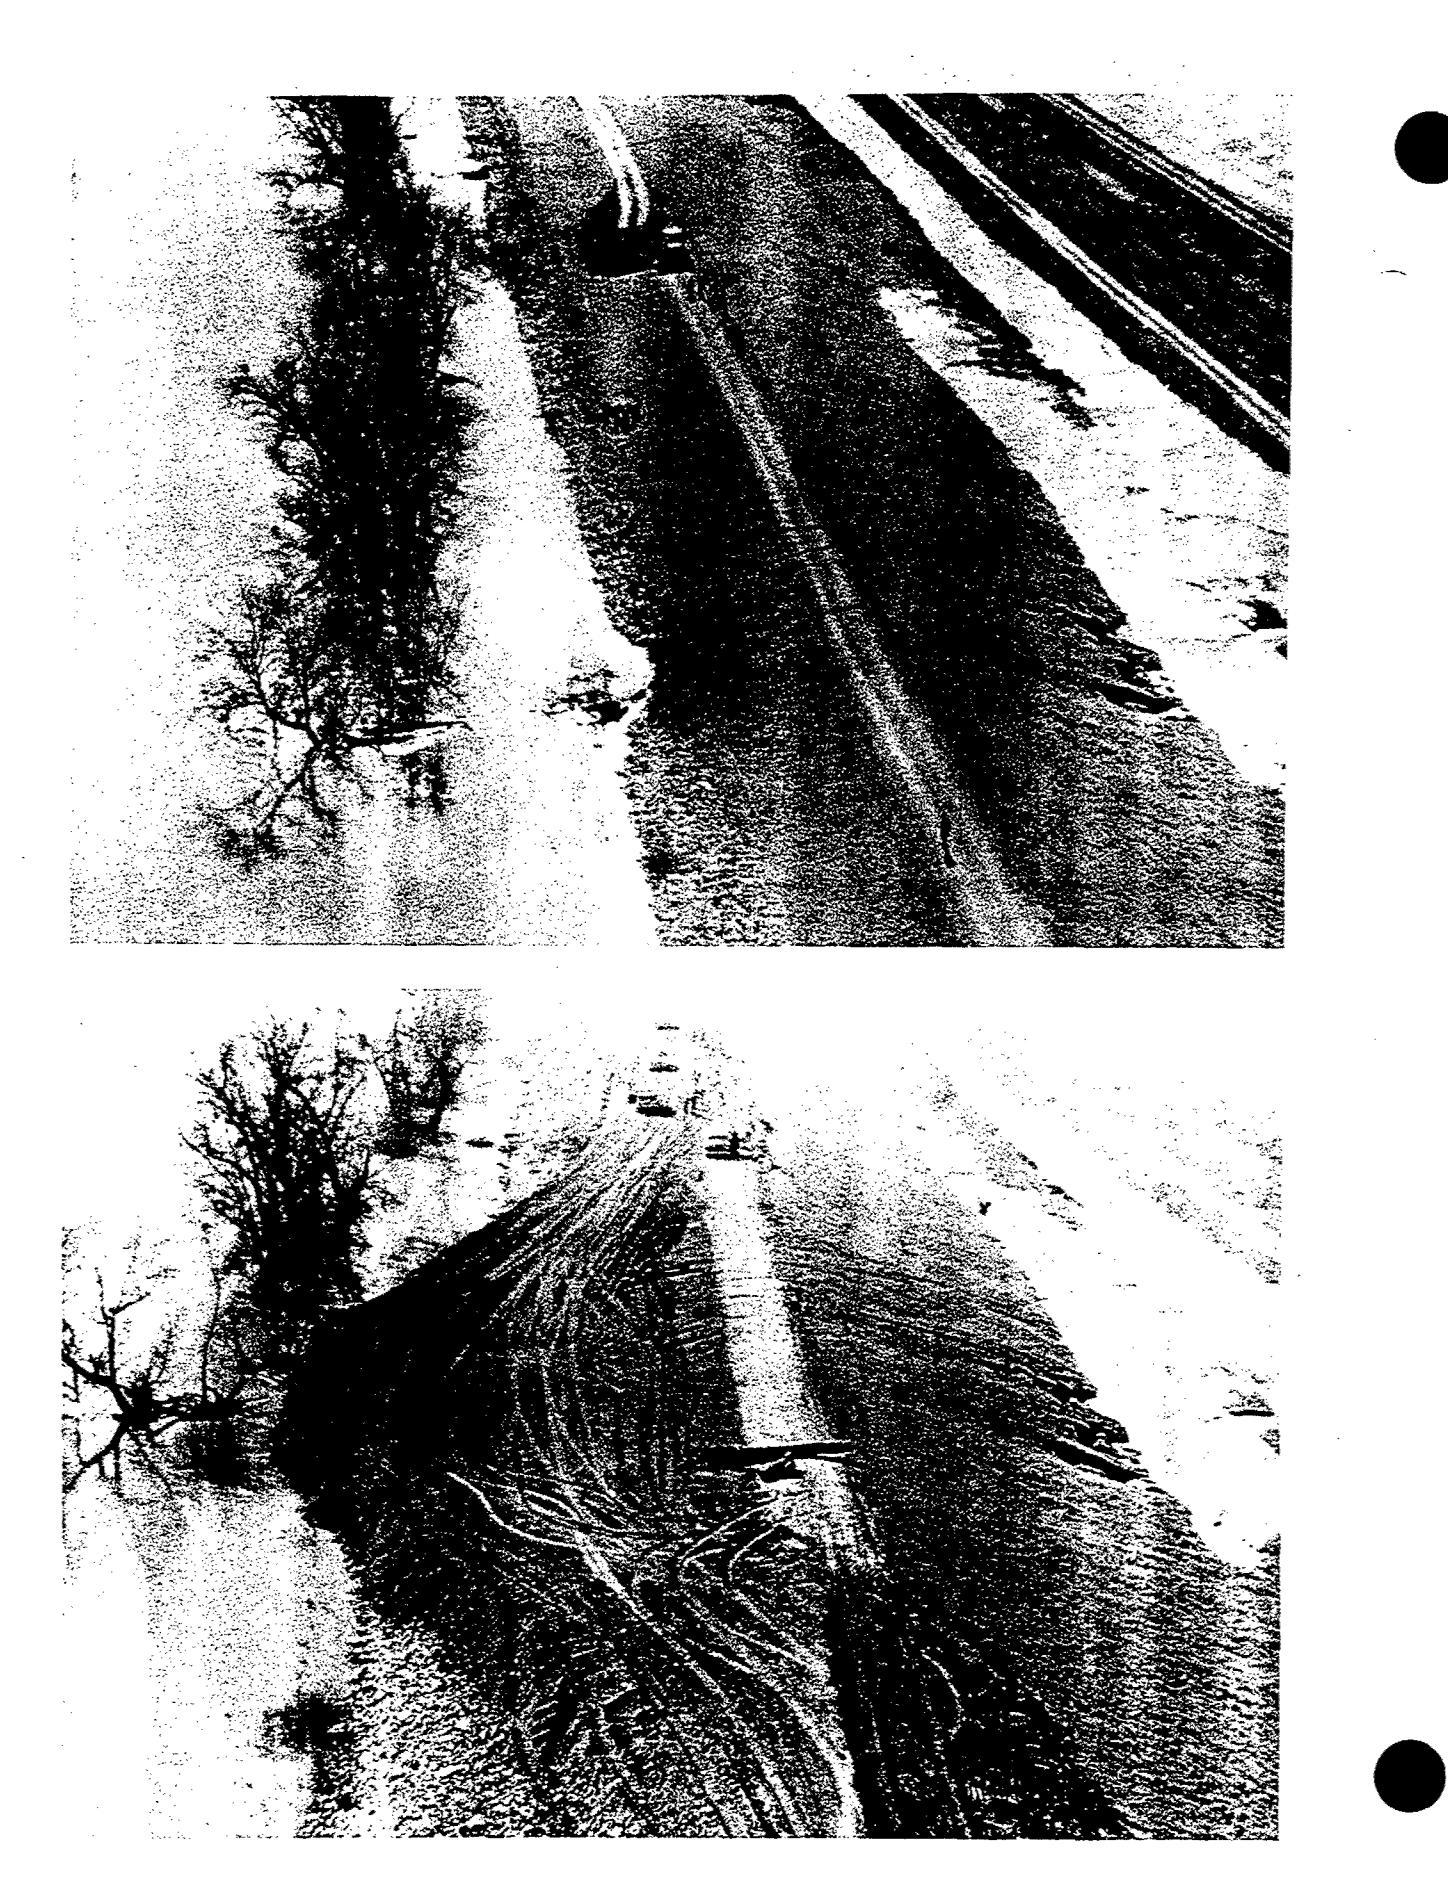
EMERGENCY FLOOD FIGHT EFFORTS ON WEST LEVEE SUTTER BYPASS DURING FEBRUARY 1986 FLOOD. identifying the levee embankment problem areas that resulted from the February 1986 flood, including high water, bank erosion, seepage, and boils.

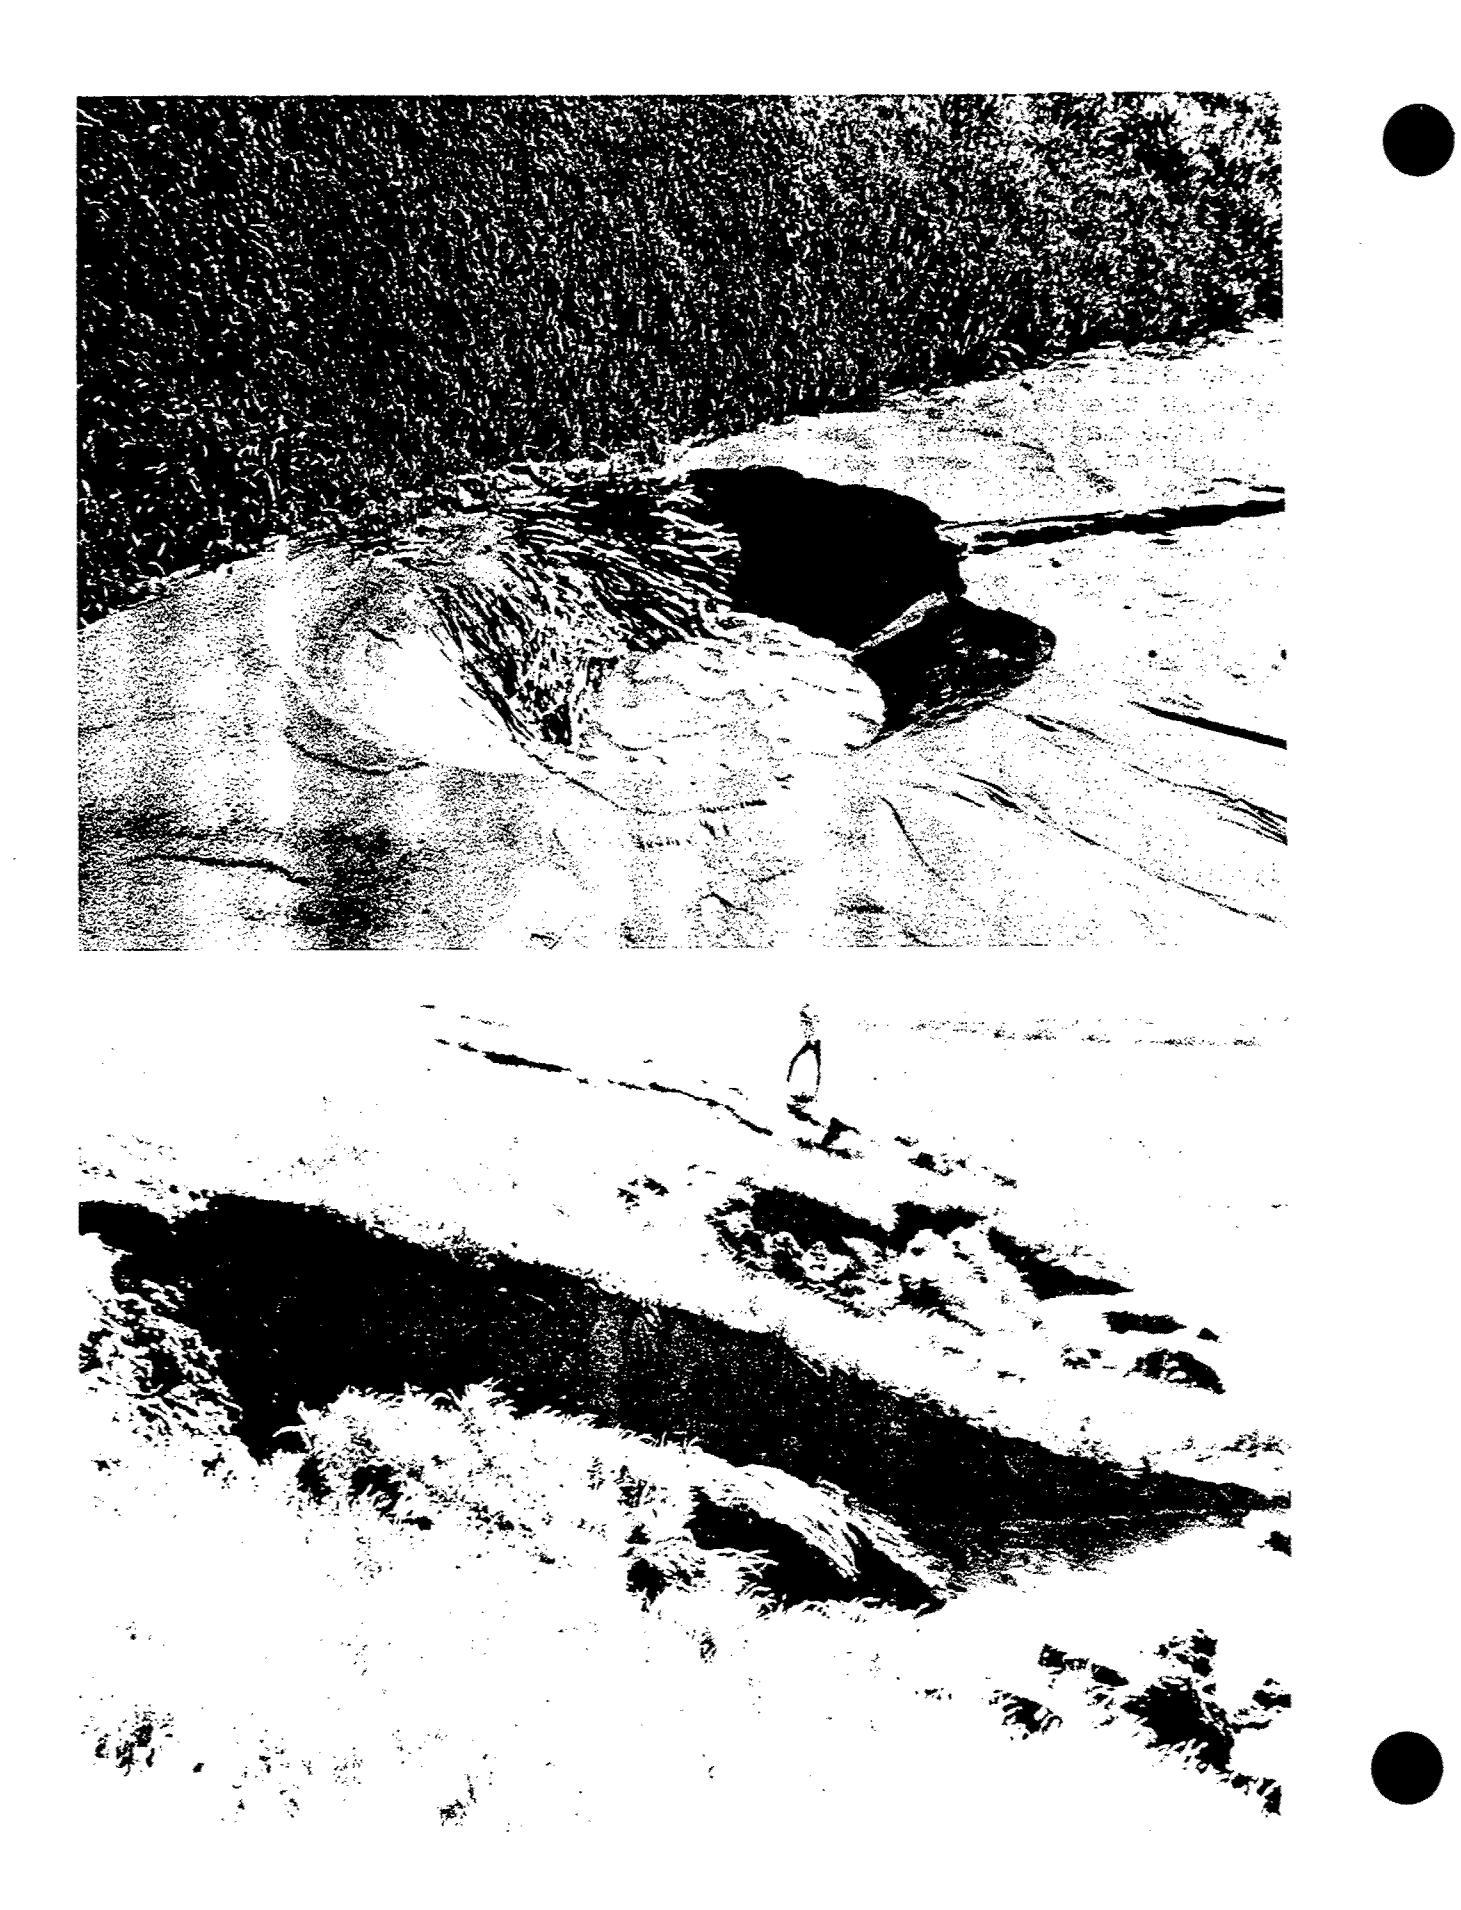
Sutter Bypass. - The west levee of Sutter Bypass just east of Robbins was the site of significant seepage and settlement in February 1986 (see front cover and Figures 1, 2, and 3). The problem began suddenly as a blowout of levee embankment toe material. Erosion of the landside levee toe continued until the levee embankment subsided at the site. Seepage water then appeared immediately downstream, eroding levee material until this too was stopped by settlement of the levee. The process continued downstream for about 200 feet. Emergency flood fight efforts (see Figure 2) were initiated by the Corps of Engineers to stabilize the levee embankment. A temporary waterside berm about 50 feet wide and 300 feet long was constructed of sand and gravel at a cost of about \$290,000. Upstream from this site (in the vicinity of Highway 113), numerous clear water boils have occurred along about 1 mile of levee during past high flows. Two of these boils, identified as boil numbers 12 and 16, have occurred regularly enough to have acquired numbers

LEVEE EMBANKMENT PROBLEM AREAS ON WEST LEVEE SUTTER BYPASS DURING FEBRUARY 1986 FLOOD.

(numbered staffs at each boil). One of these boils has a permanently installed corrugated metal standpipe to control flow. On the east side of Sutter Bypass, seepage waters appear landward of the levee during high flood stages from the Natomas Cross Canal upstream along about 8 miles of levee. Significant seepage and small boils have occurred along this levee just upstream from the cross canal. The levee embankment also failed in this same area (see Plate 3 for location) in the past.

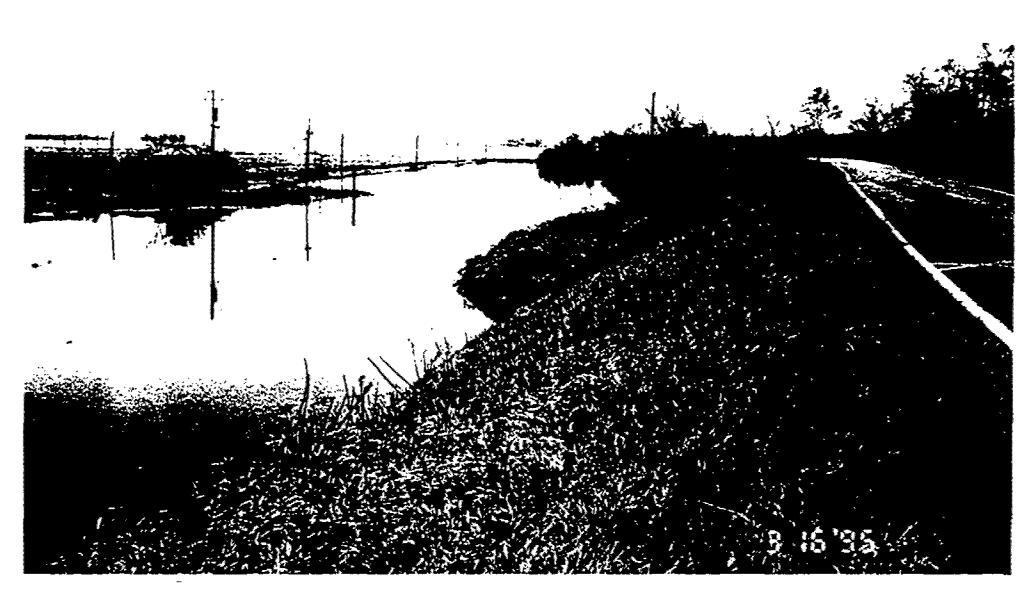
IN 1995, POND CREATED FROM EXTENSIVE SEEPAGE ALONG LEVEE TOE AT SITE 18, FEATHER RIVER/YOLO BYPASS. LAST TIME WATER PONDED HERE WAS IN 1986.

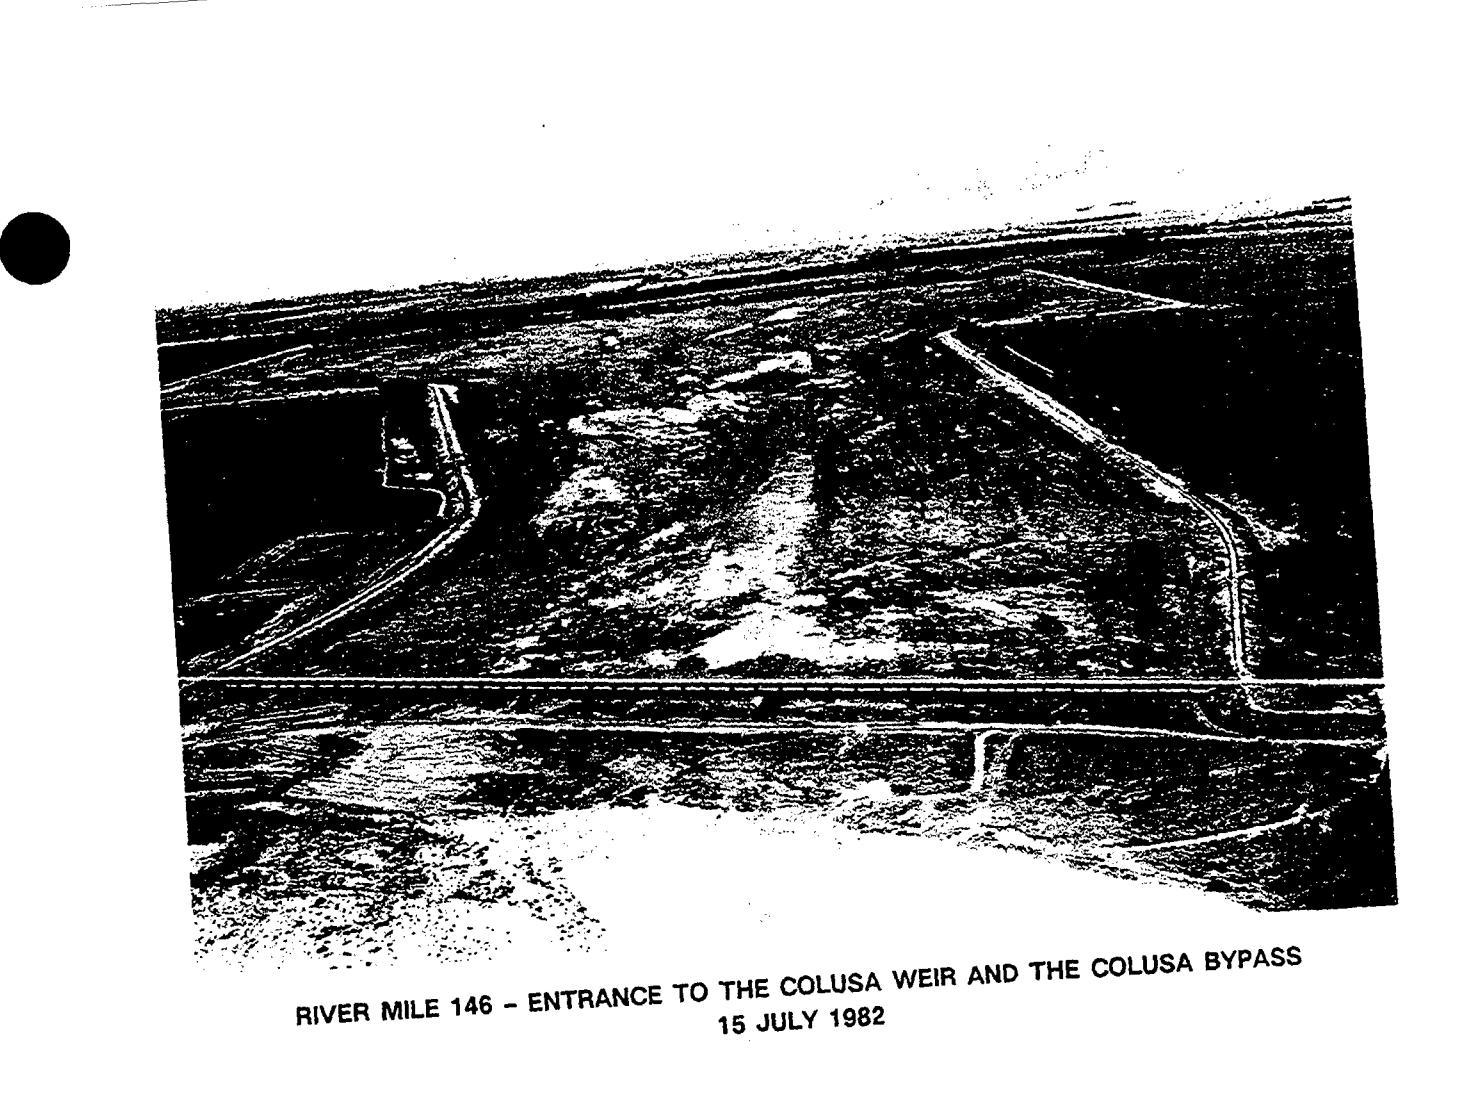
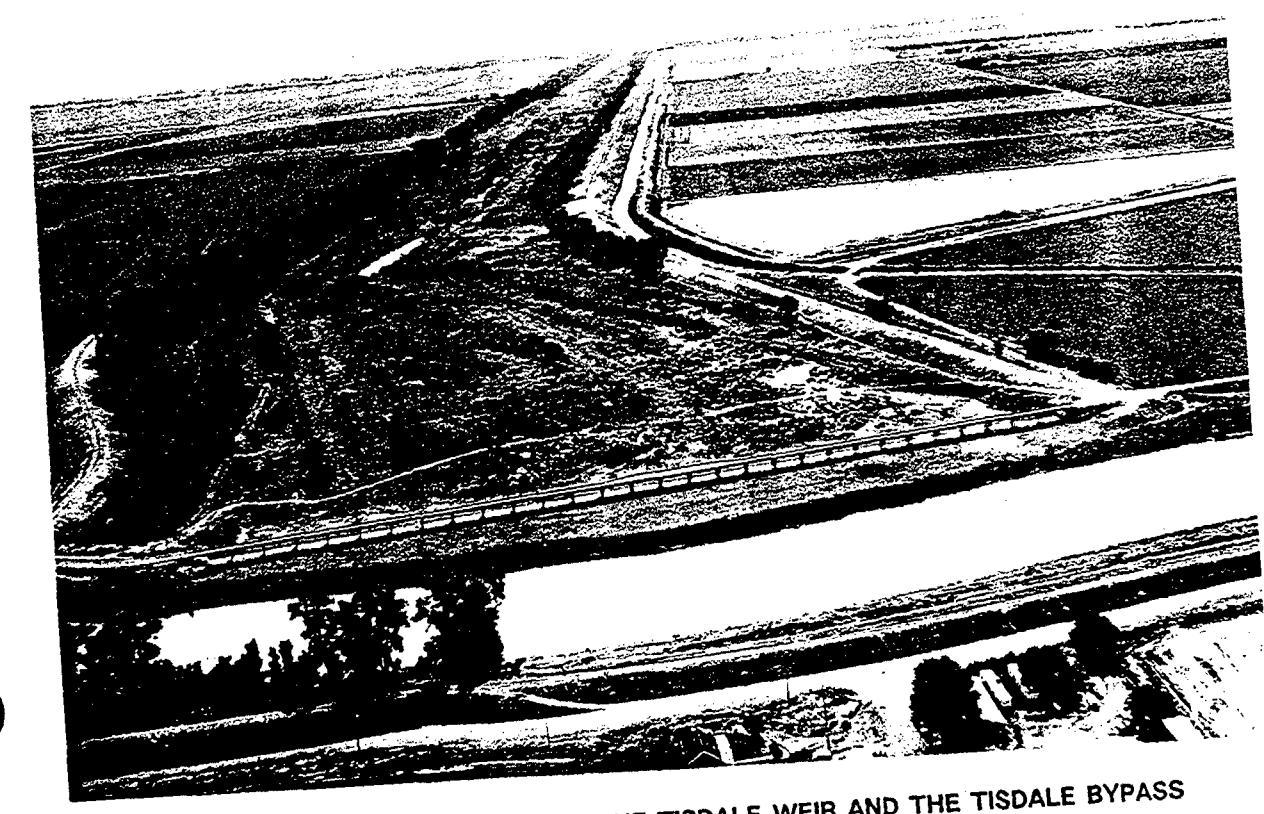
RIVER MILE 118 - ENTRANCE TO THE TISDALE WEIR AND THE TISDALE BYPASS 15 JULY 1982.

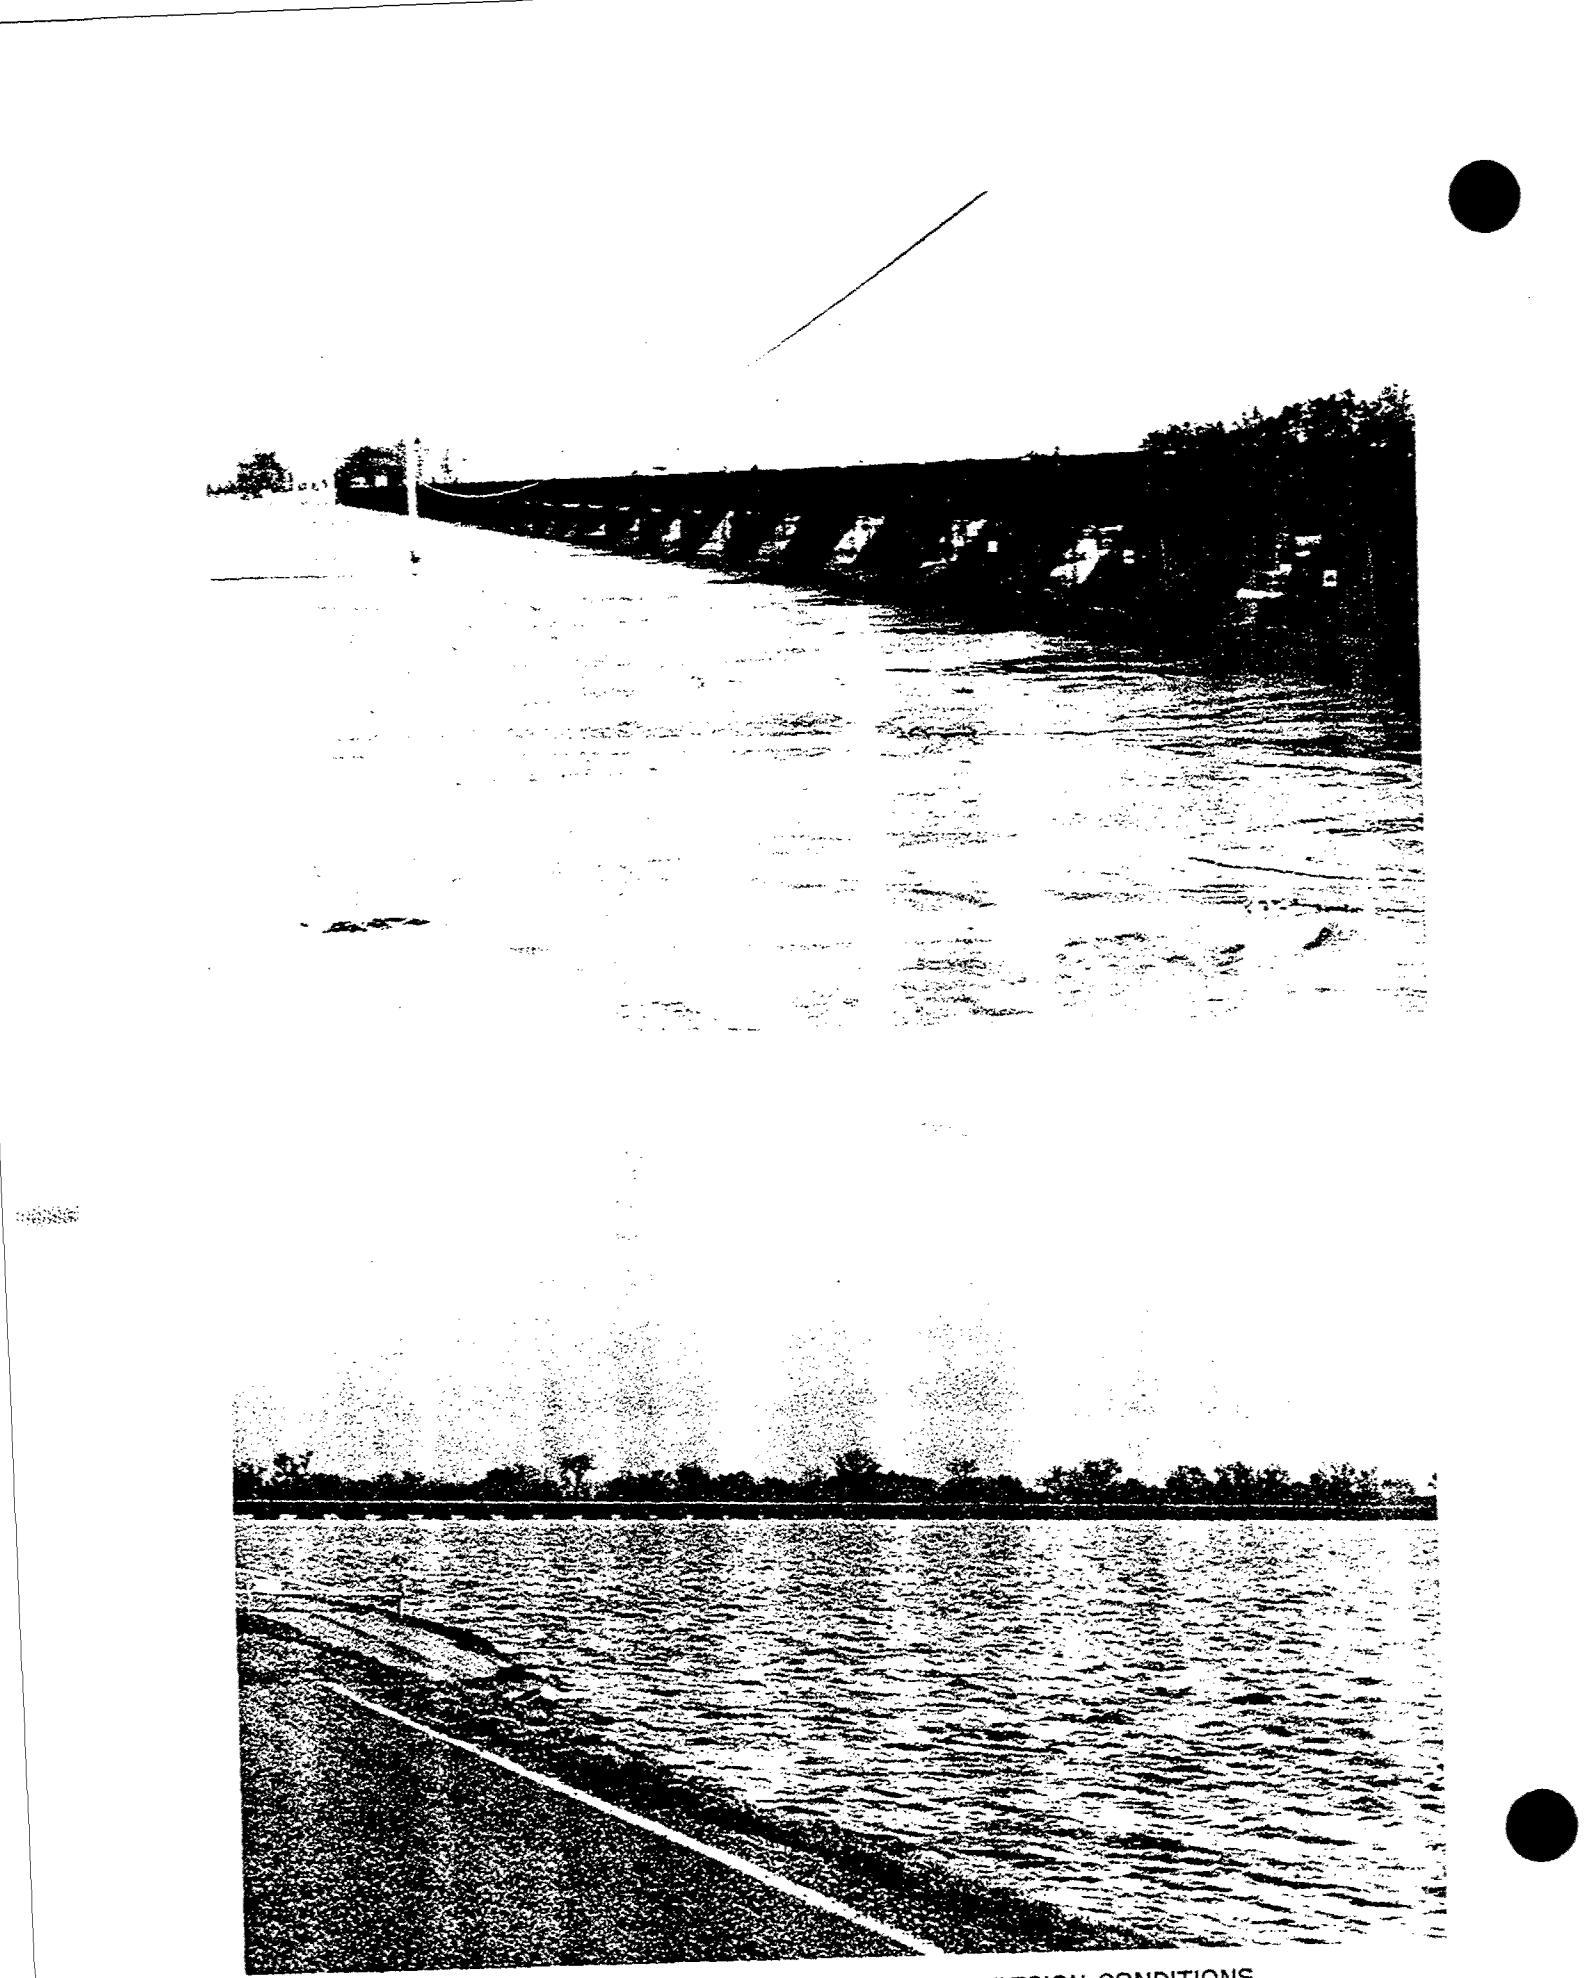
FEBRUARY 1986 FLOODFLOWS EXCEEDED DESIGN CONDITIONS FOR SACRAMENTO WEIR AND BYPASS.
