ERDC/CHL CR-06-1

## Chesapeake Bay Breakwater Database Project, Section 227 Demonstration Site: Hurricane Isabel Impacts to Four Breakwater Systems

Final Report

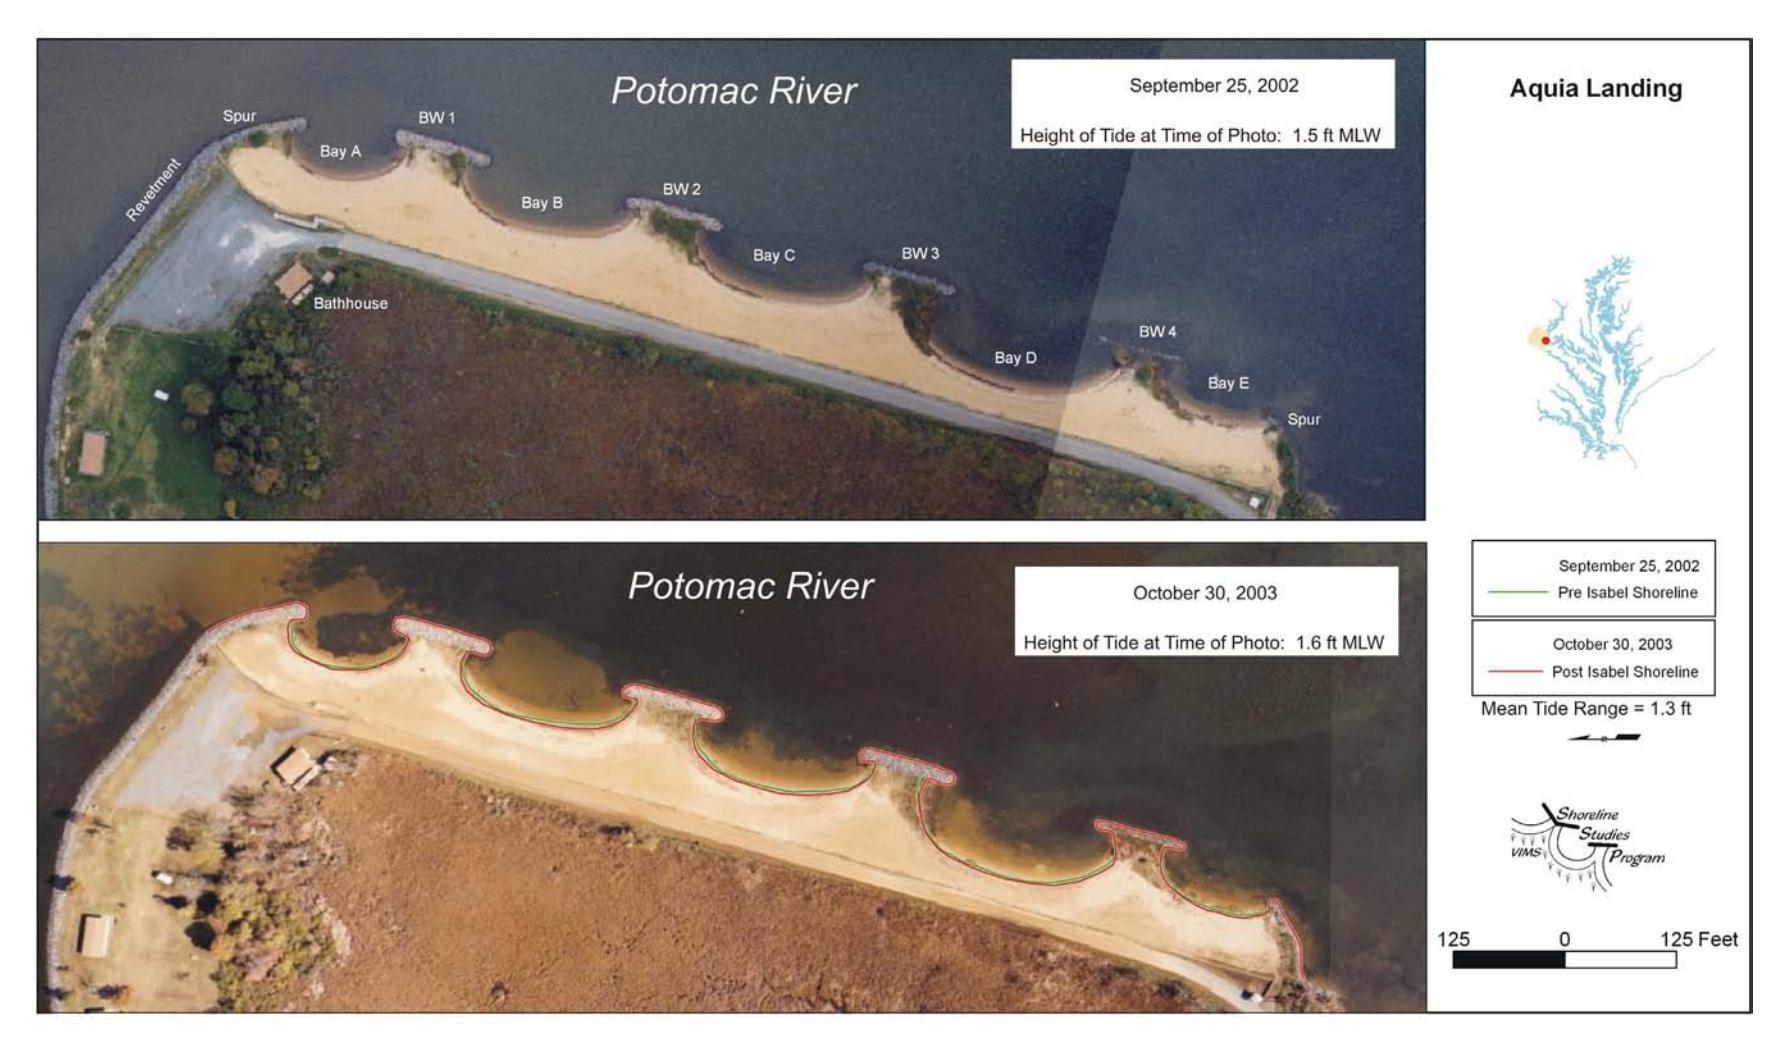
Aquia Landing was the least impacted by Hurricane Isabel of the four sites discussed in this report. It had the least storm surge and it was not directly impacted by wave attack. Nevertheless, the storm impacts were enough to carry sand into the access road due to the low backshore and the absence of an upland bank. However, no significant infrastructure was damaged at the site. Overall, this site fared well with little or no impact.

Figure 15. Aquia Landing low-level pre- and post-Hurricane Isabel ortho-rectified aerial photographs

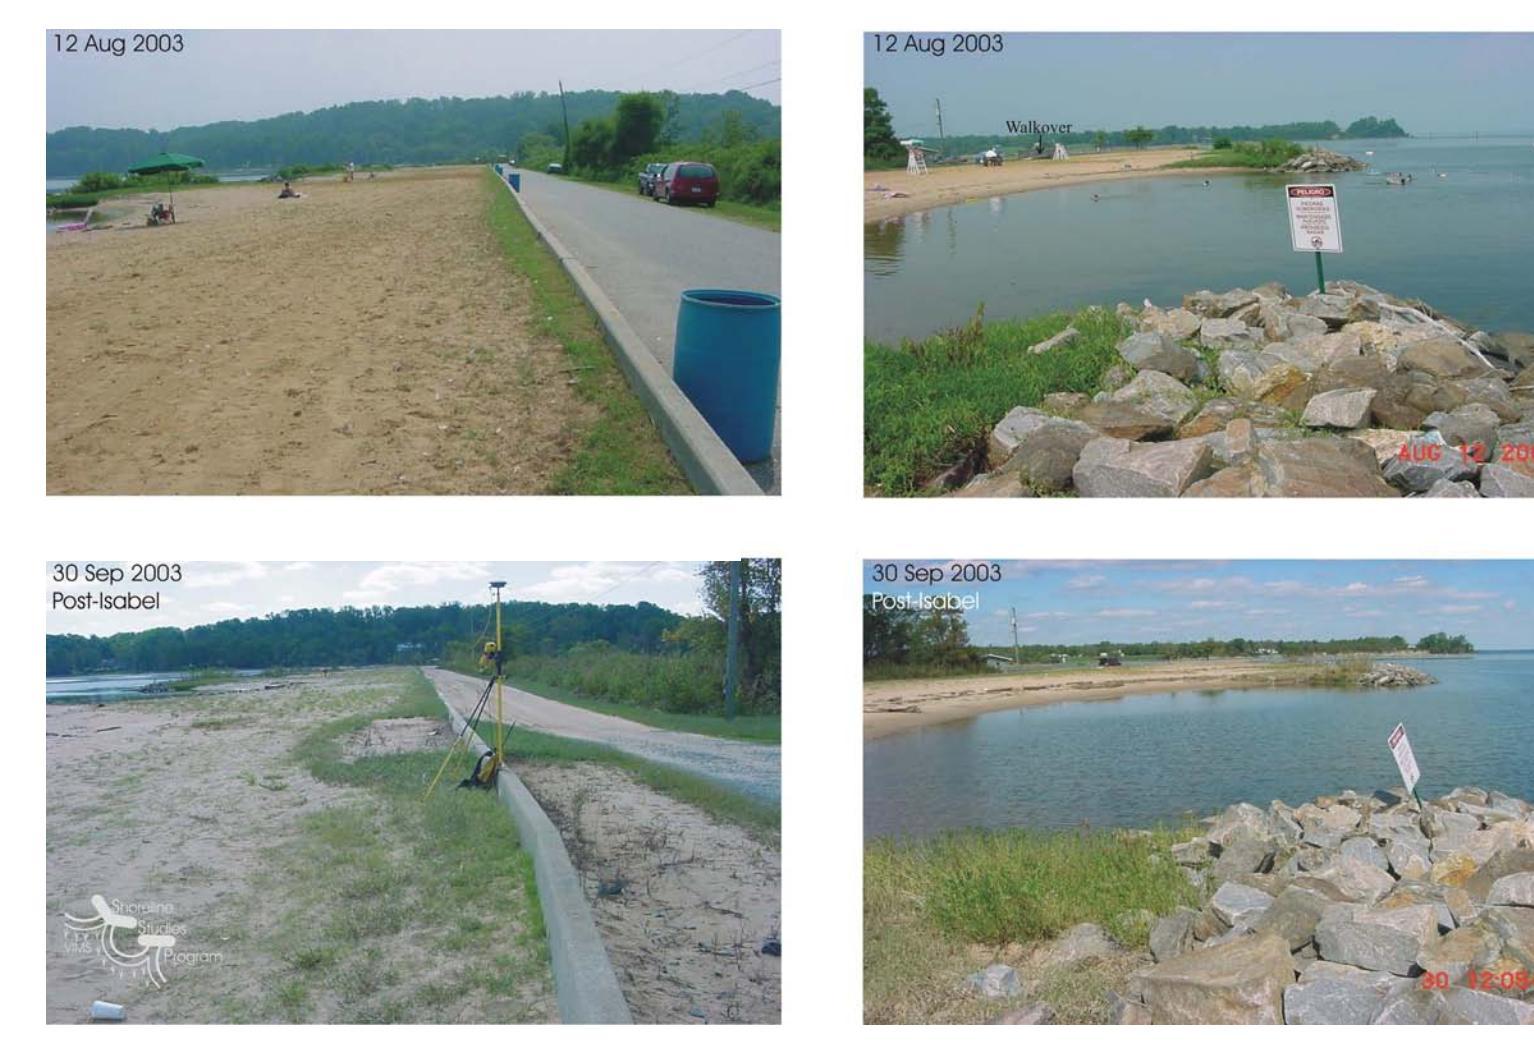
- a. Looking south along Jersey wall and access road
- b. Looking north from BW 2

Figure 17. Aquia Landing ground photographs pre- and post-Hurricane Isabel

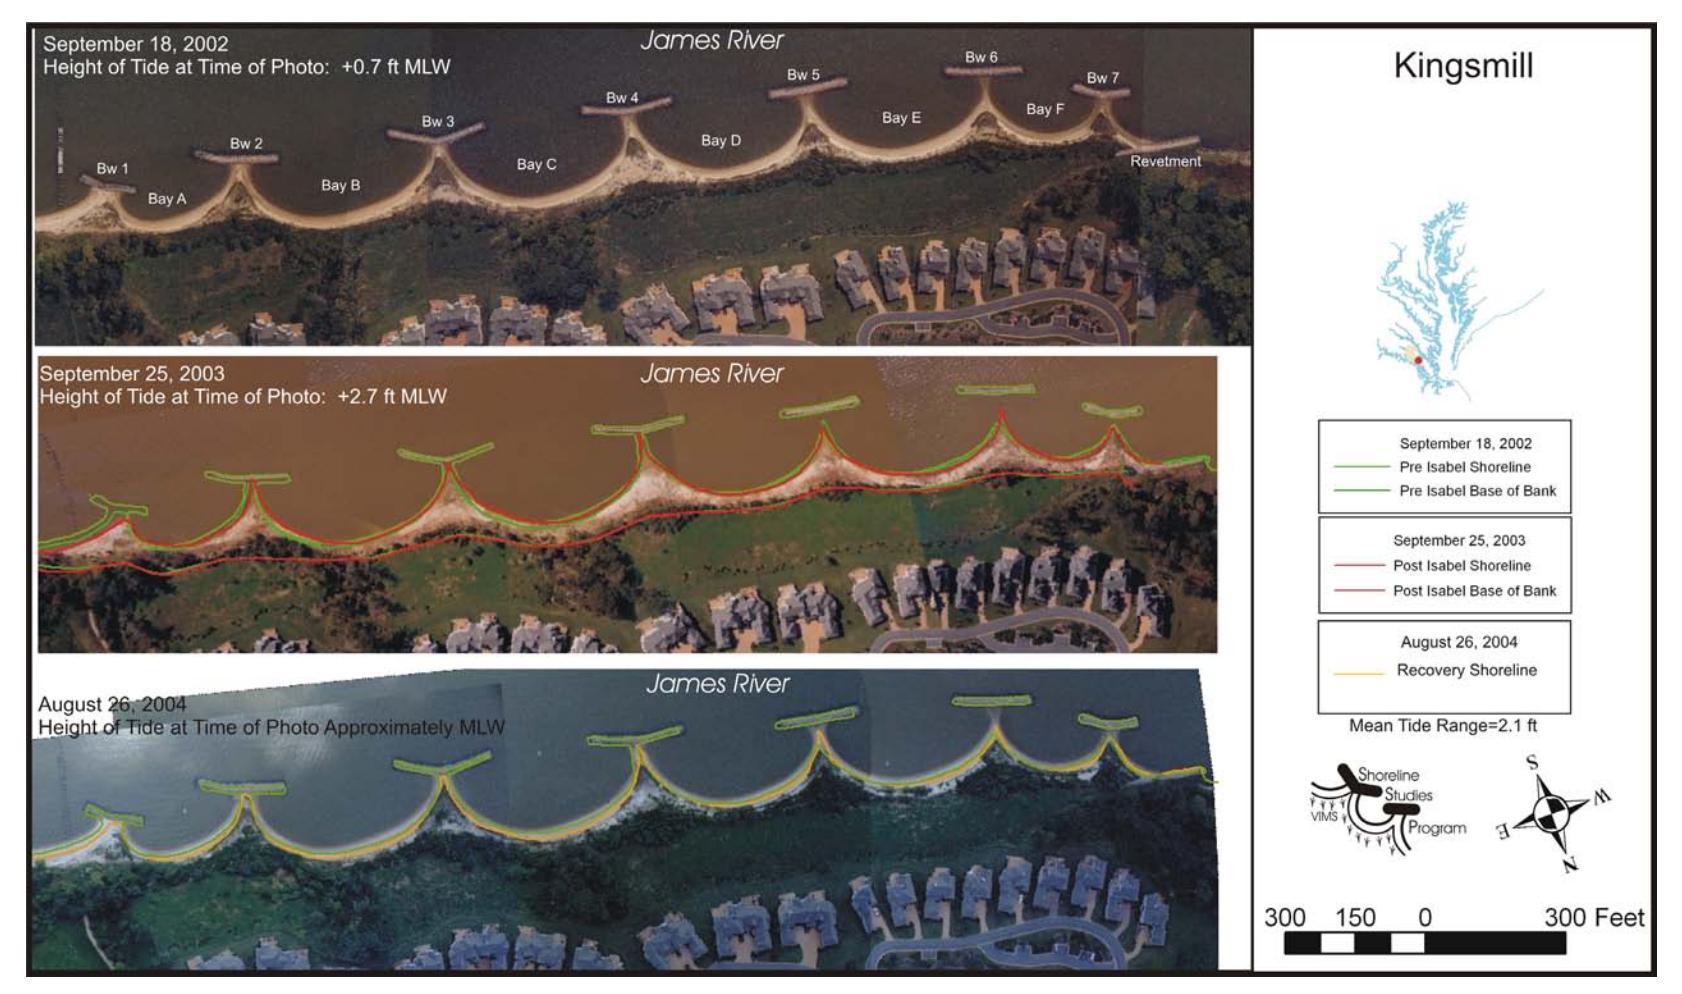
Pre- and post-Isabel aerial imagery of the site show slight changes in shore position (Figure 19). Each tombolo apex had a tendency to shift upriver. Measurable base of bank recession occurred along much of the project, but it was particularly prevalent adjacent to each embayment. These changes are illustrated in the typical bay and breakwater profiles in Figure 20. The combination of storm surge and wave runup limits was measured in the field and are shown for each typical profile at just over el 10. This was a significant event for the site, yet overall damage was minimized by the heavily vegetated backshore/base of bank (Figure 21). Post-Isabel recovery is shown in Figure 19; the beach planforms have returned to approximately their pre-storm positions. Topographic changes along the site between breakwater (BW) 3 and BW7 are shown in Figure 22. The isopach map that indicates a general pattern of reduction in elevation occurred along the beach, backshore, base of bank, and around each breakwater unit. Most increases in elevation were in the nearshore and in small pockets in the lee of each breakwater unit. The most severe scour occurred along the base of the bank (BOB) between BW5 and BW6. However, the damage did not endanger the integrity of the bank face. No slumping or failure was noted or has occurred since. Just upriver, extensive damage (more than \$3 million) occurred at the adjacent marina, which only had a timber pile breakwater for protection.

Figure 19. Kingsmill low-level pre- and post-Hurricane Isabel and recovery ortho-rectified aerial photographs

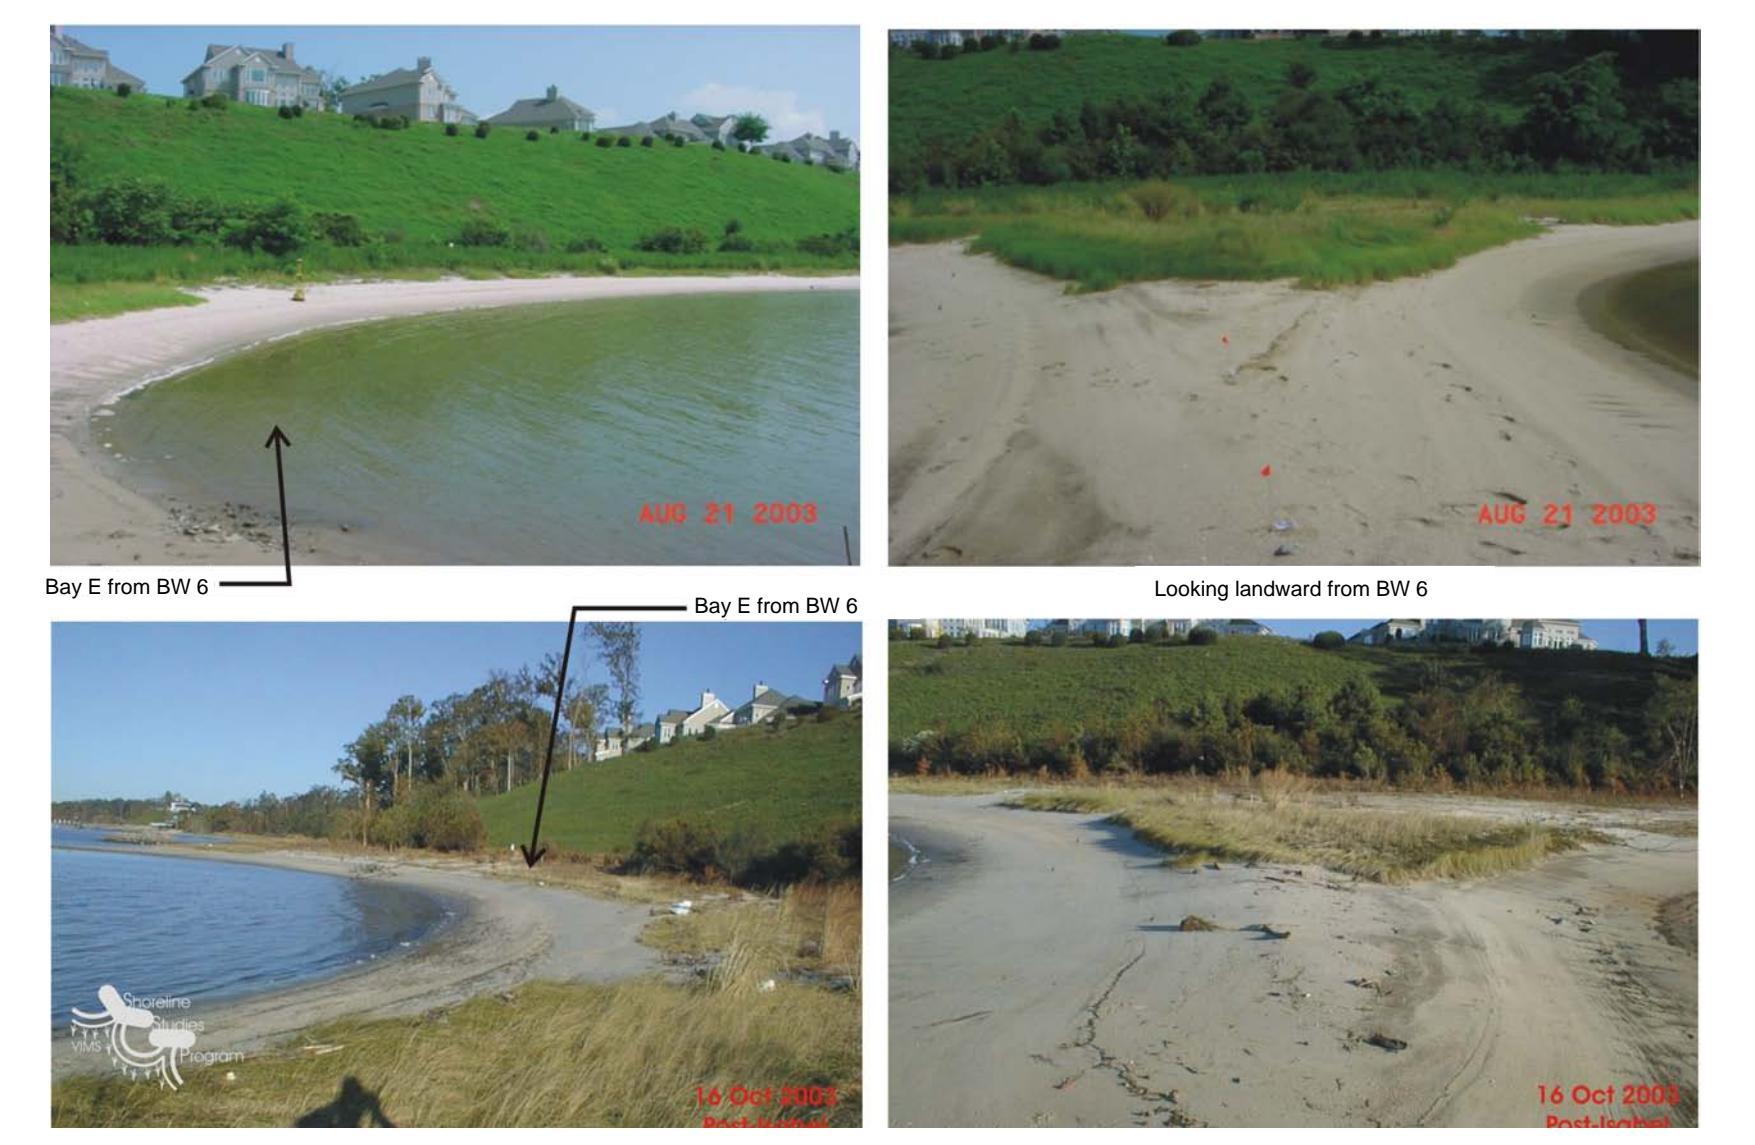
Hurricane Isabel exceeded the design conditions at the site, but it is difficult to accurately quantify its hydrodynamic forces. All of the piers along the shore sustained significant damage, and although the base of the bank was cut along most of the site, no banks failed or incurred significant damage. The banks will be regraded and a wider backshore will provide a larger buffer between the banks and storm waves once the vegetation is restored. No significant alteration in beach planform or loss of sand from the system occurred. The breakwater system is stable.

Figure 21. Kingsmill ground photographs before and after Hurricane Isabel

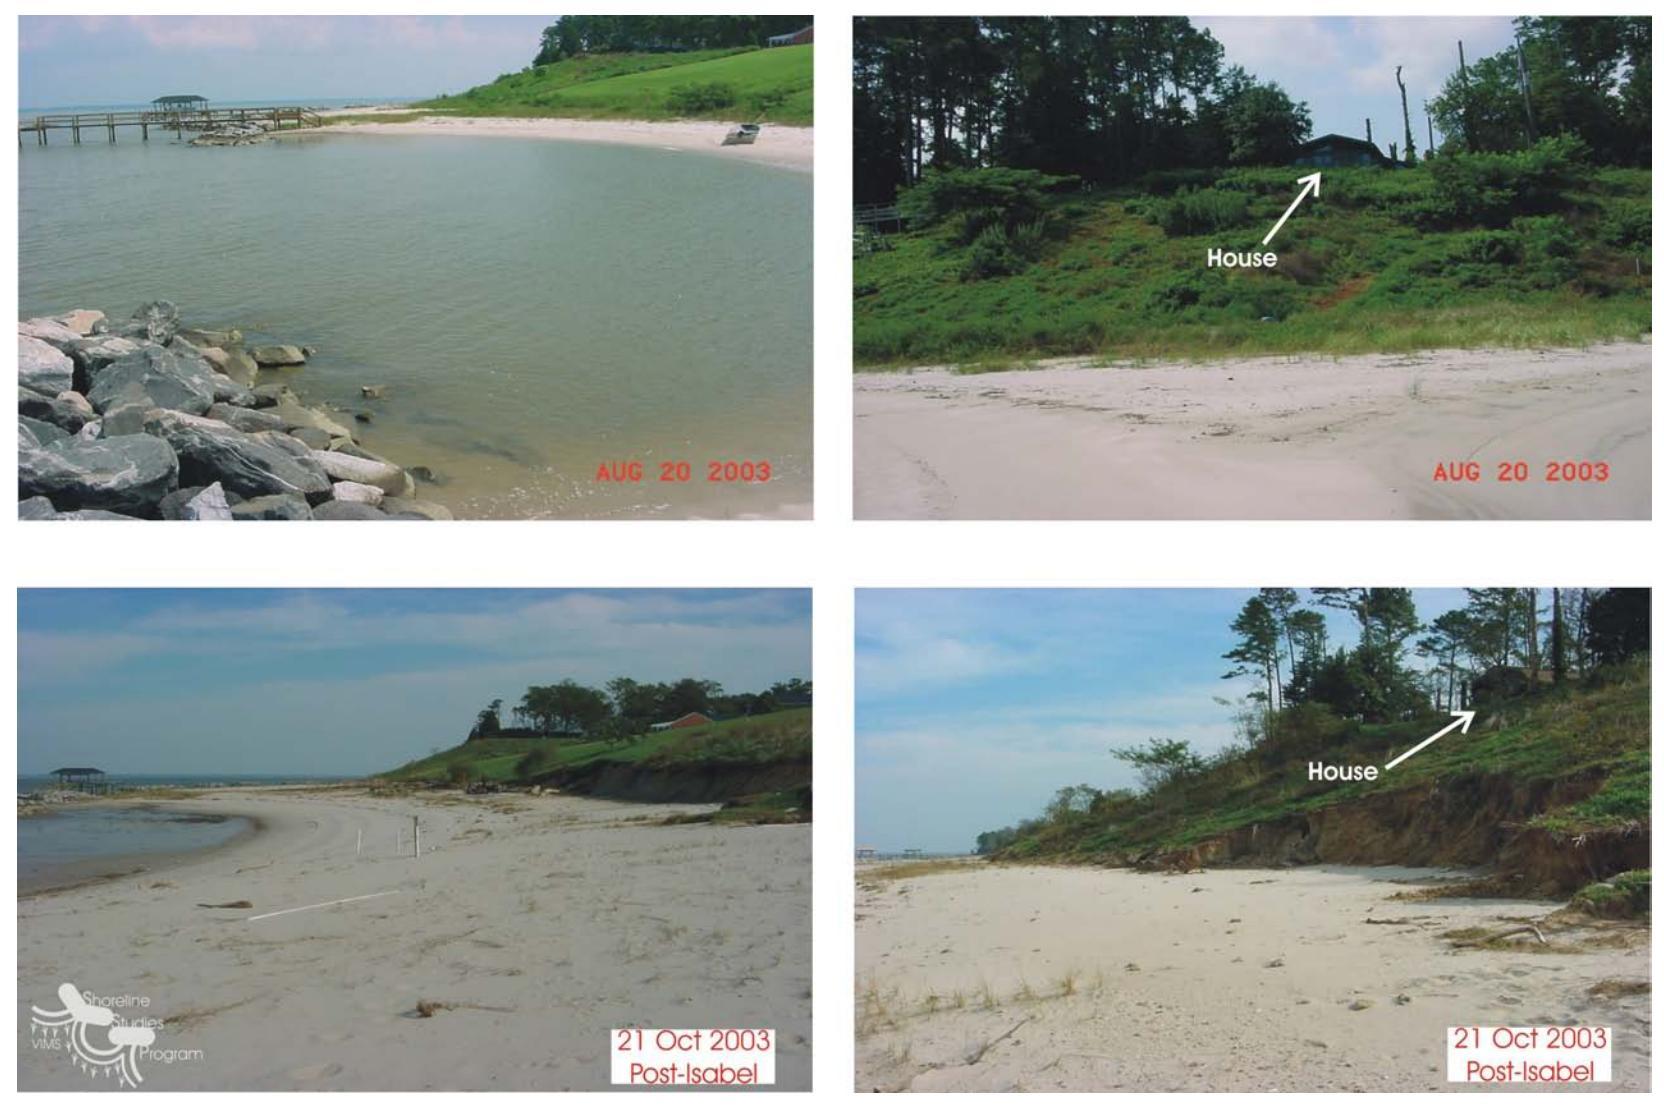
Figure 25. Van Dyke ground photographs before and after Hurricane Isabel

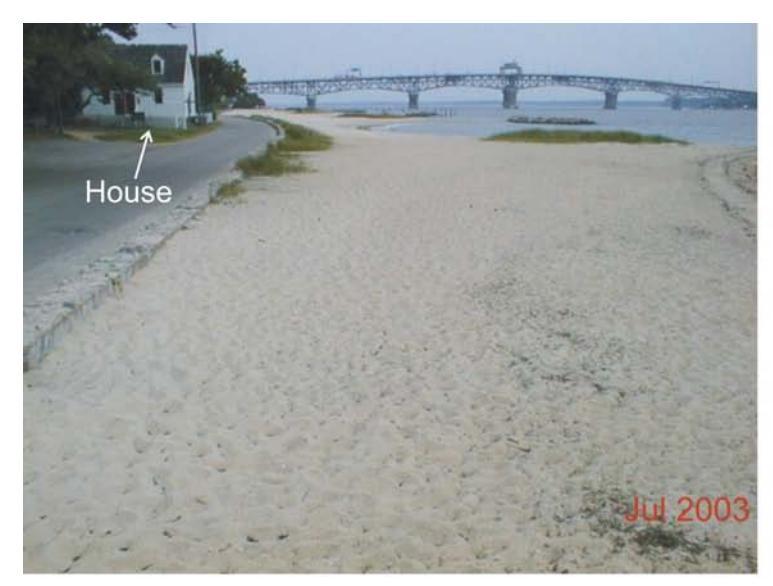
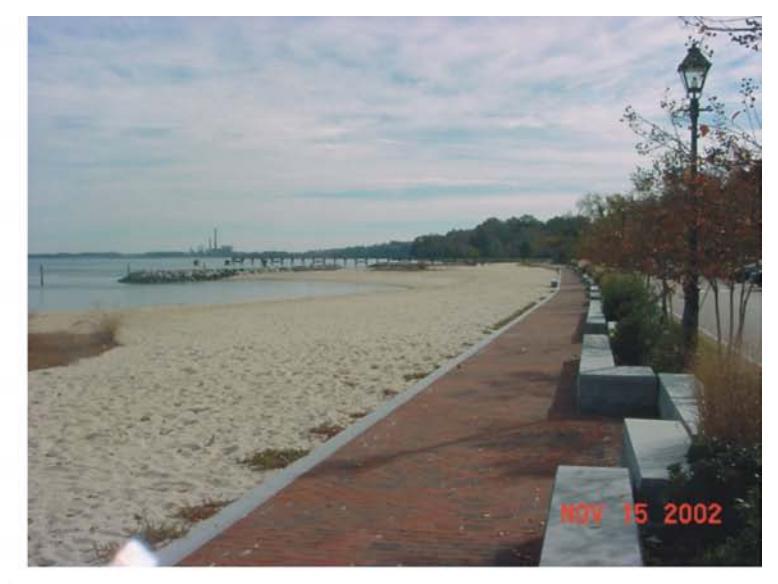
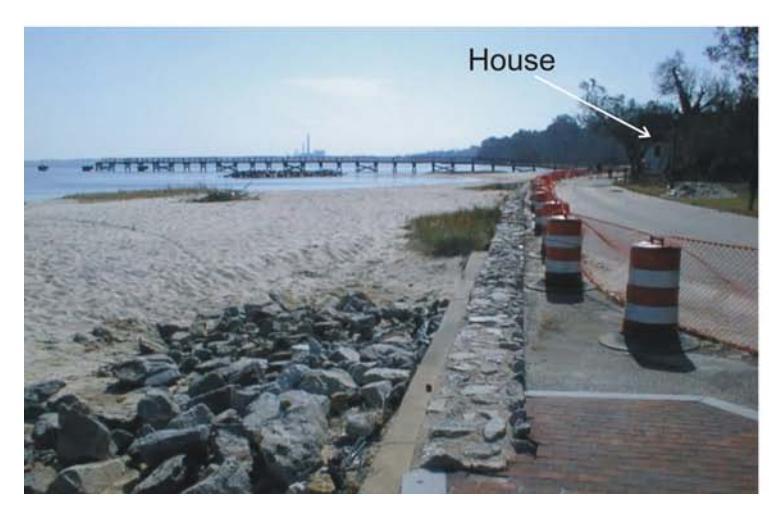
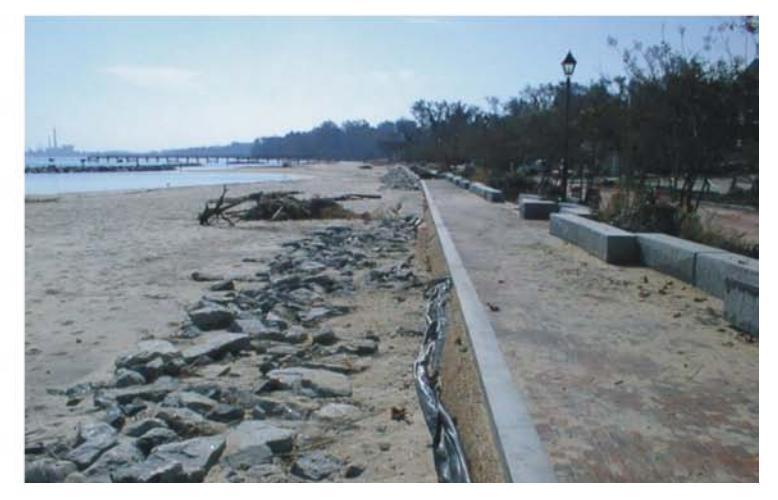
The waterfront at Yorktown was severely damaged by Hurricane Isabel. The low backshore and adjacent low bank allowed the storm surge to inundate the structures protected by the project. However, the wave action was significantly reduced by the public beach's breakwater system, which may have spared the structural integrity of the buildings located along Water Street. This system experienced sand losses and local scour but maintained its overall integrity and performed above expectations; the system was designed for a 50-year event and sustained what many consider a 100-year event in this part of the bay.

Figure 29. Yorktown ground photographs before and after Hurricane Isabel

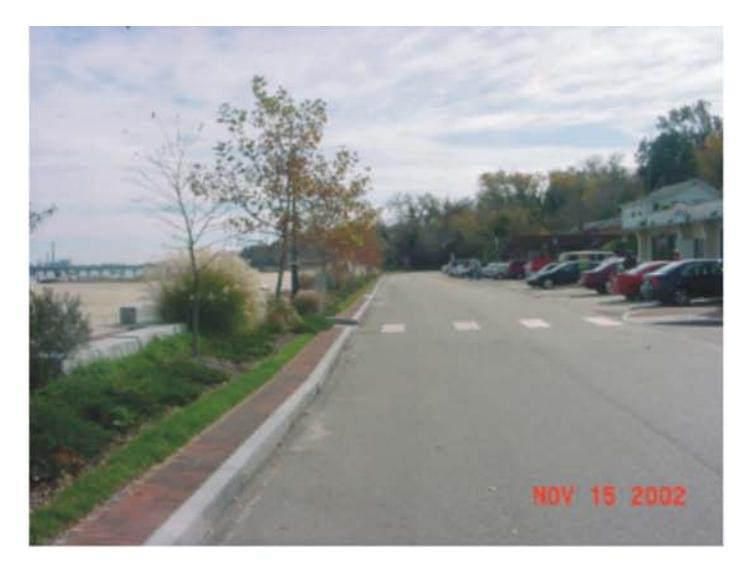
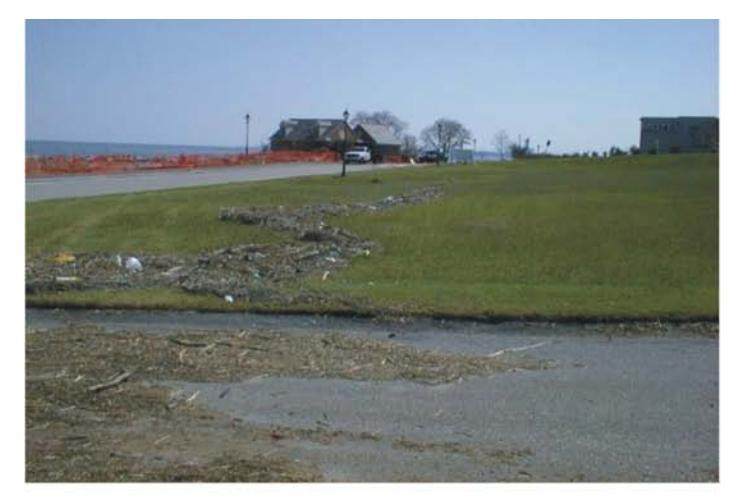
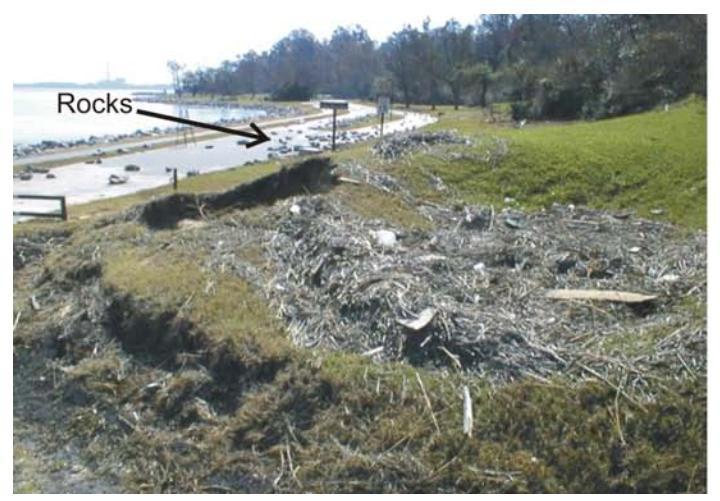
Figure 30. Yorktown

a. Pre-storm low backshore

b. Post-storm wrack line

c. Post-storm wrack line downriver

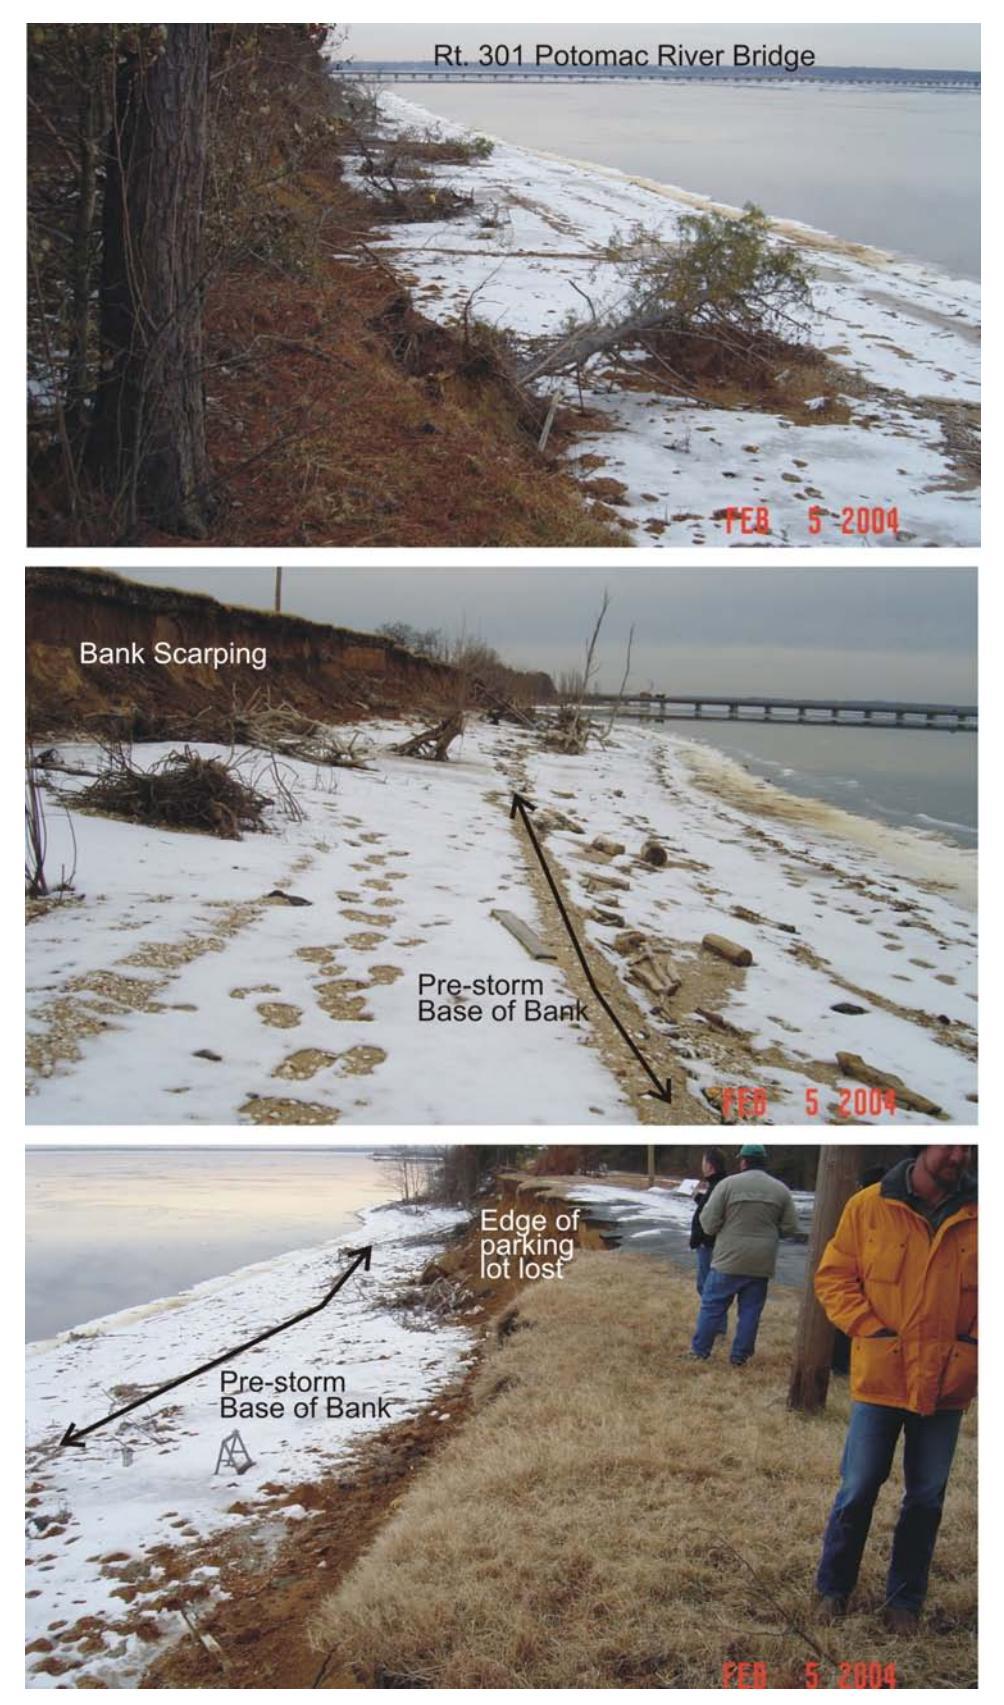
Figure 32. Impacts to unprotected shore at Dahlgren due to Hurricane Isabel

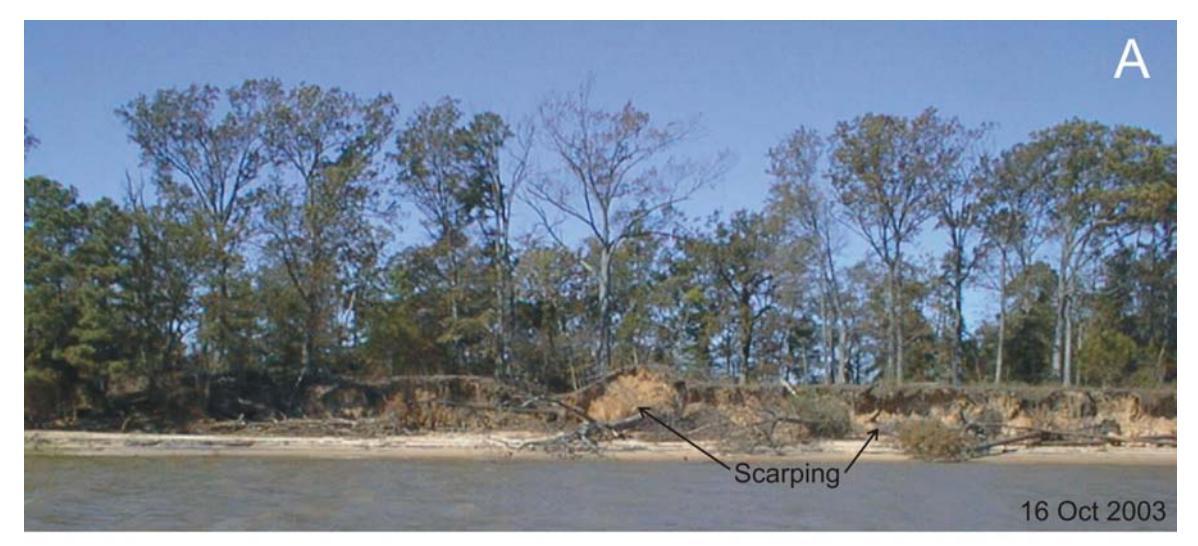
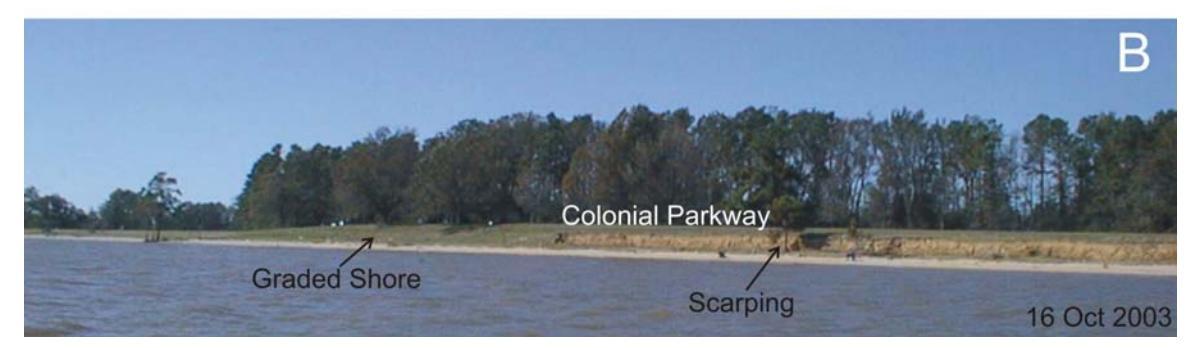
a. At Confederate Fort

b. Along Colonial Parkway

Figure 34. Impact to unprotected shores on James River due to Hurricane Isabel

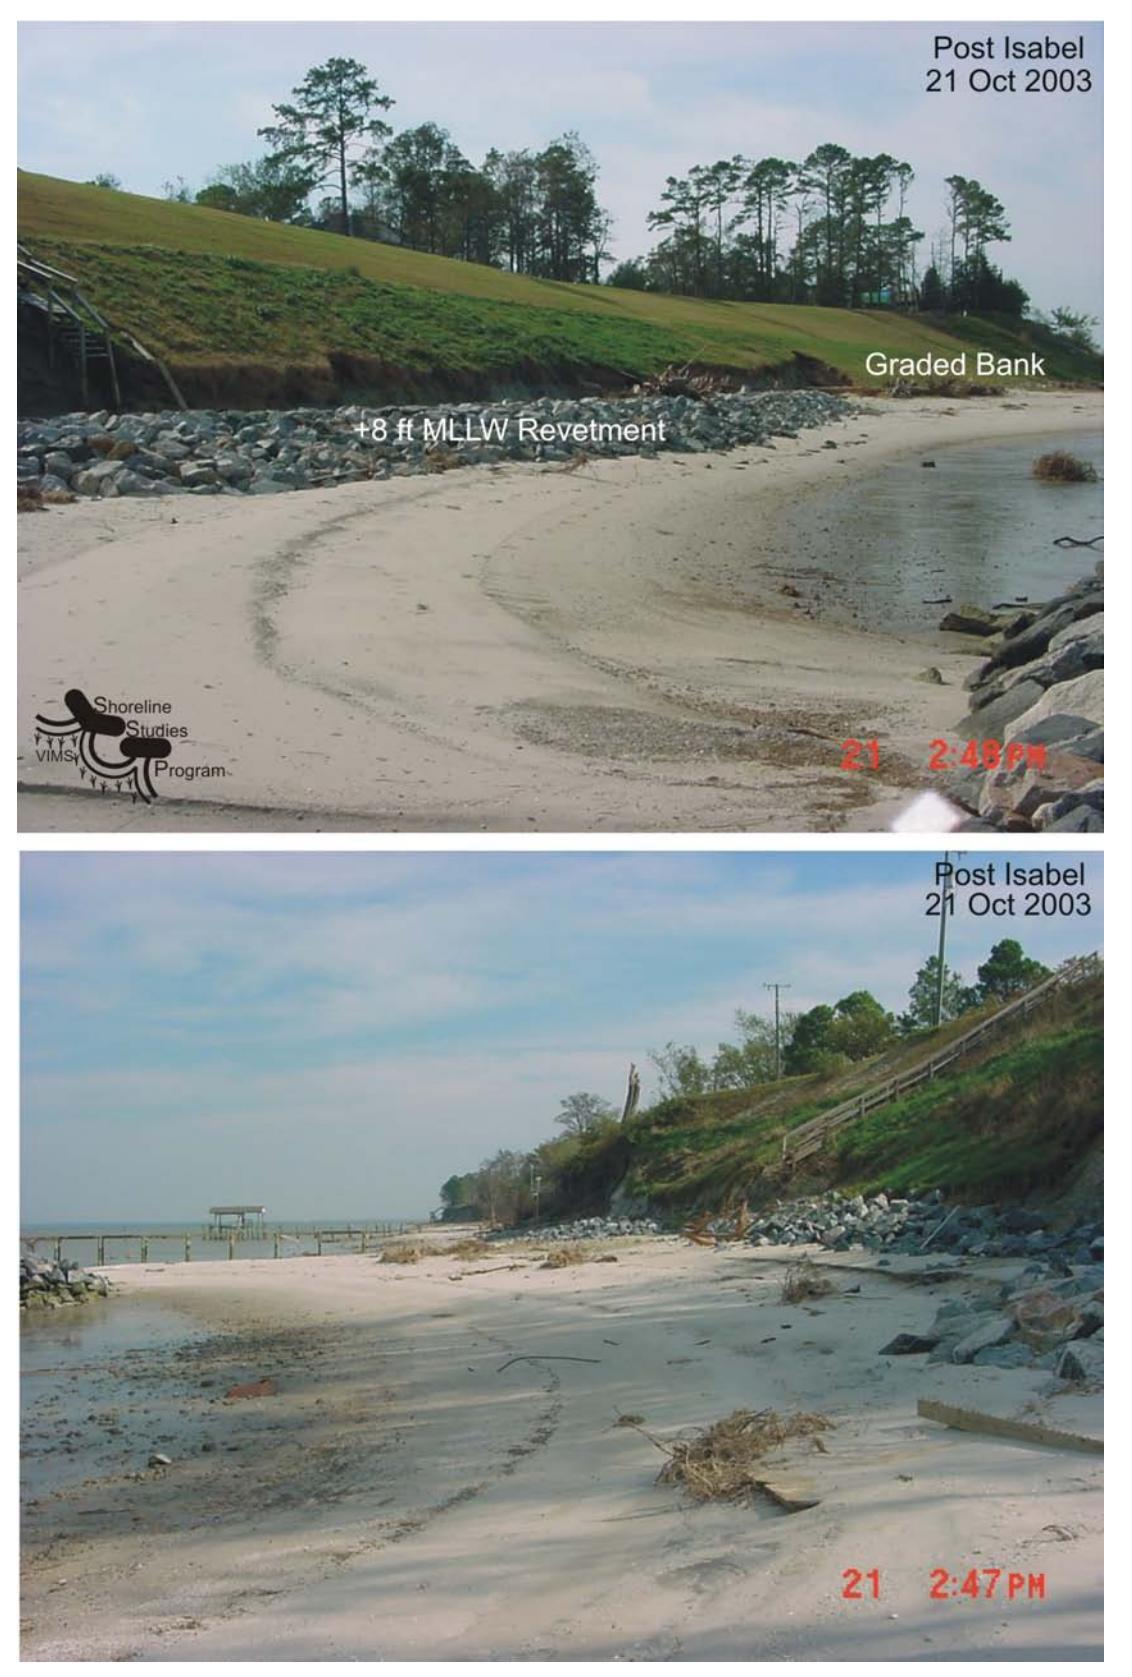
Figure 35. Impacts at downriver end of Van Dyke where shore is protected by a revetment

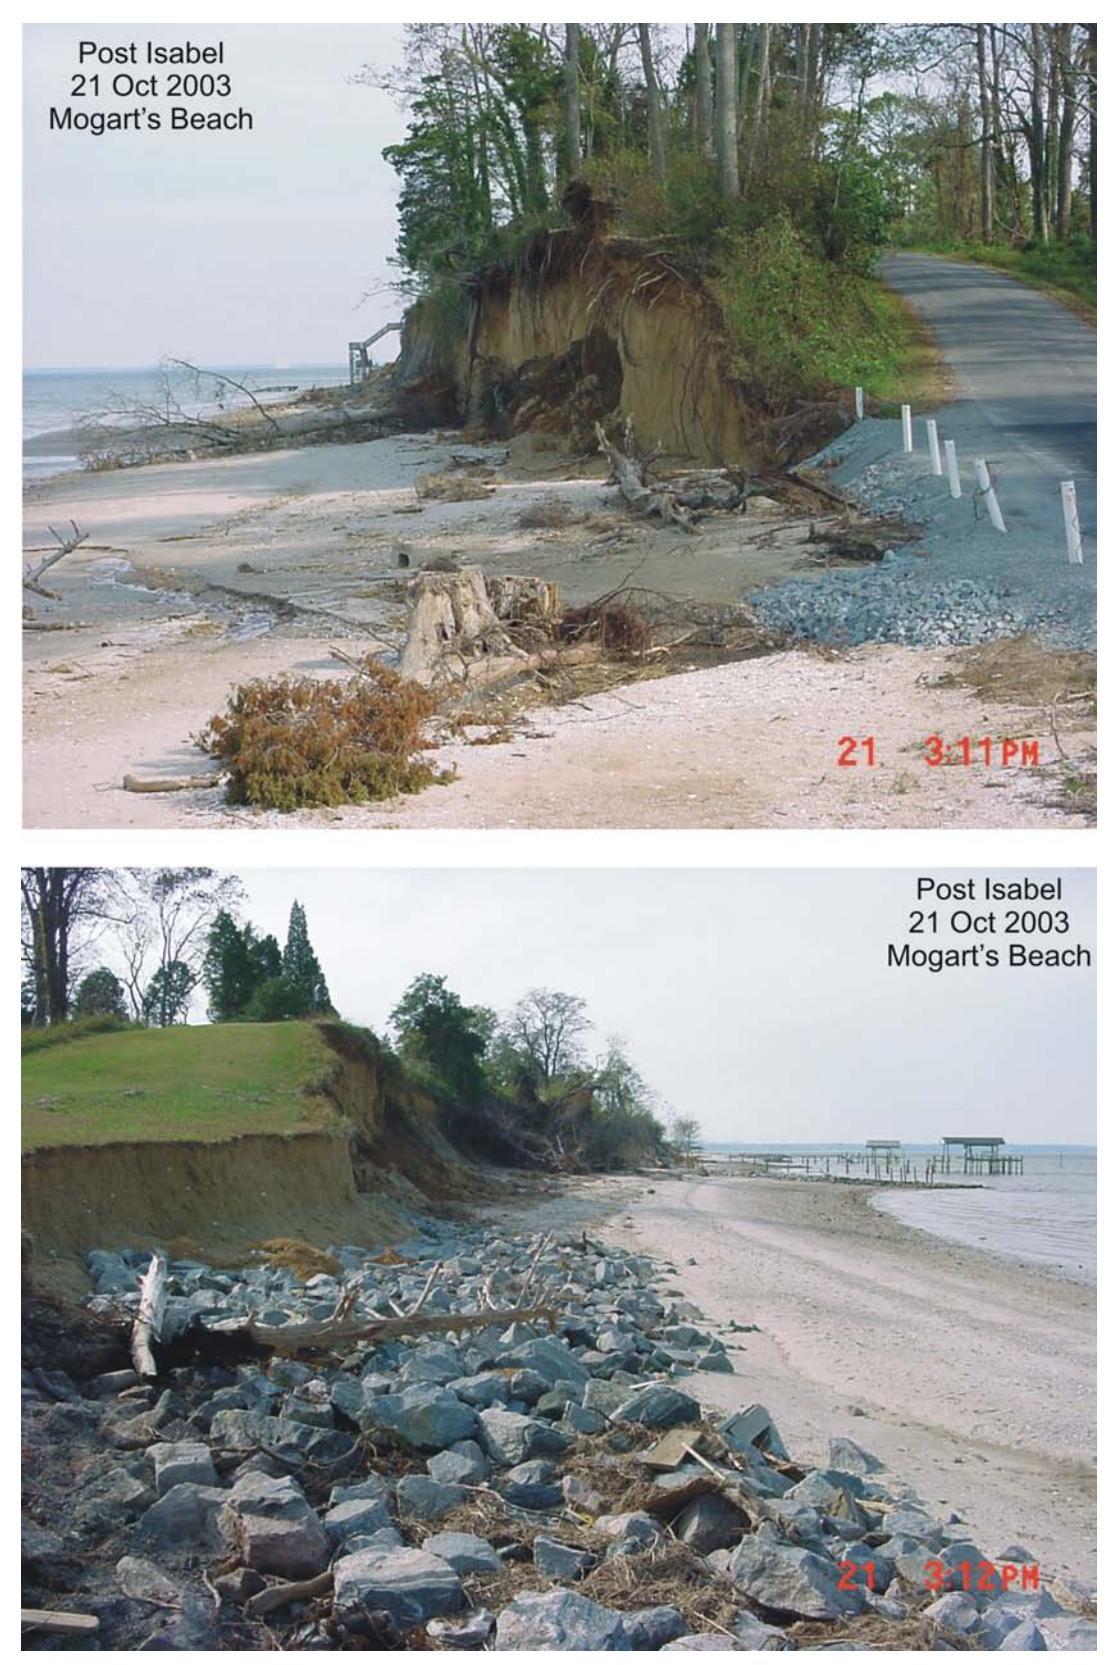
Figure 36. Impacts to shore downriver from Van Dyke at Mogarats Beach

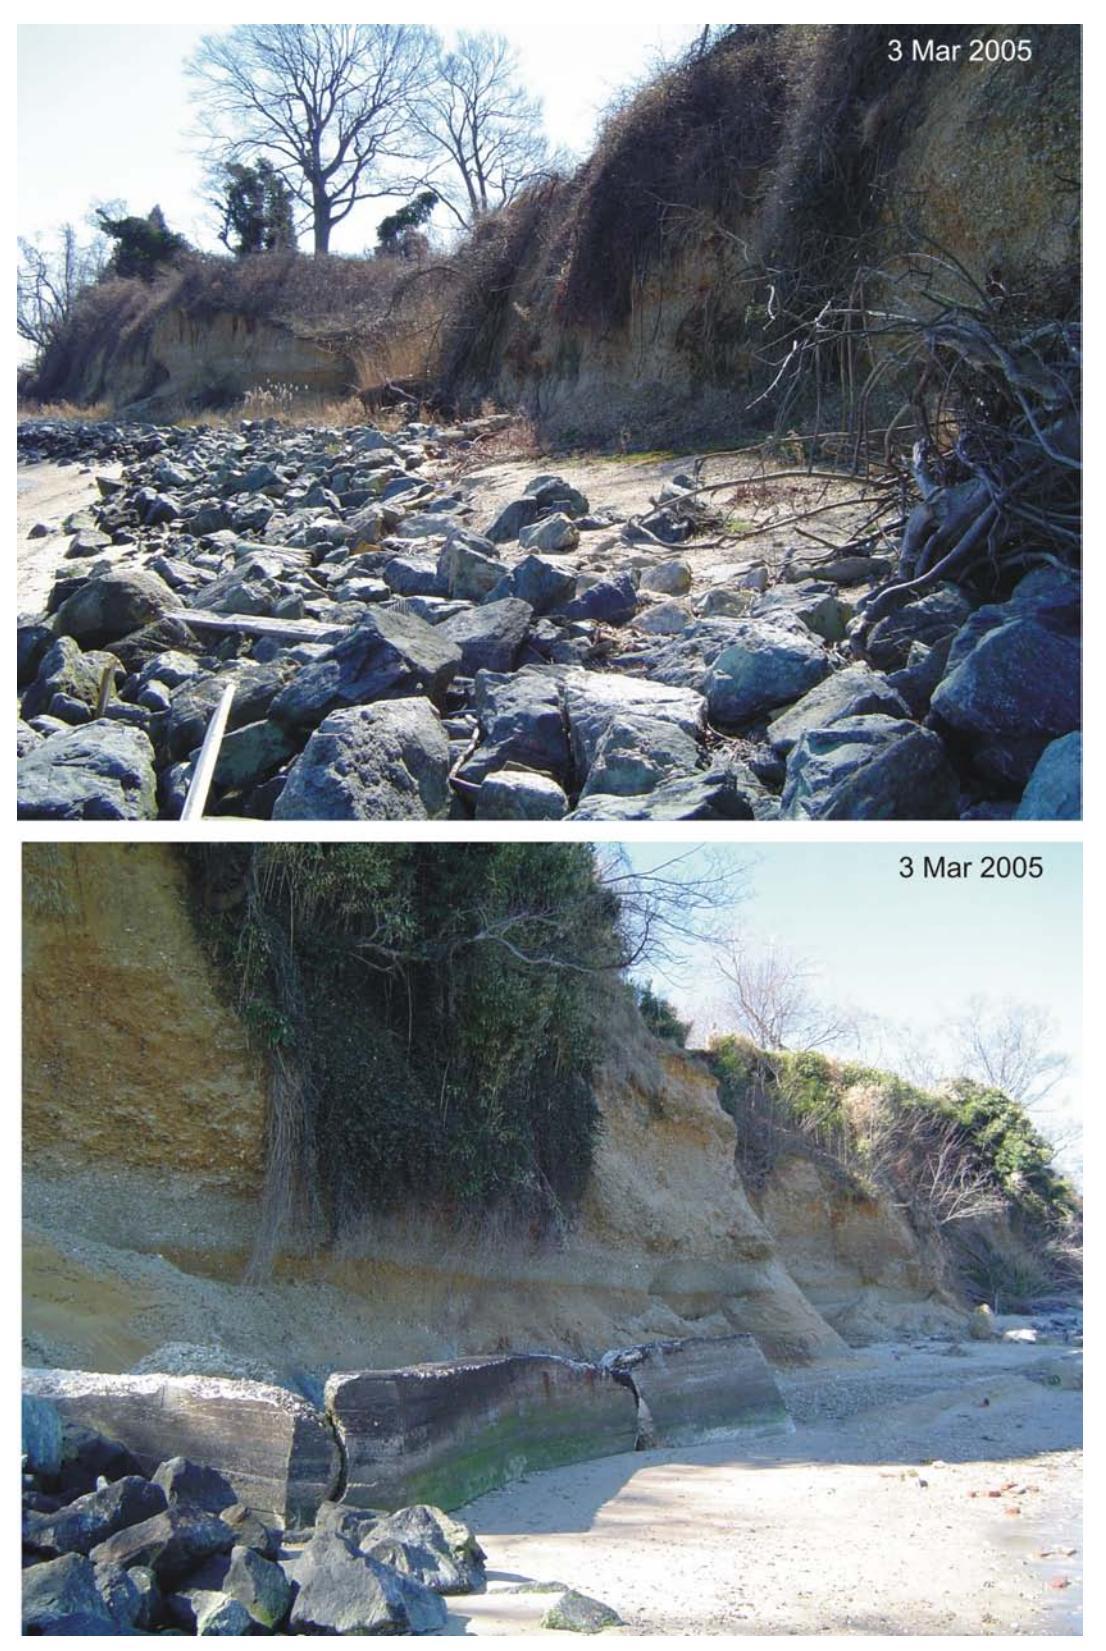
Figure 37. Impacts to shoreline downriver from Yorktown Beach at National Park Service's Moore's House
