**US Army Corps
of Engineers®**
Engineer Research and
Development Center

ERDC
INNOVATIVE SOLUTIONS
for a safer, better world

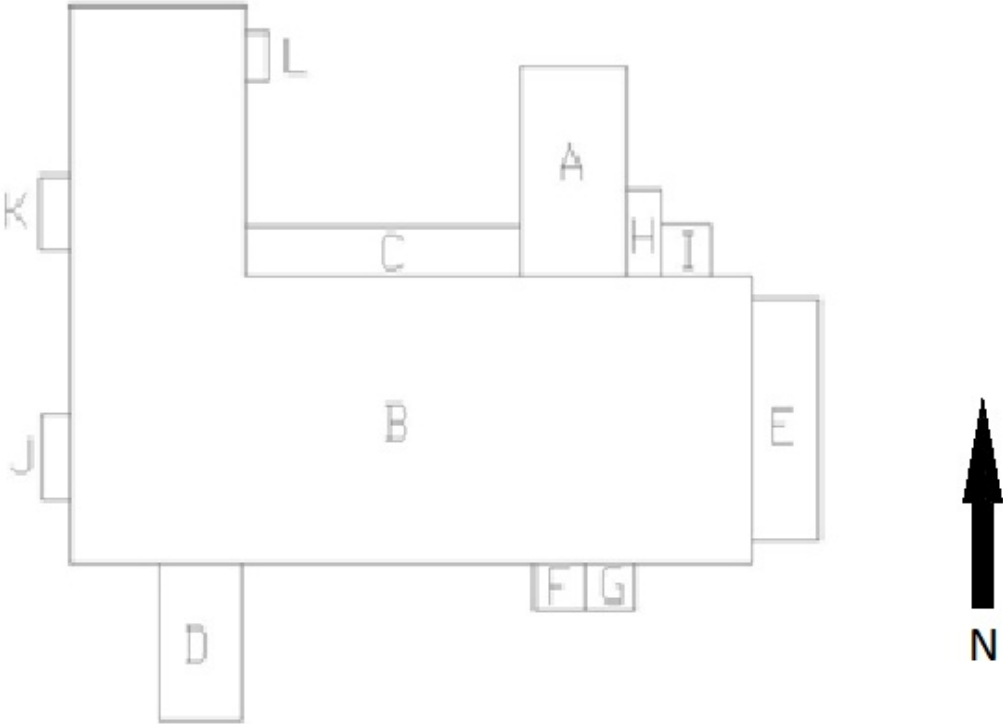
BUILDING ROOF PLAN		SCALE:

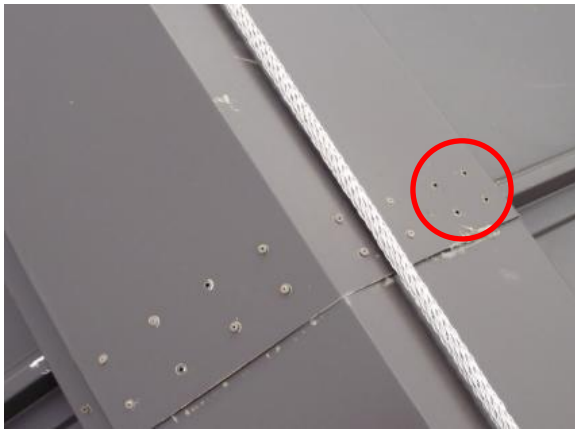
FF-H-1: Fastener or flexible gasket (where one was originally installed) is loose, deteriorated or missing and is allowing water to penetrate the roofing system; or fastener has an enlarged hole that is allowing water to penetrate the roofing system.

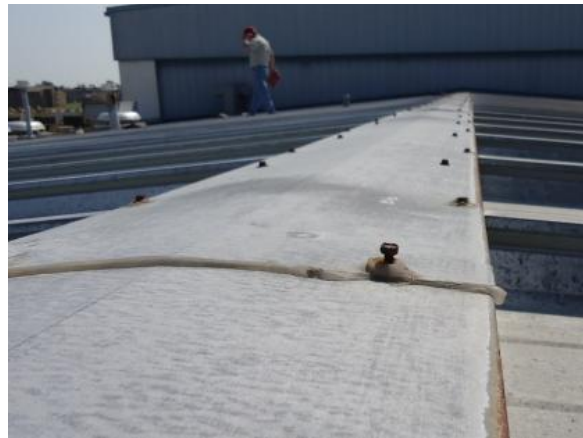
FF-H-1: Fastener or flexible gasket (where one was originally installed) is loose, deteriorated or missing and is allowing water to penetrate the roofing system; or fastener has an enlarged hole that is allowing water to penetrate the roofing system.

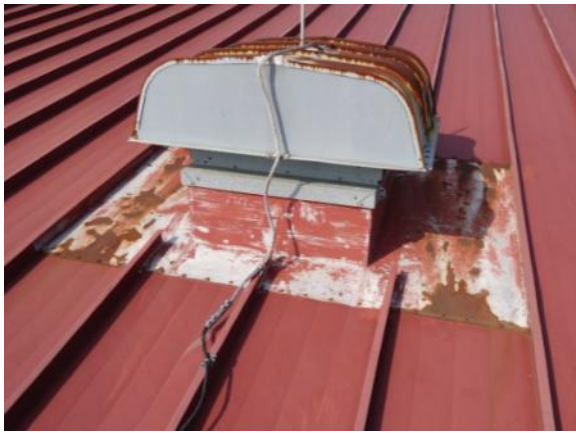
FD-M-1: Flashing has localized loss of applied finish or localized metal corrosion.

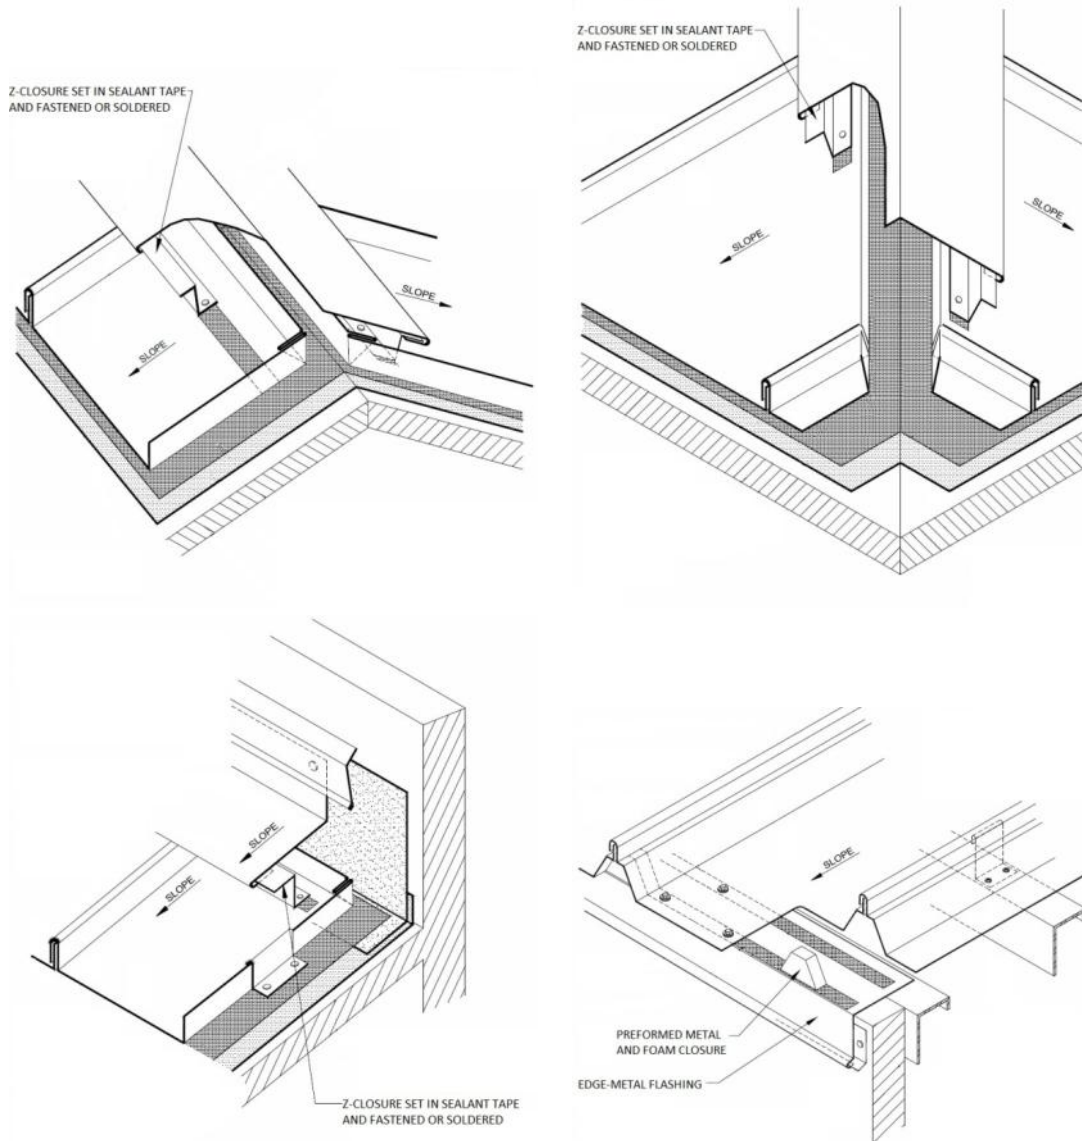
Panel closure details (source: NRCA).

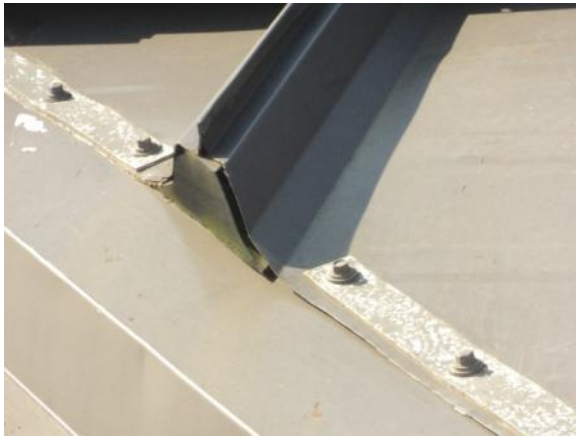
PC-M-1: Panel closure is misaligned but appears to be watertight.

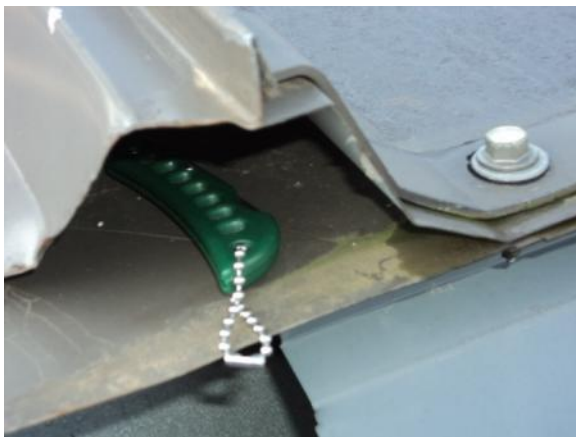
PC-H-1: Non-metal panel closure is deformed, misaligned, damaged or missing; allowing water to penetrate the roofing system.

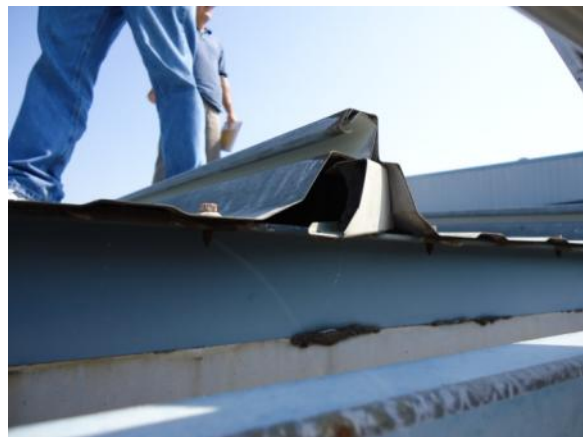
PC-H-1: Non-metal panel closure is deformed, misaligned, damaged or missing; allowing water to penetrate the roofing system.

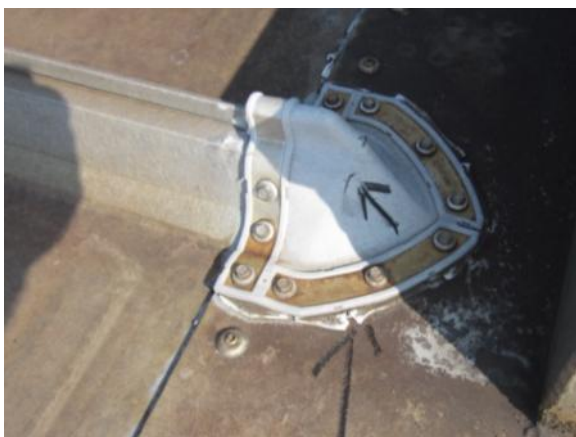
PC-H-2: Metal panel closure is deformed, misaligned, or missing; allowing water to penetrate the system.

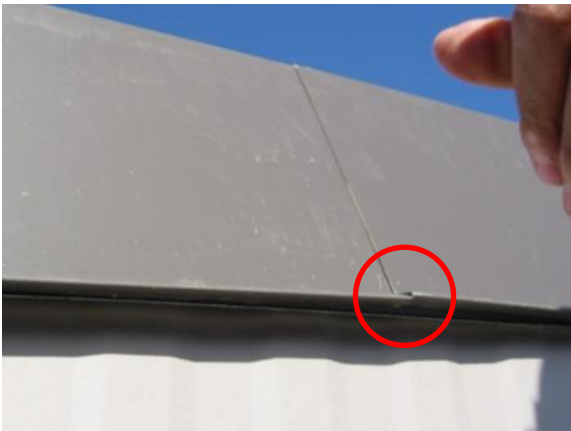
EA-H-3: Cleated eave flashing is displaced or disengaged.

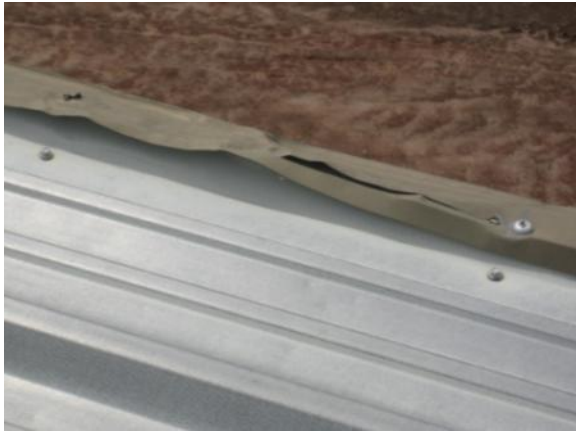
RE-H-1: Rake flashing has holes.

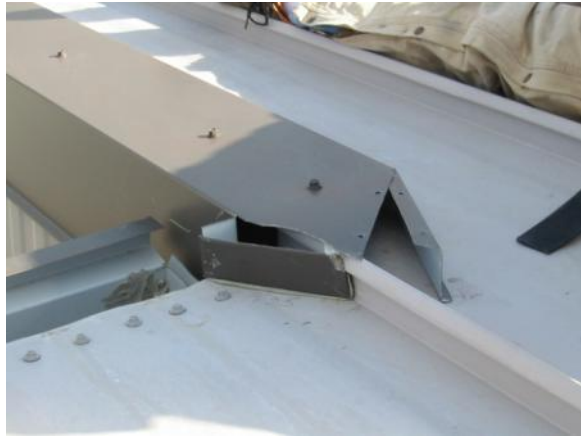
RE-H-2: Rake flashing is loose, displaced, or missing, allowing water to penetrate the roofing system and/or compromising panel securement.

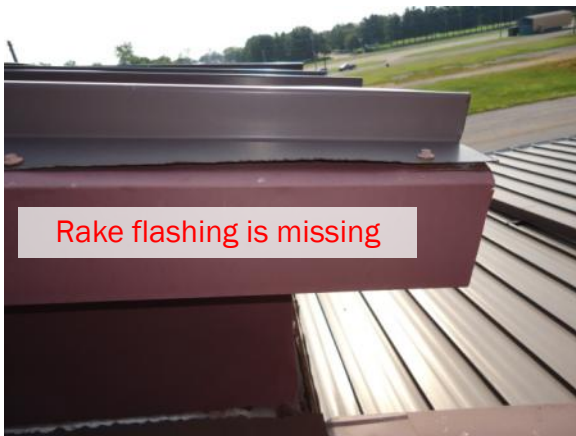
RE-H-2: Rake flashing is loose, displaced or missing, allowing water to penetrate the roofing system and/or compromising panel securement.

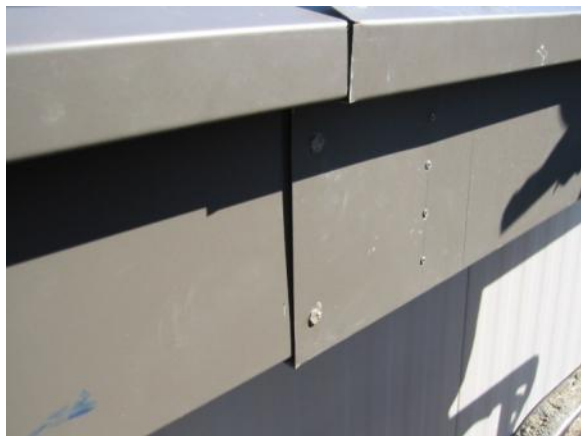
RE-H-4: Rake flashing has open joint or butt joints.

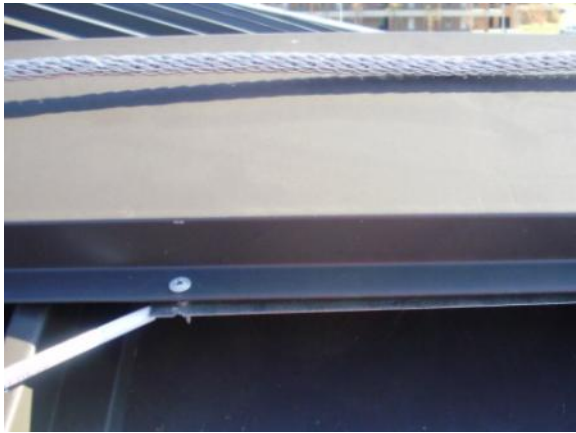
CP-M-1: Ridge or hip cap flashing is disengaged but appears to be watertight.

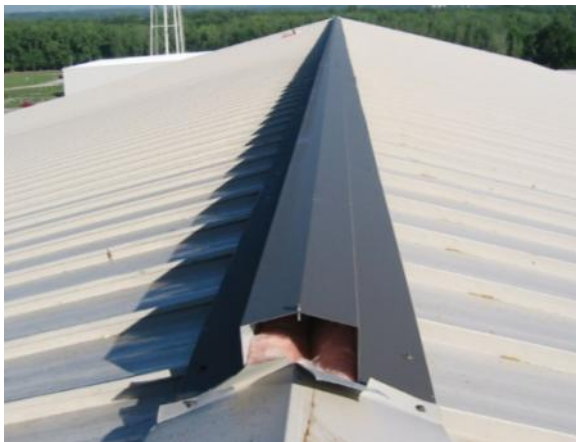
CP-H-3: Ridge or hip cap flashing is missing.

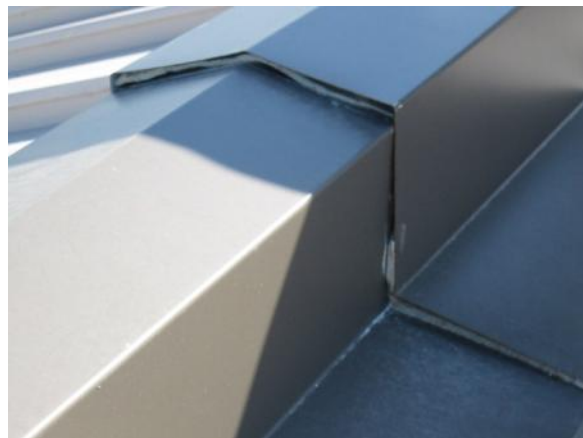
CP-H-5: Ridge or hip cap flashing has open joint or butt joints.

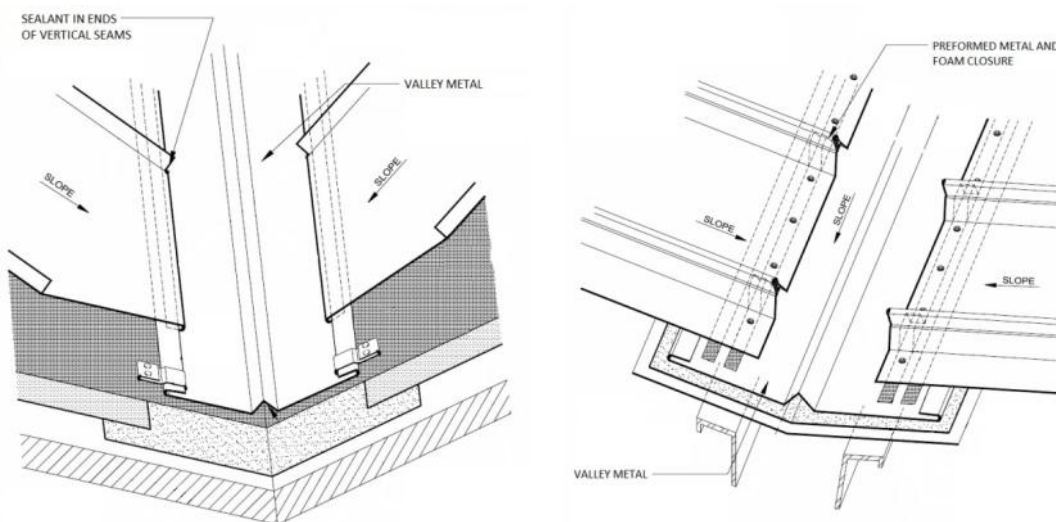
Valley flashing details (source: NRCA).

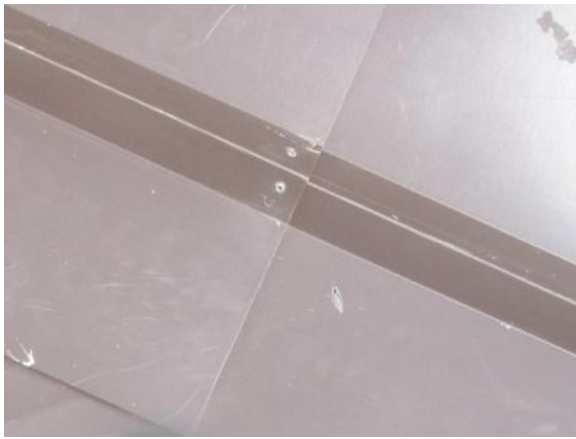
VF-L-1: Valley flashing fastener is located in the valley but appears to be watertight.

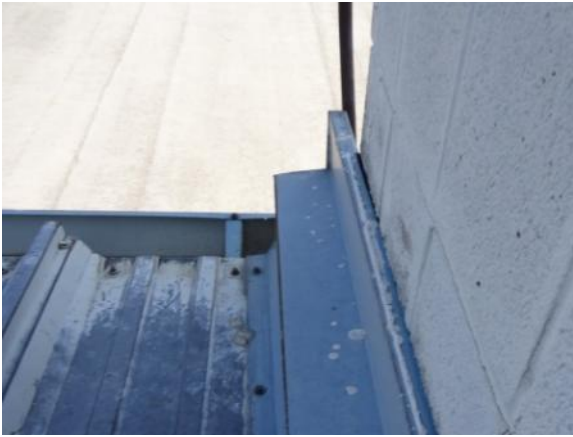
ST-H-2: Transition flashing is disengaged or loose and is allowing water to penetrate the roofing system.

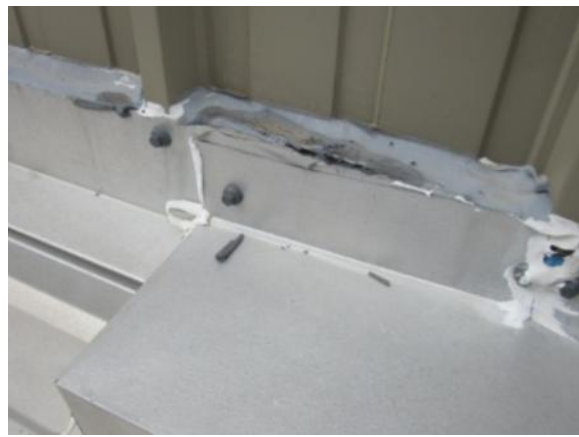
ST-H-3: Transition flashing has open joints or butt joints, or joints that are bucking water.

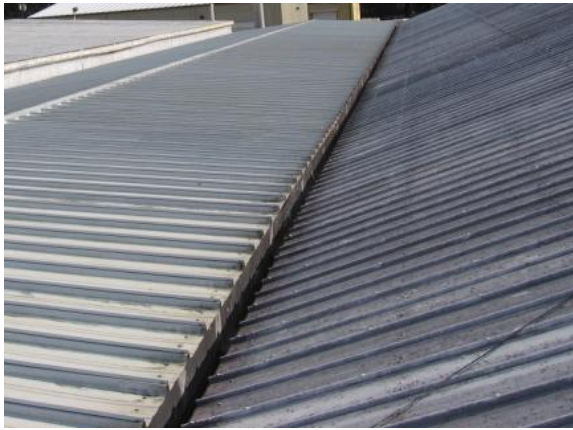
IG-L-1: Interior gutter is lined with elastomeric membrane or coating and appears to be watertight.

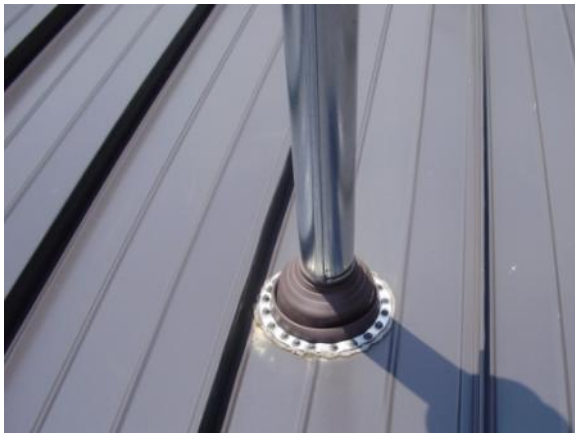
FB-L-1: Flexible boot flashings are rated low-severity as a minimum due to inherent maintenance problems.

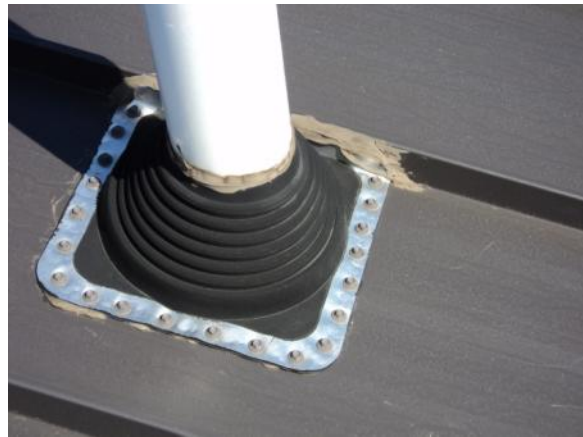
FB-M-1: Flexible boot flashing has loose, missing, corroded or misaligned draw band.

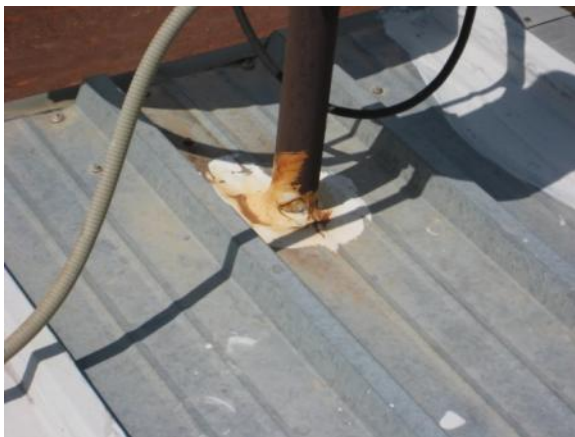
FB-H-1: Flexible boot is missing or has holes; or flexible boot flashing interferes with a panel seam and is allowing water to penetrate the system.

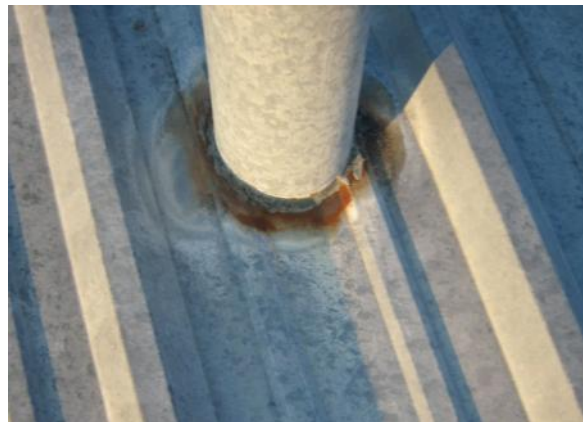
FB-H-1: Flexible boot is missing or has holes; or flexible boot flashing interferes with a panel seam and is allowing water to penetrate the system.

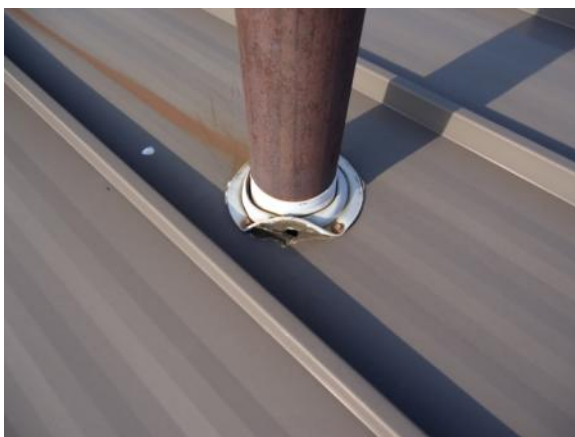
FB-H-2: Flexible boot flashing has deformed securement ring, allowing water to penetrate the roofing system.

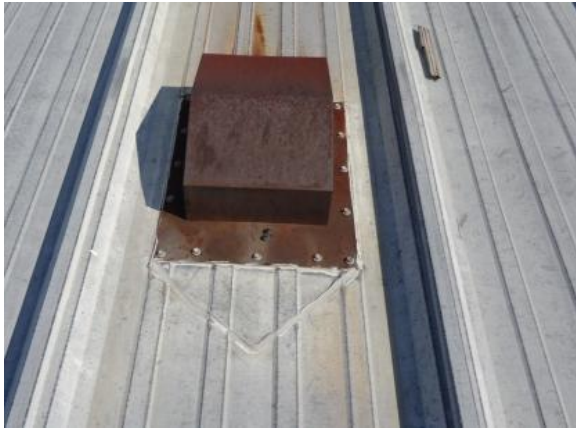
FM-M-1: Flashing flange on upslope side is mounted on top of panel, bucking water, but appears to be water-tight.

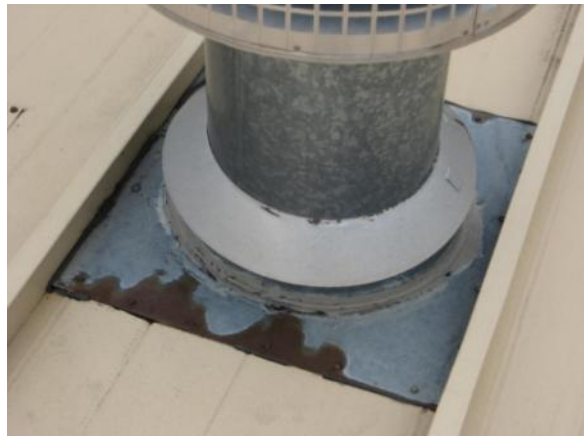
FM-H-9: Sealant around umbrella is missing or is allowing water to penetrate the roofing system.

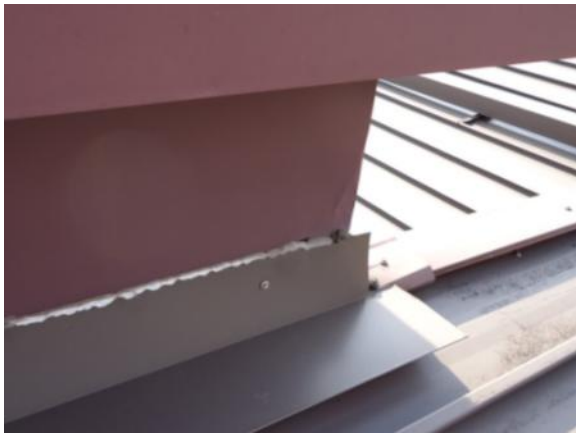
AF-H-6: Sealant at reglet, top of counterflashing, or sealed joint is missing or no longer functioning.

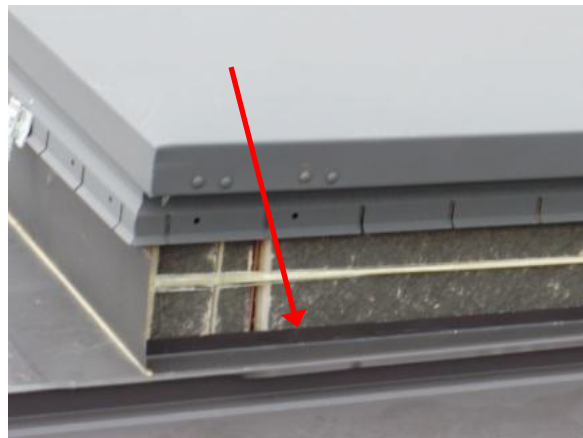
AF-H-9: Top of transition flashing is not properly counterflashed or terminated.

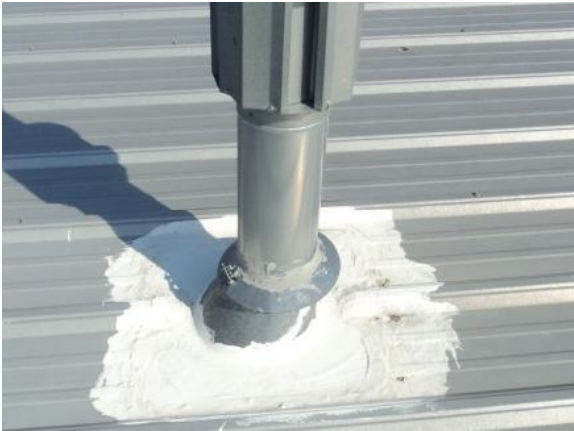
FR-L-1: Flashing patch appears to be performing a waterproofing function and appears to be watertight and does not require a more permanent repair.

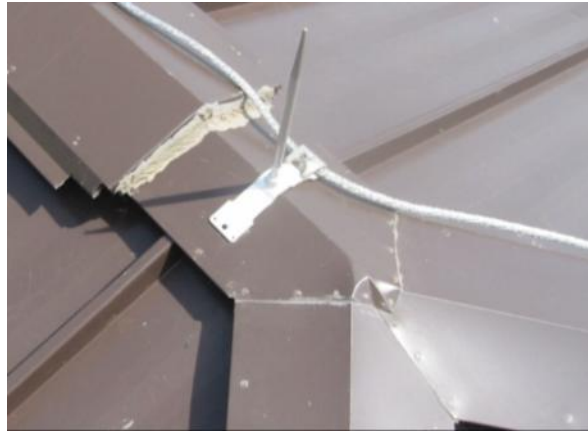
FR-M-1: Flashing patch, which appears to be performing a waterproofing function, appears to be watertight but requires a more permanent repair.

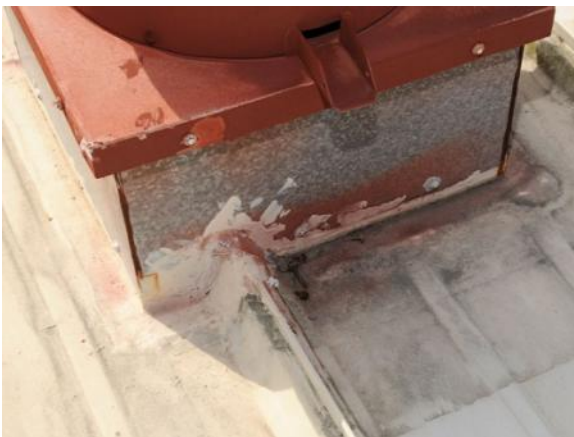
FR-M-1: Flashing patch, which appears to be performing a waterproofing function, appears to be watertight but requires a more permanent repair.

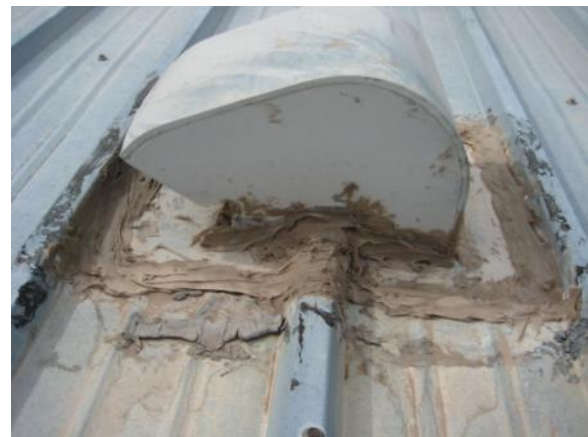
FR-M-1: Flashing patch, which appears to be performing a waterproofing function, appears to be watertight but requires a more permanent repair.

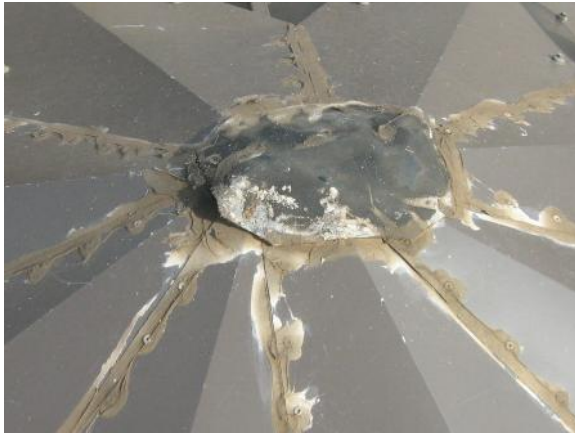
FR-H-1: Flashing patch is allowing water to penetrate the roofing system.

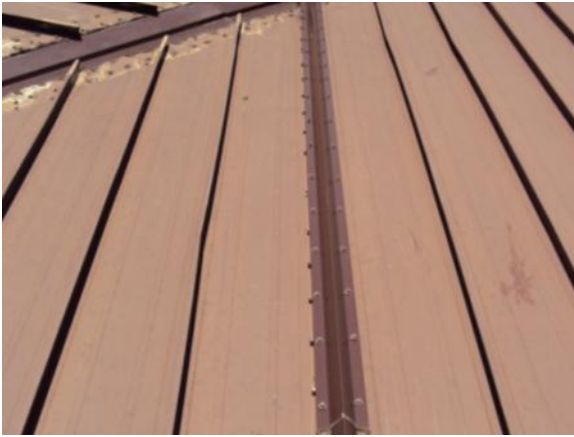
SW-L-1: Applied finish exhibits chalking, fading, or scratching over the entire roof section, but underlying corrosion is not apparent.

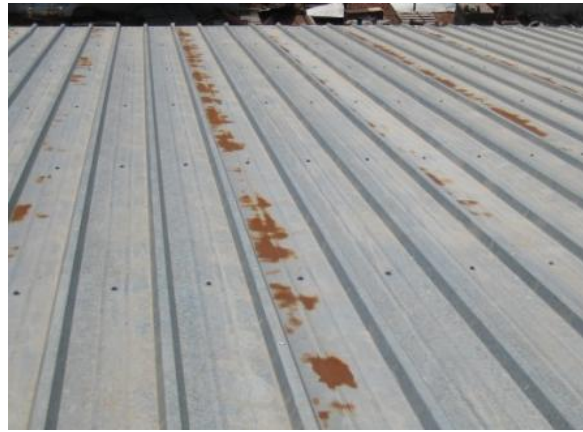
SW-M-1: Base metal or applied finish exhibits chalking, fading, or scratching over the entire roof section, requiring a coating or surface treatment repair.

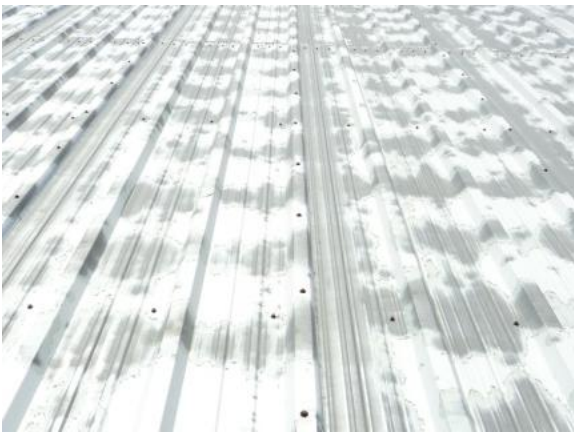
SW-M-1: Base metal or applied finish exhibits chalking, fading, or scratching over the entire roof section, requiring a coating or surface treatment repair.

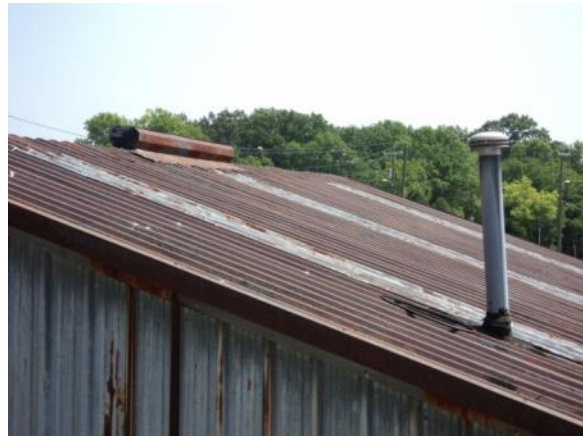
SW-H-1: Base metal exhibits corrosion over the entire roof section requiring a roof replacement.

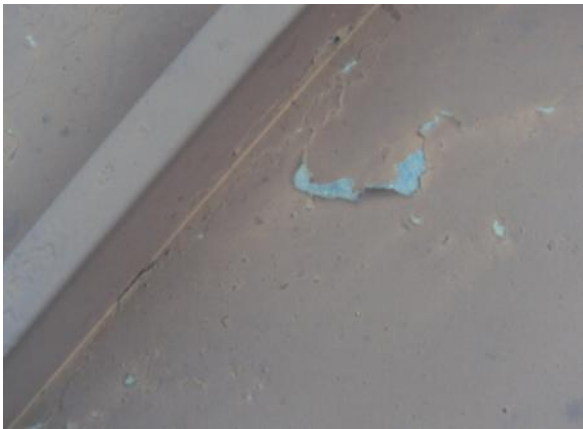
SD-M-1: Localized loss of applied finish or localized metal corrosion.

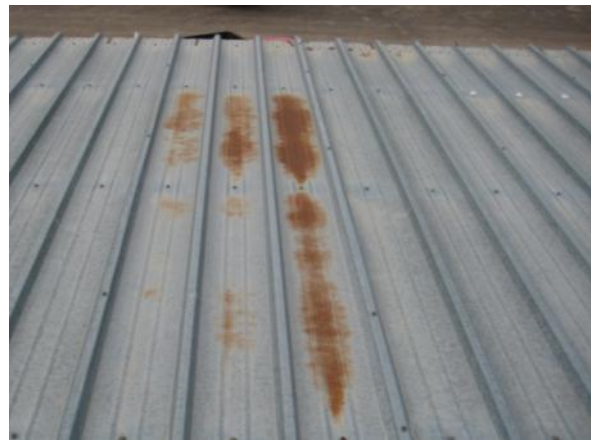
SD-M-1: Localized loss of applied finish or localized metal corrosion.

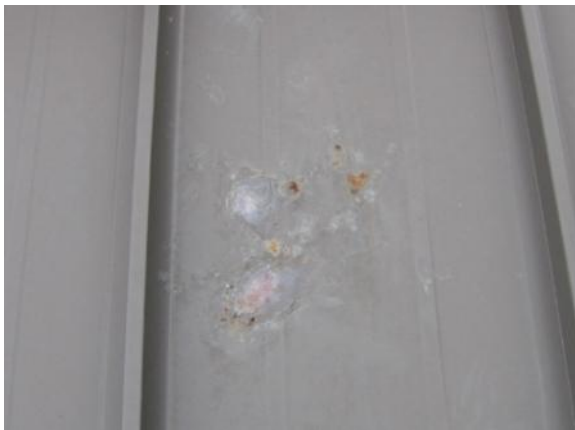
SD-H-1: For panel system that has mechanically interlocked seams, panel has corrosion holes that require localized repair .

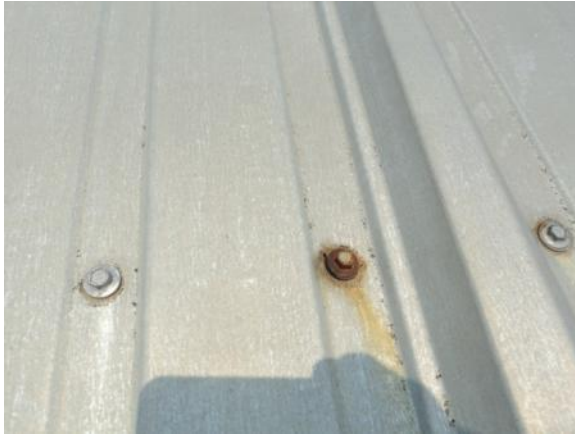
PF-M-1: Fastener has no flexible gasket (where one was originally installed) or has a flexible gasket that is deteriorating but appears to be watertight; or fastener is corroded, improperly seated, or has a sealant repair but appears to be watertight.

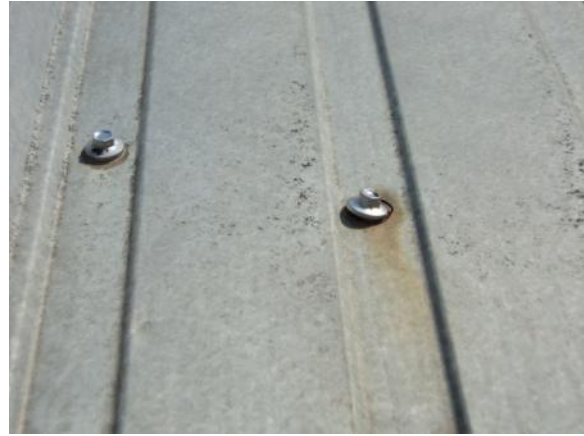
PF-H-1: Fastener, flexible gasket (where one was originally installed) and/or metal washer is loose, deteriorated or missing; allowing water to penetrate the roofing system; or fastener has an enlarged hole that is allowing water to penetrate the roofing system.

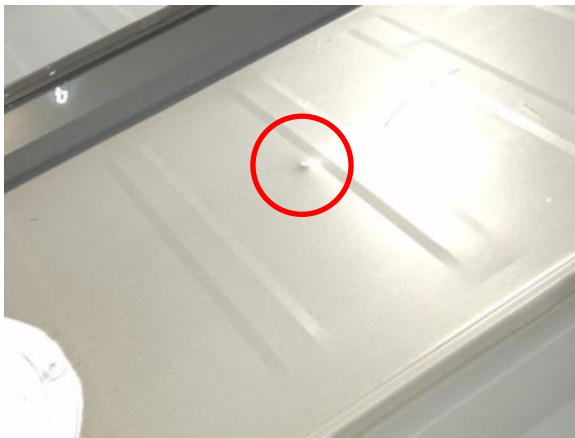
DP-L-1: Panel is dented, deformed, or kinked with no deformation of the seam, no loss of coating, and no corrosion; and appears to be watertight.

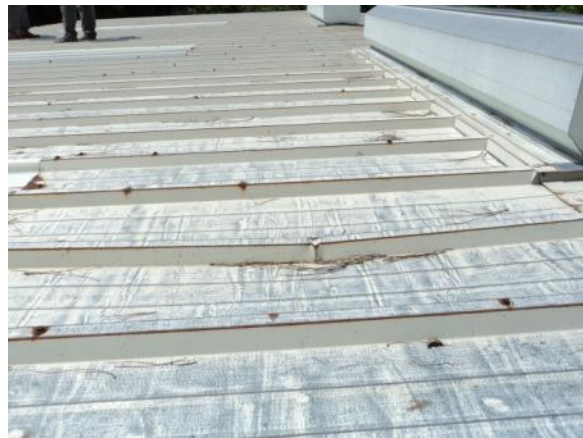
DP-M-1: Panel is dented, deformed or kinked, allowing ponding water and/or corrosion.

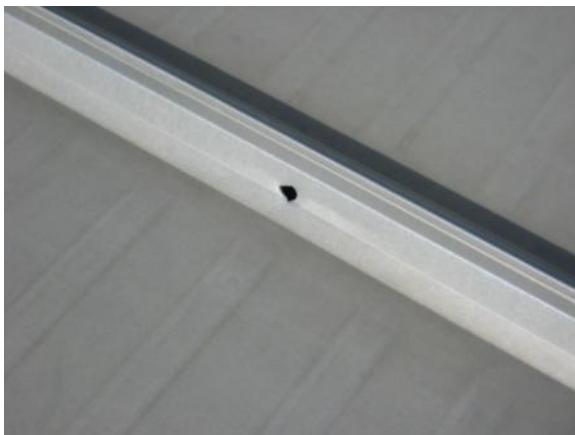
DP-H-1: For panel system that has mechanically interlocked seams, panel has holes, splits, or tears that require localized repairs.

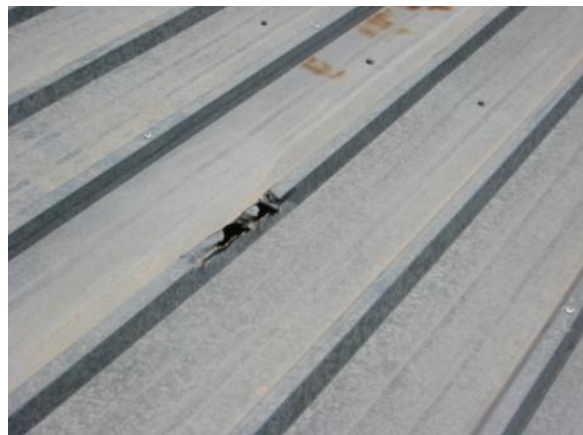
DP-H-2: For panel system that does not have mechanically interlocked seams; panel has holes, splits, or tears that require panel replacement.

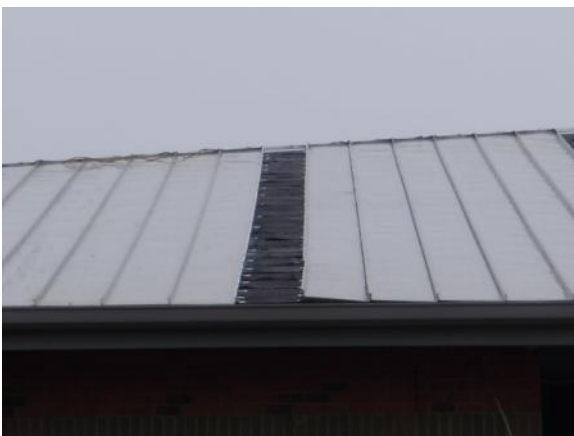
DL-H-2: Panel is missing and requires replacement.

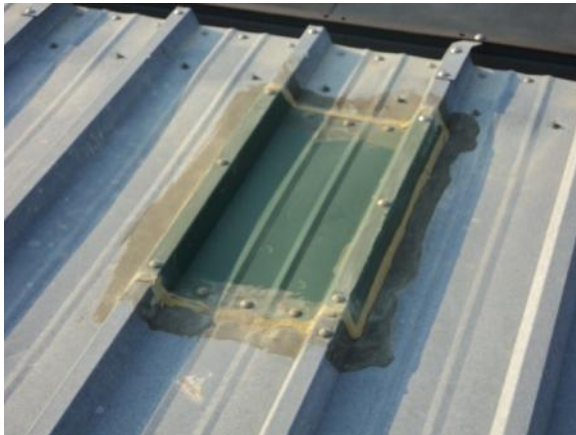
PA-L-1: Panel patch appears to be performing a water-proofing function, appears to be watertight, and does not require a more permanent repair.

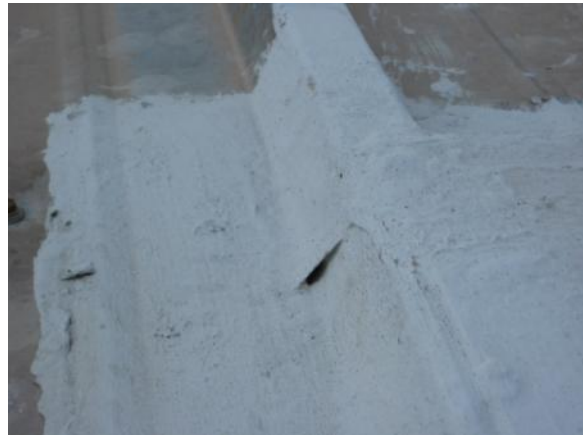
PA-H-1: Panel patch is allowing water to penetrate the roofing system.

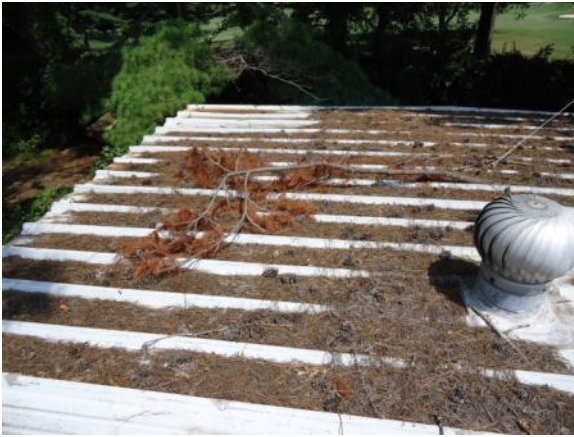
DV-M-1: A collection of foreign objects or vegetation not removed from the roof during the inspection; or grease, solvent, or oil drippings on the roof that cause no degradation of the panel's applied finish.

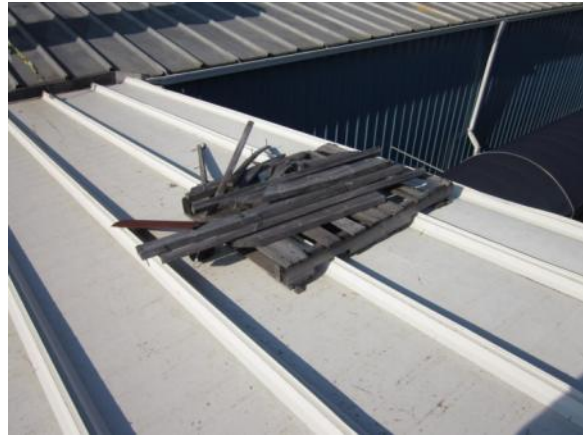
DV-M-1: A collection of foreign objects or vegetation not removed from the roof during the inspection; or grease, solvent, or oil drippings on the roof that cause no degradation of the panel's applied finish.

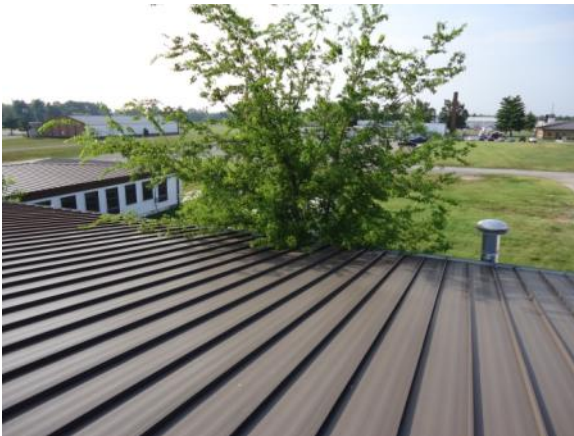
DV-M-2: Evidence of tree branches making contact with the roofing system.

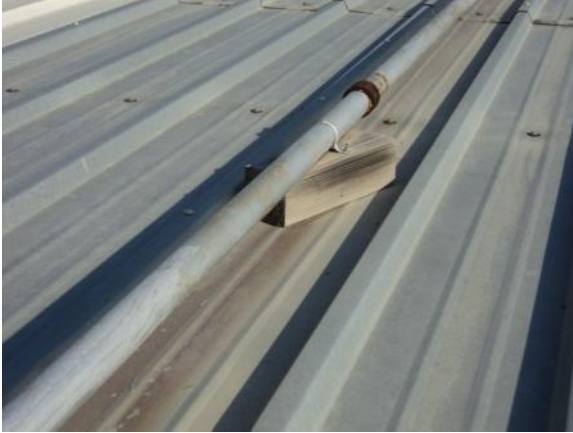
EQ-L-1: All improper equipment supports are rated low severity as a minimum due to the maintenance problems associated with them.

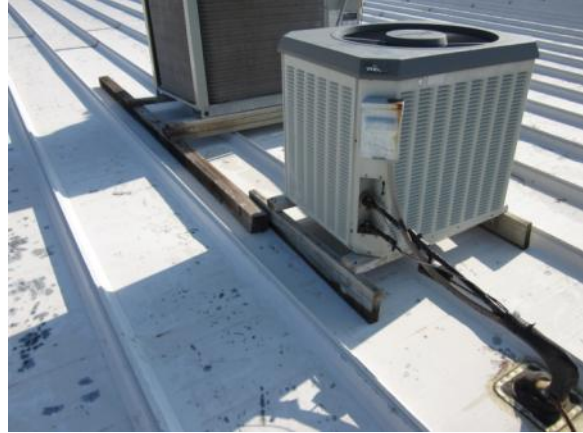
EQ-L-1: All improper equipment supports are rated low severity as a minimum due to the maintenance problems associated with them.

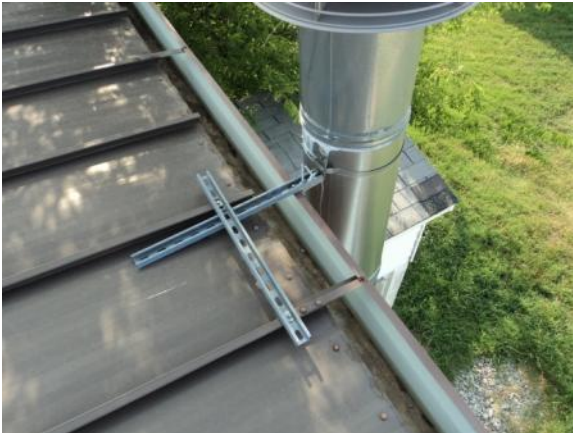
EQ-H-1: The equipment support is bolted or fastened through the metal panel seams or flashing and allowing water to penetrate the roofing system.

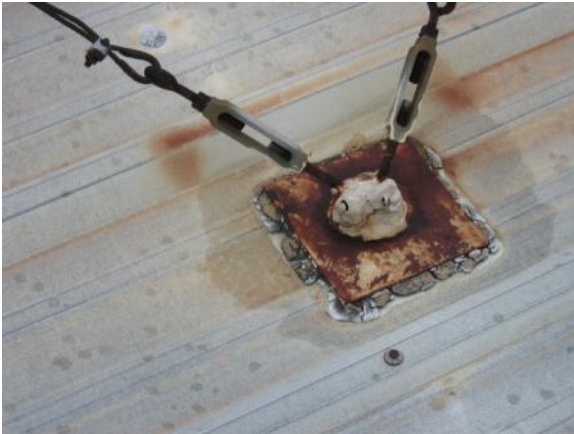
EQ-H-2: The equipment support has caused damage to surrounding panels and is allowing water to penetrate the roofing system.

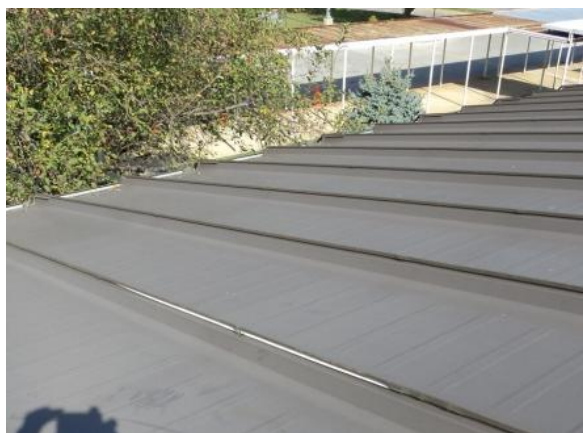
MS-H-1: Seam is open or allowing water to penetrate the roofing system; or seam is disengaged.

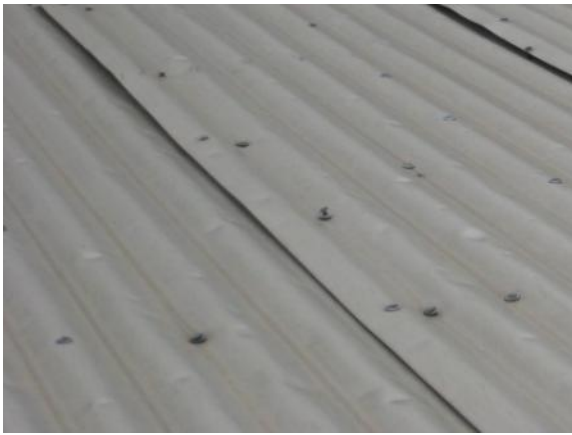
LS-H-1: Seam is open with no panel deformation, requiring localized repair.

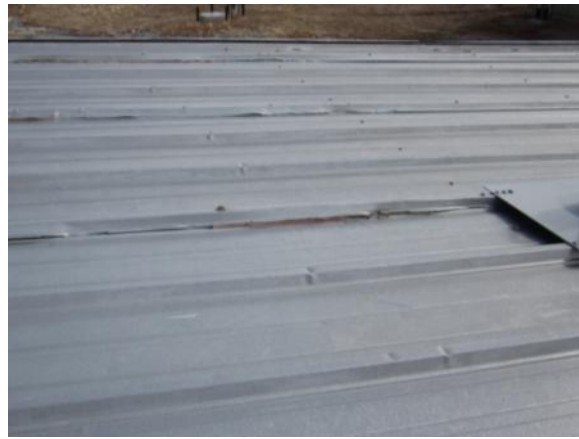
LS-H-2: Seam is open due to panel deformation, requiring panel replacement.

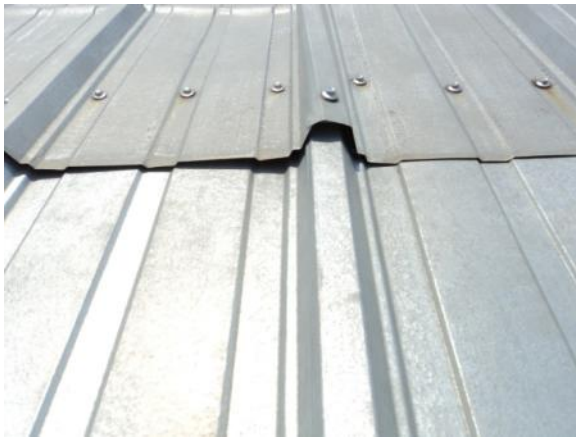
PL-M-2: End lap joint between panels has failed sealant or open fishmouths.

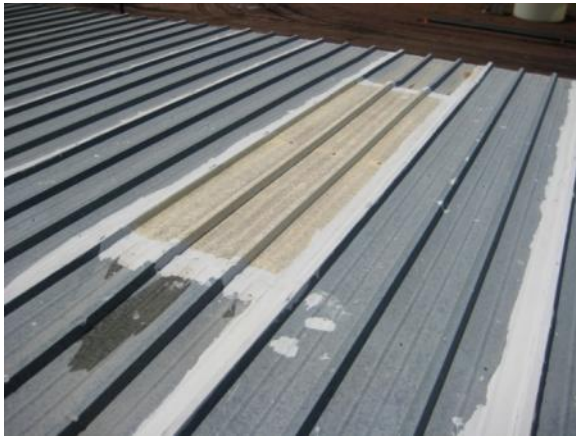
SP-L-1: Integrated skylight panels are rated low severity as a minimum due to their shorter service life as compared to the metal roofing system.

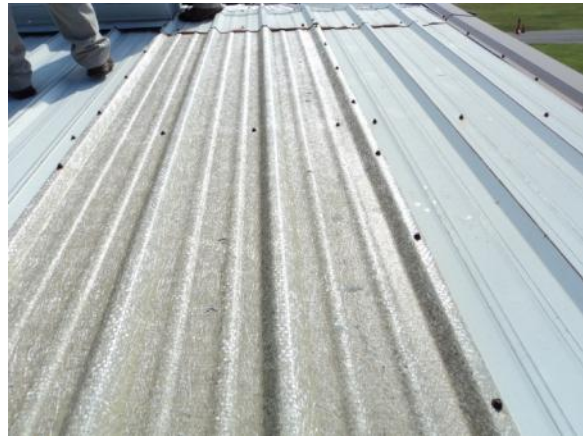
SP-M-1: Skylight composite material exhibits visible fibers, significant discoloration or other signs of degradation.

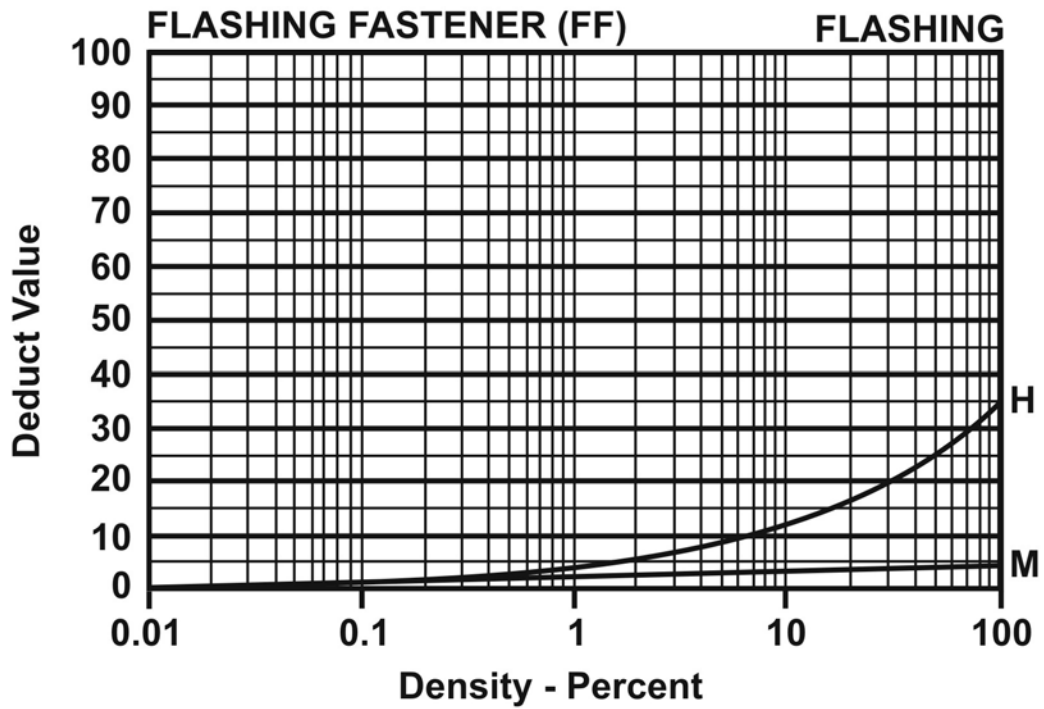
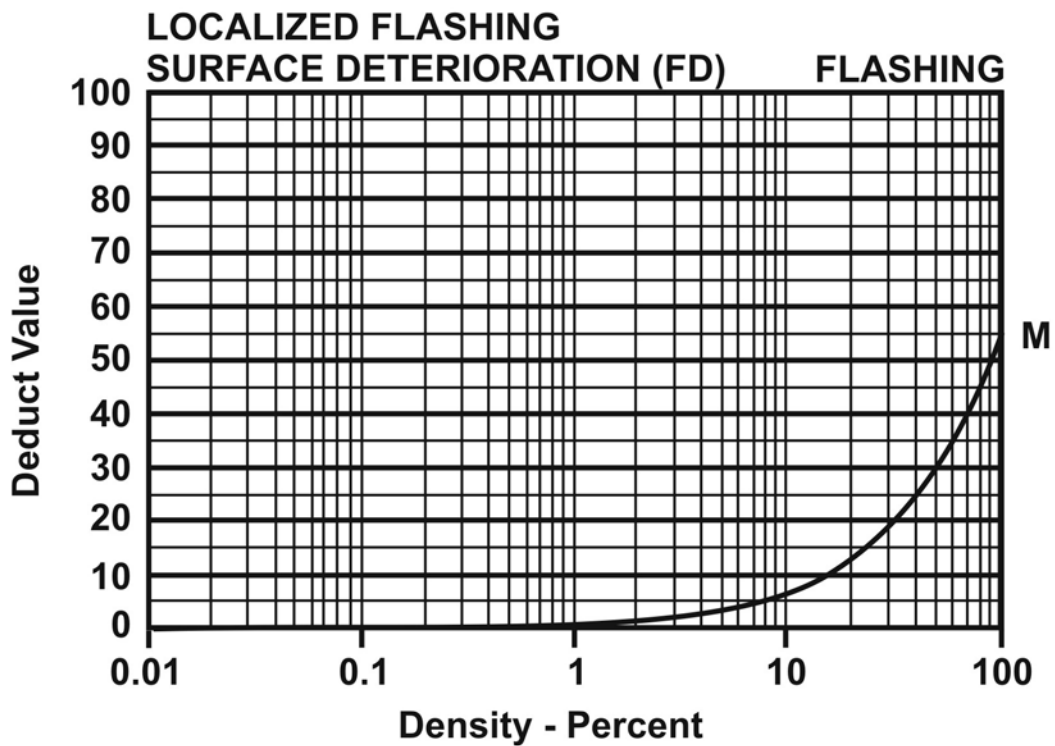
Appendix A: Deduct Value Curves

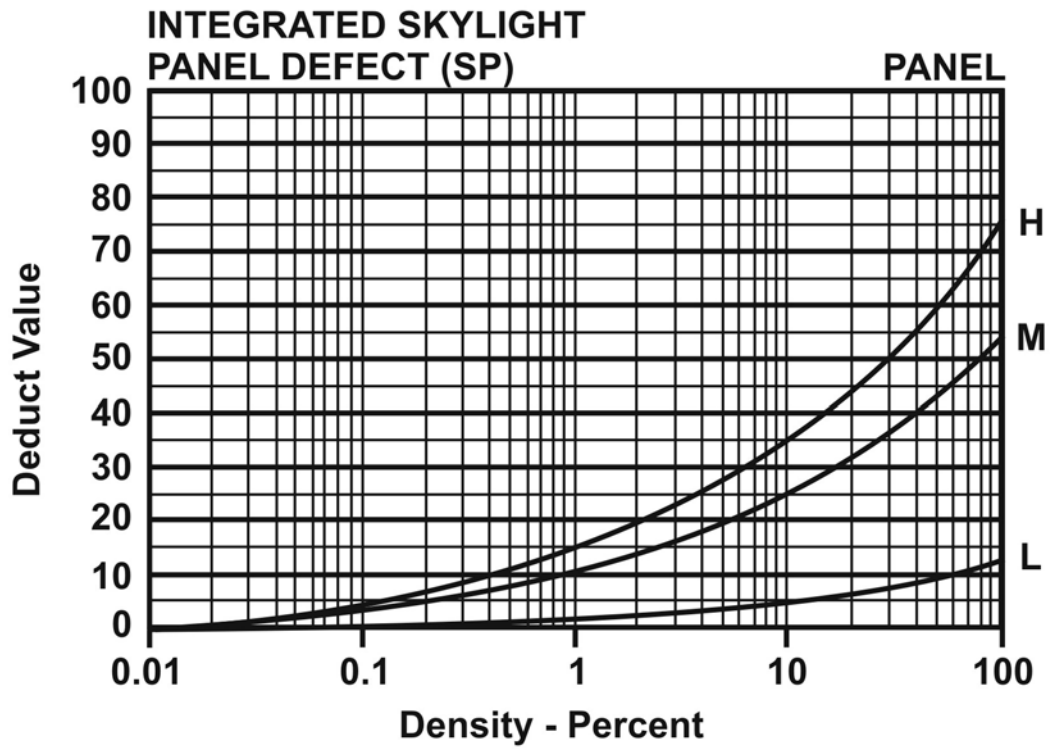
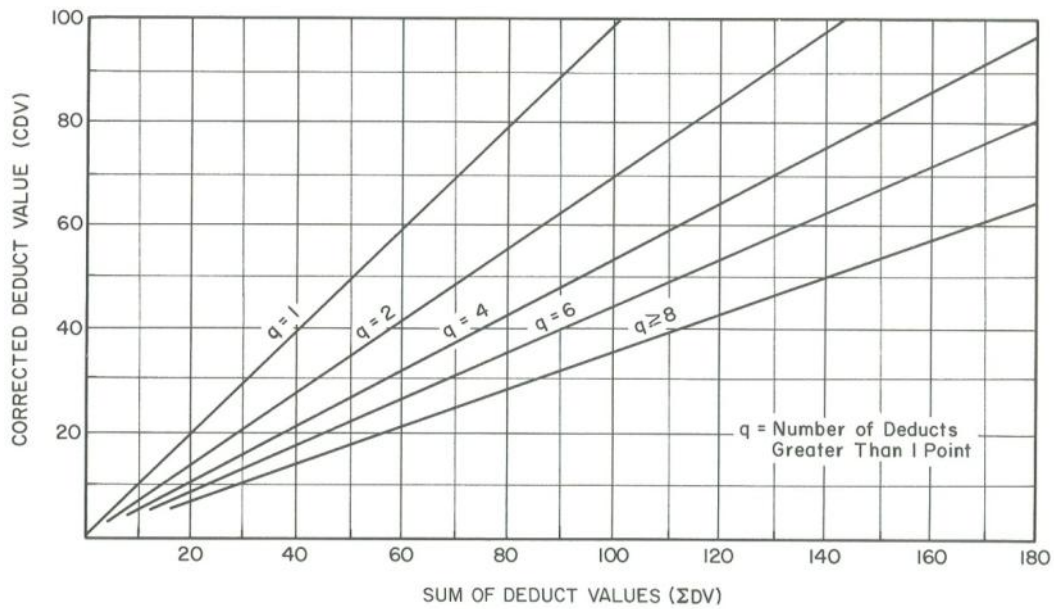
Corrected Deduct Values for Panels.
