**US Army Corps
of Engineers®**
Engineer Research and
Development Center

ERDC
INNOVATIVE SOLUTIONS
for a safer, better world

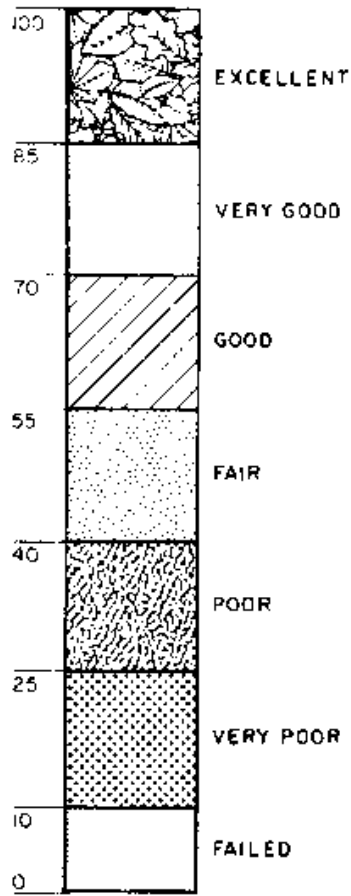
FR -Flashing Patch													
DIS	SEV	QUANTITIES		TOT	DEN	DV	DIS	SEV	QUANTITIES		TOT	DEN	DV
EA	H	4+2+10		16	2.8	6	SP	L	112		112	6.91	7
CP	H	20+10		30	5.2	14	MS	H	35+20		55	6.94	15
FM	H	4		4	0.76	2	MS	L	10		10	6.08	2
							PF	M	6		6	1.1	7
							DP	L	44		44	0.36	7
CORRECTED DEDUCT VALUE (CDV)						14	CORRECTED DEDUCT VALUE (CDV)						17
FCI = 100 - CDV =						86	FCI = 100 - CDV =						83
FLASHING RATING						EXCELLENT	PANEL RATING						VERY GOOD
